Preview of PCI's New Zealand earthquake reconnaissance team report

Precast concrete structural design in New Zealand

Case study: PricewaterhouseCoopers office building

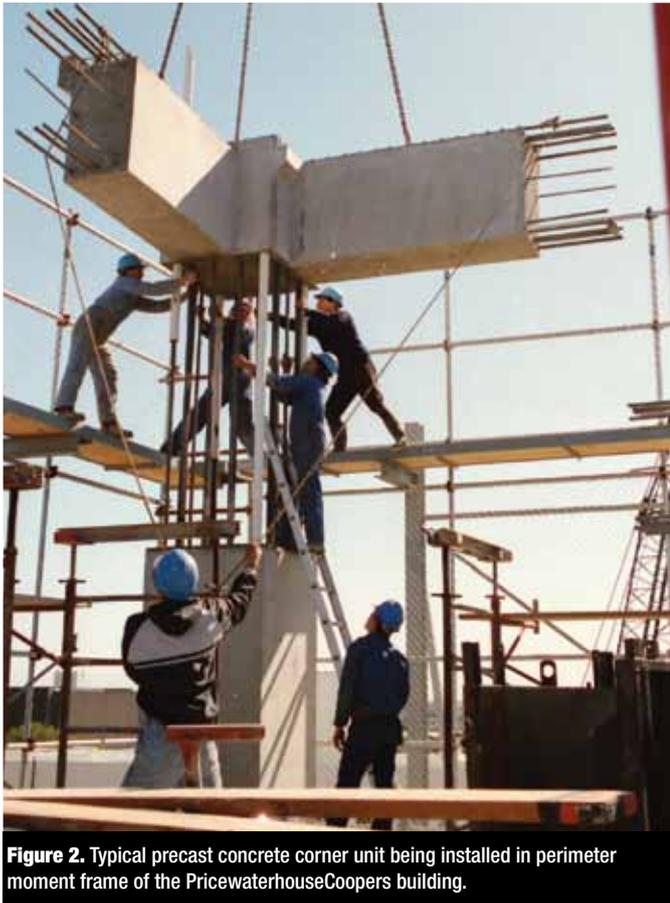
The 21-story PricewaterhouseCoopers office building was constructed in the 1980s (**Fig. 1**). It was designed with an exterior moment-resisting frame and constructed using a detail in which the precast concrete joint (**Fig. 2**) is placed over the column below. Vertical ducts in the precast concrete joint allow the vertical reinforcement from the column to be threaded through and into the column above. The ducts are grouted once the joint is in place.¹

Figure 2. Typical precast concrete corner unit being installed in perimeter moment frame of the PricewaterhouseCoopers building.

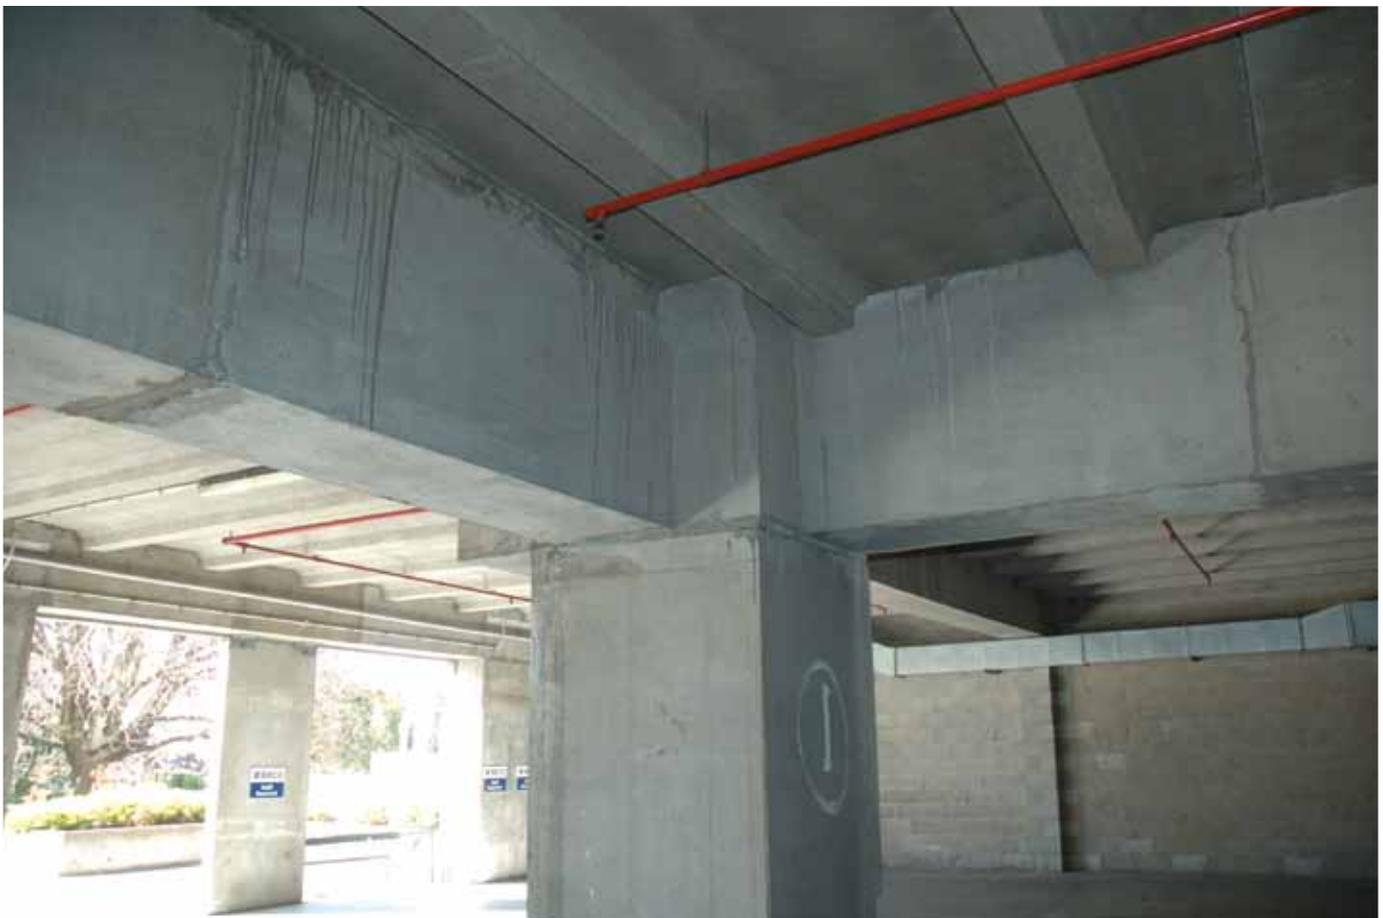
Figure 3 shows the perimeter moment-resisting frame (background) and the interior “gravity” frame (foreground) following the earthquake of February 22. As can be seen, the columns are more closely spaced in the perimeter frame.

Figure 3. Corner joint in first-level parking podium area after February 22, 2011, earthquake in New Zealand. Photo courtesy of Franz Kahn.

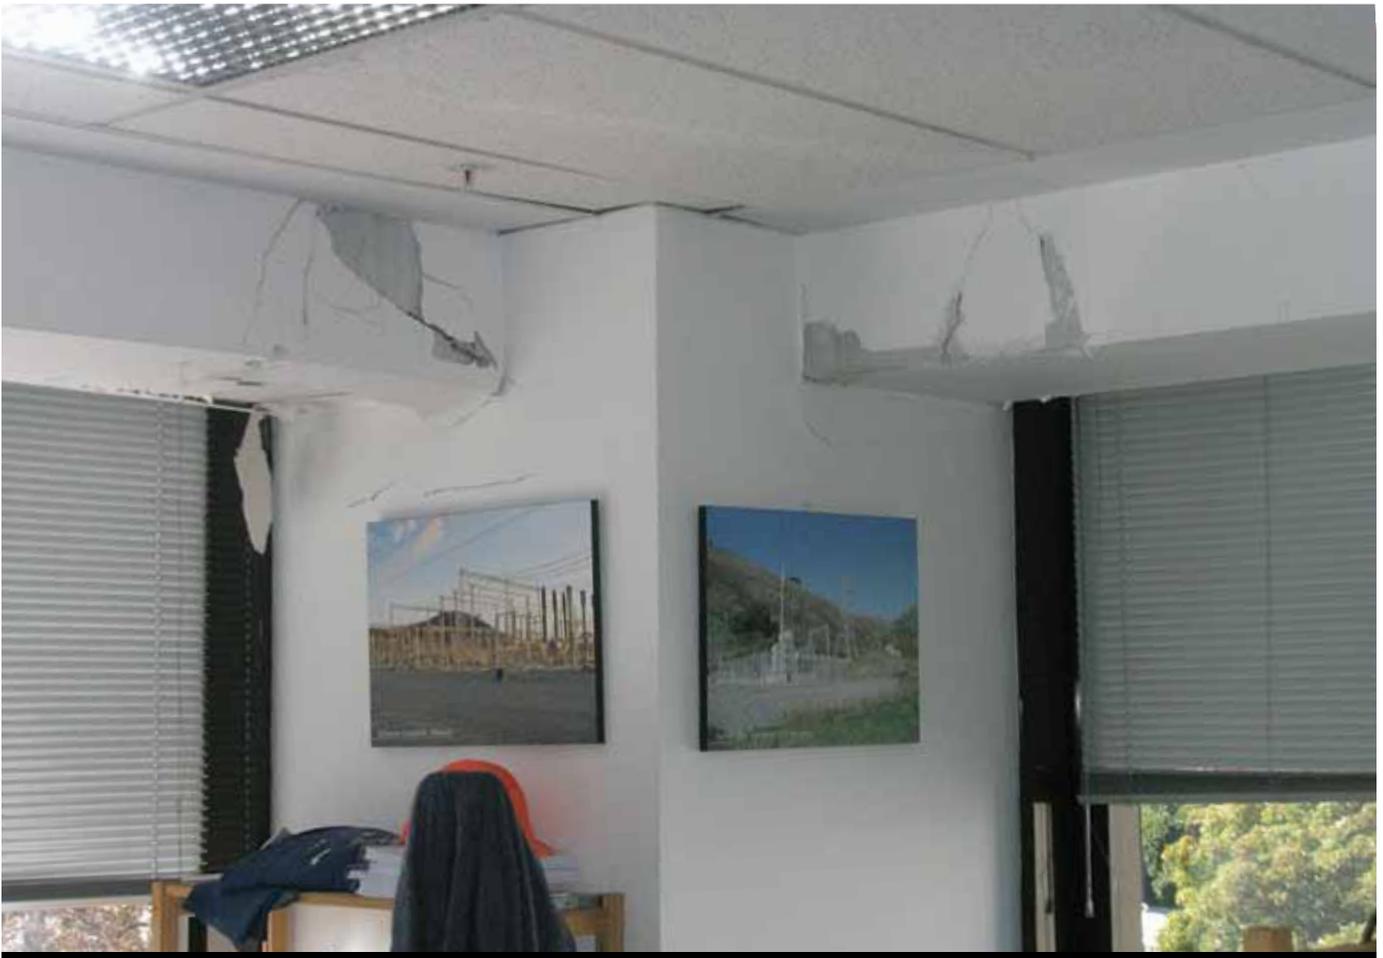
A visual survey of this building by the authors showed a pattern of damage consistent with capacity design (**Fig. 4**). The lowest two floors, situated above a parking garage and undergoing less deformation, showed no plastic hinging. The lower- to midlevel floors showed the greatest beam de-

formation and damage, and the upper floors less damage. Figure 4 shows the damage to the perimeter frame on the interior of the 10th floor. The north-south beam exhibits flexural-torsional cracks from earthquake displacement perpendicular to the frame, while the east-west beam exhibits flexure cracks. The authors judge that the flexural cracking observed does not reduce the strength of the beams and does not substantially diminish their continued deformation capacity or the ability of the structure to resist future earthquakes.

The exterior moment-resisting frame of the PricewaterhouseCoopers building performed as intended, forming the desired flexural plastic hinges at the ends of the beams. No structural damage was observed in the columns. Where the damage was greatest, cracking and flexural torsion were associated with these hinges. The extent of the damage is not surprising given the extreme intensity of the earthquake motions. The authors judge the office building to have met or exceeded its design requirements to avoid collapse in the maximum considered earthquake.

Figure 4. Corner joint in upper floor indicated damage suffered in February 22, 2011, earthquake in New Zealand. The north-south beam (upper left) exhibits flexural-torsional cracks, while the east-west beam (upper right) exhibits flexure cracks.
