**EVALUATION OF NDT METHODS FOR CONDITION ASSESSMENT
OF POST-TENSIONING TENDONS
IN PRECAST BALANCED CANTILEVER CONCRETE BOX GIRDER BRIDGES**

Juan José Goñi, Ph.D., P.E., DMJM+HARRIS, Inc., Tallahassee, FL
Rafael Foinquinos, Ph.D., P.E., DMJM+HARRIS, Inc, Coral Gables, FL
Larry Sessions, P.E., Florida Department of Transportation, Tallahassee, FL

BRIDGE DESCRIPTION – RAMP D FORT LAUDERDALE-HOLLYWOOD INTERNATIONAL AIRPORT

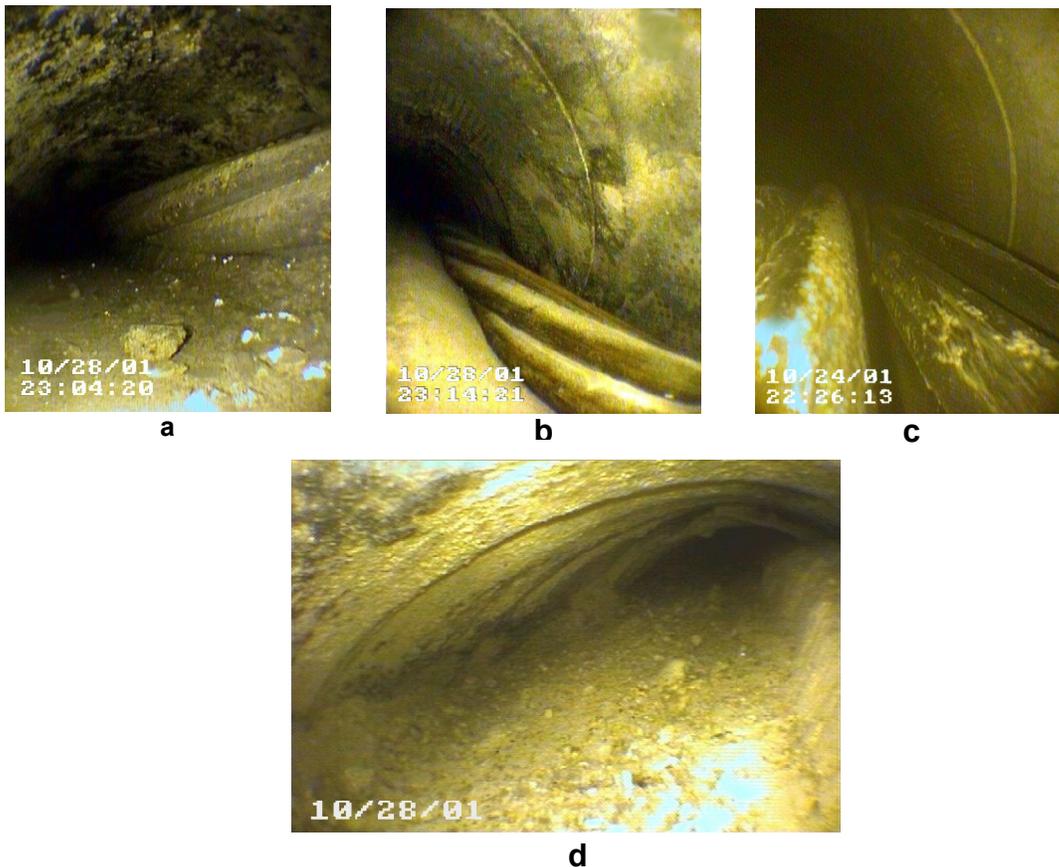
Figure 5 – Photos a and b show duct partially grouted with strand exposure. Photo c shows voided duct with strands fully exposed. Photo d shows partially grouted duct, no strands exposed.

It appears that the small voids are the result of bleed water accumulation and subsequent evaporation. The large voids with exposed tendons were the obvious result of poor grouting procedure. In most of these locations the strands presented moderate signs of superficial corrosion. Voids with water present were probably due to deck cracks at duct joint locations, and in these cases it was not possible to assess the conditions of the strands (exposure and signs of corrosion) due to the difficulties of using the endoscope in a humid environment.

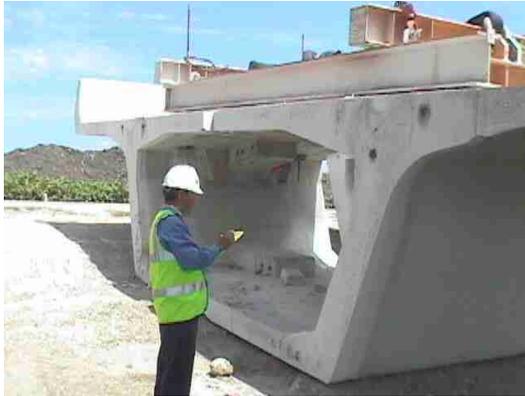
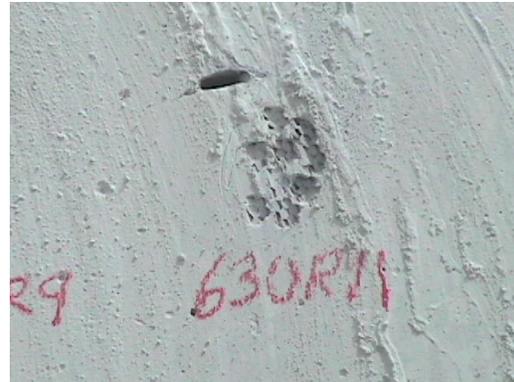
Figure 13 and 14 - Inspection of the segments removed from bridge

In addition to the core drilling, a total of nine segments from span 5 and 6 were inspected after their disassembly. Most of the bridge was demolished using a concrete crushing machine that demolished the concrete segments in place. Only sections of the bridge on spans 5 and 6 were disassembled by cutting across the bridge cross section at the segment joints using a wire cutting machine. Some of these segments were visually inspected before the demolition. Figure 13 shows one of the disassembled segments, and Figure 14 shows a tendon duct with a small void, which was typically found in most of the ducts. A total of 216 points were inspected and, again, voids smaller than $\frac{1}{2}$ " deep were reported as small voids. The statistics of this inspection shows that approximately 70% of the locations were classified as small voids, 10% as voids and 20% as fully grouted ducts. It should be noted that the strands in the ducts with small voids were mostly encased within the grout.

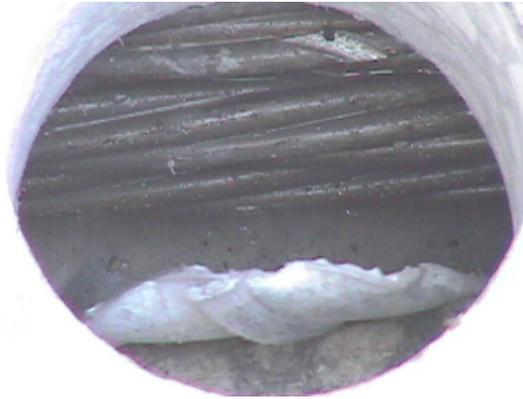
Figure 15. Tendon No. 10, core drilled at segment No. 54.

The last test location was at Tendon No 10 in Segments No. 54, 55 and 56 in the Southern portion of the bridge (a total of 22 points were tested). This tendon was found completely voided during the endoscopy inspection and, later, during the inspection of the segments after deconstruction. Picture No. 15 shows this tendon at the hole drilled in Segment No 54. The strands can clearly be seen with no sign of grout. Although this tendon was completely ungrouted, no signs of corrosion were found. In this location professor Ghorbanpoor reported evidence of grout voids in Segment No. 56, and no strong indications of any significant void in Segment No. 55. Possibly, some of the points tested were not located exactly over the tendon ducts which would explain why no clear wave reflection from the voided ducts were found in some areas.

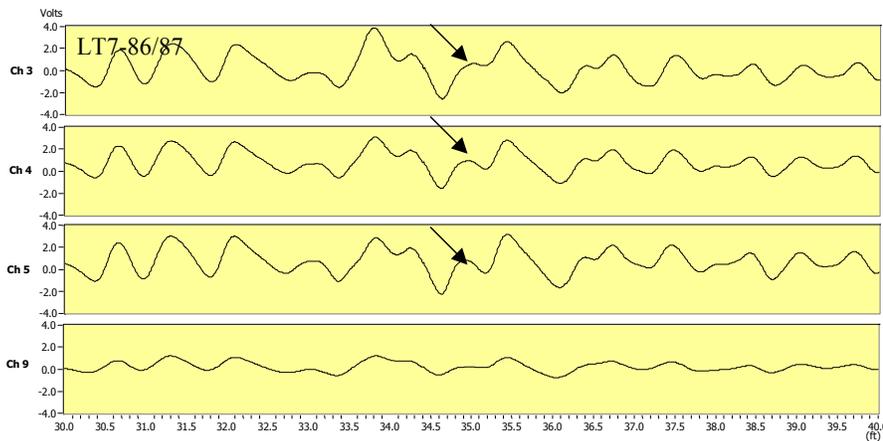
Location 1: Two strands were cut in tendon 7 (16.7% of tendon area) in the North (left) part of the bridge at the up station edge of segment 89. Tendon 9 was chosen as the control tendon. In this case, the starting point for the test was the centerline of pier No. 7. Figures 17 and 18 graphically display the MFL data for tendons 7 and 9, respectively. The data shown represents the 10 ft length beginning at a distance of 30 ft from the starting point of the test. Professor Ghorbanpoor explains that the data for tendon 7 reflects an indication for

the possible presence of a flaw at approximately 35 ft from the starting point of the test. This point corresponds exactly to the location of the man-made flaw. He indicates that the signal amplitude pattern at that location is similar to that observed in the laboratory tests. He also indicates that the MFL data for tendon does not reveal a pattern associated with a flaw. The results of his comparative analysis correctly identify the flawed and control tendon.

Figure 17 - MFL signals (4 channels) for tendon # 7 between segments 86 and 87 (data for 5 feet of the tendons on both sides of the joint between segments 86 and 87)

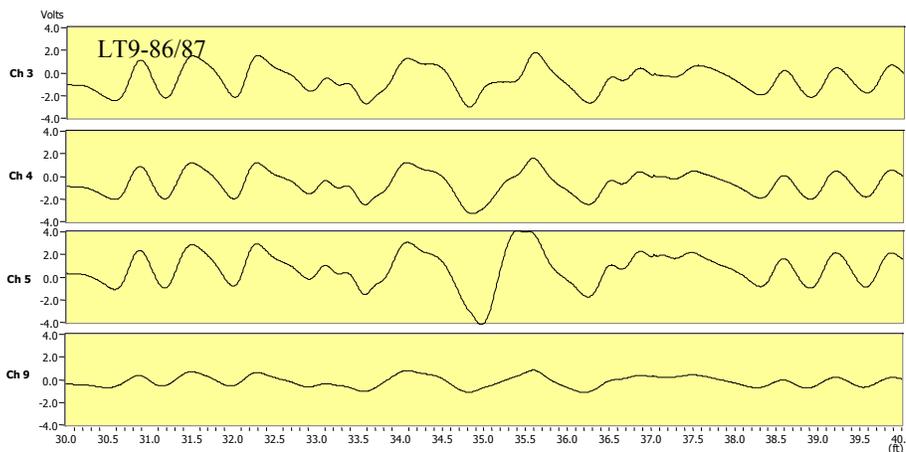
Figure 18 - MFL signals (4 channels) for tendon # 9 between segments 86 and 87 (data for 5 feet of the tendon on both sides of the joint between segments 86 and 87)
