**STATUS OF POST-TENSIONING CONDITION EVALUATIONS AND  
ENHANCEMENTS**

**Jerry L. Potter, P.E.**, Office of Bridge Technology, Federal Highway Administration

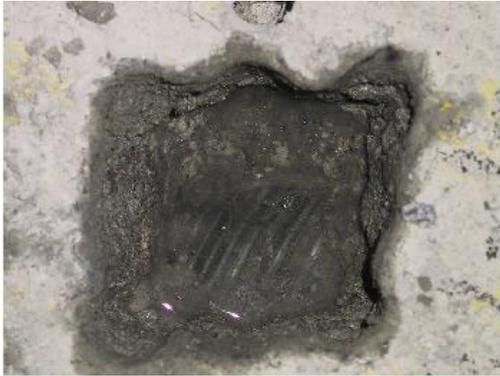
Fig. 1 Drilling to Duct

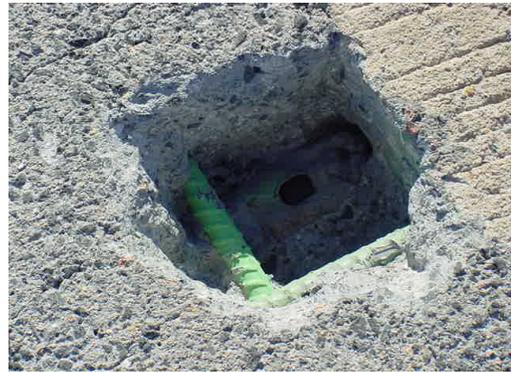
Fig. 2 Removal of Concrete

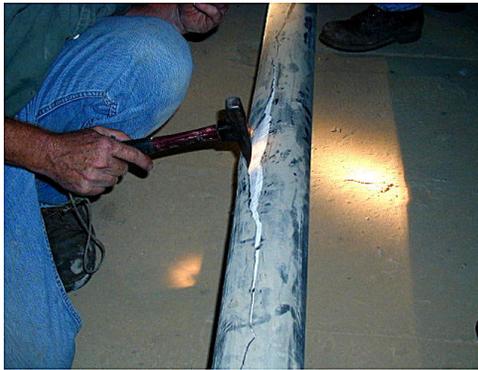
Fig. 3 Cracked PE Duct

Two methods of repair of cracked PE ducts have proven successful. One consists of wrapping the pipe with sheet material and heat shrinking around the existing PE duct. The other consists of the addition of an outer new PE duct by using a split PE pipe with couplers and grouting the annular space between the old and new pipe. The split PE pipe repair concept is reflected in Figure 16 below.

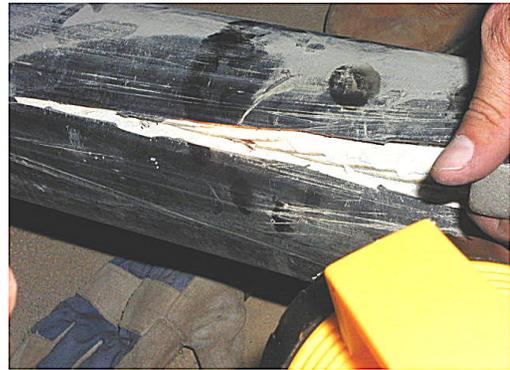
Fig. 4 Cracked PE Duct

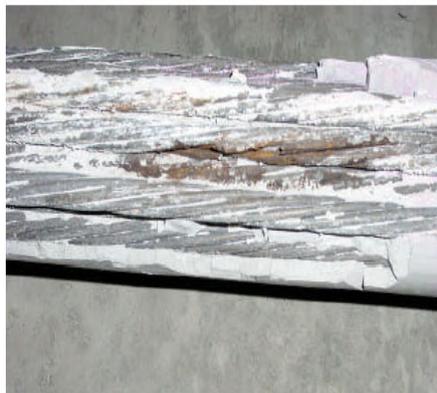
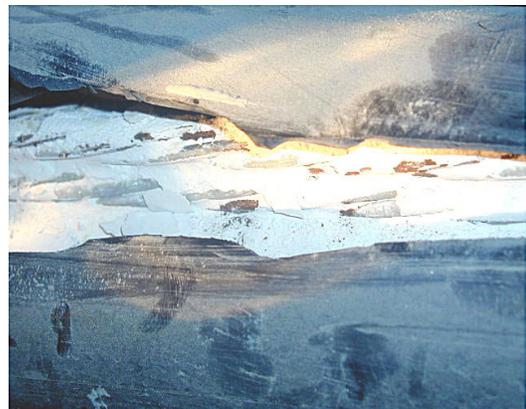
Fig. 5 Strand Corrosion from Cracked PE Duct

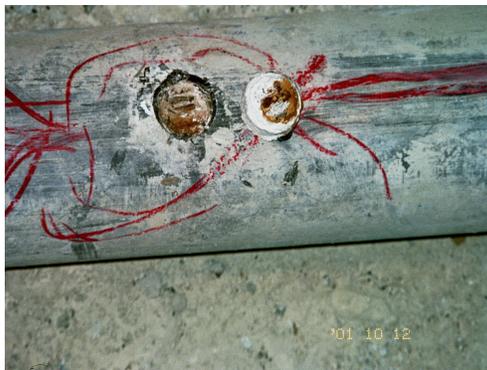
Fig. 6 Hole in PE Duct

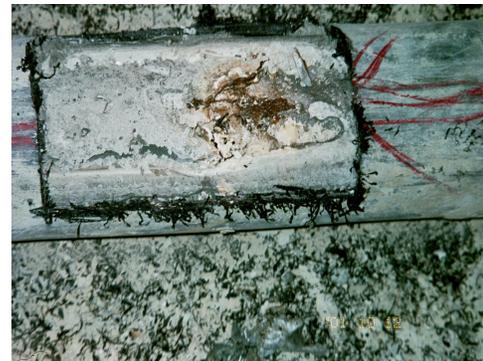
Fig. 7 Localized Strand Corrosion at Hole

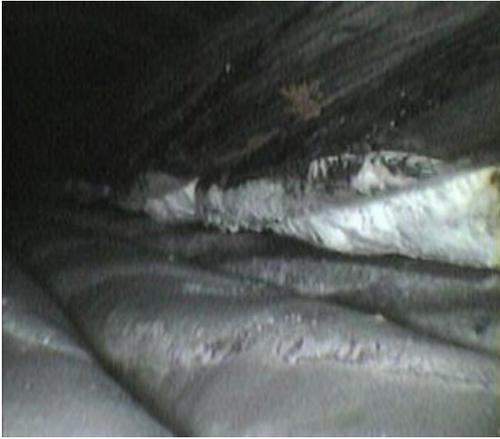
Fig. 8 Void With Strands Exposed

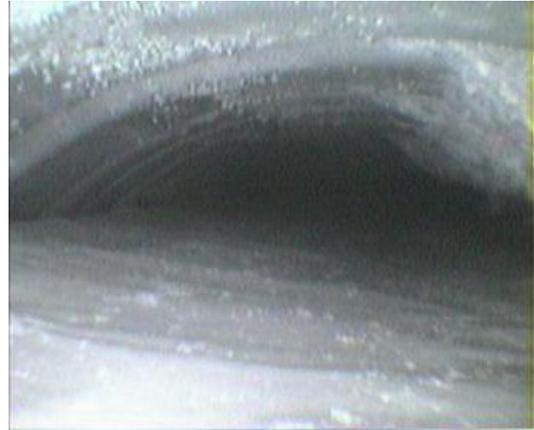
Fig. 9 Void without strands exposed

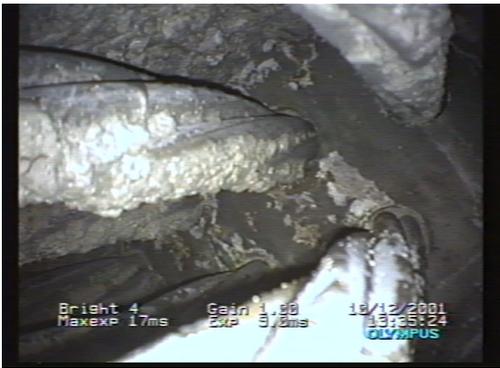
Fig. 10 Void in Top of Duct Existing Construction

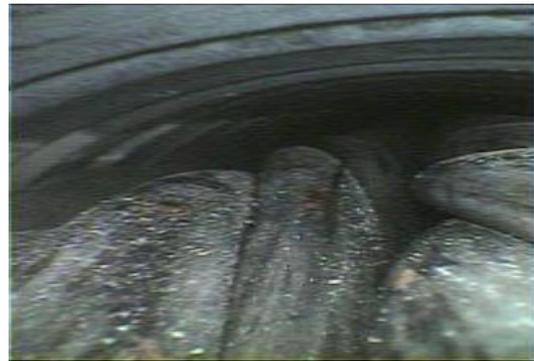
Fig. 11 Void in Top of Duct Recent Construction

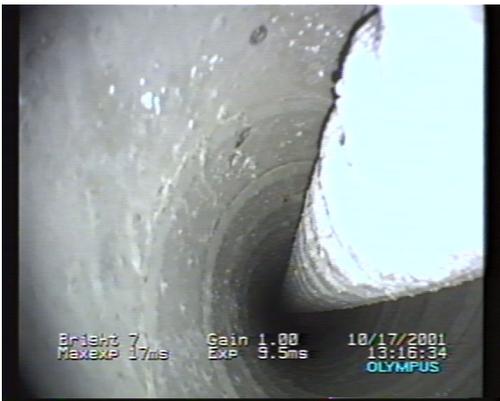
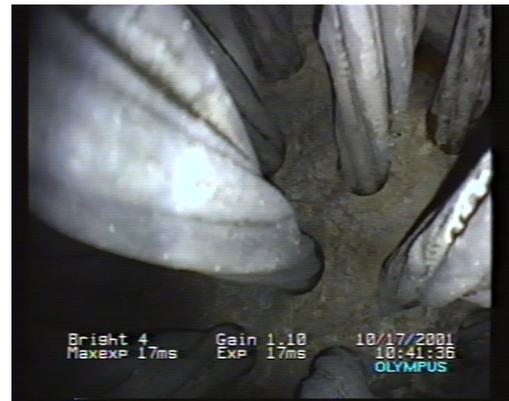
Fig. 12 Vertical Tendons With Void

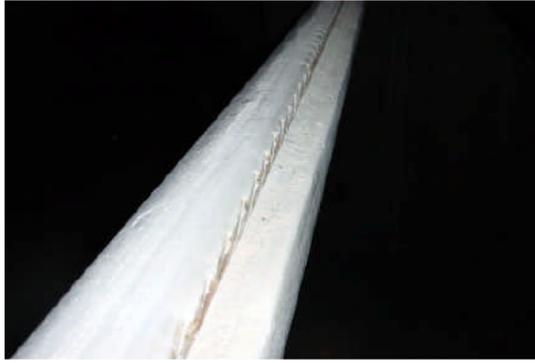
Fig. 13 Bleed Trail in Draped Tendon  
PE Pipe Removed

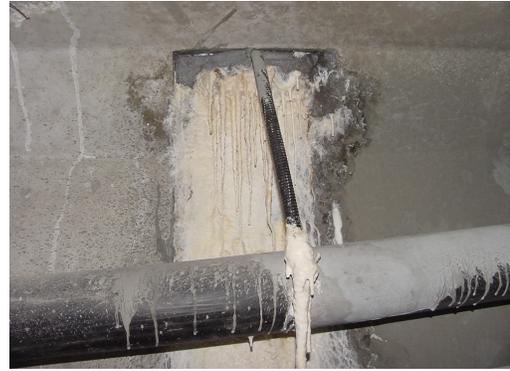
Fig. 14 Efflorescence from Anchorage

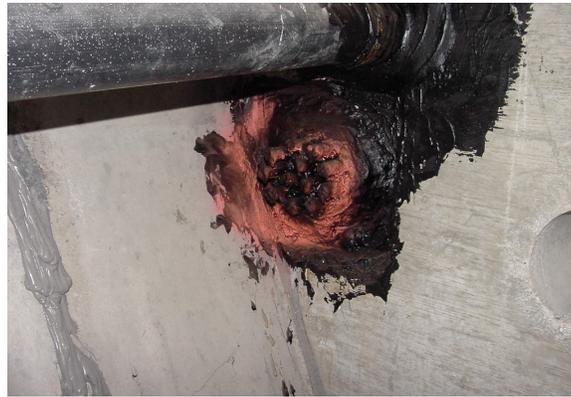
Fig. 15 Exposed Unprotected Anchorage

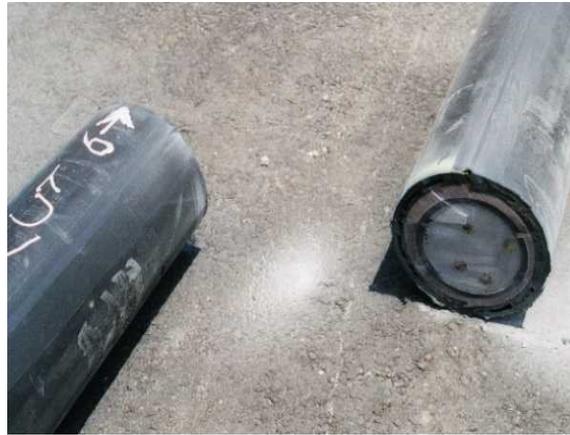
Fig. 16 Split PE Pipe Repair

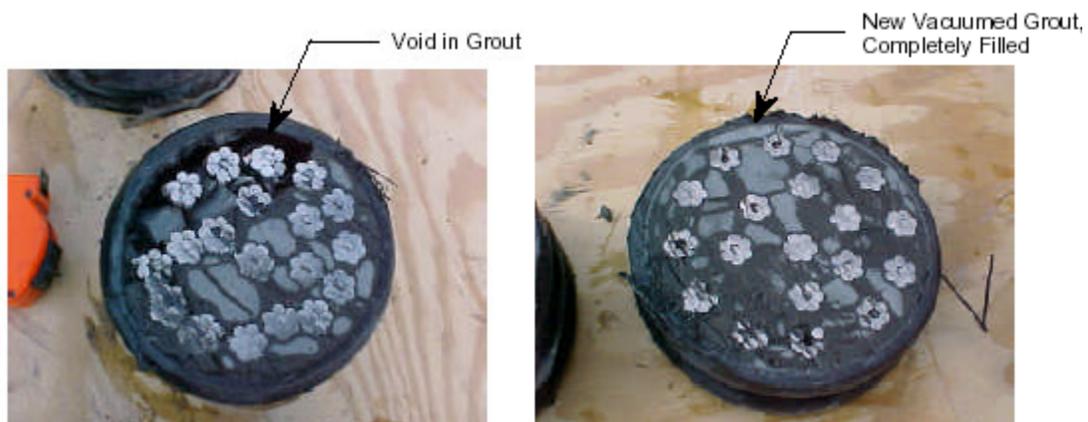
Fig. 17 Voids left with Pressure Grouting

Fig. 18 Voids filled with Vacuum Grouting

Two methods of filling voids that have proven successful are pressure grouting and vacuum grouting. Vacuum grouting has proven very successful for small voids such as in anchorage zones or high places in draped tendons. It is not efficient for large voids or long runs of ungrouted ducts. Pressure grouting is more efficient for large voids, but may be unsuccessful in filling the complete void if grout inlet and outlet locations are restricted. Figures 17 and 18 below reflect the effectiveness of the two methods as provided in a mock-up test performed for FDOT.

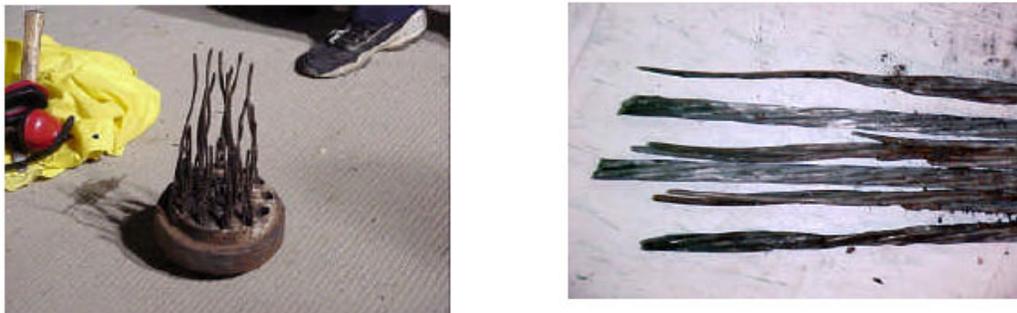
The more recent information somewhat eases the concerns for wide scale severe corrosion problems with post-tensioning tendons and the integrity of post-tensioned bridges as previously reported for some structures and reflected in Figure 19 below. However, the current information clearly supports the need to improve the quality of post tensioning grouting operations to ensure the long-term integrity and service life of post-tensioned bridges. The findings to date reflect weaknesses in several work areas including materials specifications, grouting specifications and procedures, design details and inspection and construction quality.

Fig. 18 Condition of Removed Tendon at Anchorage
