SURPRISES INSIDE POST-TENSIONING DUCTS AND REMEDIES

Vijay Chandra, P.E., Parsons Brinckerhoff Quade & Douglas, Inc., New York, NY
Anthony L. Ricci, P.E., Massachusetts Turnpike Authority, Boston, MA
Daryl Sargent, Bechtel Corp., Boston, MA

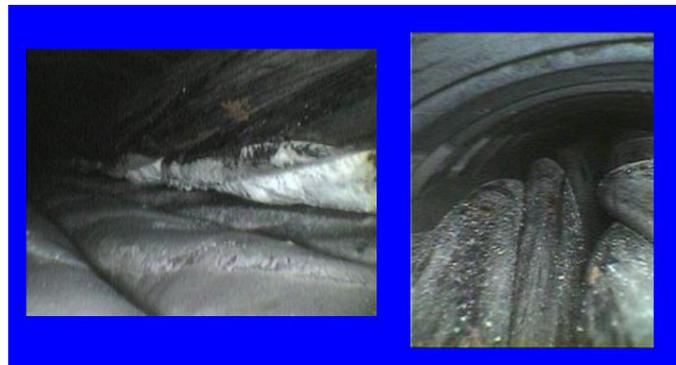
Voids in the draped ducts were more prone to contain bleed water. Approximately 40% of the voids contained several liters of water. This water was tested with litmus paper which indicted the PH level to be 14, which is the same alkalinity as

the water tested from a standard bleed test. After the water was drained, visual inspection using a boroscope revealed that the strands were exposed but did not show any visible

Fig. 12: Boroscope examination revealing partially and totally ungrouted tendons

evidence of corrosion. The voids in the horizontal ducts were usually dry and shallow so that the strands were not exposed. However, some larger voids were identified that did have exposed strands and did contain water.

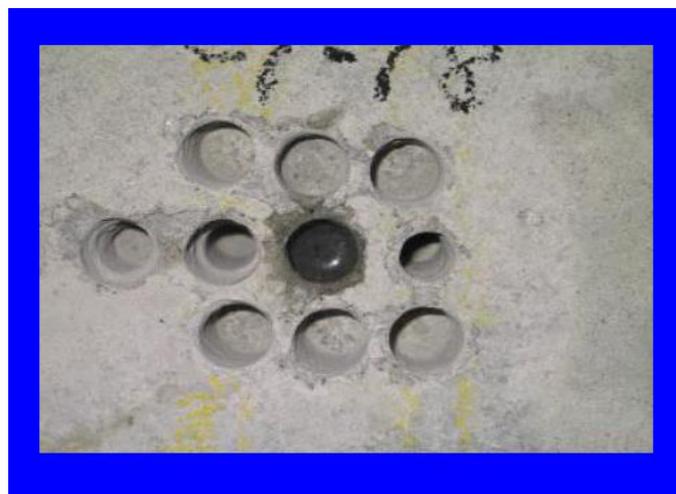
Fig. 13: Water seeping from drilled hole

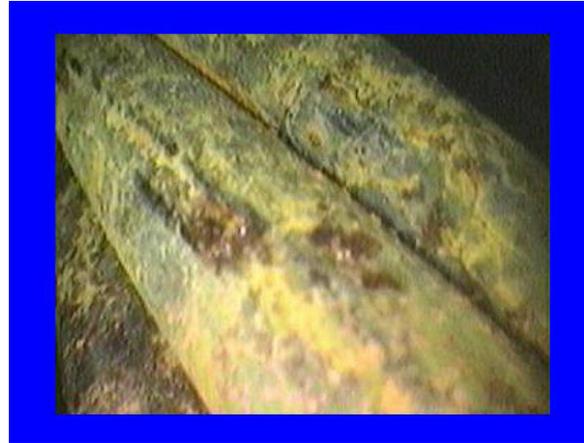
Fig. 14: Slight onset of strand corrosion

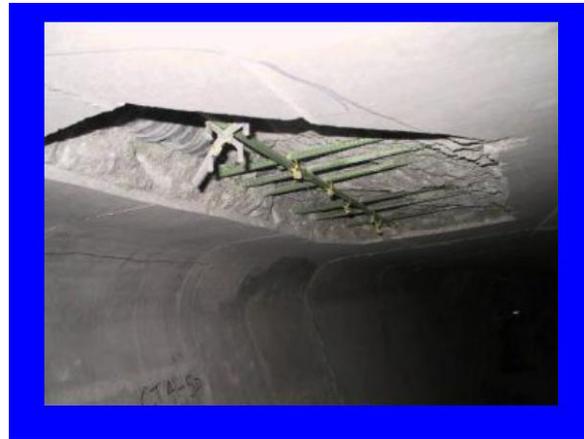
Fig. 15: Water entering ungrouted temporary tendons, creating freeze-thaw damage inside the top slab of segment

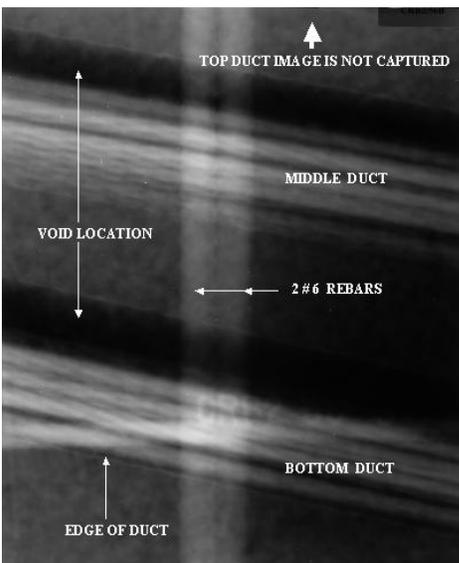
Fig. 19: X-ray image showing voiding

X-rays were also used as part of a blind test on ducts in the web walls of a cast-in-place structure (see Fig. 18). These were draped metal ducts, 4 inches in diameter that were centered in a web wall that was approximately 12 inches thick. Sixteen separate test areas were examined. The results of this testing method were found to be very accurate for all areas being evaluated. X-rays were able to show the degree of voiding and water in the ducts (see Fig. 19). The system has other positive features in that the equipment used is relatively portable; the film can be developed on site and used to guide any necessary excavations; interpretation of the film is not as complicated as some other testing methods; and the testing time is faster than drilling.

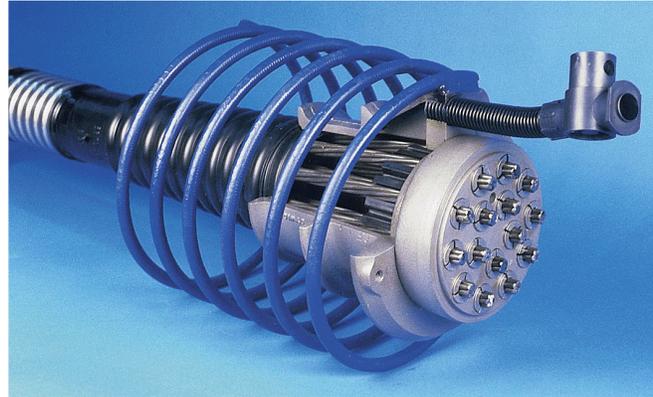
Fig. 21: Improved grout inspection access

- Added additional vent ports in bottom slabs
- Required all post-tensioning anchors to have permanent caps irrespective of concrete pour backs
- Enhanced grout inspection access (see Fig. 21)
- Improved waterproofing details to protect anchorages at expansion joints (see Fig. 22)
- Investigated improved methods to connect post-tensioned ducts at segment joints
- Enhanced sequencing details for grouting parabolic tendons (see Fig. 23)
- Dedicated grout inspection team

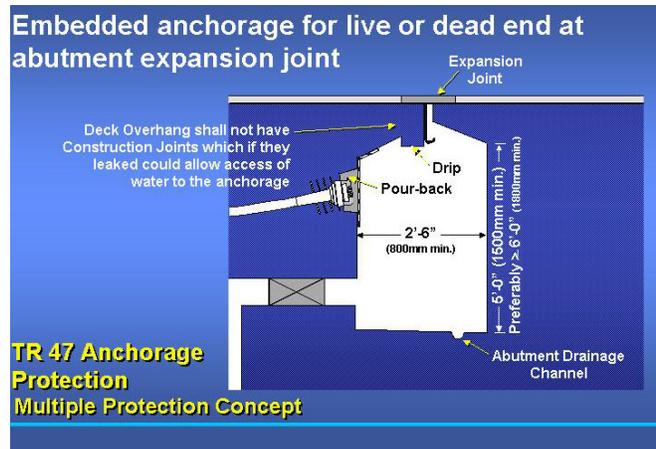
Fig. 22: Protection of anchorage at expansion joint

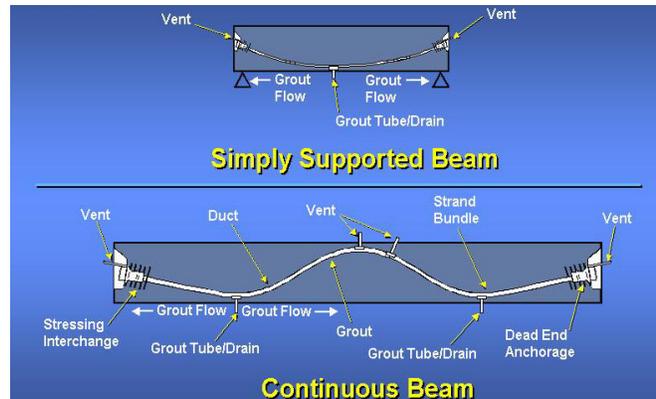
Fig. 23: Parabolic tendon grouting
