# REHABILITATION OF CONCRETE BRIDGES USING POST-TENSIONED CARBON FIBER PLATES

David White, P.E., Sika Corporation, Lyndhurst, NJ

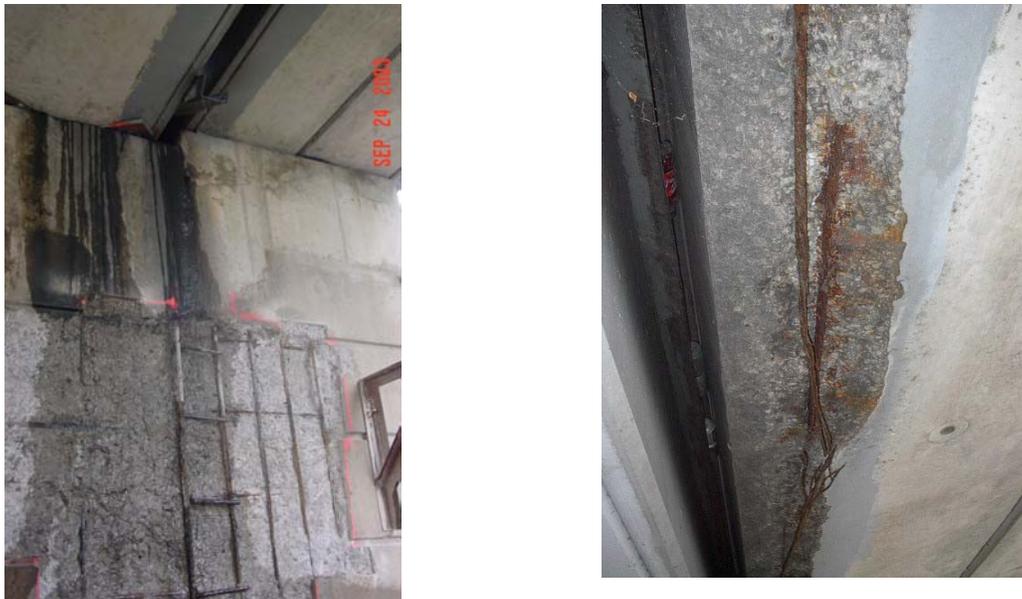
Due to significant deterioration of the prestressed strands (Fig. 10) in the two bridges, coupled with extensive cracking and spalling of the concrete, a carbon fiber system was selected to restore the flexural strength of the beams. However, to optimize the high strength of the carbon fibers and replace the strands, of which approximately 25% were corroded, an innovative method of post-tensioning was chosen. This was the first time this post-tensioning system, known as the Sika StressHead® System, would be installed in North America, and only the sixth time it would be installed worldwide.

Fig. 10 Typical corrosion problems on Hopkins and Clinton Street Bridges

After considering all the factors, it was determined that an improperly designed drainage system was the root cause of the problem on both bridges. The original design of the structures was such that storm water drained off the bridges by flowing over the asphalt roadway through a gap between the road and a sidewalk. This drainage gap ran the entire length on each side of both bridges and was a typical deck drainage detail for these types of structures constructed in this time frame. The storm water picked up all the deleterious materials, especially de-icing salts, and deposited them onto the exposed side of the fascia box beams.

The extensive use of de-icing salts in this part of northern Ohio, over the years, allowed the chlorides a direct path to the beams, pier caps, and abutments. The corroded steel expanded in volume, causing extensive cracking, spalling and delamination of the concrete. On the Hopkins Street Bridge, there was particular damage to the roadway deck fascia beams, and on the Clinton Street Bridge, the sidewalk beams were most severely damaged.

In prestressed concrete, corrosion of the strands is a very serious issue since the steel is the primary tensile reinforcement for the beams. Also, since the strands are tensioned during construction, they are even more susceptible to failure due to stress corrosion. During inspection, it was noted that approximately 25% of the tendons were either missing or could not be counted on for strength in the affected beams. Thus, one of the objectives of the repair was to restore and reinforce the flexural capacity of the beams, as well as restore as much of the compressive force back into the beams lost by damaged tendons.

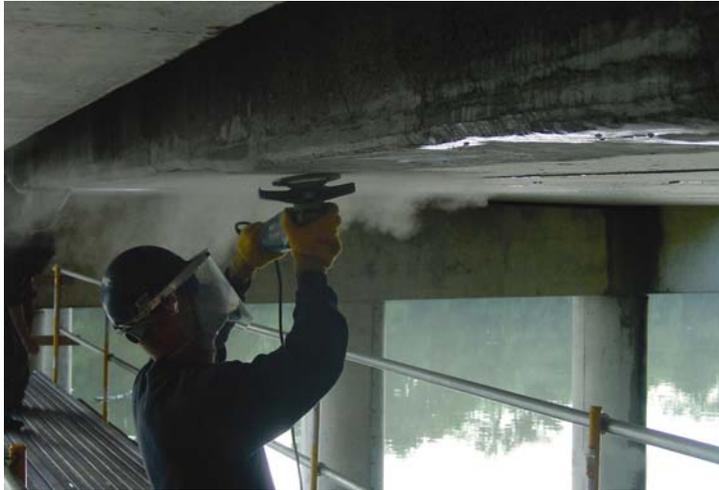
Fig. 11 Concrete surface preparation with grinders

The areas that required the most concrete repair were the face of the abutments and the sides and the bottom of the fascia beams on each bridge. A polymer-modified bonding agent and anti-corrosion coating were used on the exposed rebar (after being cleaned) and concrete. The deteriorated areas were patched using a polymer-modified repair material containing a corrosion inhibitor for future protection. The areas patched were dictated by the project engineer after a thorough inspection was performed during construction.

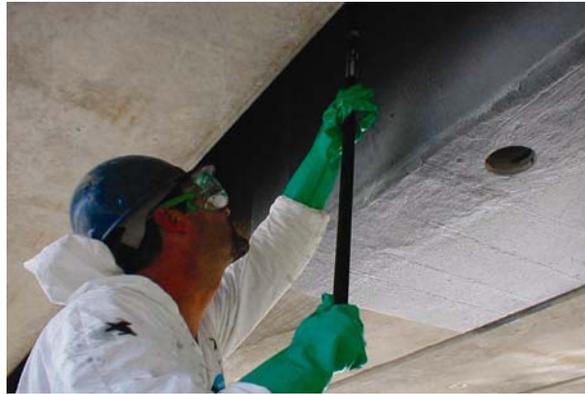
Fig. 12 Installation of carbon fiber fabric

A number of different carbon fiber systems were designed and installed on this project to strengthen the concrete and replace the damaged reinforcement. After repairing all the damaged concrete using conventional means, a carbon fiber wrap (SikaWrap®) was applied to stabilize the diaphragms in the anchor zones. The Plastic Sheet Method (ASTM D4263) was used to test the moisture transmission, ensuring that the repair mortar be cured and the substrate is ready to be bonded with the carbon fiber wrap. The bottom and sides of the diaphragm were mechanically grinded (ICRI CSP-3) to provide an open textured finish and the corners of the beams were rounded to a ½" radius per the specifications. A bi-directional, carbon fiber fabric (Fig. 12), impregnated with a high modulus epoxy resin, was then bonded onto the surface. After cure, the beams were ready for the next step in the strengthening process.

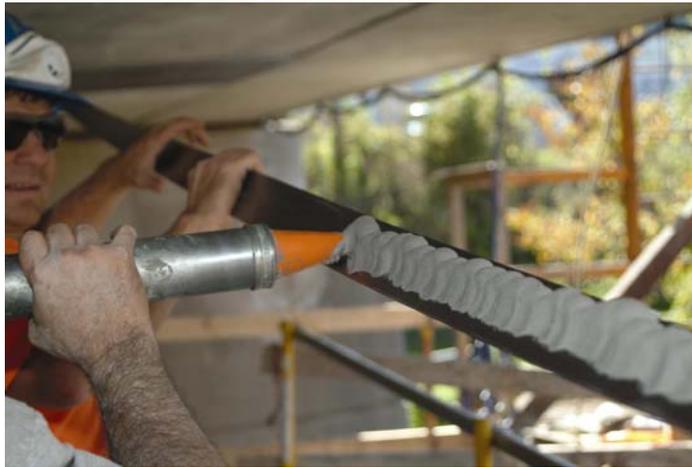
Fig. 13 Epoxy resin being applied onto carbon fiber plates

In addition to post-tensioning the plates, they were also bonded onto the concrete with an epoxy resin (Fig. 13). This provided additional stability, offered a balanced failure mode, and was also done to prevent moisture or frost from getting behind the plates over time. The carbon fiber plates were jacked in tension to forces ranging from 19,000 pounds (84 kN) to 36,000 pounds (160 kN), depending on the capacity of the diaphragms (Fig. 14). The capacity of the diaphragms was calculated via ACI using  $f'c$  determined through testing the cores taken for the anchors. This force was pre-determined by the Engineer and measured with a calibrated hydraulic ram, gauge and pump assembly. A Stressing Journal was kept by the Inspector which noted parameters such as the beam location, the location of the anchorages, the length of the plate, the displacement in the plate, the strain, and the stressing force.

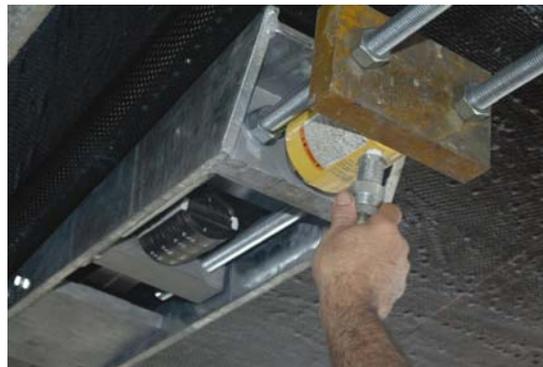
Fig. 14 Post-tensioning force being applied with hydraulic ram

Due to a slight camber in the beams, a deviator (guide plate) was used to ensure the carbon fiber plates would remain intact with the bottom of the beams after tensioning. The location of the deviator varied depending on the length and curvature of the beams. The contractor had previously surveyed the beam and noted elevations at 5 foot (1.5 m) increments to design for the camber and to calculate the exact length needed for the factory mounted plates, since the tolerance was only 2 in. (50 mm).
