INNOVATIONS REDUCE COST AND SCHEDULE ON US-24 BRIDGE REHABILITATION OVER LOWER ROUGE RIVER

Robert R. Breen, PE, Wade Trim Associates, Inc., Taylor, MI

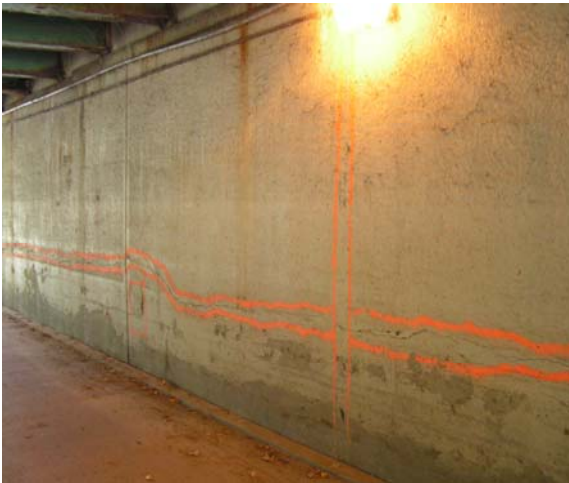
Fig. 2 – North Abutment

Structure B01 is located within a slight horizontal curve of US-24. The existing cross-slope did not meet current AASHTO standards. Although the original scope of work called for deck replacement among other items of work, it became clear during early stages of the project that for cross-slope corrections to occur, work on the top of abutments would require removal of the existing steel girders, temporary storage and re-setting in place. Another major item of work was concrete patching at both abutments. The original scoping report noted horizontal cracking along the faces of both abutments. The horizontal cracking was continuous from one end to the other and measured 1/16 inch on average. Cracking was present some six to eight feet below the bearing seats. This is seen in Figures 2 and 3.

Two other measurements taken during the preliminary phases of the project indicated further deterioration. One was a measurement along the construction joint where the older and newer sections of the abutment wall were joined. Above the cracks, near the top of the wall, the two faces either side of the construction joint were offset by 1 3/4 inches, while below the cracks, the two faces were plumb and flush with one another as shown in Figure 4. The other measurement was taken between the north and south abutment faces and compared to plan dimensions. According to the as-built plans, the clear dimension was 56'-7". The as-measured dimensions were short by 3 1/2" to 5 1/2", depending upon the location along the abutment faces.

Full depth concrete core samples were taken from each abutment wall at the location of the cracks to determine the character of the cracks. It was noted that the cracks were either full depth or near full depth, and that they were widest at the front face and minimal to no crack at the back face. This was consistent with a wall bending outwards towards the river, acting in a simple span configuration rather than as a cantilever.

It was determined that the back face (soil-side) reinforcement was 13% overstressed. In addition, the pile sliding resistance was 64% less than required, and the vertical pile capacity was 32% less than required. Based on these values, it was concluded that the walls most

likely had slid towards each other due to the deficient pile capacities, and along with the strutting action of the steel stringers, the front face horizontal cracks developed along both walls. The minimum reinforcement provided on these front faces could not resist the tension causing cracks to form.

With the type of analyzed deficiency that occurred at the abutments, it was felt that reducing the lateral soil loads and also "re-connecting" the top half of the wall to the bottom half to close up the crack could provide a long term solution to the cracking problem, rather than just patching the crack. The goal was to provide a permanent fix rather than one that would require additional, more costly repairs in the near future.

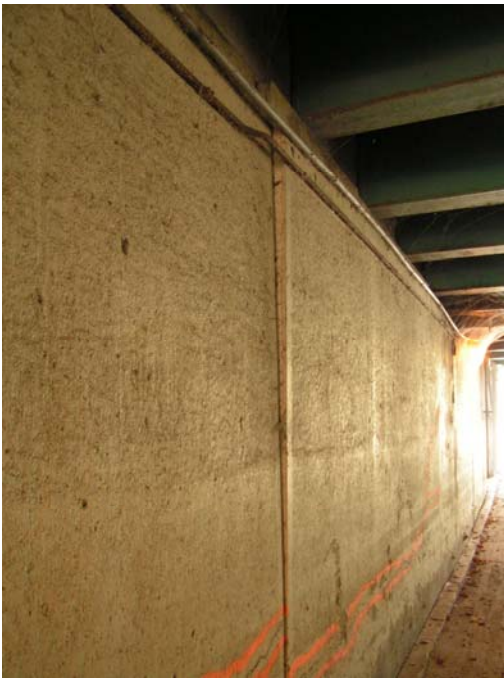
Fig. 4 – Differential Wall Movement

An initial assumption proposed that if the top of the wall was offset by almost two inches and portions of the walls at and below the horizontal cracks were plumb, it seemed logical that the top of the walls may have been pushed back or towards the approaches. Cracks appearing on the outside face supported this assumption. Under true cantilever wall design, walls overloaded from lateral soil loads above what they were designed for would show

tension cracks on the inside face while the outside face would be in compression. Any horizontal cracks along the outside face should close from this compressive force.

The next assumption was that the walls are sliding or had previously slid in conjunction with the bearing lock up and subsequent strut action of the steel stringers. The walls sliding towards each other, along with the strut action at the top of the abutments, would have caused the outside faces to go into tension, for which they would not have been designed for as cantilever walls. This assumption seemed consistent with the change in horizontal measurements between the north and south
