## **FULL SCALE DESTRUCTIVE TESTING OF AN ADJACENT PRESTRESSED CONCRETE BOX BEAM BRIDGE**

**Eric Steinberg, PhD, PE**, Associate Professor, Civil Engineering, Ohio University, Athens, OH  
**Richard Miller, PhD, PE, FPCI**, Professor, School of Adv. Struct., Univ. of Cincinnati, Cincinnati, OH  
**Jon Huffman**, Graduate Research Assistant, Civil Engineering, Ohio University, Athens, OH  
**Tyler Stillings**, Grad. Research Assist., School of Adv. Structures, University of Cincinnati, Cincinnati, OH

### **ABSTRACT**

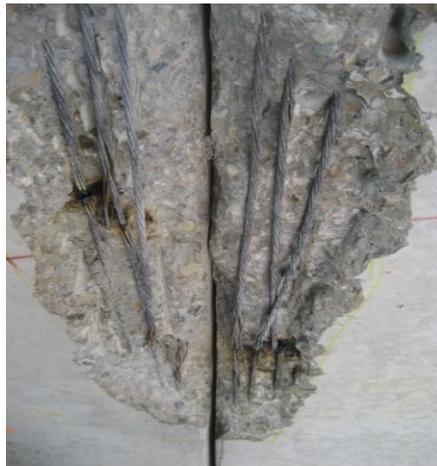
The East span was damaged by removal of concrete with jack hammers to expose strands. The strands were then flame cut with a torch (see Figure 7). Damaging occurred near mispan for a length of approximately 50 to 60 inches and a width of approximately 9". Figure 8 shows the damage pattern for the East span. It should also be noted that Beam 3 had longitudinal cracking near the pier and Beam 9 had the exterior strand exposed and broken.

**Figure 7: Exposed and Cut Strands – East Span**

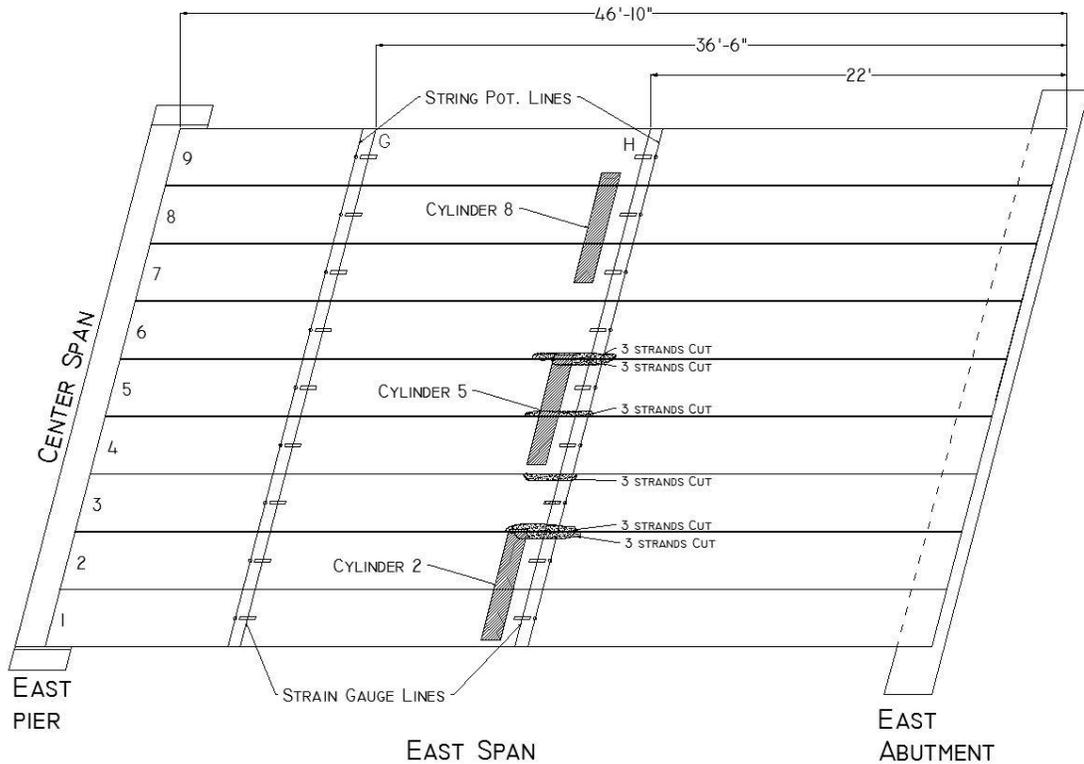
**Figure 8: Damage of East Span**

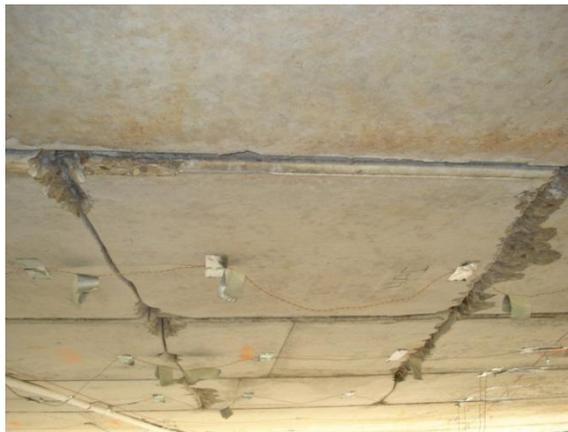
The damage imposed on the West span consisted of cutting through the bottom of the concrete and through all of the bottom row strands in the three center interior beams (Beams 4-6). Two cuts were made approximately 3 feet apart about the mid-span of the beams to assure no redevelopment of the strands (see Figure 11). Instrumentation (see Figure 12) and loading on the West span was similar to the East span. Since the West span was the last span to test, loading continued until the span collapsed.

**Figure 11: Damage Created in West Span Beams 4-6**

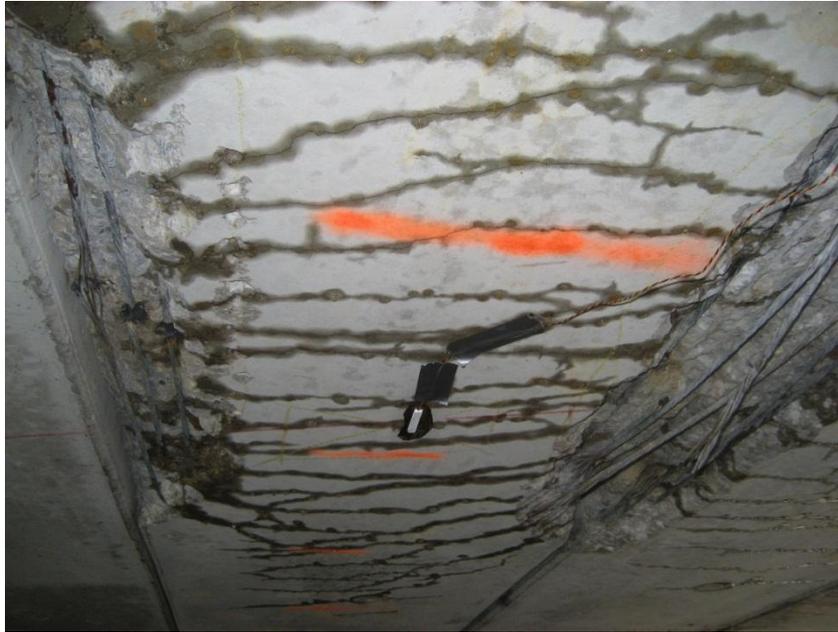
During ultimate loading of the East span, flexural cracking was initiated in the beams and then resulted in water leaking from the cracks indicating the voids of the boxes contained water. This water was significant judging from the duration of leakage (see Figure 15). The bridge failed by crushing of the top flange concrete in Beams 1 and 9. Additional load was no longer able to be supported by the bridge and testing was terminated in order to assure damage to the loading system did not occur. Figure 16 shows the flexural cracking and concrete crushing failure of Beam 1.

**Figure 15: Flexural Cracking and Void Water Leakage**

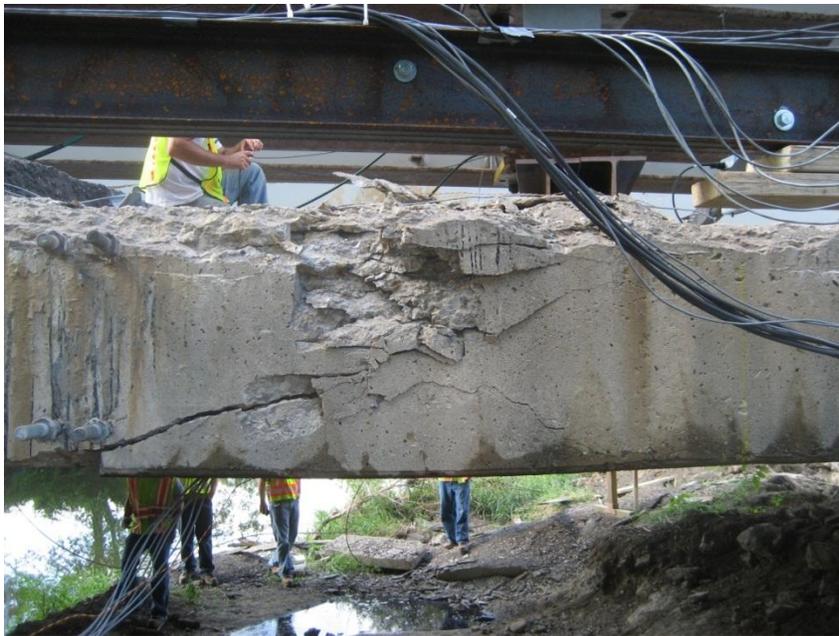
**Figure 16: Flexural Cracking and Concrete Crushing in Beam 1**

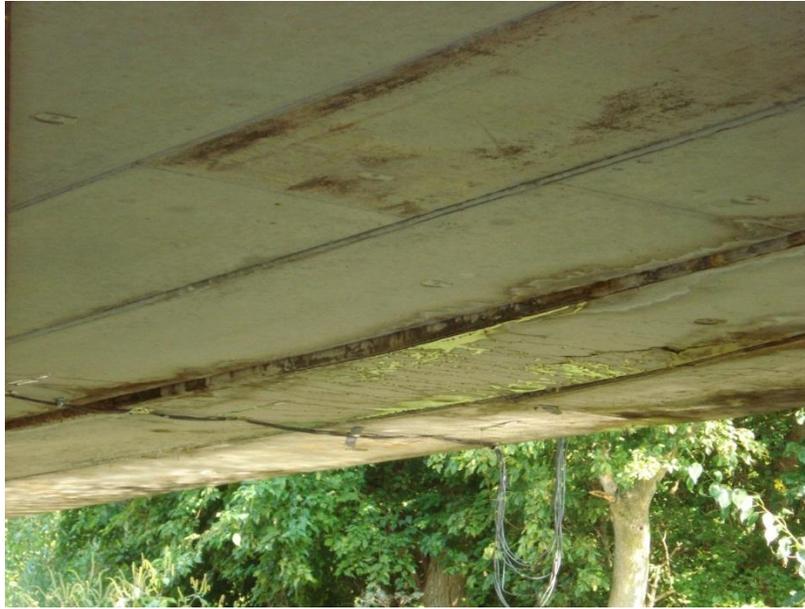
The Center span failed to carry more load after the girders failed by crushing of the top flange and flexural cracking of the bottom flange. Figure 18 shows large relative deflections between Beams 2 and 3 caused by likely failure of the shear keys between the beams. Figure 19 shows the underside of Beams 8 and 9 along with the cracking and spalling of concrete.

**Figure 18: Relative Deflection of Beams 2 and 3**

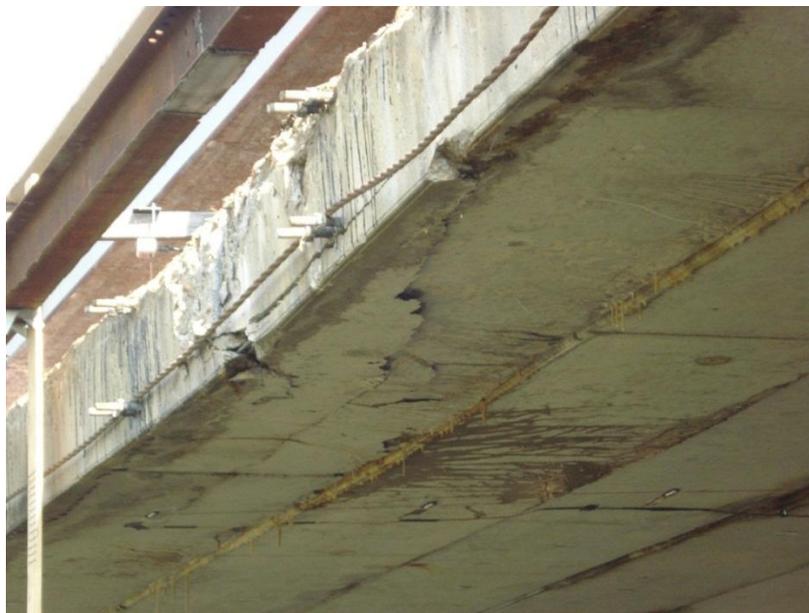
**Figure 19: Spalling and Cracking of Beams 8 and 9**

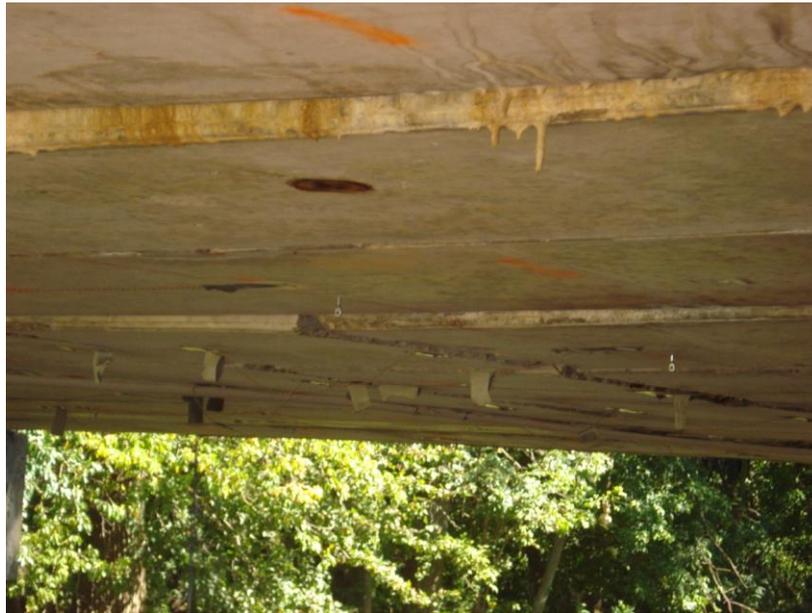
Figures 21-22 show the west span prior to collapse. The large relative deflections shown between Beams 8 and 9 and also Beams 6 and 7 in Figure 21 imply the loss of the shear key between those beams. The shear key between Beams 3 and 4 has also failed (Figure 22). However, the bridge was still able to maintain and transfer load throughout the system. This was likely due to the transverse tie rods existing between the beams as well as some shear friction between the shear keys and beams.

**Figure 21: Shear Key Failures Between Beams 8-9 and 6-7 Prior to Collapse**

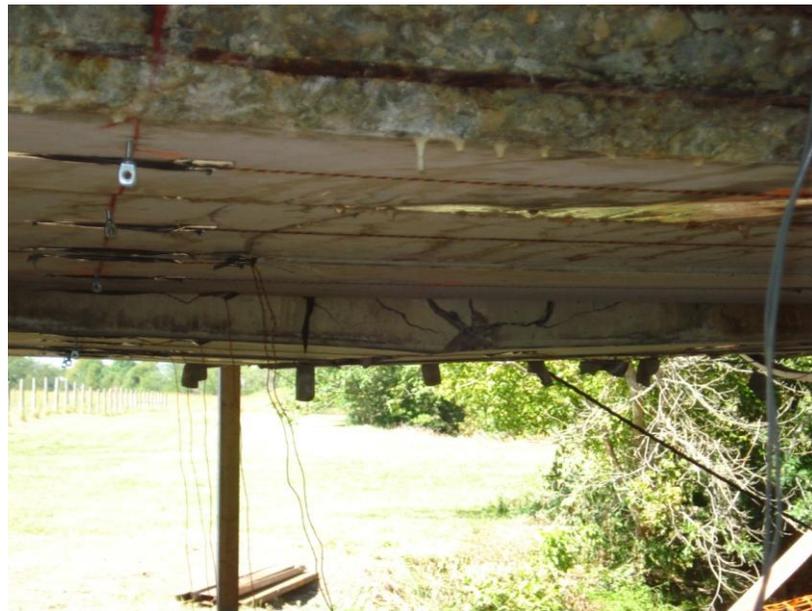
**Figure 22: Shear Key Failure between Beams 3 and 4 Prior to Collapse**

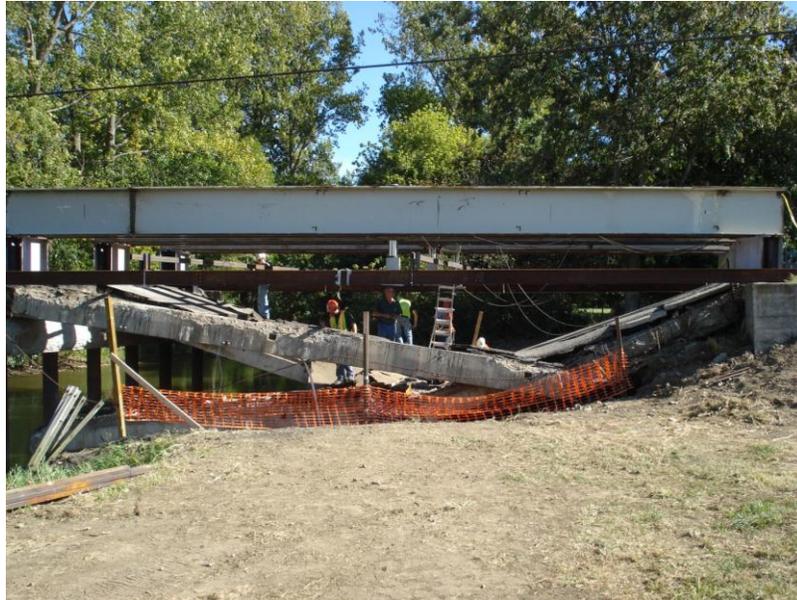
Loading was stopped and the string potentiometers were removed to prevent damage. Loading was again applied to the span without being able to exceed the previous maximum total loading. Eventually the span completely collapsed in a ductile manner (see Figure 23 - 24). Beams 1-8 failed near midspan close to the loading locations and Beam 9 failed near the abutment. Beams 7 and 8 pulled sufficiently away from the pier and fell to the ground near the pier. The transverse tie between Beams 8 and 9 (see Figure 24) and Beams 6 and 7 fractured allowing Beams 7 and 8 to be separated from the remaining beams. Beam 9 had lost its top flange which was a patched section at this location. A combination of separation of the top flange, poor concrete, and shear resulted in the failure of Beam 9.

**Figure 23: Collapsed West Span**

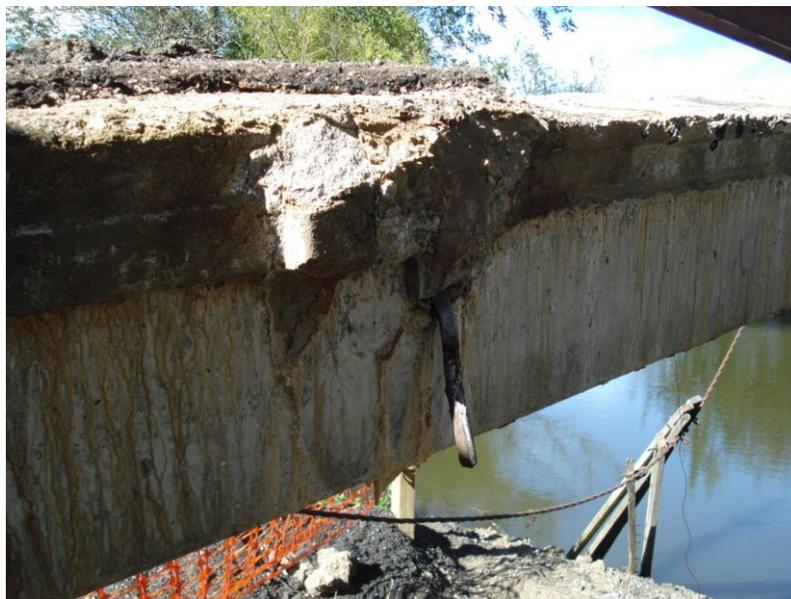
**Figure 24: Fractured Transverse Bar (West Span)**
