## **RESIDUAL STRENGTH ASSESSMENT AND DESTRUCTIVE TESTING OF DECOMMISSIONED CONCRETE BRIDGE BEAMS WITH CORRODED PRETENSIONED REINFORCEMENT**

**Rhys A. Rogers, BE**, University of Auckland, Auckland, New Zealand  
**Liam Wotherspoon, PhD**, University of Auckland, Auckland, New Zealand  
**Allan Scott, PhD**, University of Canterbury, Christchurch, New Zealand  
**Jason M. Ingham, AP**, University of Auckland, Auckland, New Zealand

## **TIWAI POINT BRIDGE**

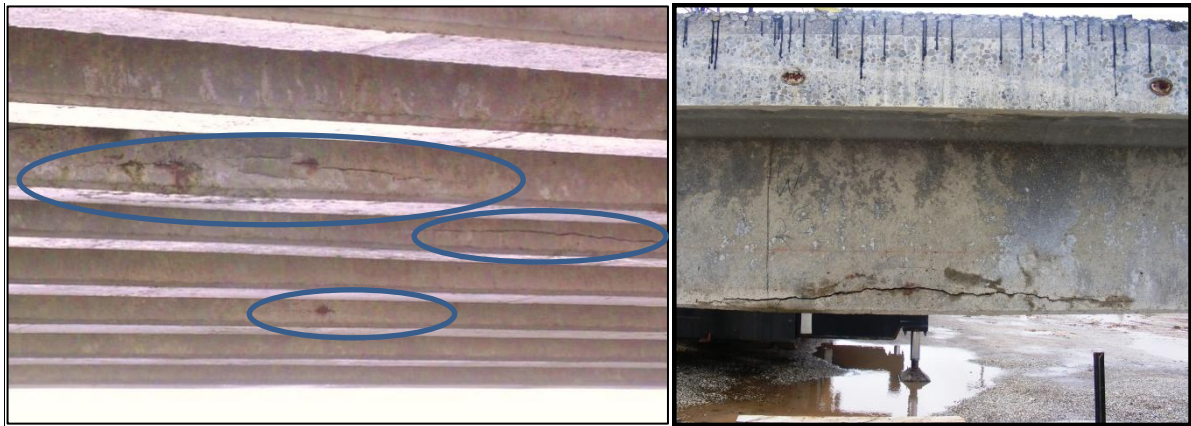
The reinforcement corrosion was a result of chloride ingress and was evidenced by longitudinal cracking along the sides of the beams at the level of the bottom layer of pretensioned strands. After a thorough investigation, it was estimated that in the worst cases this cracking correlated to a loss of up to 60% of the cross section of the bottom layer of pretensioned strands<sup>1</sup>. Several visual inspections were carried out to determine the prevalence of this damage, the most recent was in 2007 and found longitudinal cracking in fifty five of the two hundred and forty three beams<sup>5</sup>.

Fig. 2 Corrosion induced cracking in side of web near soffit

Evidence of longitudinal cracking and rust staining in three beams from the same span is shown on the left of Fig. 2, and similar cracking in one beam is shown on the right. The maximum measured width for this type of crack was 5 mm and the cracking was consistently at the level of the bottom layer of pretensioned reinforcement.

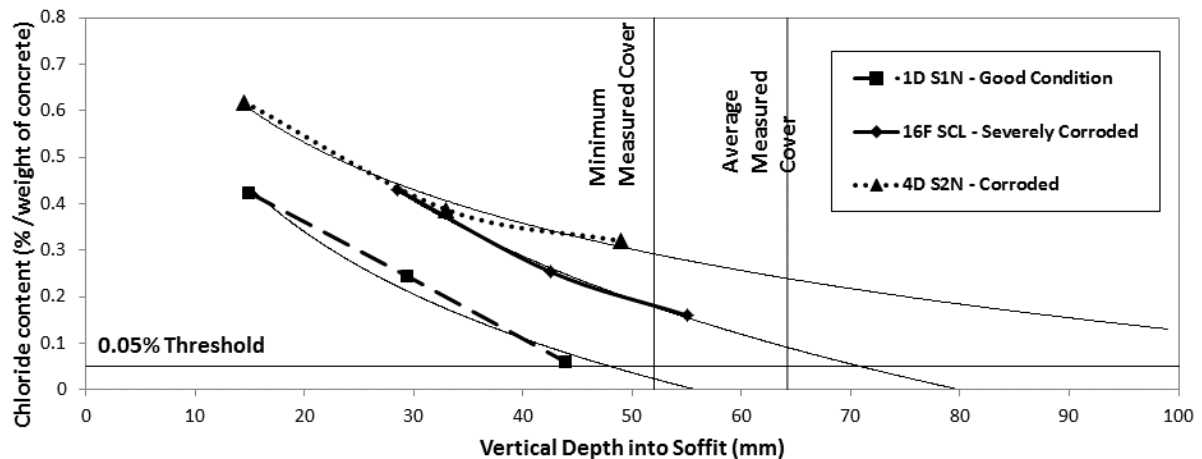
An example of chloride ingress in the soffit of three beams is given in Fig. 4. A considerable difference in chloride content at the depth of reinforcement is observed between the good condition beam and the two corroding beams. Chloride ingress testing is a useful tool for assessing the likelihood that corrosion of steel is occurring in a given beam and for estimating the time to initiation, but is not useful for assessing the extent or location of corrosion in a beam that is known to be corroding. Full chloride ingress results are therefore excluded from this paper as they do not aid in the assessment of residual strength.

Fig. 4: Preliminary chloride ingress results

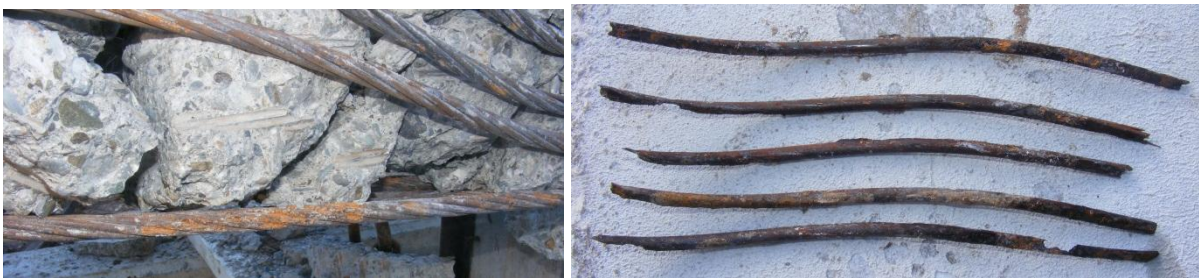
Fig. 5 Strands with uniform corrosion and individual wires with pitting damage

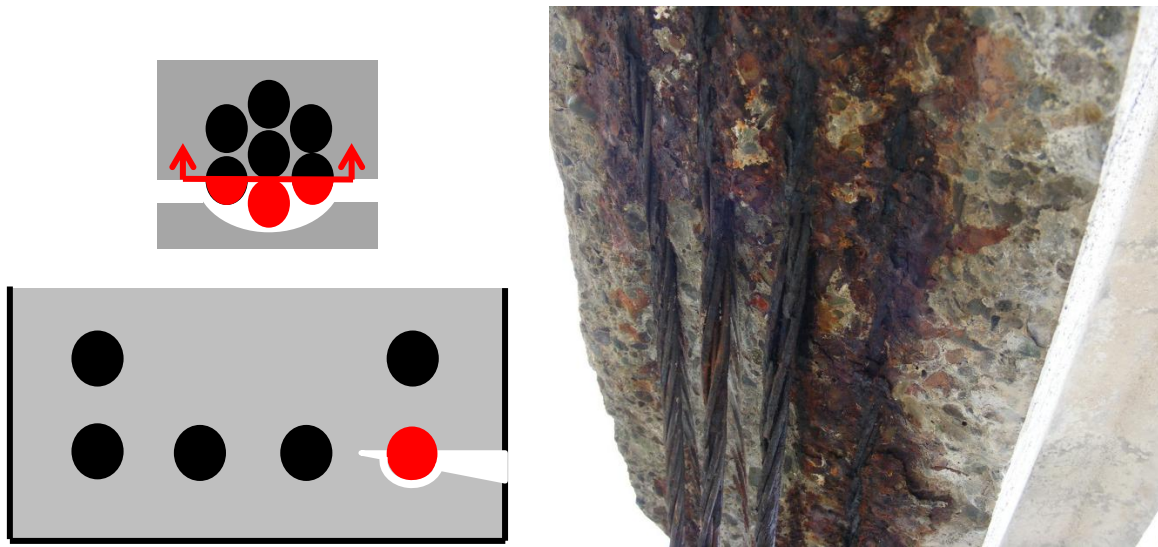
This type of corrosion was widespread in cracked regions of the corroded test beams, a typical example is shown in Fig. 6. Because strands are made up of six helical wires wrapped around a central wire all six of the helical wires rotate past the bottom of the strand in a length of less than 200 mm. Combined with the compromised bond in corroded and cracked regions it is not overly conservative to assume that 85% of the capacity of a strand is lost when corrosion has progressed one third of the height of the strand, this correlates to approximately 30% of the cross-sectional area. When corrosion has progressed two thirds of the height of the strand 100% of the capacity is lost.

Fig. 6 Diagrams of crack and debonding, and evidence of upward strand corrosion

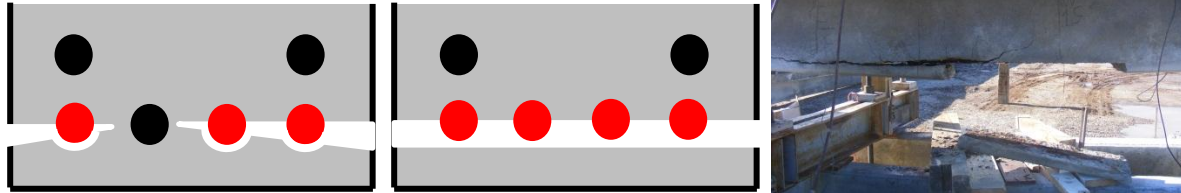
debonding and upward corrosion process began again. Because both sides of each beam's web are subjected to very similar exposure environments and concrete conditions many of the beams had this process occurring concurrently on both sides of the web. This repeats until the crack reaches the opposite side of the web and the soffit concrete is completely delaminated. This is diagrammatically shown in Fig. 7 and an example is given of a beam after the delaminated soffit has fallen away during destructive testing, evidence of strand corrosion is visible on the spalled concrete section.

Fig. 7 Diagram of crack and debonding progression, and evidence of soffit delamination

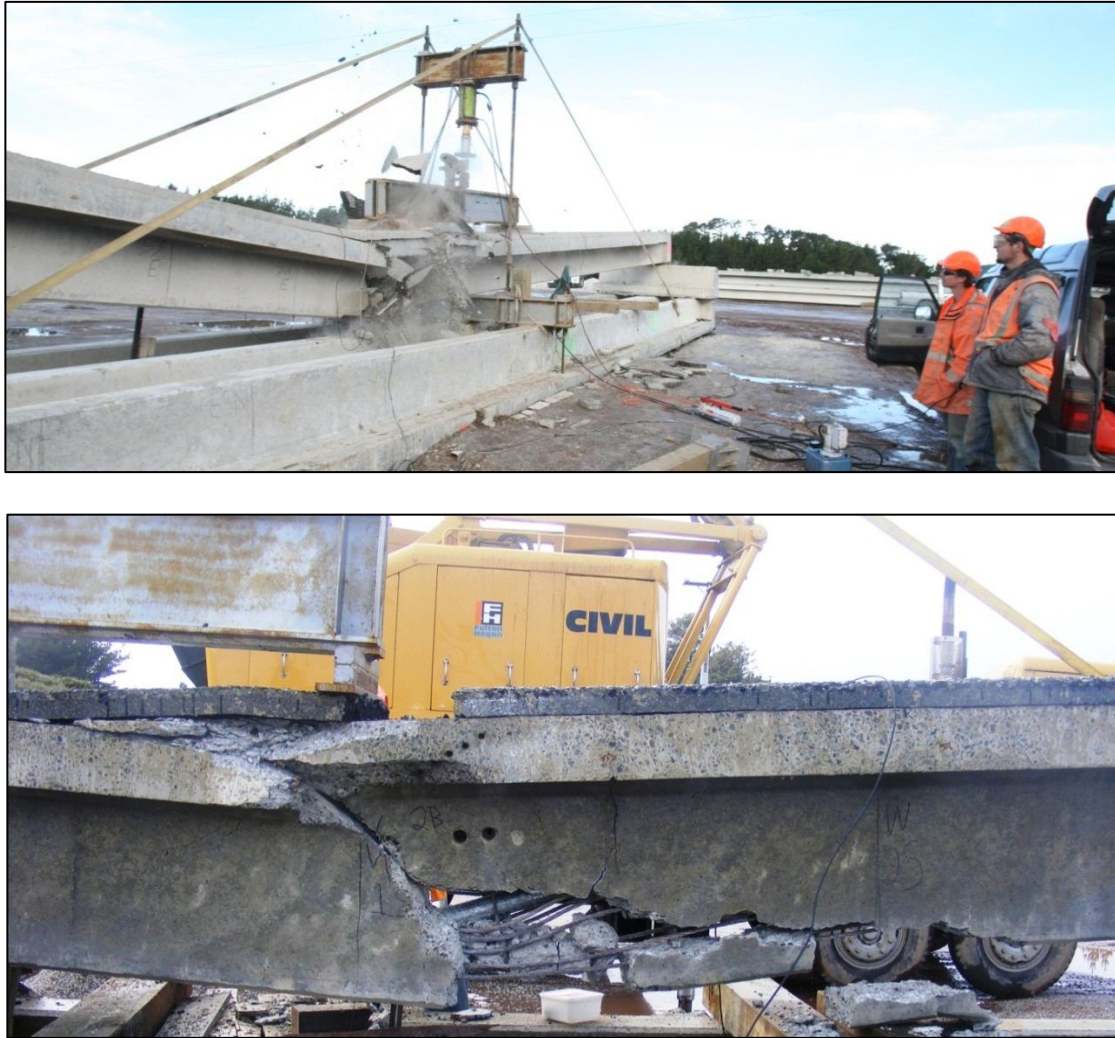
Fig. 10. The bottom image shows the failure crack; concrete crushing is evident under the loading point and the longitudinal reinforcement is intact and visible where the cracked concrete in the tension zone has fallen away during failure of the beam. The AE system detected no strand breakage during the good condition tests and this was confirmed by breakout and inspection around the failure plane.

Fig. 10: Typical good condition beam failures

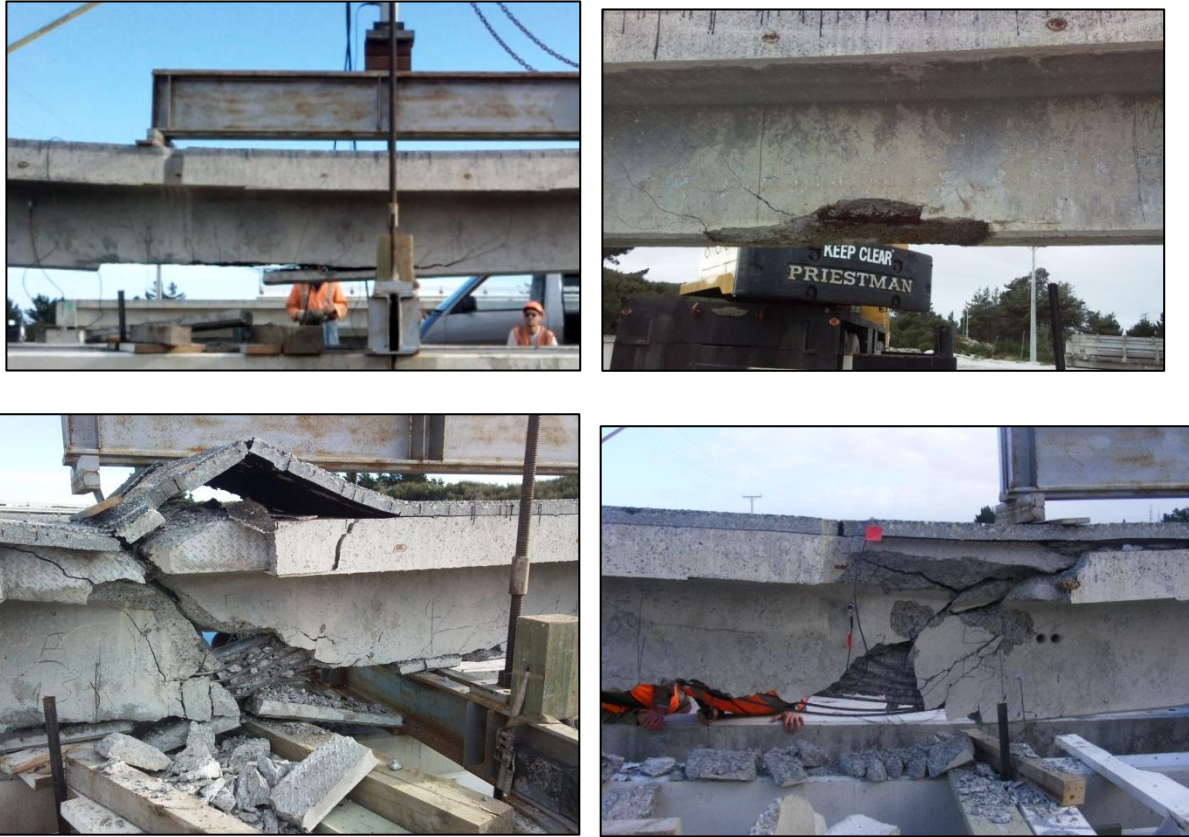
The deflection of beams with corrosion damage was typically concentrated around the damaged area. Flexural cracking would extend up and outwards from the original corrosion crack and the soffit would spall off at a low deflection. The Acoustic Emission system did not detect any strand failures outside of the corroded area that ultimately failed. Typical cracking patterns for corroded beams are shown in the top two images of Fig. 11. Usually failure would occur at a loading point, with the failure crack extending from the corroded area to meet the loading point, as shown in the two bottom images in Fig. 11. If the corroded area was too far away from the loading point, the strands would fail at the corroded section

and then pull through to a separate failure crack closer to the loading point; this can be seen in the bottom right image.

Fig. 11 Typical corroded beam cracking and failure

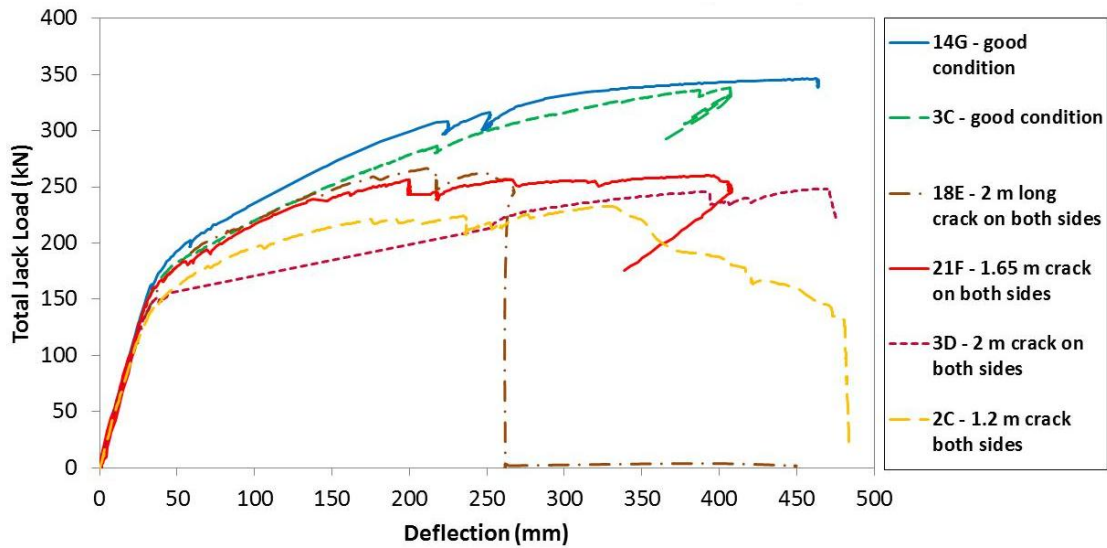
Six tests were performed on beams with twelve pretensioned strands and no expansion joint, two were on good condition beams and four tests were on beams displaying corrosion damage to the pretensioned reinforcement. The six load-deflection plots are displayed in Fig. 13. The average ultimate strength of the beams in good condition was 342.5 kN, whereas the weakest of the corroded beams supported only 68% of this load. Post-test inspection revealed that the weakest beam had corrosion damage to all four strands in the bottom layer of pretensioned reinforcement, evidenced by a 1200 mm crack 1.5 m from mid-span that was visible on both sides of the web.

Fig. 13: Load vs. deflection: 12 pretensioned strands, no expansion joint

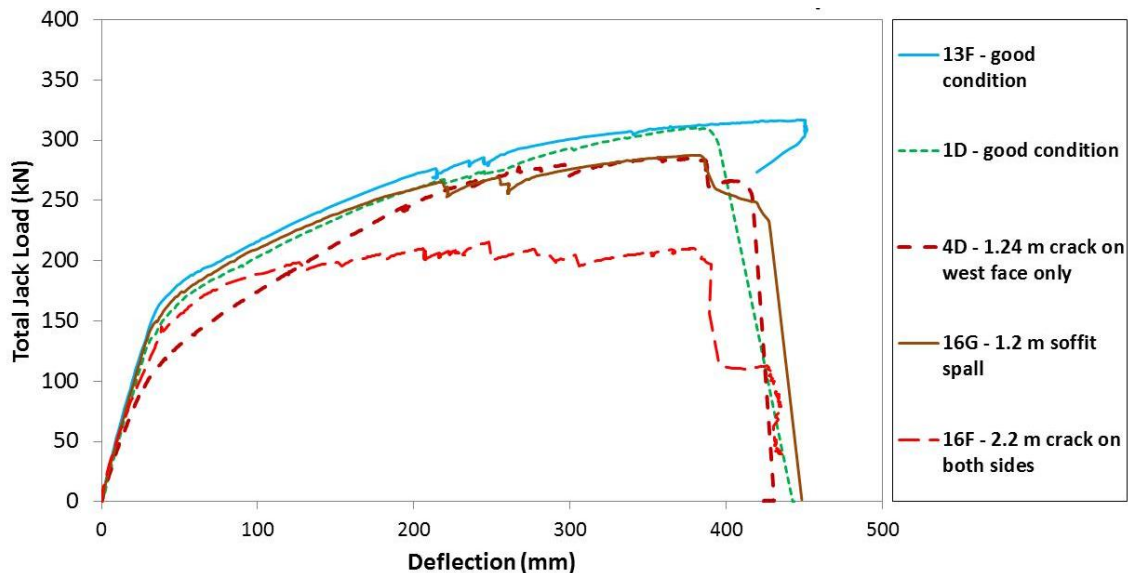
Five tests were carried out on beams with twelve pretensioned strands and an expansion joint. Two tests were on beams in good condition and four tests were on beams displaying corrosion damage to the pretensioned reinforcement. Load-deflection plots are displayed in Fig. 14. The average ultimate strength of the beams in good condition was 313.5 kN, whereas the weakest of the corroded beams supported only 69% of its good condition counterpart. Post-test inspection revealed that the weakest beam had corrosion damage to all four strands in the bottom layer of pretensioned reinforcement, which was evidenced by cracking and spalling of the lower part of the web and soffit over a length of 2.2 m extending outwards from near to mid-span.

Fig. 14: Load vs. deflection: 12 pretensioned strands with expansion joint

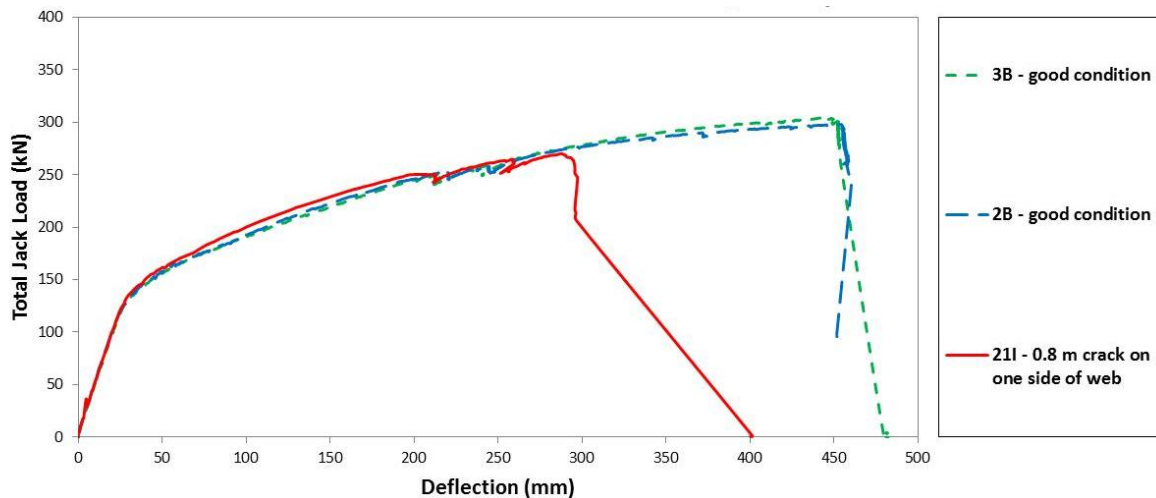
Three tests were carried out on beams with ten pretensioned strands and no expansion joint. Two tests were on beams in good condition and one test was on a beam displaying corrosion damage to the pretensioned reinforcement. Load-deflection plots are displayed in Fig. 15. The average ultimate strength of the beams in good condition was 301 kN, whereas the corroded beam sustained 90% of its good condition counterpart. This weaker beam had corrosion damage to one of the two pretensioned strands in the bottom layer of reinforcement, which was evidenced by an 800 mm long crack visible on only one side of the web.

Fig. 15: Load vs. deflection: 10 pretensioned strands, no expansion joint
