Precast-Prestressed Concrete Bridge Girders Damaged by Over-Height Load Impacts

Richard Brice, P.E., Washington State DOT, Olympia, Washington

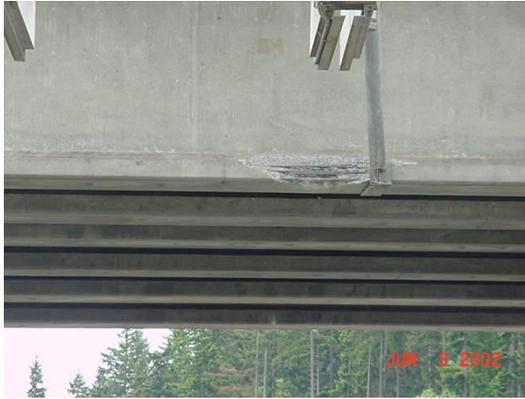
Damage to the structure was minimal. A patch of concrete cover on the bottom flange of the girder, directly adjacent to an unused sign support bracket, was spalled off at the point of impact. The damaged area was approximately 3 feet in length. Several strands were exposed, however none were damaged. The location of impact and subsequent damage is shown in Figure 2.

Figure 2 Impact site and damage to the Trigger Avenue structure

Repair of the girder was complicated by the sign structure support bracket. The bracket was permanently removed to simplify the repair. The structure was repaired by chipping away all loose concrete, forming the bottom flange, and patching with a concrete patching and repair mortar. Repairs were conducted by WSDOT maintenance personnel.

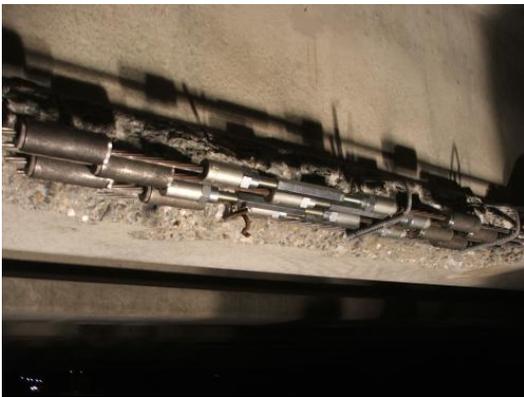
A similar impact event occurred on February 4, 2008. A dump truck hauling an excavator traveling eastbound on SR 14 hit three girders. The exterior girder had a single impact spall and four severed strands in the bottom flange. There was a 40 ft long hairline crack at the interface between the top flange and the web directly above the point of impact. The bottom flange was laterally displaced 3/8" at the impact location. The next three interior girders were not damaged suggesting that the load was compressed or rotated from the initial impact and then rebounded to impact two interior girders. The second girder hit had one impact spall and two exposed strands. One of the strands had two wires that were severed and a third that was nicked. The third girder hit had minor spalling.

Figure 4 Repair of severed strands with coupling device

All of the girders were deemed repairable. Loose concrete was removed from the damaged areas. Additional concrete was removed around the severed strands to facilitate the repair. Severed strands were joined and tensioned with a splice coupler system shown in Figure 4. The damaged areas were formed and the concrete was repaired with a patching and repair mortar. Repairs were carried out by WSDOT maintenance personnel.

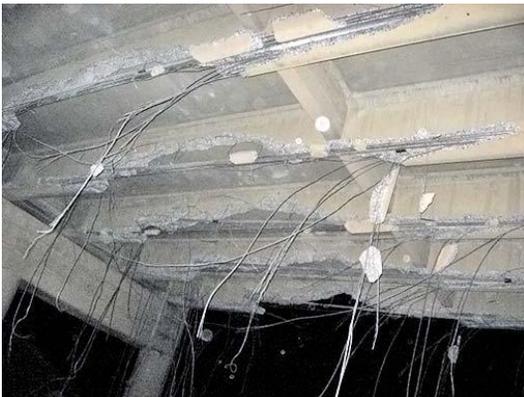
The impact caused a complete loss of structural integrity in one span of the bridge. The bottom flange and web of all six of the girders in the cross section were damaged beyond repair. The damaged structure is shown in Figure 6. The collision forced the closure of the I-90 eastbound lanes and traffic was detoured onto the Easton interchange ramps. WSDOT crews and an emergency contractor demolished the damaged bridge span and re-opened the eastbound lanes of I-90 within 24 hours of the collision. Secretary of Transportation Paula Hammond challenged WSDOT engineers to “get creative – get this bridge replaced as quickly and effectively as possible.” WSDOT met the challenge and opened the structure in 45 days.

Figure 6 Damage to the Easton Road Bridge

This structure is located in a mountain pass and winter weather conditions are common in late fall. Placement of concrete in cold weather conditions was a major concern. WSDOT designers selected decked bulb tee girders rather than in-kind replacement of I-girders with cast-in-place deck. This eliminated a substantial quantity of cast-in-place concrete and accelerated the construction of the replacement span. With the availability of high performance concrete and 0.6” diameter prestressing strands, five precast-prestressed decked

bulb tee girders replaced the six original I-shaped girders. The total cost of the replacement contract was \$703,000. This equates to a cost of \$2,379 per foot of girder.

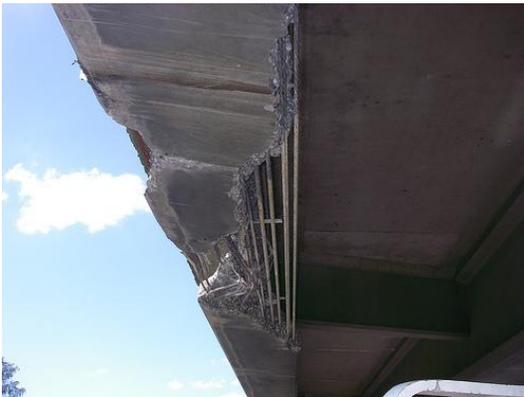
The cross section of the bridge consists of six simple span precast-prestressed girders with a cast-in-place composite concrete deck. Three girders were damaged by this impact event. The exterior girder taking the initial impact, shown in Figure 7, suffered severe spalling of the bottom flange and web concrete. Twenty strands were exposed and eleven were severed. The harped strands were fully exposed at the harp point. The concrete confining the harped strands was damaged resulting in a change of strand geometry and loss of prestress force. The next three girders in the cross section were undamaged suggesting that the load was compressed or rotated due to the initial impact and then rebounded as it moved beneath the structure.

Figure 7 Damage to girder receiving direct impact

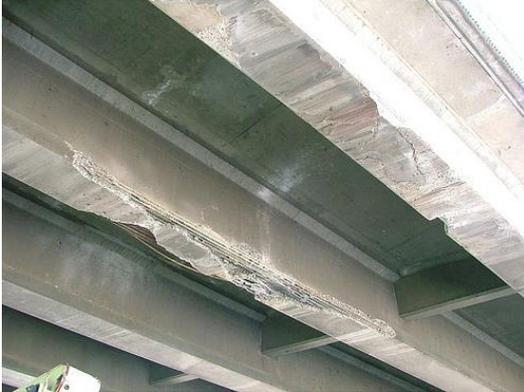
The second girder damaged was the first interior girder on the opposite side of the structure relative to the point of initial impact. The damage to this girder was nearly identical to the girder experiencing the initial impact. There was significant cracking and spalling of the bottom flange and web concrete. Twenty strands were exposed and eleven were severed. The harped strands were partially exposed. The third girder hit was adjacent to the second damaged girder and was the exterior girder on the far side of the structure. The damage to

this girder was much less severe. There was moderate concrete spalling and eight prestressing strands were exposed. The impact damage to the second and third girders is shown in Figure 8.

Figure 8 Damage to second and third girders

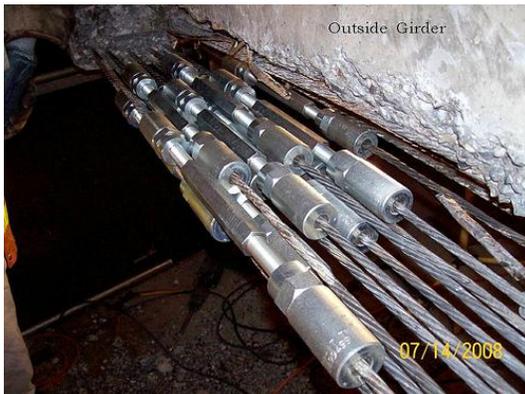
Figure 9 Temporary repairs using strand couplers

Truck traffic was removed from the structure and car traffic was reduced to one alternating lane of traffic over the three undamaged girders. Temporary repairs were made by WSDOT maintenance personnel. The repairs consisted of splicing and re-tensioning the severed strands, shown in Figure 9, to restore some of the load carrying capacity to the girders. Due to space constraints, only seven of the eleven severed strands could be spliced. The structure was returned to its original two lane configuration though gross vehicle weight was restricted to 80,000 lbs. Ultimately WSDOT secured federal emergency funds to repair the structure. The damaged span was removed and replaced. The total cost of the span replacement project was \$723,000. This equates to a cost of \$2,939 per foot of girder.

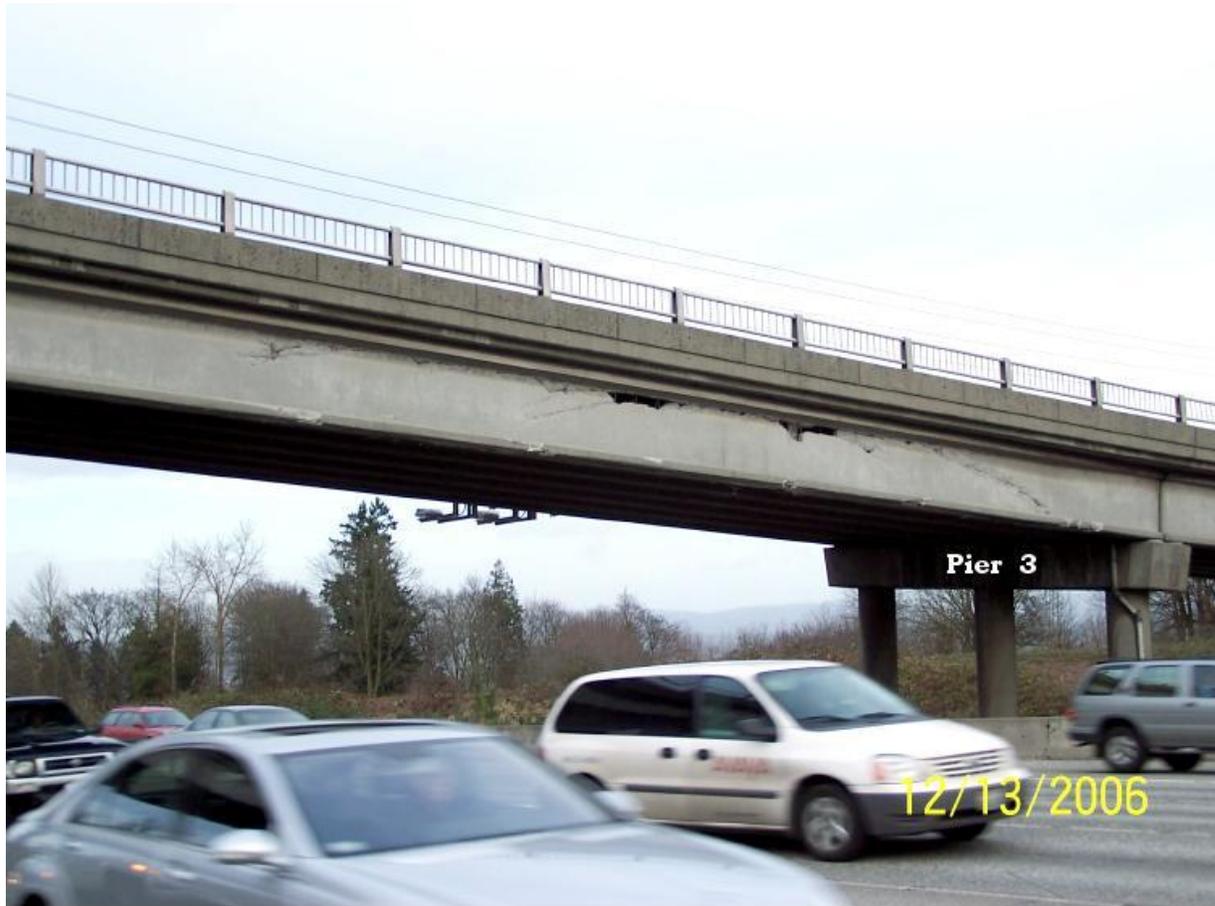
The impacted girder suffered cracks and spalls to the bottom flange and web concrete over the majority of the length of the girder. The damage in the web extended to the interface with the top flange of the girder as seen in Figure 10. Several strands were exposed and three were severed. The bottom flange was displaced 4” laterally at the point of impact.

Figure 10 Damage to the South 178th Street Bridge

This structure was repaired by removing the affected railing, deck, and damaged girder and replacing these components in-kind. Repairs were carried out under contract at a total cost of \$895,000. This equates to a cost of \$8,861 per foot of girder.

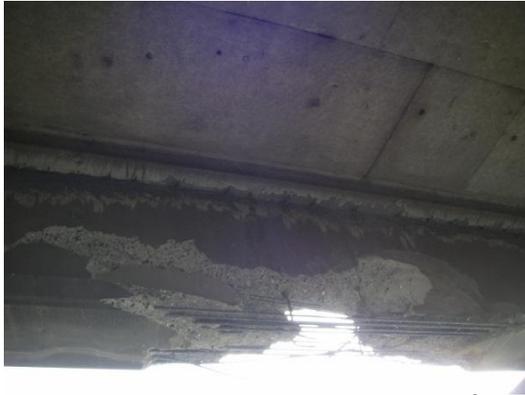
A single girder was damaged by this impact. The mast was torn from the forklift preventing damage to other girders as it moved beneath the structure. The bottom flange and web suffered severe cracking and spalling. Fourteen strands were exposed, two strands were severed and one strand was nicked. A section of the web and bottom flange was knocked out at the point of impact. Epoxy sealed web cracks from previous impacts were widened due to the impact of this event. The bottom flange was permanently displaced 1/2" laterally.

Figure 11 Girder damage on the 113th Avenue Bridge

This structure was repaired by removing the affected railing, deck, and damaged girder and replacing these components in-kind. Repairs were carried out under contract with a Preliminary Engineering cost of \$109,639, a Construction Engineering cost of \$106,815 and a construction cost of \$272,065. The total cost was \$488,519. This equates to a cost of \$8,246 per foot of girder.

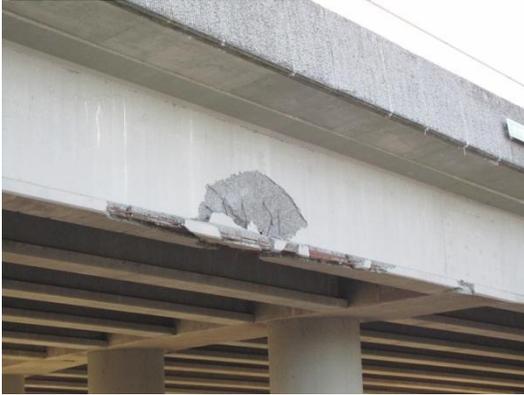
The mast impacted the girder causing numerous fractures including bottom flange and web spalls exposing twenty six prestressing strands, two longitudinal mild steel reinforcing bars, and eight stirrups. The exposed stirrups were permanently deformed. Spalling also occurred away from the point of impact at the interface of the girder and the pier cap at the center pier. This spall exposed one prestressing strand and three mild steel reinforcing bars. There was

also longitudinal web splitting cracks along the top flange for most of the girder length, several elliptical web cracks around the point of impact, and a few longitudinal cracks along the bottom flange. No prestressing strands were severed. The concrete diaphragm connection at the 1/3 point of the girder sustained a prying force creating cracks and shallow spalls in the girder web adjacent to the diaphragm. These web cracks extend and join the longitudinal crack at the top flange/web interface. Damage to the exterior face of the girder opposite the point of impact and at the center pier is seen in Figure 12.

Figure 12 Olympic Road Bridge Girder Damage

The damage to the girder was too extensive to repair. The affected railing, deck, and damaged girder were removed and replaced in-kind. Repairs were carried out under contract with a Preliminary Engineering cost of \$132,286, a Construction Engineering cost of \$177,232 and a construction cost of \$541,800. The total cost was \$851,318. This equates to a cost of \$8,643 per foot of girder.

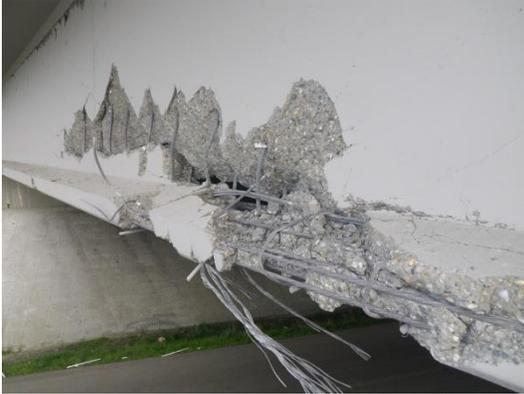
A similar impact event occurred March 17, 2013. A semi-tractor with a low boy trailer hauling an asphalt burner hit the girder that was replaced due to the 2011 event. The resulting damage in this event was more severe than the previous event. There were large spalls and cracking in the bottom flange and webs at the point of impact. Twenty six strands were exposed and five strands were severed. The bottom flange was permanently displaced 3" laterally at the point of impact. Several stirrups had permanent deformation or were pulled free from the concrete. Prying forces were developed at the 1/3 point intermediate diaphragm causing cracking and spalling of the web concrete. There was a 1½" separation between the web and diaphragm. The end of the girder was laterally displaced 3/16" at its interface with the center pier diaphragm. Damage at the point of impact is seen in Figure 13 and lateral displacement of the girder at the center pier is seen in Figure 14.

Figure 13 Olympic Road Bridge girder damage at point of impact

The damage to the girder was too extensive to repair. The affected railing, deck, and damaged girder will need to be removed and replaced in-kind similar to the repairs for the 2011 impact event.

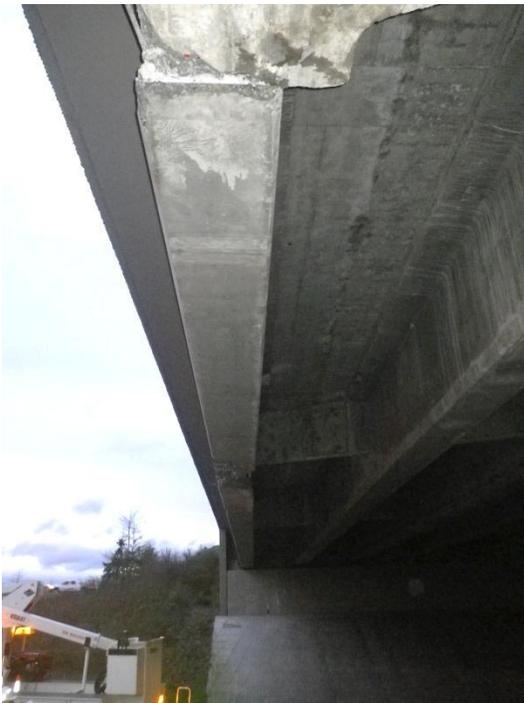
Figure 14 Lateral displacement of girder at center pier diaphragm

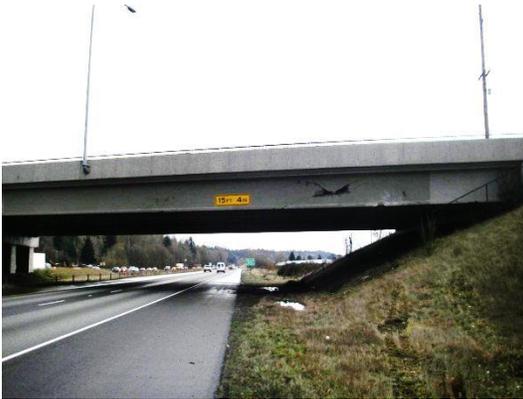
The impact damaged the exterior girder in several locations as seen in Figure 15. At the east abutment, the bottom flange had spalled off the girder resulting in a loss of bearing. Six prestressing strands were exposed and were clearly no longer tensioned.

At the point of impact the bottom flange had considerable spalling with exposed prestressing strands. Several of the strands could be moved by hand indicating a loss of prestress. Stirrups were exposed, bent, and broken. The bottom flange was permanently displaced 3-1/4" laterally.

Cracking and spalling occurred at the continuity diaphragm on the west end of the span.

Figure 15 Impact damage to the 24th Street Bridge

The damage to the girder was too extensive to repair. The affected railing, deck, and damaged girder were removed and replaced in-kind. Repairs were carried out under contract with a Preliminary Engineering cost of \$250,952, a Construction Engineering cost of \$204,614 and a construction cost of \$658,225. The total cost was \$1,113,791. This equates to a cost of \$8,328 per foot of girder.
