REHABILITATING PRECAST CONCRETE HISTORY USING DESIGN-BUILD DELIVERY

Matthew J. Lengyel, PE, SE, David Evans and Associates, Inc.

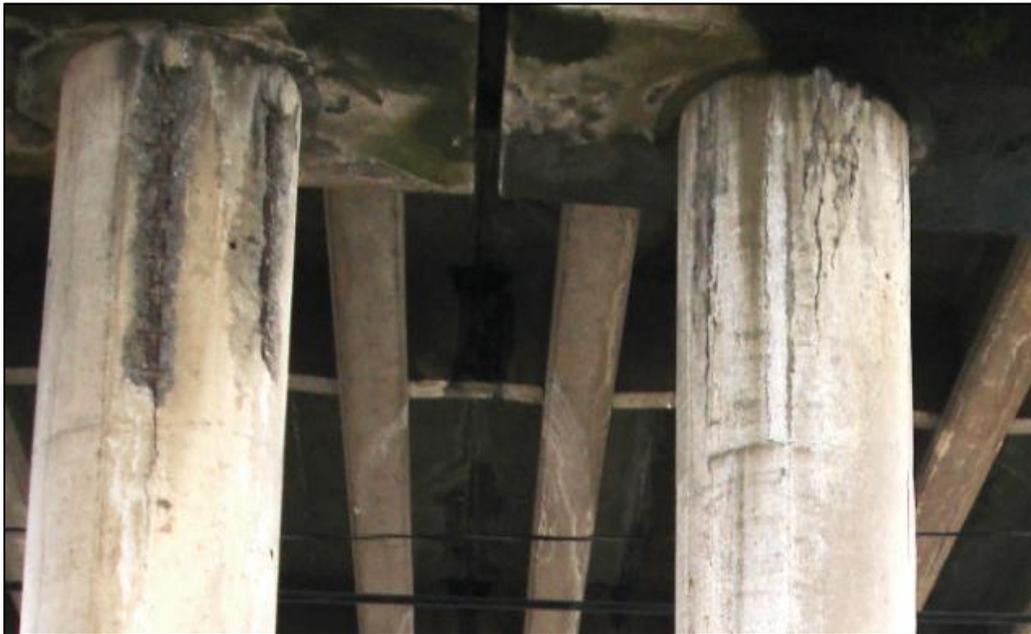
Unfortunately, after more than 50 years of service in a marine environment, the Port Approach was beginning to show signs of deterioration. Cracking and spalling were seen in many of the high stress areas, such as at the tops of the hollow precast concrete columns (see Figure 2), and in areas regularly exposed to weather, such as exterior girders. Also, a few of the high strength post-tensioning rods that ran through the precast superstructure diaphragms had failed at the anchorage locations on the fascias of the bridge.

Fig. 2 Deteriorated Port Approach Hollow Precast Concrete Columns

Each hollow precast/prestressed concrete column measured 3 feet in diameter and had 5-inch-thick walls. The cracking and spalling that was located at the tops of many of the columns where they connected to the concrete caps presented the unique problem of how to repair the columns without excessively damaging them during repair. One concern was how to prepare the outer surfaces of the hollow columns while not damaging or spalling the inner surfaces of the hollow columns, because such damage would definitely reduce the capacity of the columns. Additionally, the columns were found to not meet current seismic requirements (common in older bridges) and this deficiency also had to be addressed during the project.

The contractor and designer found a unique solution to address both the top-of-column deterioration and the seismic inadequacy of the columns in one repair method. This repair involved filling the tops of the concrete columns with structural foam and then wrapping the tops of the columns with a steel jacket. The two-component rigid polyurethane system of poured structural foam specified for the repair was a 2.0 pound (lb.) density foam that when fully cured had a compressive strength of about 300 pounds per square inch (psi). Note that as the density of the foam increases, the compressive strength can also be increased up to a maximum of about 1,200 psi for the product used on the project. The installation method for the structural foam was first proven in a mock-up test on the project site (see Figure 3) in order to properly calibrate the foam installation to on-site conditions.

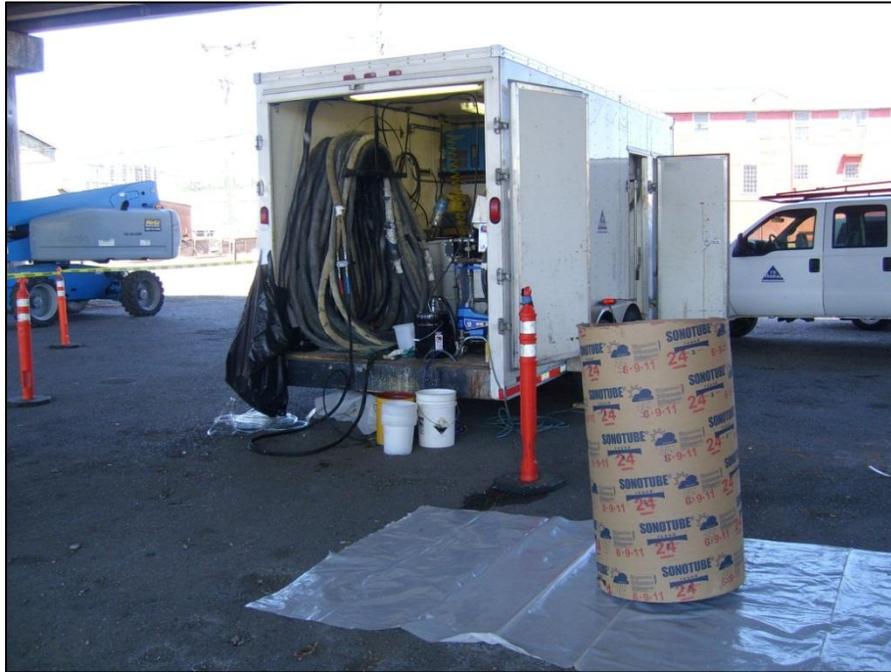
Fig. 3 Mock-Up Structural Foam Field Test

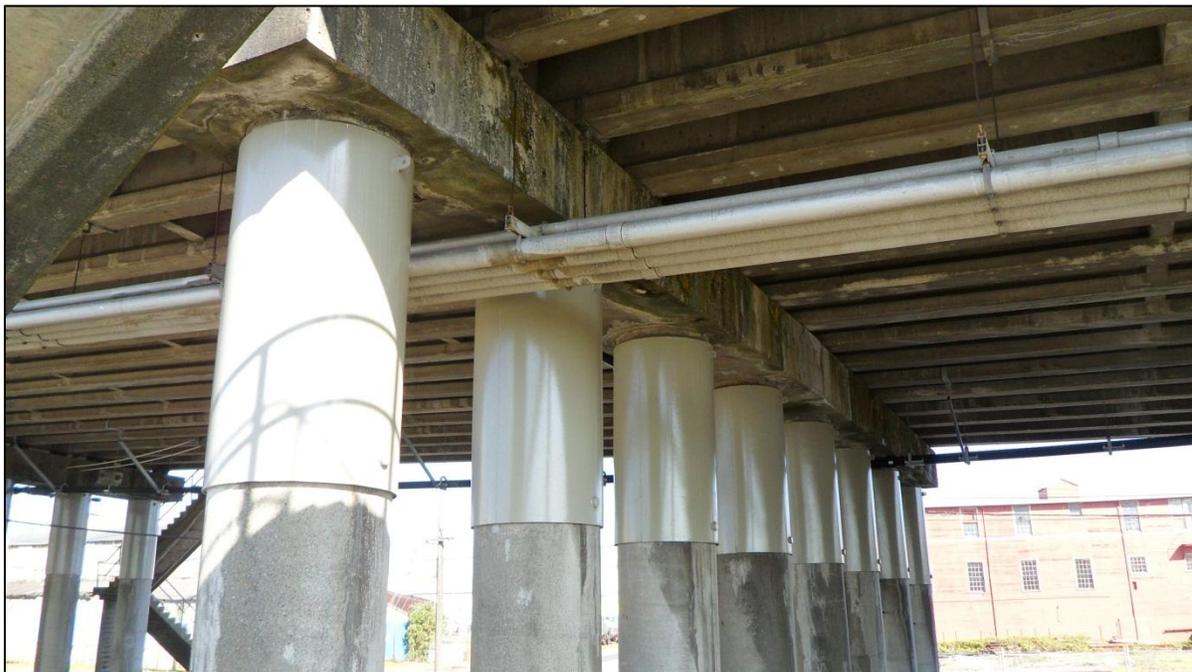
Fig. 4 Completed Hollow Precast/Prestressed Column Repair

Once the installation procedure was properly calibrated to the proper installation temperature, foam chemistry, flow rate, and incremental placement time increments, the production installation of the structural foam was ready to begin. A small, 5-inch hole was drilled in each of the hollow columns about 10 feet below the concrete cap. An inflatable, plastic, heat-resistant plug was inserted into the hole and inflated, sealing off the top 12 feet to 14 feet of the hollow columns. The 5-inch hole was patched and two small, 1-inch-diameter holes were drilled in each column—one at the top of the column and the other about 6 feet below the concrete cap. These holes allowed for the multiple lift placement of the structural foam in the hollow columns. The two-part mixture was first pumped through the lower hole and allowed to set, so that the lower foam was secured to the interior walls of the hollow columns. The mixture was then pumped through the upper hole to ensure that the entire top portion of the column was filled with the structural foam.

After the foam fully cured (after about 72 hours) the inner surfaces of the hollow columns were now supported and the outer surfaces could be properly chipped and prepared for spall repairs. Since all of the hollow column tops were receiving steel jackets, it was decided to use the grout between the steel jacket and column as the spall repair grout, instead of repairing the columns with one type of stiff, self-supporting structural repair mortar and then installing the jacket with a fluid grout. After all of the deteriorated material was removed from the tops of the outer hollow column surfaces, the steel jackets were installed and were externally supported, and the void between the jacket and outer surface of the hollow column was sealed. A flowable grout was pumped in through the bottom valve of the steel jacket. Once clean grout flowed out of the upper valve, both valves were closed and the grout was allowed to cure to full strength (see Figure 4 for completed repair).

The jackets were finally painted in a Washington Gray color paint to protect the steel from corrosion. The efficient repair restored capacity to the hollow precast/prestressed concrete columns. In addition, the use of the exterior steel jackets and interior structural foam increased the confinement capacity of the columns and added additional seismic capacity to the columns in the column plastic hinging zones.

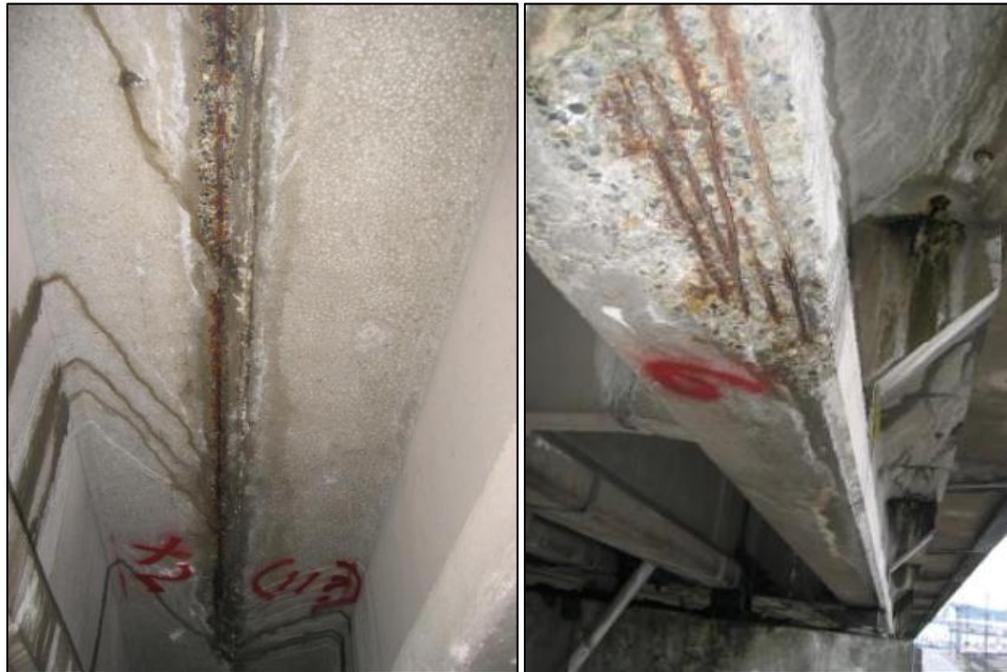
The precast/prestressed concrete deck girders were typically 74 feet long by 3.5 feet deep and 3.75 feet wide at the top flanges. The deterioration in the deck girders primarily consisted of spalling at the top flange shear key connections and spalling in the bottom flanges of the exterior girders (see Figure 5). A number of the bottom flange spalls had exposed and severely deteriorated the prestressing strands.

Fig. 5 Damage to Prestressed Girder Top and Bottom Flanges

have the individual strand capacities restored. Because the lane configuration of bridge was changing and a permanent traffic barrier would now be separating the exterior pedestrian sidewalks from the vehicular traffic lanes, the live loads on the deteriorated exterior girders would be significantly lower than the original configuration design live loads (which did not have a permanent barrier that separated pedestrian and vehicular traffic). This meant that, of the 25 broken strand locations discovered, only 12 broken strands required strand couplers to restore strand capacity and girder capacity. This saved both time and money while still allowing the precast/prestressed concrete girders to meet the minimum required inventory rating factor of 1.25 that was specified in the RFP.

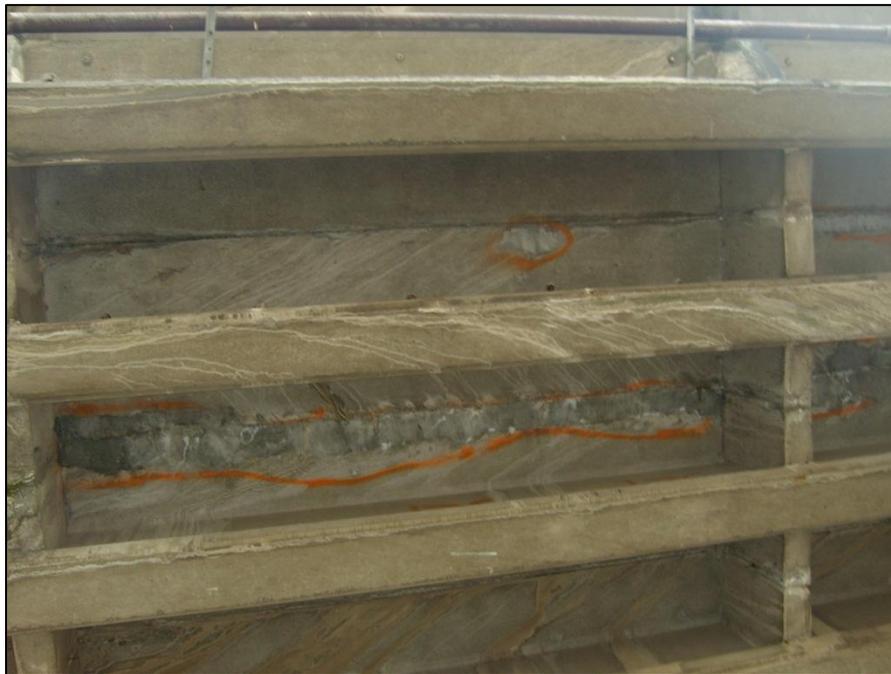
Fig. 6 Repaired Precast/Prestressed Girder Top Flange

The top flanges shear key connection spalling of the precast/prestressed concrete deck girders were repaired by chipping a minimum of $\frac{3}{4}$ inch behind the exposed reinforcing steel to sound concrete. The oxidized reinforcing steel had to have all rust removed from the reinforcing bars within the spalled area using abrasive blasting or compressed air pressure flushing, which had to produce a minimum 100 psi pressure at the nozzle. Pressure washing was not permitted. Once the surface of the spalled area was properly prepped, the builder applied a traditional stiff non-shrink structural repair mortar that achieved 4,000 psi compressive strength after seven days (see Figure 6 for a completed top flange repair).

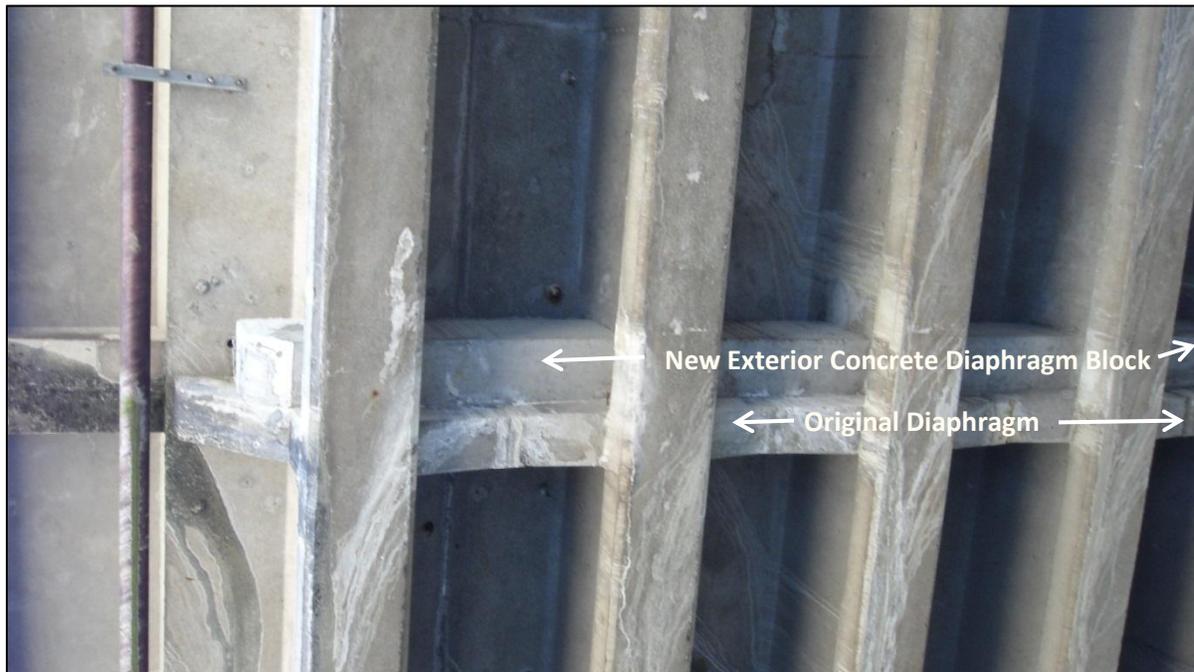
It was discovered during previous and pre-construction inspections that 5 of the 70 diaphragm end anchorage locations had failed. The post-tensioning rods were grouted; however, it was difficult to determine the extent of post-tensioning loss in the diaphragms. Therefore, it was decided to build an exterior concrete diaphragm block that would subsequently be post-tensioned and grouted. This would ensure that any lost post-tensioning force at the fascia locations where the exterior anchorages had failed would be restored. A 3-inch-diameter hole was cored through the girders and a 1-inch-diameter high strength bar was threaded through the newly constructed concrete diaphragm block and cored holes. The high strength bar was tensioned to 70 kips and grouted using a traditional pre-packaged thixotropic grout (see Figure 7 for a completed precast/post-tensioned diaphragm repair).

Fig. 7 Repaired Precast/Post-Tensioned Concrete Diaphragm

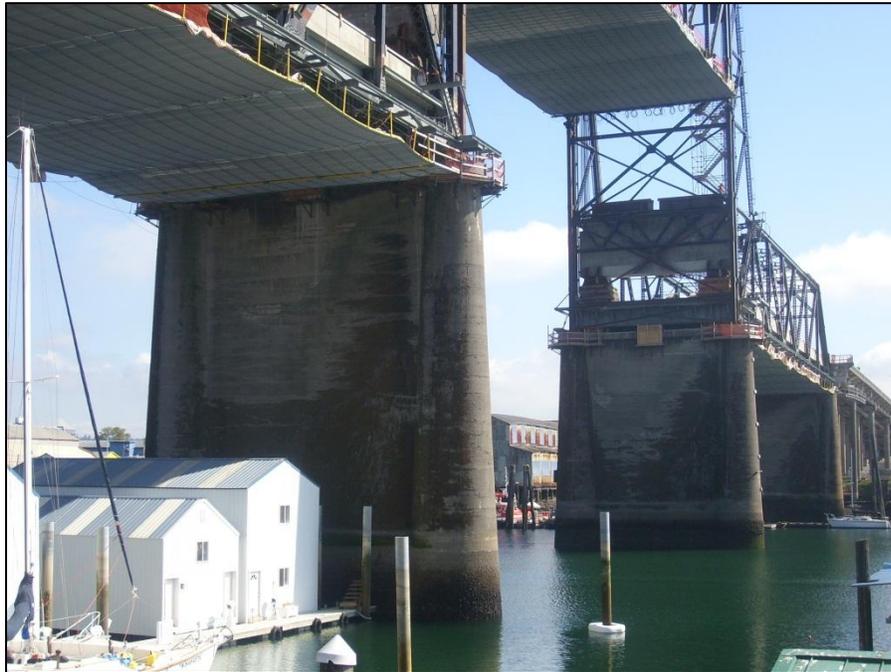
cap (see Figure 8 for an overall view of the concrete river piers). The main river pier columns and cap were in good condition after roughly 100 years of service with just minor cracking and spalling. The web walls of the main river piers require repair due to moderate to heavy spalling, but those repairs are scheduled to be completed as part of the phase three seismic retrofit of the bridge that will be completed in the next phase of the project. However, it was decided to enhance the seismic capacity of the pier caps during the second phase of the rehabilitation project to provide intermittent protection between the superstructure and substructure connection points.

Fig. 8 Overall View of Concrete Main River Piers

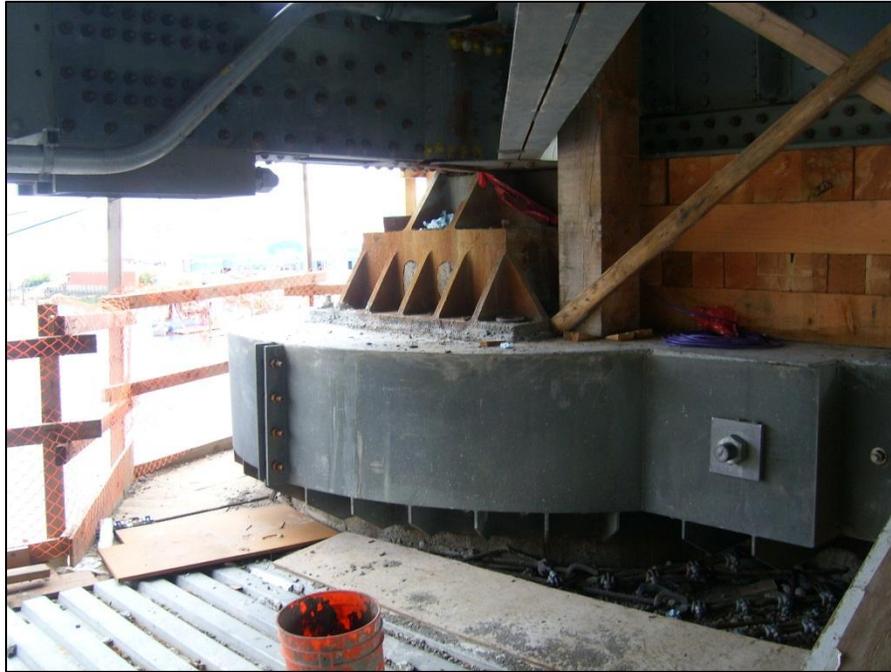
Calculations showed that the original concrete pier caps could not resist the current AASHTO level earthquake design loads at the main lift tower bearing locations. However, to prevent future rework, the cap strengthening needed to be compatible with a variety of possible seismic retrofit options. It was decided that the rehabilitation of the pier caps would consist of primarily adding radial reinforcing steel bars and a radial steel cap casing at the bearing locations to achieve the necessary seismic capacity at each main lift tower bearing location.

Fig. 9 Main River Pier Cap Bearing Seismic Retrofit

The strengthening construction of the main river pier caps started by chipping back 6 inches of the existing concrete cap at the bearing locations, so that the new steel reinforcing bars could be tied in with the existing reinforcing steel bars. Two layers of #6 Grade 60 steel reinforcing bars were placed and spaced at 6 inches on-center around the existing pier caps at the bearing locations. The ½-inch-thick ASTM Grade 50 radial steel cap casing had steel studs welded to the interior of the casing to ensure composite action with the new cap

To complete the seismic retrofit, a 2 ½-inch-diameter ASTM F1554 Grade 55 galvanized tie rod was installed through a 3-inch core hole that was drilled through the pier cap. The rod was designed to resist the demand radial forces generated by the lateral seismic demands at the bearing location. Finally, the retrofit was completed by placing a standard concrete mix that achieved a 28-day design strength of 4,000 psi. See Figure 9 for the final main river pier cap seismic retrofit.

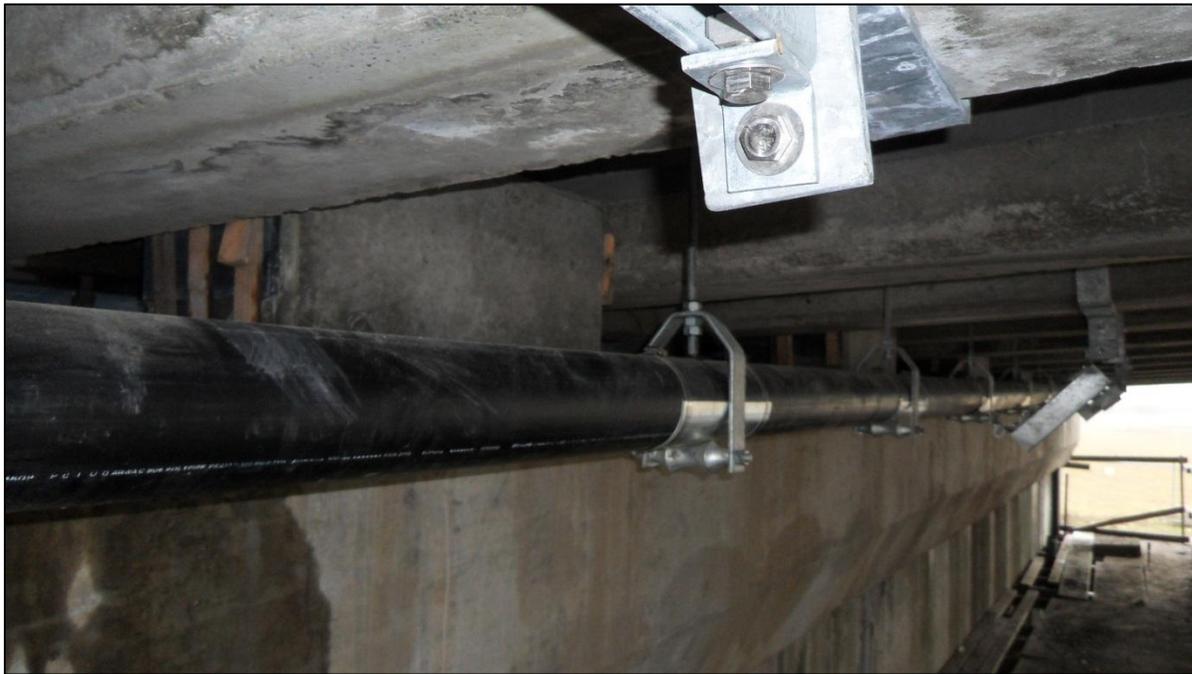
New seismic design requirements meant that the movable bearings location at the Port Approach Abutment required seismic enhancement to meet current seismic design requirements. Calculations showed that the beam seats did not have sufficient width to meet seismic design/detailing requirements. Therefore, the designer-builder decided to build out the abutment beam seat by building an additional 9-inch-wide corbel on the face of the abutment cap. To handle the transverse requirements, eight new shear keys were built on top of the new corbel.

Fig. 10 New Concrete Girder Stops at the Port Approach Abutment

Construction of the retrofit started with drilling $\frac{3}{4}$ -inch-diameter holes 8 inches into the existing abutment cap and stem wall. Three layers of #5 Grade 60 steel reinforcing bars that were spaced at 18 inches on-center were set in the holes and secured using a standard two-part epoxy resin. The steel reinforcing bars and wood forms were set for the corbel, and the corbel was completed by placing a standard concrete mix that achieved a 28-day design strength of 4,000 psi. Once the corbel achieved strength, the forms for the shear keys were built and the same concrete as for the new corbel was placed for the new shear keys (see Figure 10 for the completed seismic retrofit). The RFP gave controlled flexibility to the design-builder that allowed it to develop an acceptable and simple solution to meet current seismic design requirements.

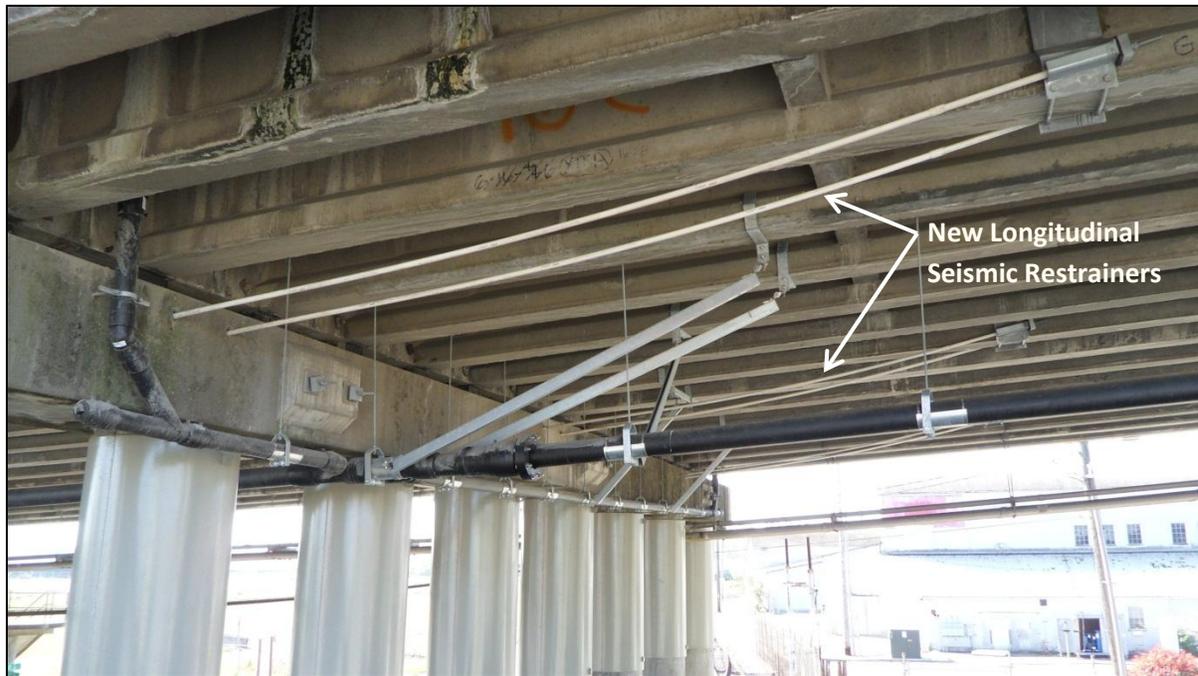
Fig. 11 New Port Approach Longitudinal Seismic Restrainers

The seismic retrofit called for three pairs of seismic restrainer rods to be installed in each span that was adjacent to an expansion joint intermediate bent. The girder rod connection consisted of a $\frac{5}{8}$ -inch-thick ASTM Grade 50 steel plate bracket that was fabricated for each girder connection location. Four 1-inch-diameter connection holes were drilled through the webs at the girder restrainer rod connection locations. Special care was taken to miss the girder vertical reinforcement and longitudinal draped prestressing strands. The girder

The 3/4-inch-diameter F1554 Grade 105 seismic restrainer rods were secured between the girder and cap connections with ASTM A563 Grade DH double jam nuts at each end. A 1-inch gap between the double jam nuts and the cap rod connection bearing plate was provided, so that the seismic restrainers would not be engaged during normal thermal movements of the bridge. The seismic restrainer rods were sealed in a 1-inch-diameter P.V.C. sheathing in order to provide long-term protection to the high strength rods (see Figure 11 for the newly completed longitudinal seismic restrainers).
