PRECAST DOUBLE TEE ROOF COLLAPSE INVESTIGATION - A CASE STUDY

Paul Bennett, MS, PE, Managing Engineer, Exponent, Boulder, CO
Pedro Fernandez, MS, PE, Senior Structural Engineer, Atkins, Denver, CO

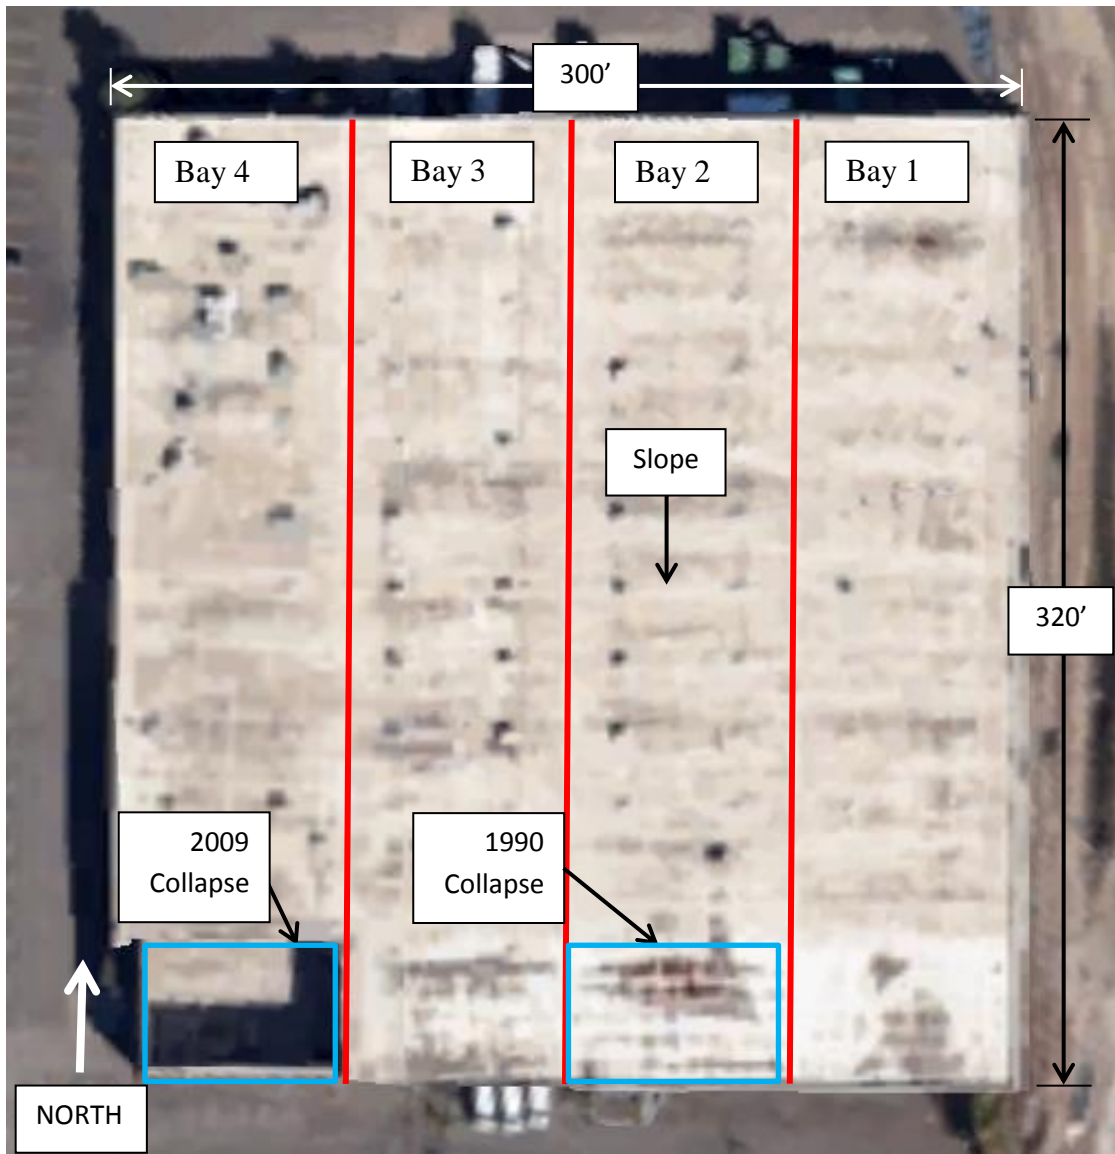
The subject structure is an approximately 96,000 square foot building located in the greater Denver area. An aerial view of the building is shown in Figure 1 wherein the collapsed area can be seen. The building was constructed in 1977 and is currently utilized as a warehouse and manufacturing facility. The exterior walls are partially grouted reinforced concrete masonry walls supported on spread footings. The roof structure consists of simply supported precast prestressed concrete double-tee (DT) sections that are eight feet wide and seventy five feet long with two 24-inch-deep stems. At the perimeter of the building, the DTs are supported by the concrete masonry and at interior locations the DTs are supported by precast prestressed inverted tee beams that bear on precast concrete columns. The roof can be divided into four bays with each bay being seventy feet wide corresponding with the span of the DT members.

Fig. 1 Aerial view of building

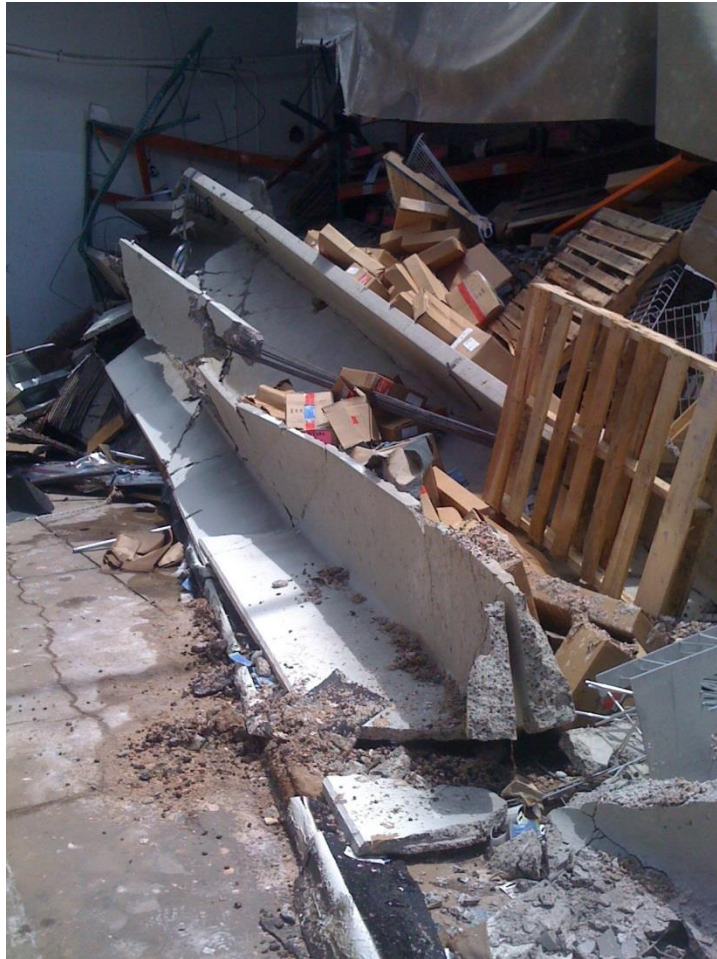
On June 24, 2009 a severe thunderstorm impacted the building resulting in collapse of a portion of the DT roof structure in Bay 1 as shown in Figure 2. Fortunately, this collapse happened after normal business hours otherwise the collapse may have resulted in loss of life as workers often occupied the area below the collapse.

Fig. 2 Collapsed double tee in Bay 1

It did not take long to determine that the collapse was caused by the severe rainfall and that the covered-up overflow scupper, limited roof slope, new roof membrane, hail accumulation, and ill-maintained drains were all contributing factors to the collapse. The rainfall runoff accumulation at the south end of the roof reached a depth great enough to catastrophically fail the DTs in Bay 1. One might assume that the depth of water would have been consistent across the entire south end of the roof and this would be true to an extent. However, given that each bay acts independent (structurally speaking) and that each bay had its own unique configuration of drains (or lack thereof) it is likely that the depth of water somewhat varied between bays leading to the possibility of progressive ponding and a likely explanation as to why Bay 1 collapsed while other nearby Bays sustained no damage. Further, once the collapse occurred, the hole in the roof served as a drain mechanism for the roof to rapidly drain the other bays.

The authors considered many repair concepts one of which was an external post-tensioning system for the DTs that had excessive deflections – such repairs have successfully been implemented in the past. External post tensioning still required removal of building contents below damaged DTs, roofing system repairs, removal and re-installation of fire suppression systems, and removal and re-installation of certain mechanical and electrical systems. There were other concerns with external post tensioning, such as reduced clearance to the bottom of the DTs and loss of use time, that were critical to the use of the facility. Conceptual drawings were submitted to a repair contractor who ultimately determined that the costs associated with external post tensioning met, or exceeded, the costs associated with removing and replacing the damaged DTs; thus, new DTs were installed.

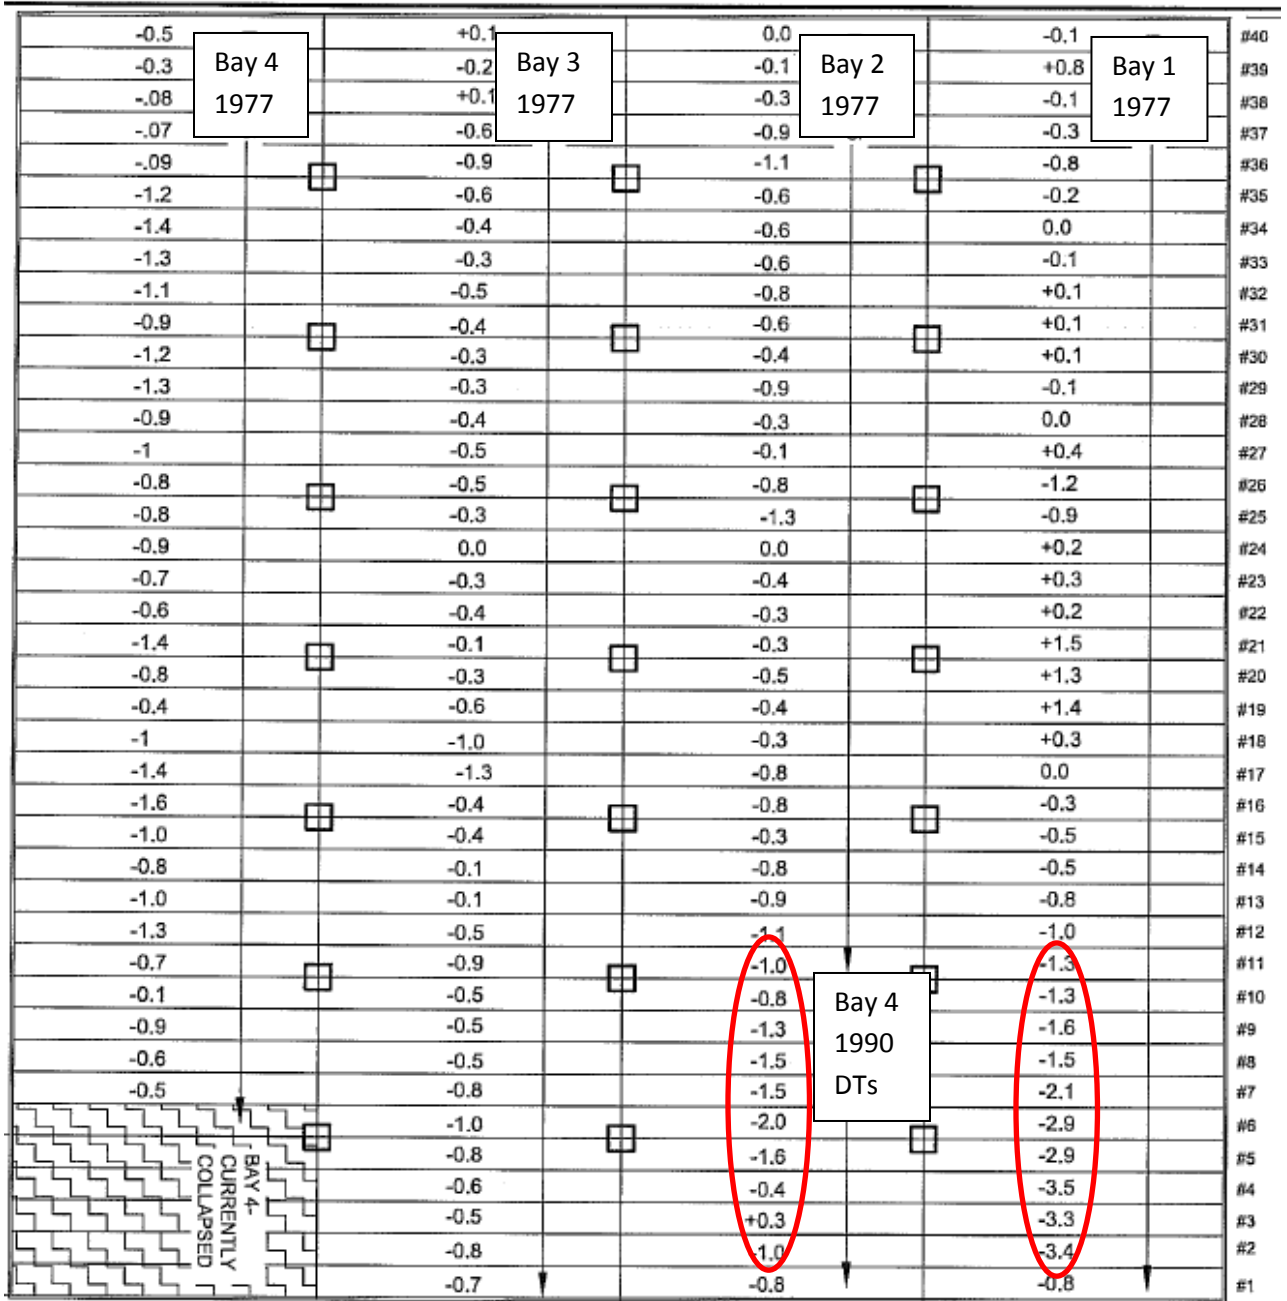
After the collapse, the health of the remaining DTs was called into question. Were the adjacent and original 1977 DTs compromised? Were the newer 1990 DTs damaged? In order to determine the health of the remaining DTs, the deflection under dead loads was measured for each DT. Figure 3 shows the measured deflections at each DT wherein a positive (+) symbol depicts camber and a negative (-) symbol depicts downward deflection. Unexpected deflections were found at the south end of the building and at this point an investigation began in order to determine the cause of the large deflections since opposing experts opined the cause was long-term creep. Localized low areas at the south end of the roof were found to pond to two inches of water and questions arose as to whether or not standing water could have induced the observed deflections due to accelerated creep.

Most of the DTs at the south end of the building were found to have no camber and excessive downward deflections under self-weight and a roof superimposed dead load of 7.7 pounds

per square foot (psf). Most surprising was the finding that the 1990 DTs, manufactured with low-lax strands and three inches of theoretical initial camber, also had up to two inches of deflection under roof superimposed dead load. Other, 1977 DTs on the south end of Bay 1 had deflections of up to 3.5 inches under self-weight and roof superimposed dead load alone.

Fig. 3 DT deflections (north is up)

From the theoretical analyses it was determined that the deflections found to be in excess of 1.6 inches, were not caused by long-term creep due to the roof sustained load (self-weight and superimposed dead loading). That is, through the analyses it was determined that a sustained load (in addition to the DT self-weight and the roof's superimposed dead load) of more than 17 psf would have had to be present for an extended period of time (years) in order to cause such deflections. This additional sustained load would be equivalent to approximately 3.5 inches of standing water on the entire DT for years. However, no evidence of such load was found as whatever water ponded on the DT's typically evaporates in days in the dry Denver climate. Thus, it was concluded that the large deflections were not due to long-term creep induced by standing water.

With regard to the loss of prestress, the results showed that the amount of theoretical prestress loss that would cause the permanent deflections, shown in Figure 3, would have been approximately 38 percent. This amount of prestress loss far exceeds any measured loss in the industry and was unlikely the cause of such deflections.

After determining that, neither long-term creep nor strand slippage could have caused the permanent deflections shown in Figure 3, progressive ponding analyses were performed. The progressive ponding analyses showed that the probable load due to the rain event caused the DTs to deflect in excess of 6 inches. This deflection then led to more water on the already deflected DTs and likely caused the strain in the prestress strand to exceed 1 percent, leading to a loss of prestress and consequently the permanent deflections shown in Figure 3. Thus, it was concluded the most likely cause of the excessive permanent deflection was an overload on the DT's due to both the magnitude of the rain event and the poor drainage conditions on the roof.
