LIVE LOAD TEST OF A 54-YEAR OLD PRESTRESSED CONCRETE VOIDED SLAB BRIDGE

Bernard L. Kassner, Ph.D., P.E., Virginia Center for Transportation Innovation and Research, Charlottesville, VA

Soundar S.G. Balakumaran, Ph.D., Virginia Center for Transportation Innovation and Research, Charlottesville, VA

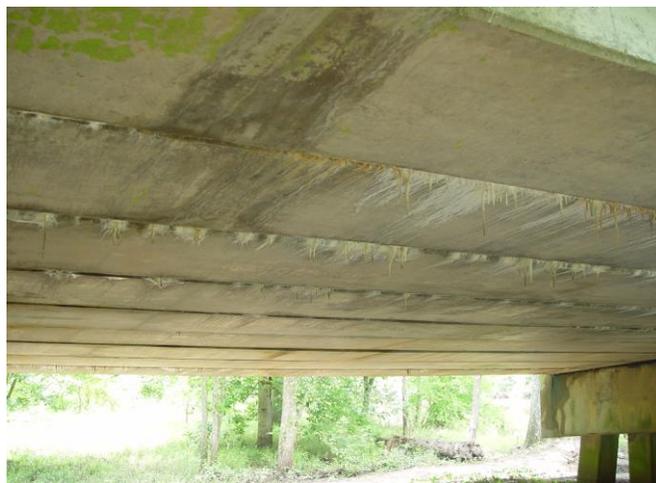
Fig. 5 Efflorescence on the bottom of and along the longitudinal joints of the voided slabs

- Despite signs of deterioration in the longitudinal joints, as suggested by the efflorescence that had formed along the joints at the bottom of the beams, the grouted shear keys in those joints appeared to still be performing well. There were virtually no vertical or horizontal differential displacements at the two joints that were monitored during the load test to the point where all recorded measurements were less than the precision of the measurement instruments. One joint was deemed to be a good joint without efflorescence while the other joint was in a more dilapidated state that had efflorescence.

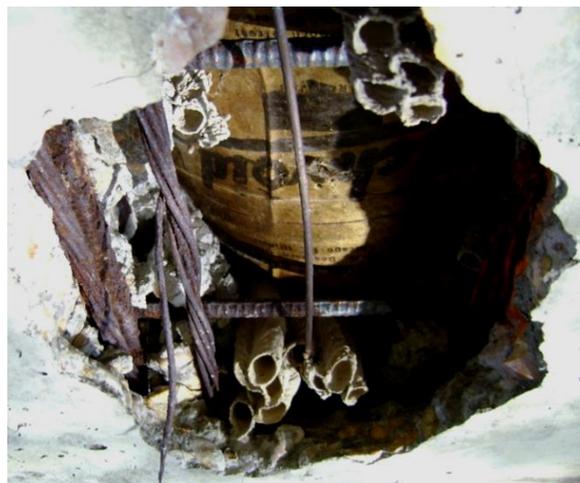
Fig. 6 Poorly consolidated concrete in Beam 5, near the quarter-point closest to Bent 2, Span 3.

- The exposed and corroded or broken strands in Beams 4 and 5 appeared to have a relatively negligible impact on the beams' flexural performance when compared to adjacent beams subjected to similar loading conditions.

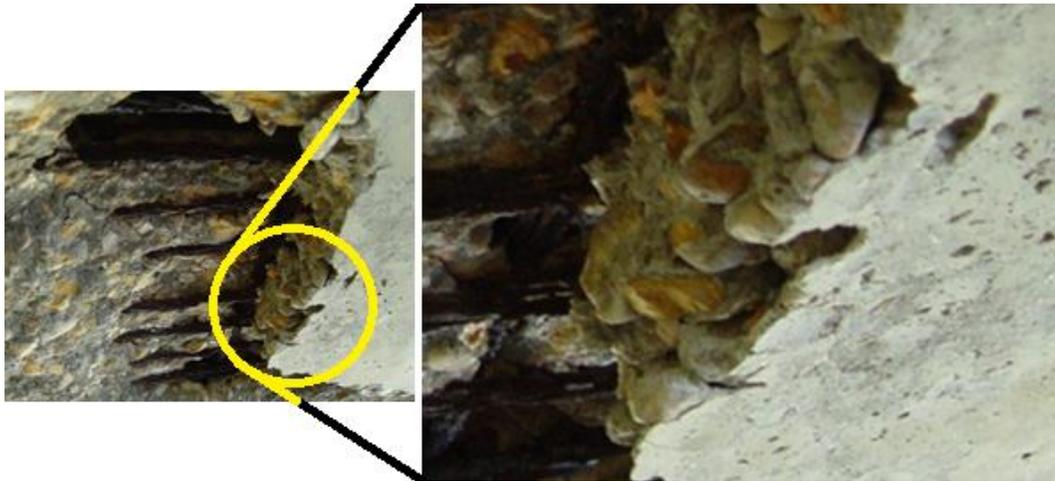
Fig. 7 Poorly consolidated concrete below corroded strands in Beam 4, near the quarter-point closest to Bent 3, Span 3.

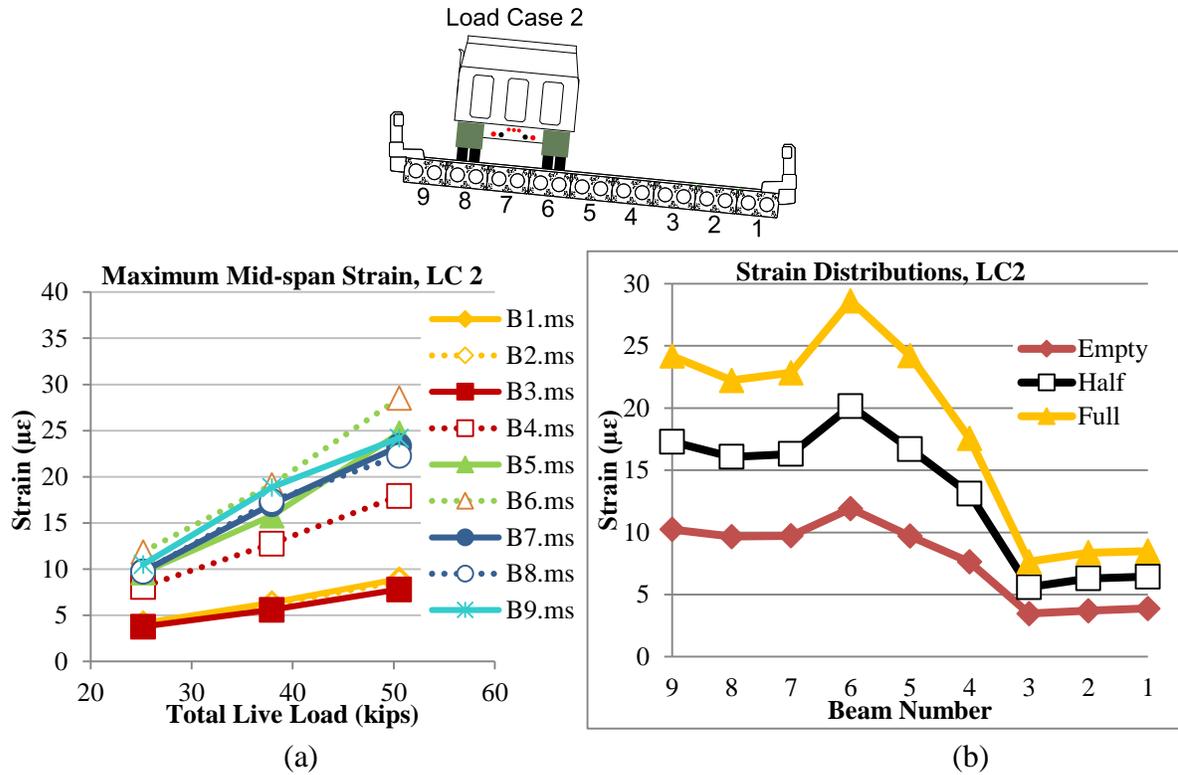
Fig. 13 Average (a) maximum strain and (b) strain distributions at mid-span for all beams [at maximum strain] for Load Case 2.

The exceptions to this linearity in load-strain behavior were Beam 5 in LC 2 [Fig. 13(a)] and Beam 3 in LC 6 [Fig. 17(a)], and to a lesser extent, Beam 6 in LC 2 [Fig. 13(a)] and Beam 2 in LC 4 [Fig. 15(a)]. In these cases, the rate of increase in strain between the Half Truck and the Full Truck was greater than the increase going from the Empty Truck to the Half Truck, on a strain per unit load basis. Recall that Beam 5 had the spall with exposed and broken strand. Interestingly, the non-linearity instances with Beams 5 and 3 occurred when a truck wheel line was adjacent to the beam in question, as opposed to being directly on top. However, the deviation from the linear strain increase for Beams 5 and 3 was only about 5 µε, which is negligible. There were some cases where the rate of strain increase was lower as the amount of load increased. These latter instances, however, occurred in beams that were adjacent to the more directly loaded beams. So, these anomalies may be attributed to minor changes in load distribution as the loading increased. Interestingly, Beam 4 appeared to indicate fairly consistent strain linearity as the load increased. This observation suggests that

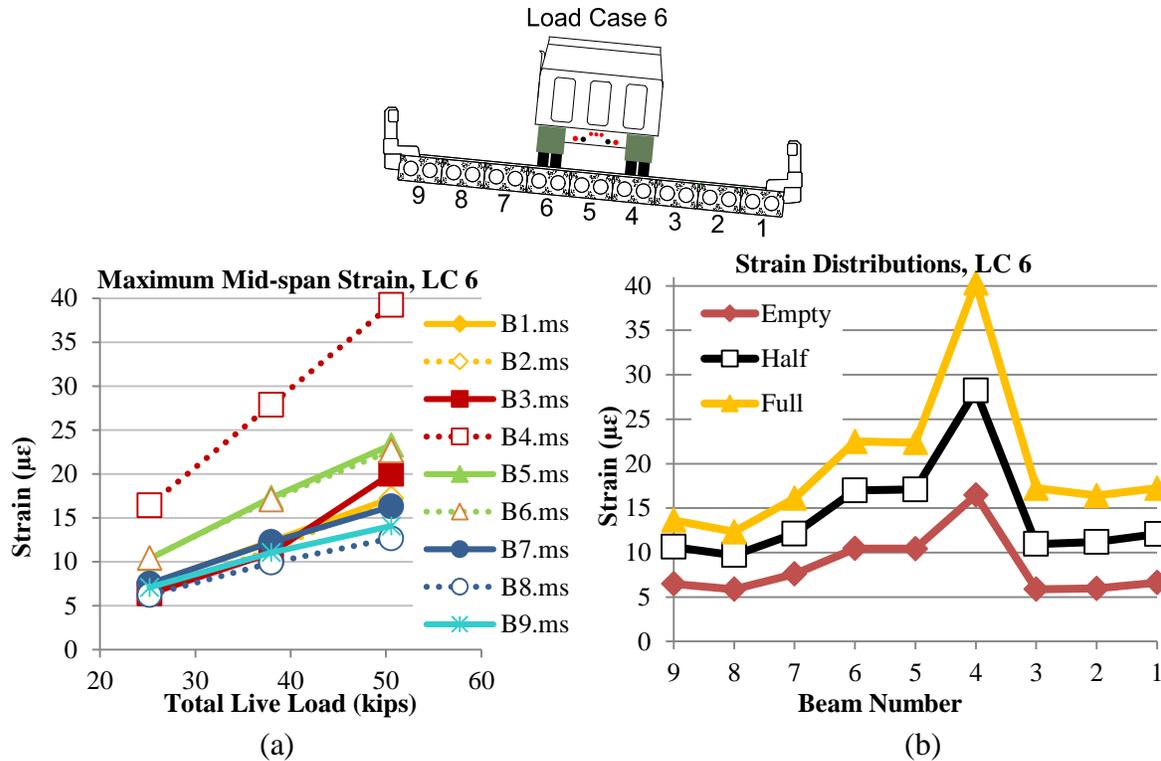
Fig. 17 Average (a) maximum strain and (b) strain distributions at mid-span for all beams [at maximum strain] for Load Case 6.

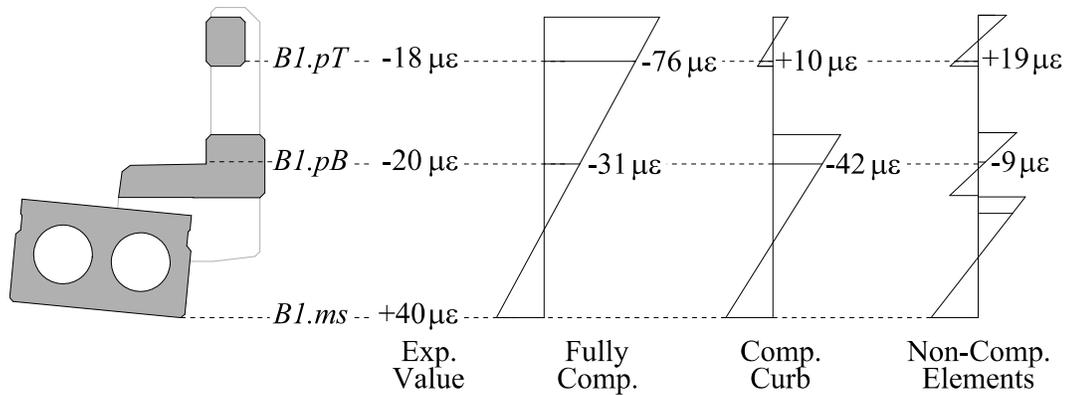
Fig. 20. Comparison of experimentally-measured strains versus calculated values assuming various degrees of composite action

Varying the assumed compressive strength, and hence the elastic modulus, did not have a major impact on the calculated strain values given in Fig. 20. In any event, comparing the experimentally recorded strains versus the calculated values revealed a slight amount of composite action occurring between the exterior beam and the parapet components. If, in fact, the railing was truly non-composite, then the railing would not feel any realistic load from the truck. However, the railing could have had additional deflection under self-weight when the supporting beam beneath the railing deflected downward and away from the railing due to the weight of the truck, and thus, the bottom of the railing would exhibit a small amount of tension. Instead, the load test showed that the bottom of the railing exhibited a small amount of compressive strain. On the other hand, the strain gage on the curb had less compressive strain than for either scenario that assumed composite action with the beam but had more compressive strain than what was calculated for the non-composite curb element. One possible explanation as to why the railing appeared to have a greater degree of

composite action compared to the curb is that the strain gage was not adequately attached to the concrete at the top of the curb due to the surface conditions of the curb. Thus, perhaps the recorded strain in the curb did not fully account for the actual strain in that element.

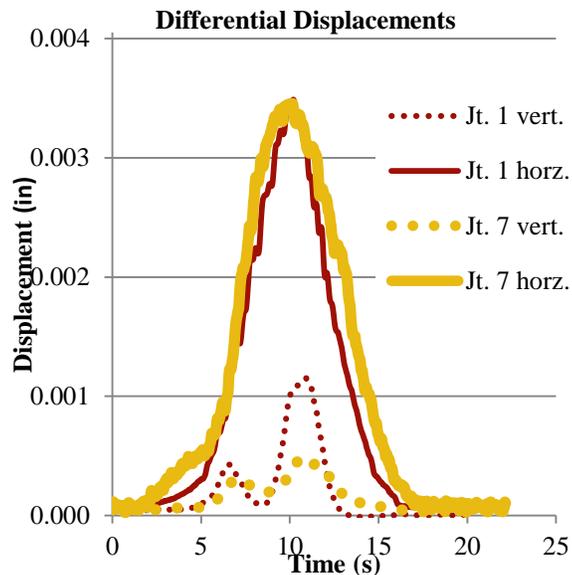
Fig. 21 Comparison of differential displacements at mid-span for Joints 1 and 7

Fig. 21 indicates that the LVDTs at mid-span of Joints 1 and 7 were able to detect responses to the load vehicle as it traversed the span. However, the relative displacements at both joints were both extremely small, with the largest vertical differential movement being just above 0.001 in. Interestingly, the differential horizontal displacement was greater than the vertical displacement in both joints. Even so, the recorded displacements were below the precision in the LVDT devices, which was 0.005 in. Nevertheless, just as a point of comparison, the two longitudinal joints had a similar degree of horizontal movement between the two beams at the given joint. On the other hand, Joint 1 had about twice as much vertical differential

movement as did Joint 7. Again, however, greater emphasis should be placed on the fact that all of the measured movements between two beams were fairly minute.
