## **ASSESSMENT OF A PARKING GARAGE WITH A BROKEN PRESTRESSED SPANDREL BEAM**

**Bishal Parajuli, EIT**, Dept. of Civil Engineering, University of Toledo, USA  
**Seyedowjan Hashtroodi, EIT**, Robert Darvas Associates, Ann Arbor, MI  
**Douglas K. Nims, PhD, PE**, Dept. of Civil Engineering, University of Toledo, USA

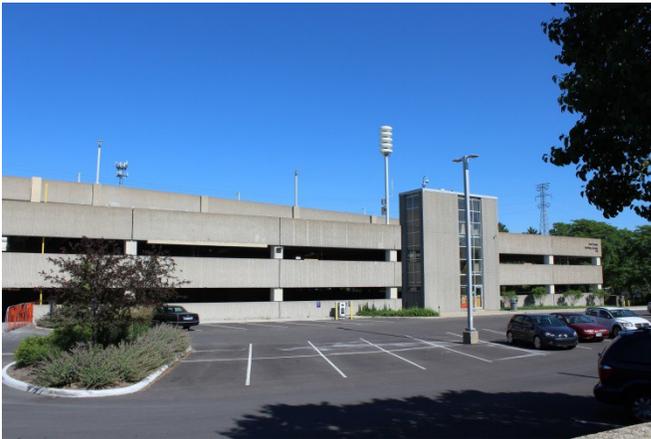
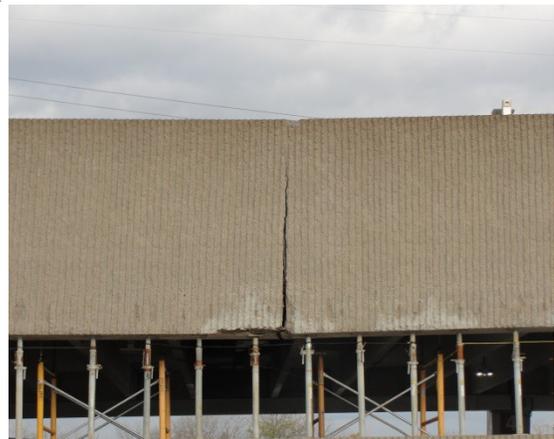
In September 2013, an exterior prestressed spandrel beam in a parking garage in Northwest Ohio failed. The 40 year old L shaped prestressed spandrel beam failed brittlely and unexpectedly due to severe corrosion of the prestressing strands. A large crack occurred at the mid-span of the beam extending nearly to the top of the beam and the concrete above the crack spalled. The beam failed completely and was prevented from falling when the broken pieces wedged against the adjacent beams. Figure 1 shows the parking garage and figure 2 shows the crack. Post failure visual inspection revealed little external indication of the extent of the corrosion. After the failure, the garage was immediately closed and inspected. The garage was reopened after extensive repairs including strengthening of some spandrel beams and the addition of columns to shorten some beam spans.

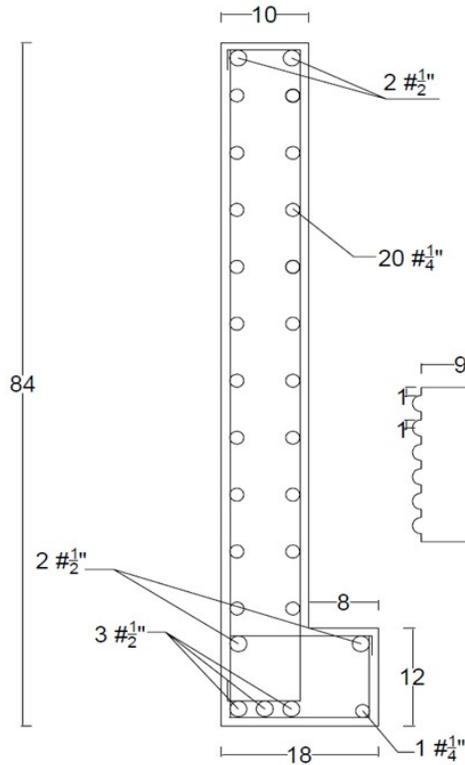
Figure 3 shows the cross section of the spandrel. Figure 4 shows a detail of the 10 inch width of the stem which consists of 9 inches of solid section and 1 inch of grooved exterior. The longitudinal reinforcement in the section consists of 28 prestressing strands: seven one-half inch prestressing strands and 21 one-quarter inch strands. There was no conventional longitudinal reinforcing steel. At the mid-span of the beam, where the crack occurred, there are number 4 bar vertical stirrups at twelve inch spacing.

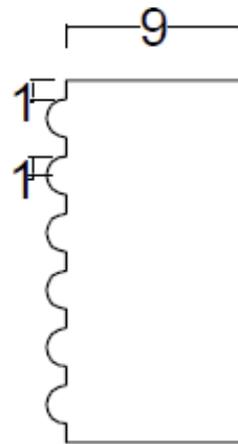
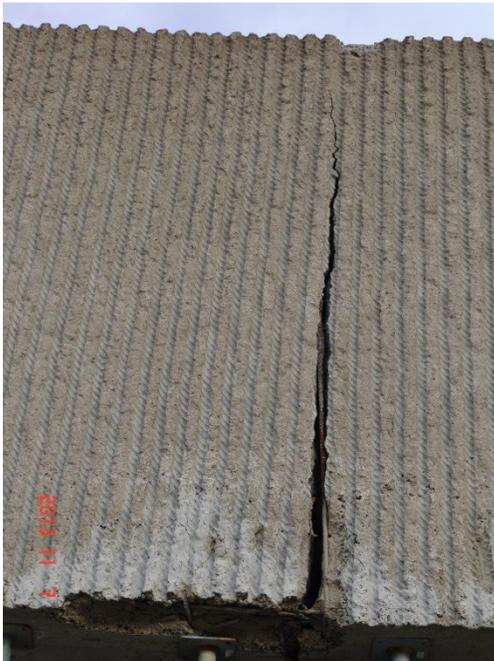
Figures 5 and 6 show the interior and exterior details of the crack. Note in Figure 5, the concrete is spalled at the top of the crack. In Figure 6, evidence of water leaking through the deck joint near the crack location can be observed. Figure 7 shows the crack extending upward from the deck to within a few inches of the top of the beam. Note the repairs in the deck joint near the crack indicating a history of leakage. The failure surface was inspected thoroughly. Even though small cracks could be easily observed on the painted interior surface, there was no sign of any distributed small cracks near the main crack, which would normally form in a ductile failure. There was only one dominant crack which had propagated through the depth of the beam at the mid-span. This is evidence of a brittle flexural failure.

The crack was approximately two inches wide at the bottom of the beam. Viewed from inside the garage and from the top deck there was an easily visible kink in the beam. Inspecting the joint between the failed beam and the adjacent beams, it was clear the failed beam had broken into two pieces which had rotated as rigid

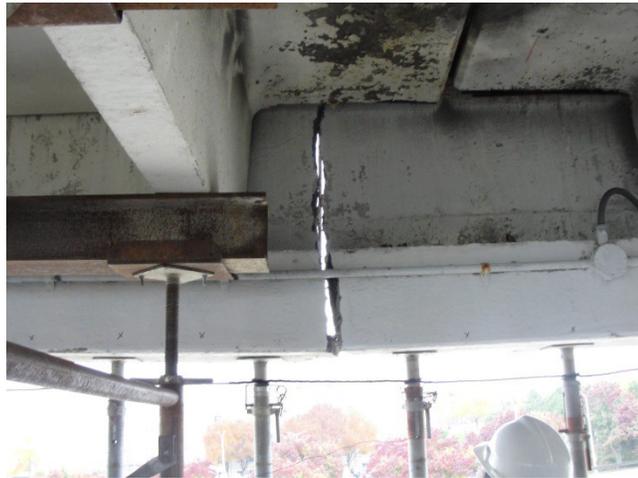
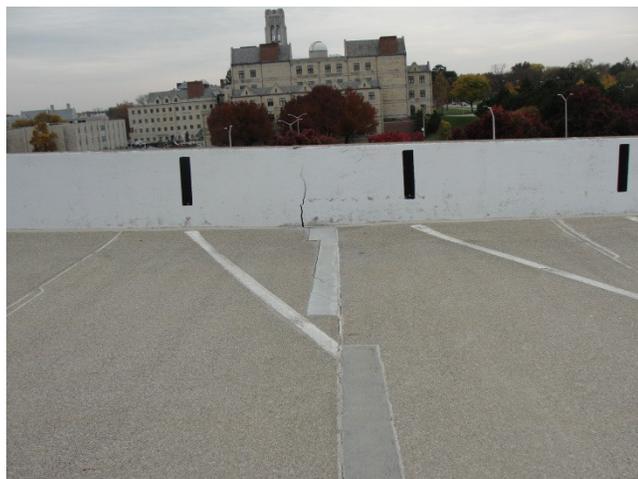
bodies. The downward motion had been arrested due to arch action with the top midspan of the beam in compression between the failed pieces and the lower corners of the broken beam pressed against the adjacent beams. The portion of the beam that the column was attached to had a smooth surface. The beam had rotated until the protruding rope roughened surface had come to rest against the column. The rough texture of the column may have inhibited further rotation and caused tension in the bolts designed to resist torsion in the spandrel. Thus, it is possible the rough texture of the exterior face prevented the collapse.

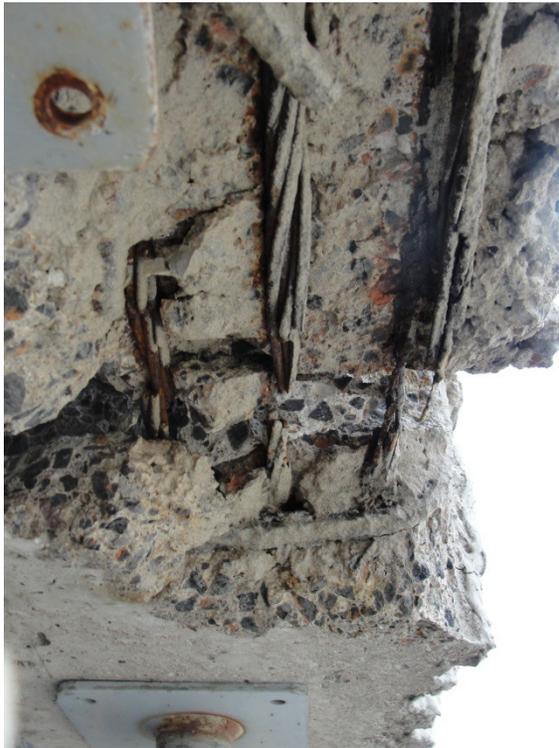
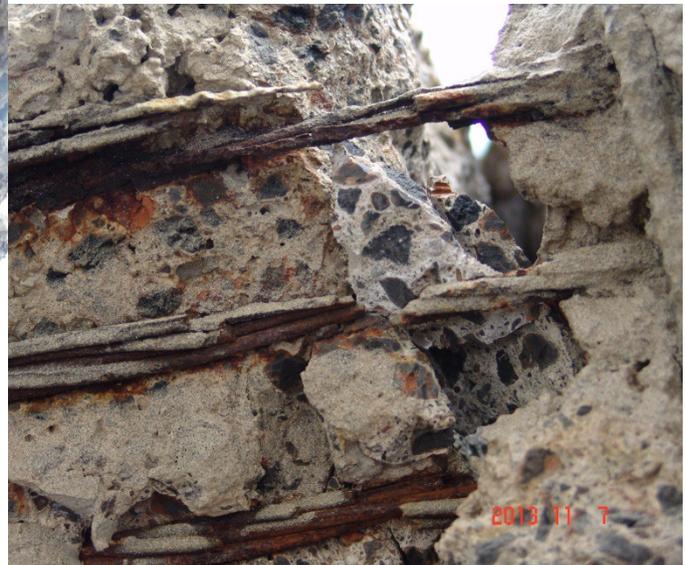
Figures 8 and 9 show details of the ½ inch strand breaks at the crack. In figure 3, this is the lowest level of strand below the stem. The outer two ½ inch strands are severely corroded with the outermost one essentially having completely dissolved. The inner most ½ inch strand also has extensive rusting. The ¼ inch strand in the bottom of the ledge could be felt, but not clearly inspected visually. The vertical face of the flange on the interior of the garage is painted white and cracks are easy to observe. However, in the region of the dominant crack, no cracks adjacent to the main crack were observed on the vertical face and there was no visible signs such as spalling, efflorescence or discoloration of the concrete on the bottom of the beam.

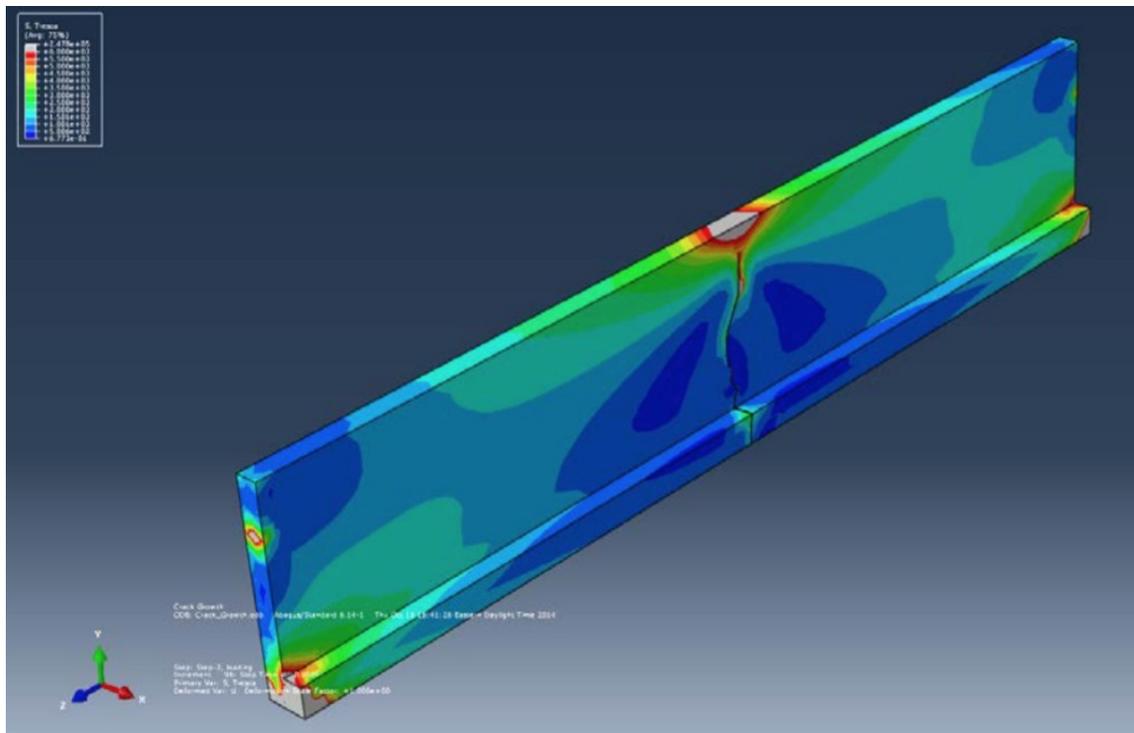
The crack propagation of the beam at a few stages before complete failure is presented in the figure 15. It can be observed that at this stage, the crack has propagated through the depth of the beam and the crack tip is at the compression zone of the beam. Comparing figures 2 and 15 – the analysis and actual crack patterns are similar.

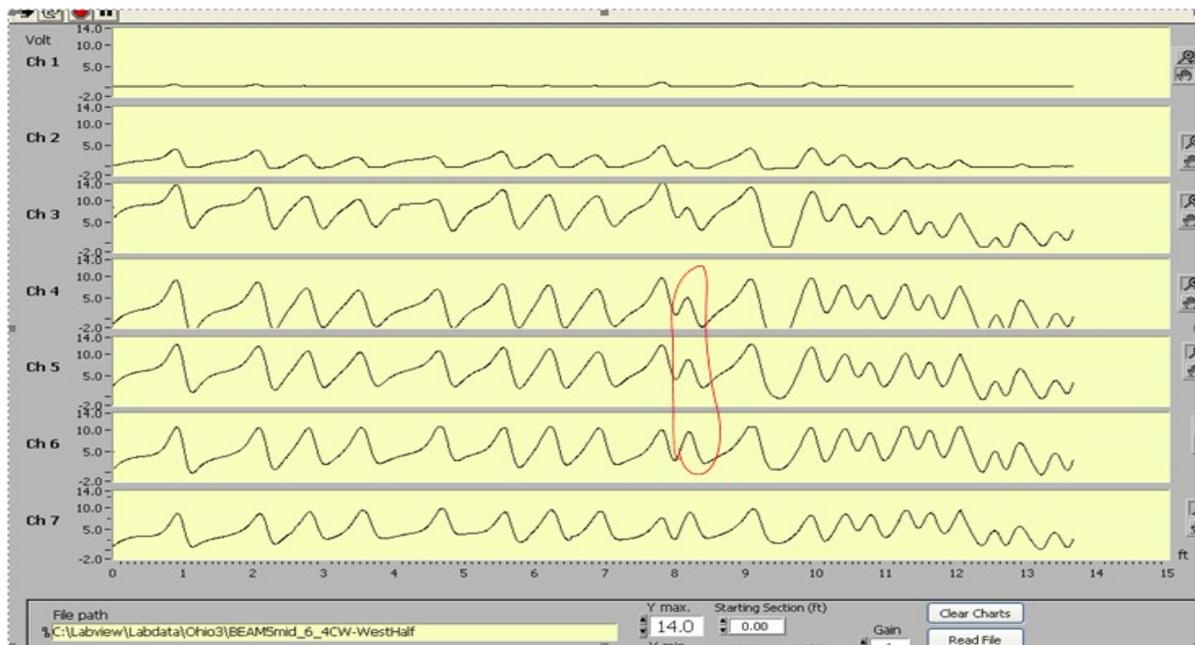
Overall, the MFL results showed some small anomalies, but no evidence of major corrosion. Significant corrosion leaves a clear signature (Fernandes, 2012 and Ghorbanpoor 2010), but no such indications were found. Three beams were excavated to confirm the results of the magnetic inspection. The amplitude (peak) of the graph marked the presence of transverse stirrup and the distance between two regular peaks indicated the distance between the stirrups in the beam (Fernandes, 2012). Any irregularity in the signal implied the presence of corroded bar or a wrongly placed stirrup. The results for two of the excavations will be discussed here. Figure 17 shows the results from beam 5mid-6-4CW. The red circle designates an anomaly.

Upon evacuation, the strand was found to be sound and it was determined that the anomaly was caused by an extra piece of steel in the beam.

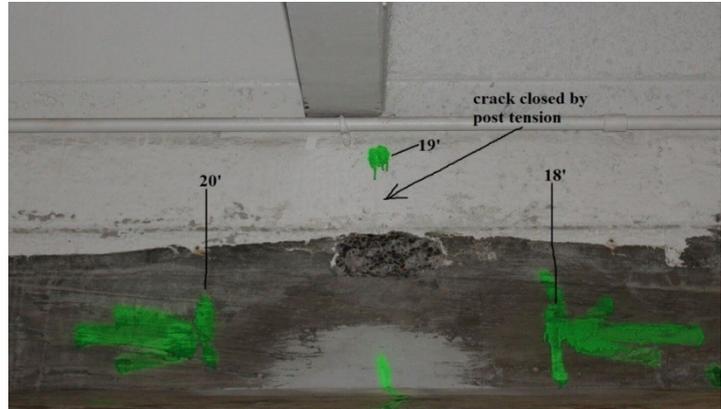
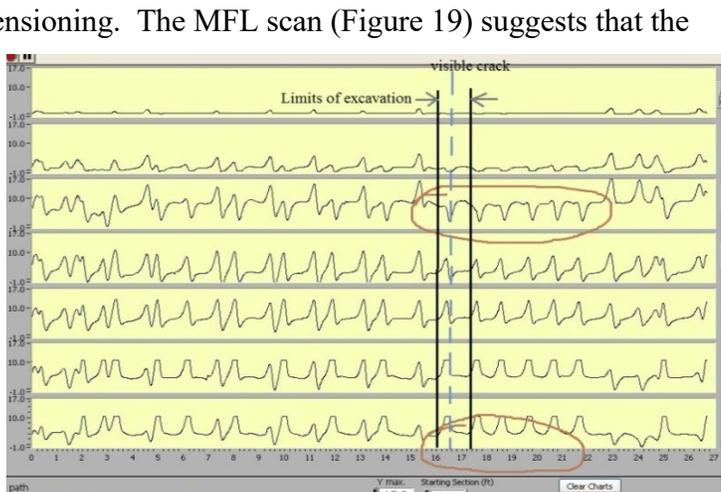
Beam 8-9-4CW had a potentially significant crack. This crack, which wrapped around the flange of the spandrel, was observed by the PDG project manager to be opening and closing with temperature. Because the crack was active, the beam was externally post-tensioned before the strand was evacuated. The crack was visible in the region between 18' and 19.5' as marked in figure 18, which shows the region that was excavated. In this figure, the white region is the existing spandrel and the unpainted region is the concrete covered for the external post tensioning. The MFL scan (Figure 19) suggests that the strands in the region of the crack may have some minor general corrosion. The anomalous region is circled. Note that since the scan results are offset by 2', the crack region falls between 16' and 17.5' on the scan plot.

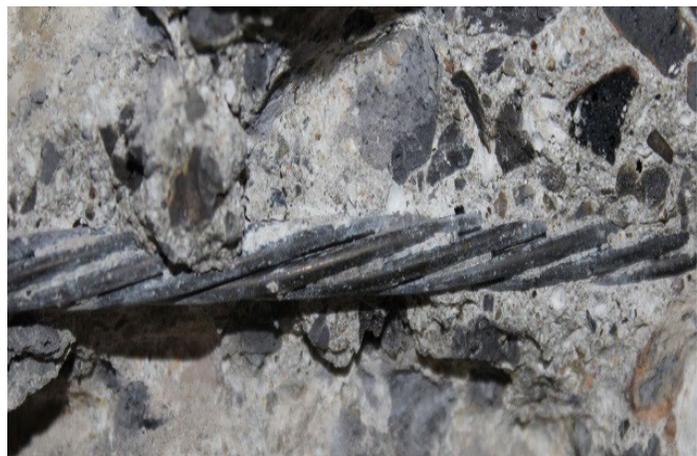
Upon excavation, the condition of the strands was found to be healthy with no visible corrosion (figure 20). The concrete in the excavation was tested with phenolphthalein. This pH test confirmed that the concrete still had a pH above 12 so the passivating layer was intact. This is consistent with the condition of the strand showing no trace of corrosion.
