Causes and Prevention of Problems in Large-Scale Prestressed Concrete Construction

Ben C. Gerwick, Jr.

Consulting Construction Engineer
San Francisco, California
(Also, Professor of Civil Engineering,
University of California at Berkeley)

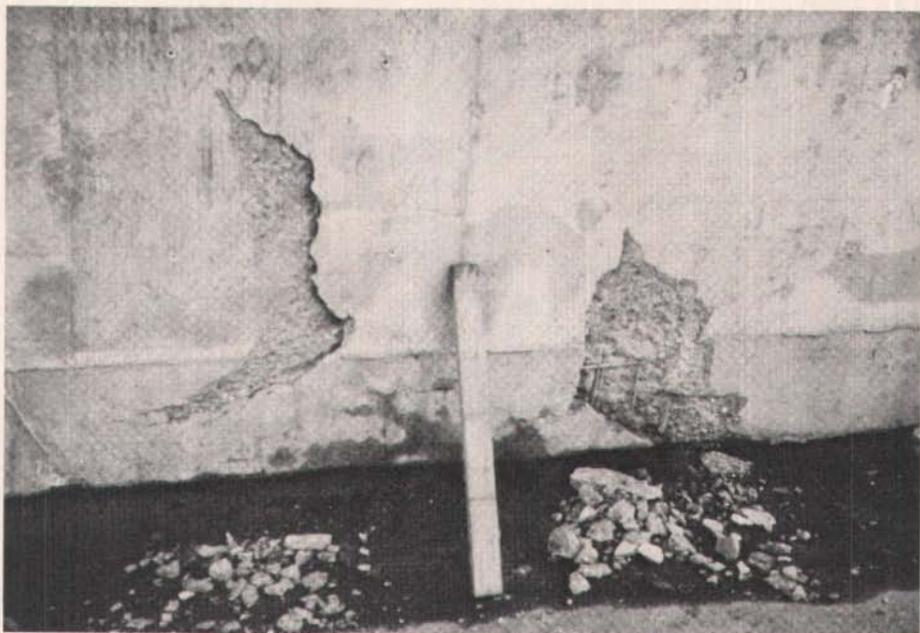
Fig. 2. Water freezing in ducts.

In the contractor's value engineering redesign, the shear near the piers was to be resisted by vertical prestressing, installed in U ducts. The first winter, only a few months after the main span construction had commenced, a period of heavy rains was followed by a sudden freeze. Some of the ducts had not been tightly sealed at deck level; as a result the ducts filled up with water which subsequently froze, causing multiple through-web cracks in the webs and, more seriously, laminar cracking in the bottom flange at the bottom of the U's [Figs. 2 and 8(1)].

Repairs to the webs were carried out by epoxy injection. Since there was ample reinforcement, both horizontal and vertical, in the webs, no problems were encountered in achieving full restoration (Fig. 3).

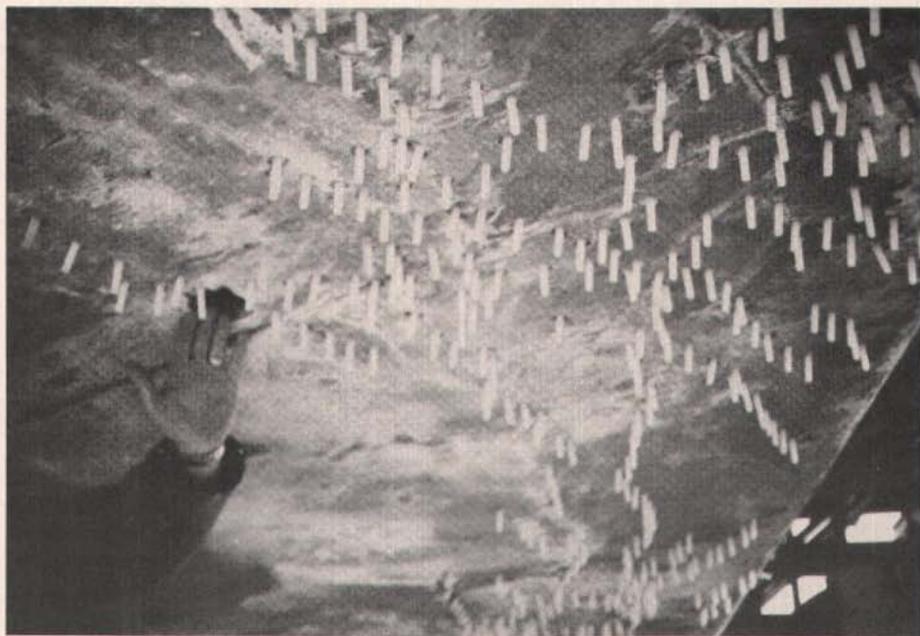
Fig. 4. Epoxy injection of bottom flange.

about 4 in. (102 mm) above the soffit. The extent of the area affected was determined by hammer sound, corroborated by the drilling of cores. These cracks were in-plane laminations, not crossed by steel.

Some temporary stitch bolting was installed by drilling through the bottom slab. Epoxy injection was then carried out in small stages, working inward from the edges, and using low pressure so as to avoid hydraulic fracturing and crack propagation (Fig. 4). Test cores and hammer testing indicated full homogeneity of the restored section.

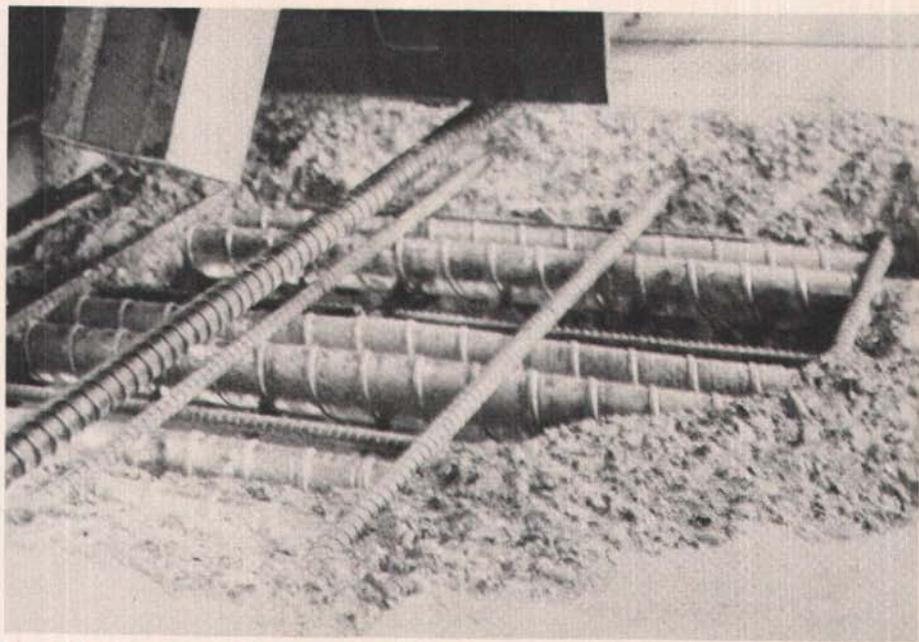
Fig. 5. Longitudinal ducts spaced too closely.

2. The close spacing of ducts, combined with transverse ducts, and longitudinal and transverse reinforcing steel in the top and bottom, made it very difficult to effectively place and consolidate concrete around and under the ducts and reinforcement. Apparently concrete did not always work its way up around the ducts [Figs. 5, 8(2)].

Prevention of these problems should properly start with design: the selection of tendon sizes and duct spacing to maximize the concrete area at mid-depth (i.e., that area capable of transmitting tensile forces through the thickness of the slab). A larger number of strands per tendon or larger wires

could well be employed. For example, the 19 x 0.5-in. (12.7 mm) tendons could presumably have been increased to 24 x 0.6 in. (15.4 mm), thus decreasing the number of tendons by 40 percent and increasing the in-plane (horizontal) mid-depth concrete area by 70 percent.

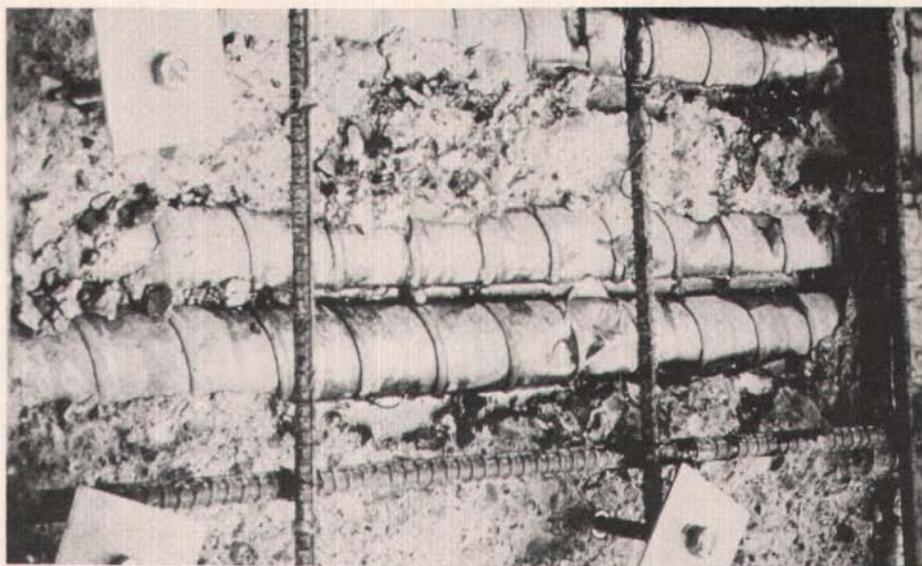
Fig. 6. Crushing of ducts during stressing.

The practice was therefore adopted of stressing two or more closely adjoining tendons before grouting any in that cluster. Unfortunately, in several cases there was a slight horizontal bend where the tendons curved out of the deck slab towards the web. Stressing of the tendon on the outer side of the curve caused the duct to crush into the adjoining duct, distorting it vertically and apparently causing the underside to spall [Figs. 6, 8(4)].

When closely-spaced ducts have bends, which can make them susceptible to displacement into one another during stressing, the use of spacers and saddle plates is advised. The tendon on the inside of the curve must be stressed, and grouted before the one on the outside of the bend is stressed. This applies, of course, to vertical as well as horizontal curves.

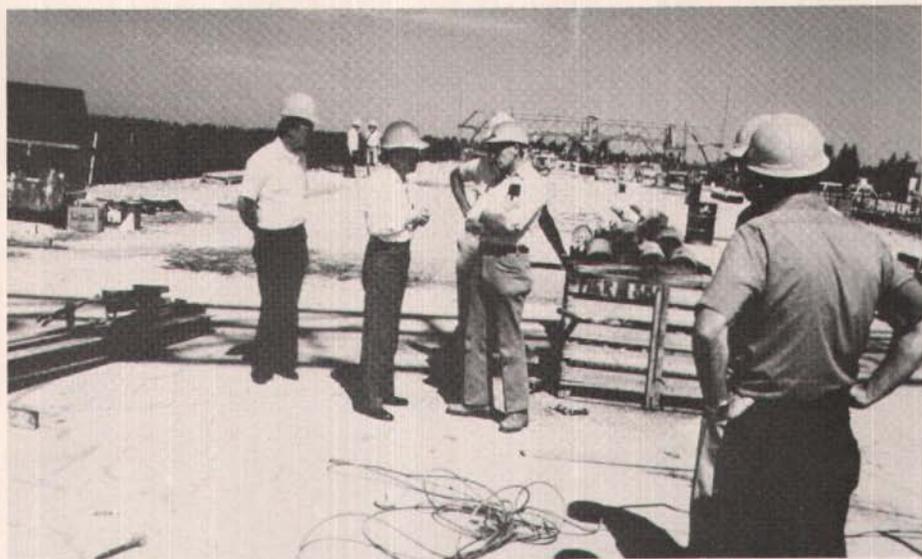
Fig. 7. Inspecting the laminar cracks in deck.

In one case on the I-205 bridge (Fig. 7) the upper portion of the deck slab laminated and spalled, affecting an area 16 x 32 ft (5 x 10 m). The lamination occurred at the underside of the longitudinal ducts. Investigation revealed that the longitudinal ducts had been deflected downward to accommodate the deflected profile of the transverse ducts; the upward component of the two prestressing systems exceeded the tensile capacity of the remaining concrete areas at that level [Fig. 8(5)]. Spalling occurred during blowing out of water from the last few unstressed ducts. It is believed that this blowing out prop-

agated and extended laminar fracturing initiated by the stressing of tendons on the deflected profile.

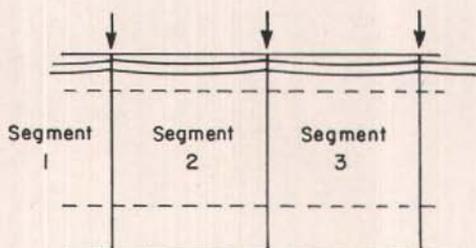
5. Longitudinal ducts were held in exact position at the leading edge form stop. In between they were deflected downward by the weight of the concrete and men walking in the fresh concrete. This meant that there was a small but significant upstanding peak in the duct profile at each construction joint. When the tendons were later stressed, a downward component of the tendon force was imparted to the concrete in the lower portion of the slab. It appeared that this was the precipitating cause in many of the cases of laminar cracking in the deck slab [Fig. 8(3)].

3. LONGITUDINAL PROFILE OF TENDONS SHOWING DOWNWARD FORCE AT CONSTRUCTION JOINTS.

Ducts should be supported during concreting so as to prevent sag. Use of an internal mandrel of relatively stiff pipe is one method that has been found successful in segmental construction.

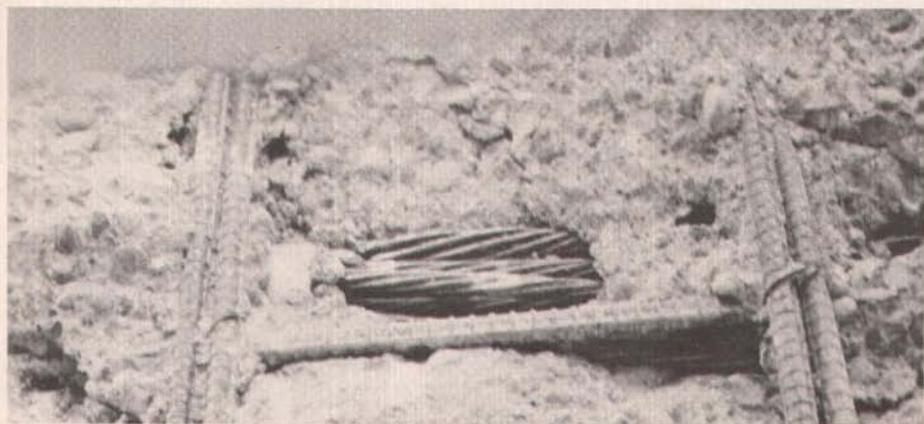
Fig. 10. Slip of dead-end anchor.

There were several cases in which the H-type dead end anchor failed during stressing, especially where there was an angle change near the anchor. In some cases, the measured elongation was 35 to 50 percent greater than calculated and severe laminar and horizontal cracking occurred at the an-

chorage itself (Fig. 10). Usually after a slip of several inches, the anchor would re-establish itself mechanically.

Proper confining steel around the anchorage can help to prevent such cracking and slippage. If the dead end

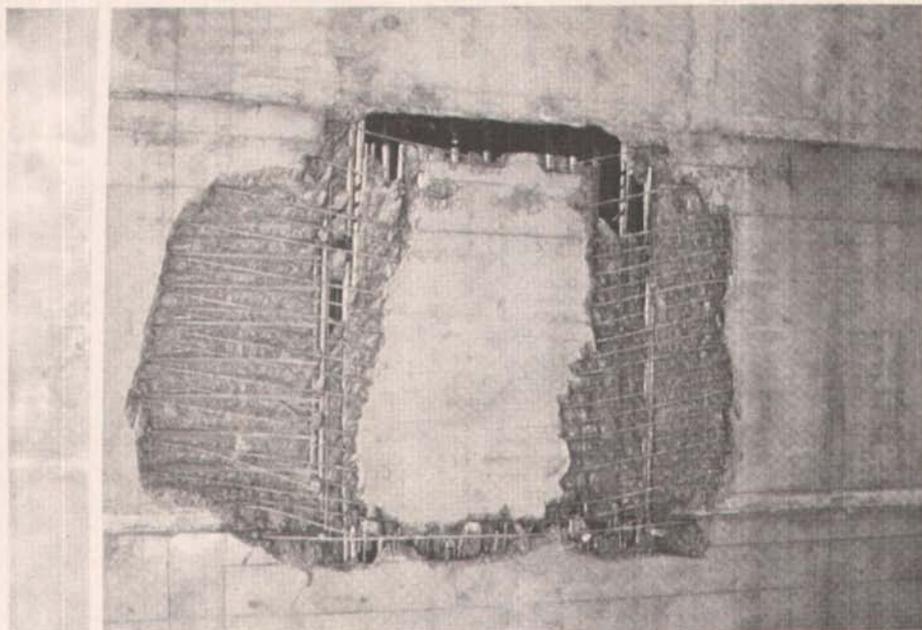
Fig. 11. Shear and tension failure at anchorage.

When the force exceeds the shear or tensile strain capacity, cracking occurs, which quickly propagates as the restraining force is relieved. Either a major local failure occurs around the anchor or, more seriously, cracks behind the anchor propagate transversely to the webs and up them, thus reducing the shear capacity. The design of reinforcement in this area must consider the transfer of stress. Sufficient longitudinal steel behind the anchor, and transverse steel abreast the anchor, must be provided to take the initial tensioning forces (Fig. 11).

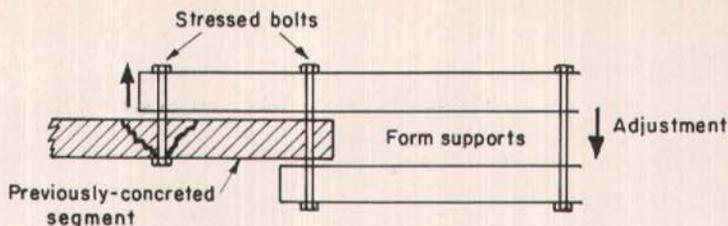
6. ADJUSTMENT OF EXTENDED FORM PLACES HIGH FORCE IN BOLTS AND ON CONCRETE, CAUSING CRACKING. SOME BOLTS ACTUALLY PULLED THROUGH SLAB

As forms are moved forward for construction of a new segment in cantilevered segmental construction of long-span bridges, they are supported at the leading end by the overhanging form traveler and at the rear by anchorage to the previously-constructed segment. They are usually anchored down by prestressing rods to the previously-constructed segment. Any subsequent adjustment of profile places very high stresses in these anchor bars, which in turn, cause high local stresses in the concrete where they are anchored [Fig. 12(6)].

On the I-205 Bridge, in several cases, this led to concrete spalling and cracking and, in extreme cases, to pull-through of the bars.

The leading ends must also be properly held up to prevent serious deflection as concrete is placed. Obviously concrete should be placed first at the far end, working back to the joint. In one German bridge, it is reported that diagonal rods stretched during concreting of the deck slab, allowing cracks to form along the web joint, thus reducing shear transfer. While epoxy injection proved to be a satisfactory repair, design of the form supports should consider deformation under each stage of concrete placement.

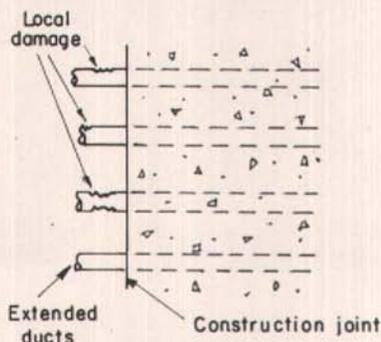
7. NINIAN, DAMAGE TO DUCTS AT CONSTRUCTION JOINT LEADS TO JAMMING OF TENDON IN DUCT.

1. Use of heavier-walled duct wherever feasible, preforming bends as necessary.
2. Cutting ends of ducts with a hacksaw, not a burning torch.
3. Changing splice details so that as tendons were entered, the nose always travelled from a male into a female end, so that it could not catch.

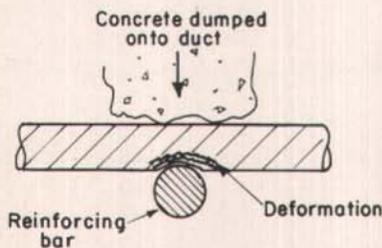
8. DEFORMATION OF DUCTS BY REINFORCING BARS.
