SCDOT Wando River 2018 Bridge Closure

M. Kevin Turner
District 6 Bridge Engineer

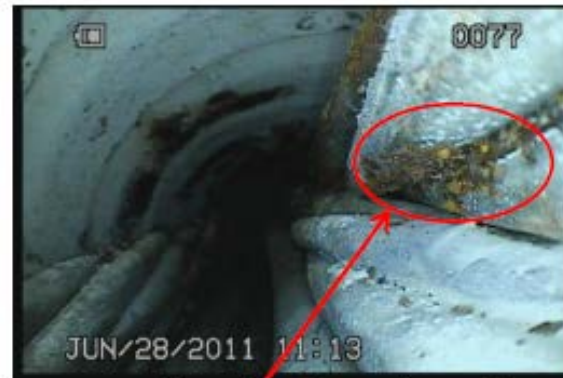
Same wire as above, but deeper into the void.

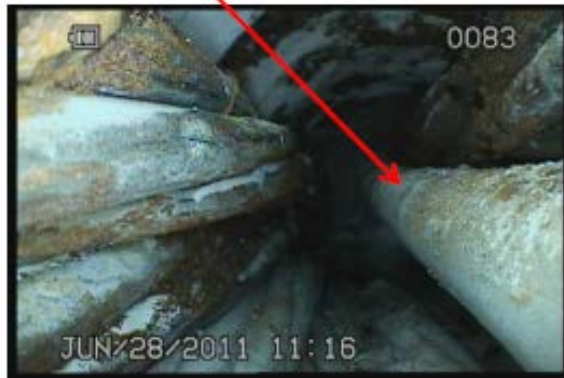
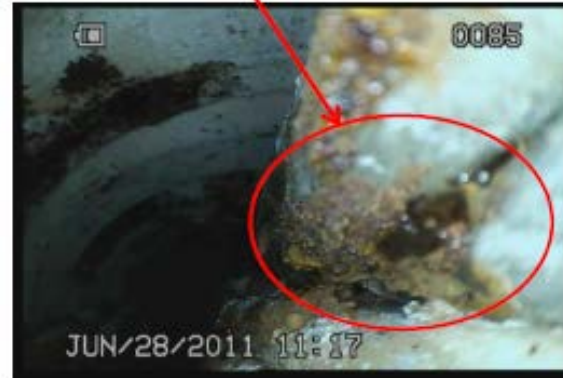
Examples of corrosion products oozing out of crevices between individual wires.
