EVALUATION OF DAMAGED PRESTRESSED CONCRETE BRIDGE BOX BEAMS

Eric Steinberg, Ph.D., P.E., Ohio University, Athens, OH

Richard Miller, Ph.D., P.E., FPCI, University of Cincinnati, Cincinnati, OH

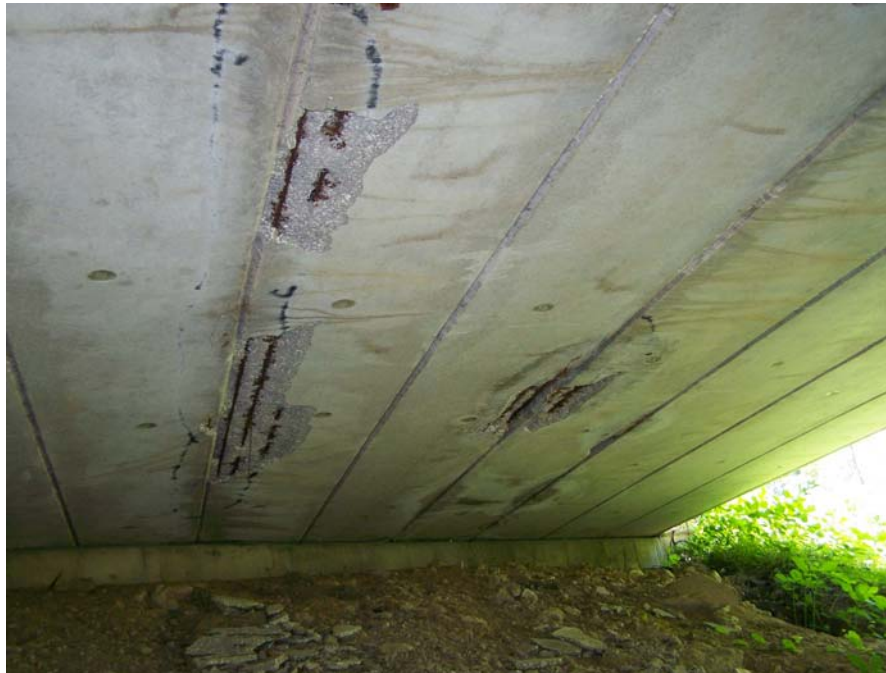
Fig. 1: South Span

As shown in the figures, a variety of deterioration levels exist for the 36 prestressed concrete beams from limited deterioration to those with severely exposed and broken strands hanging down from the bridge. The beams are 17" deep by 36" wide and contain 14 - 1/2" diameter strands for the center span and 8 - 1/2" diameter strands for the end spans. The strands are outside the stirrups. A typical cross-section of the beams for the center span is shown in

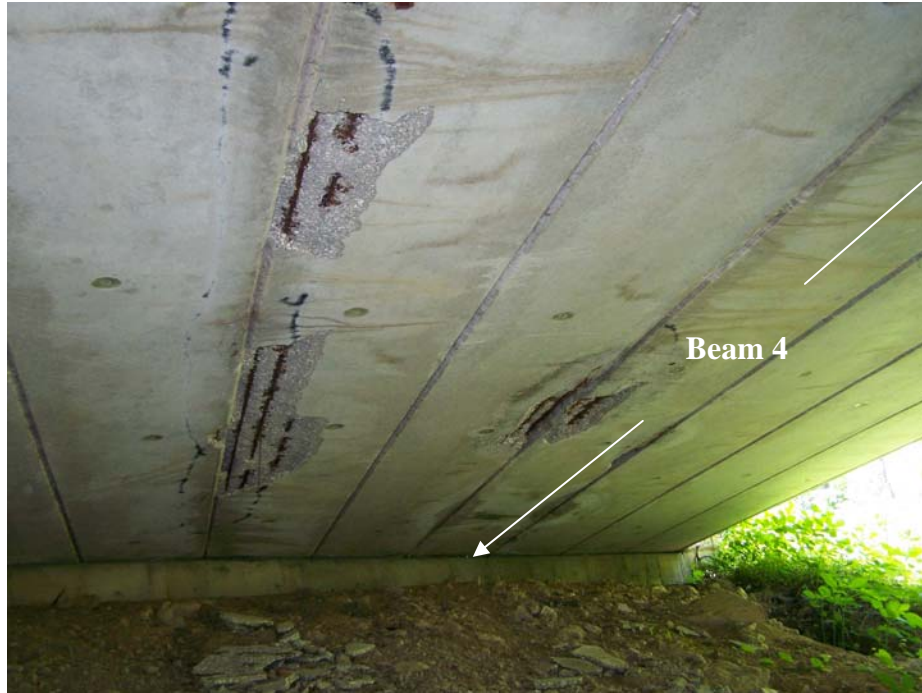
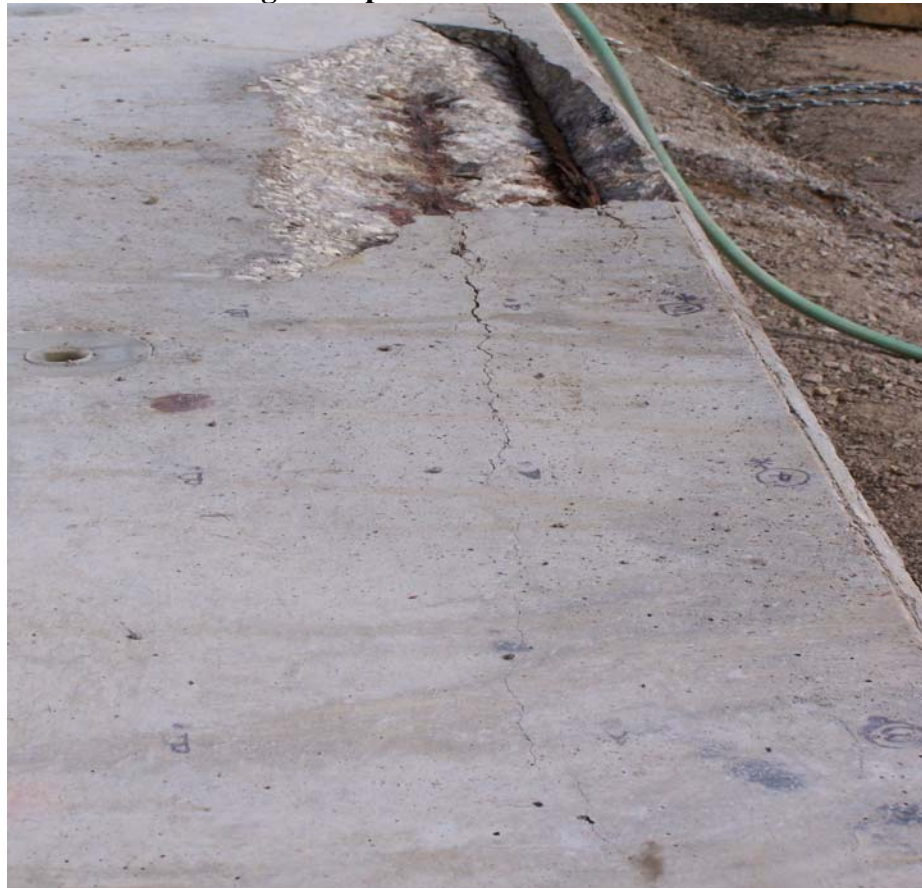
Beam 4 had 8 total strands. The two of the strands on the eastern edge were exposed near the beam’s midspan (see Figs. 6 and 7). The outside strand was completely broken. The other strand was severely corroded, but broken wires were not visible prior to any concrete removal. In addition a longitudinal crack ran above the location of the exposed inside strand (Fig. 7).

Fig. 6: Exposed Strands of Beam 4

Fig. 7: Exposed Strands of Beam 4

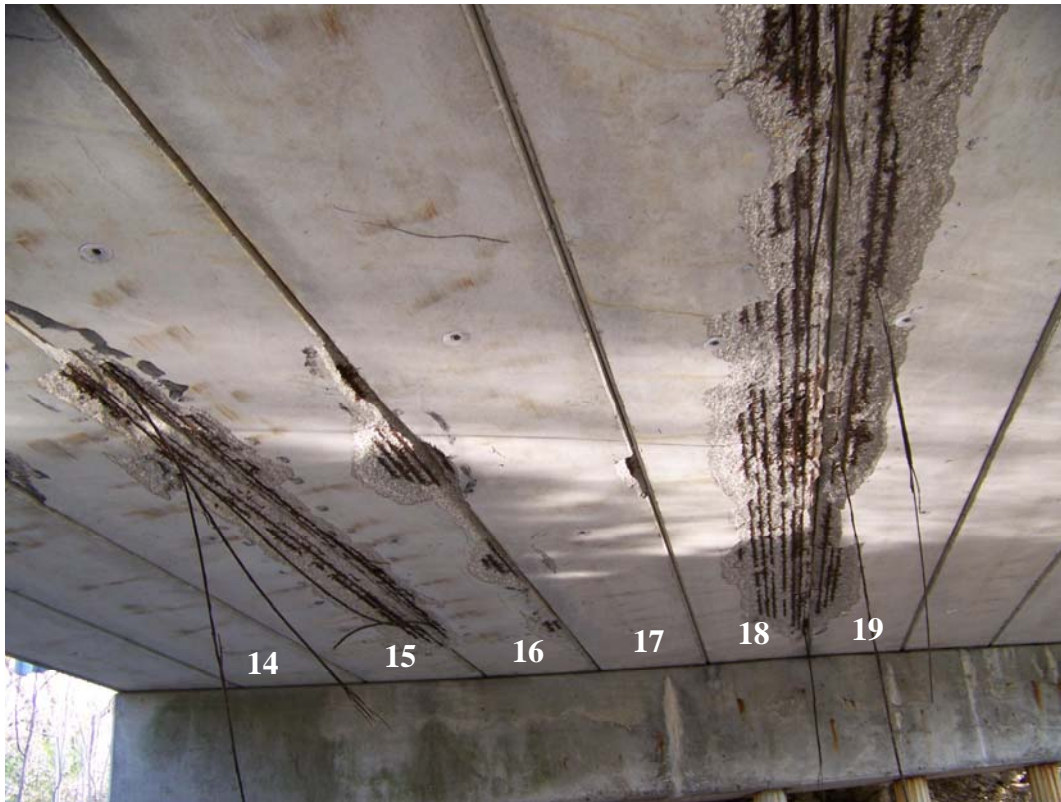
Beam 15 had 14 strands. A total of four strands from the east edge of the beam were exposed near the beam's midspan (Fig. 8). Two of these strands were also exposed near the pier. Close visual inspection of this beam has not yet occurred.

Fig. 8: Exposed Strands of Beams 15 and 18

Beam 18 had 14 strands. A total of eight strands from the east edge of the beam were exposed near the beam's midspan (Figs. 8 and 9). Four strands from the east edge were broken. Strands 5 and 6 from the east edge had 5 out of the 7 wires broken. Strand 7 did not appear broken but its partial embedment made visual verification of this difficult. Strand 8 was exposed over a short distance compared to the other strands and showed severe corrosion but did not appear to have any broken wires.

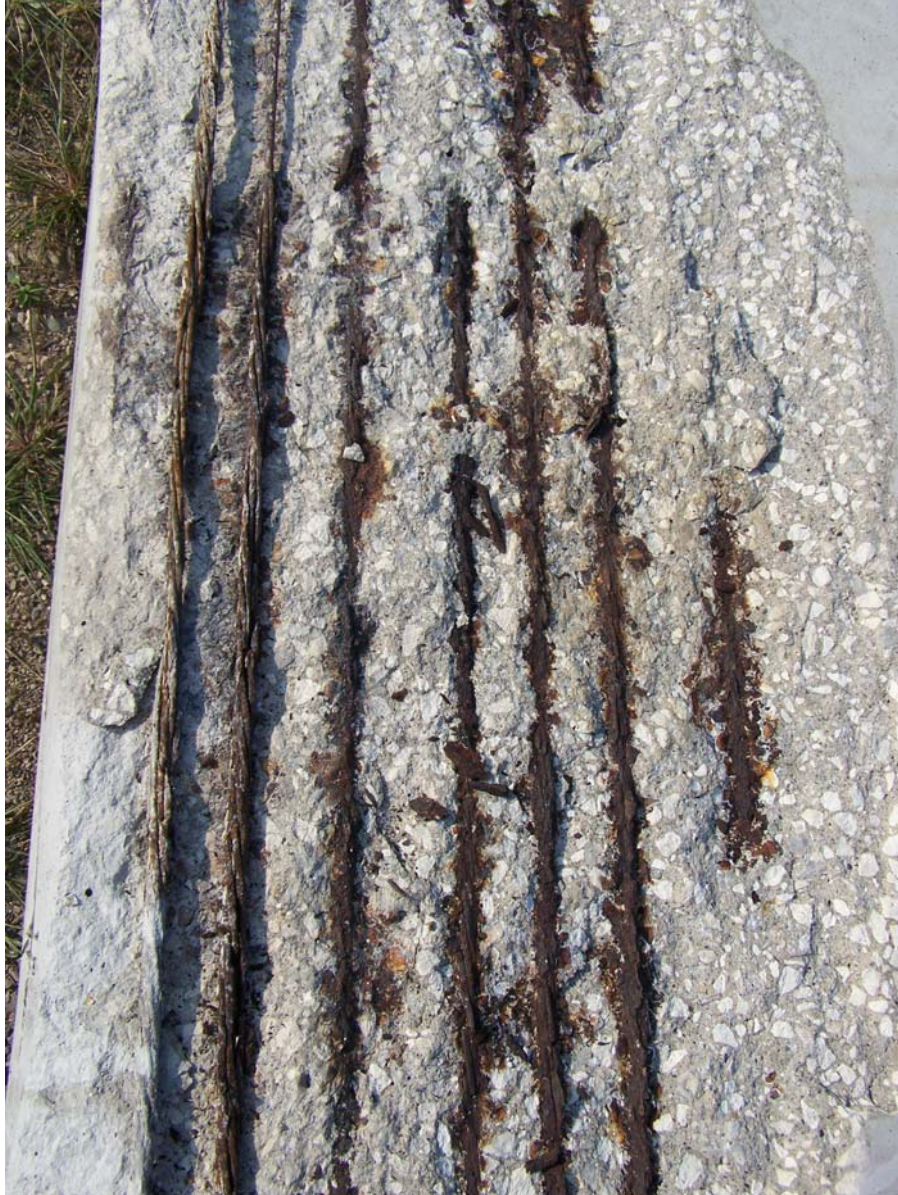
Fig. 9: Exposed Strands of Beam 18

A total of 12 holes were drilled into beam 18 resulting in 24 chloride samples. Six of the holes were drilled into the side of the beam and 6 more were drilled into the bottom of the beam. All holes avoided reinforcement. The average chloride content was 0.197% for the samples near the surface and 0.195% for the samples deeper. This also showed little difference in chloride content with the sample depth. However, the samples from the side of the beam showed an average chloride content of 0.174% and the samples from the bottom of the beam showed an average chloride content of 0.220% for samples taken from the depth nearest the surface. A similar result was shown from the samples taken at the deeper into the member, 0.169% from side samples and 0.189% for bottom samples. This again leads to the belief that the chlorides ingress is from bottom of the bridge due to joint leakage. Beam 18 was from the bridge's second span and in general had lower chloride contents than beam 4 which was from the first span of the bridge. The other point of interest was the corrosion damage of beam 18 was much more severe than that of beam 4 which had lower chloride levels.

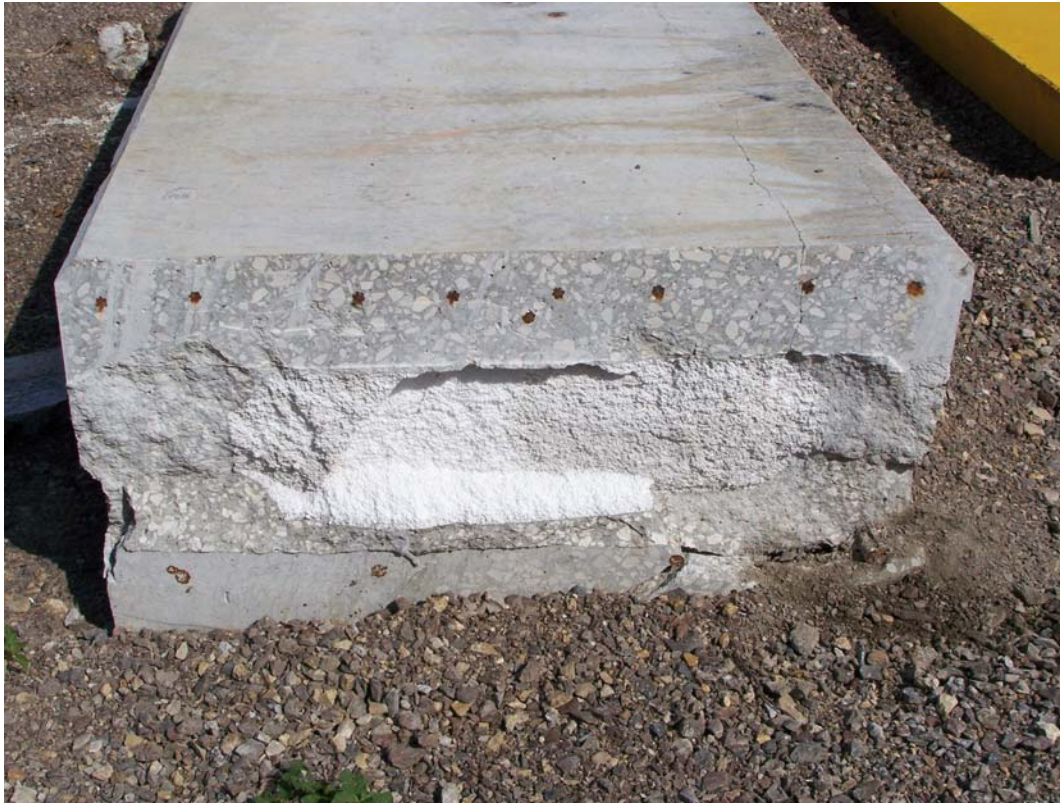
Beam 4 was cut transversely at two locations to divide the beam into approximately thirds. The south section and the north section are shown in Figs. 10 and 11, respectively (note: beams are shown with the bottom surface upward). As can be seen in the figures, no strands were exposed at the section cuts.

Fig. 10: Beam 4 South Section

The bottom flange and the webs were specified to be 5" thick. Only the bottom flange at section 1 was slightly less than specified by approximately 1/8". It should also be noted the external faces of the webs were very uneven due to the contractor's cutting of beams during removal. However, the webs on both sides at both sections were larger than specified leading to the conclusion the Styrofoam block to create the void was smaller than necessary.

The strand spacing deviated as much as 1/2" from specified locations along the width of the beam. The strands were positioned outside of the transverse reinforcement. The specified clear cover to the transverse reinforcement was 2" resulting in a 1-1/2" cover for the strand. The observed cover was in general agreement with cover varying from 1-5/8" to 1-1/8".

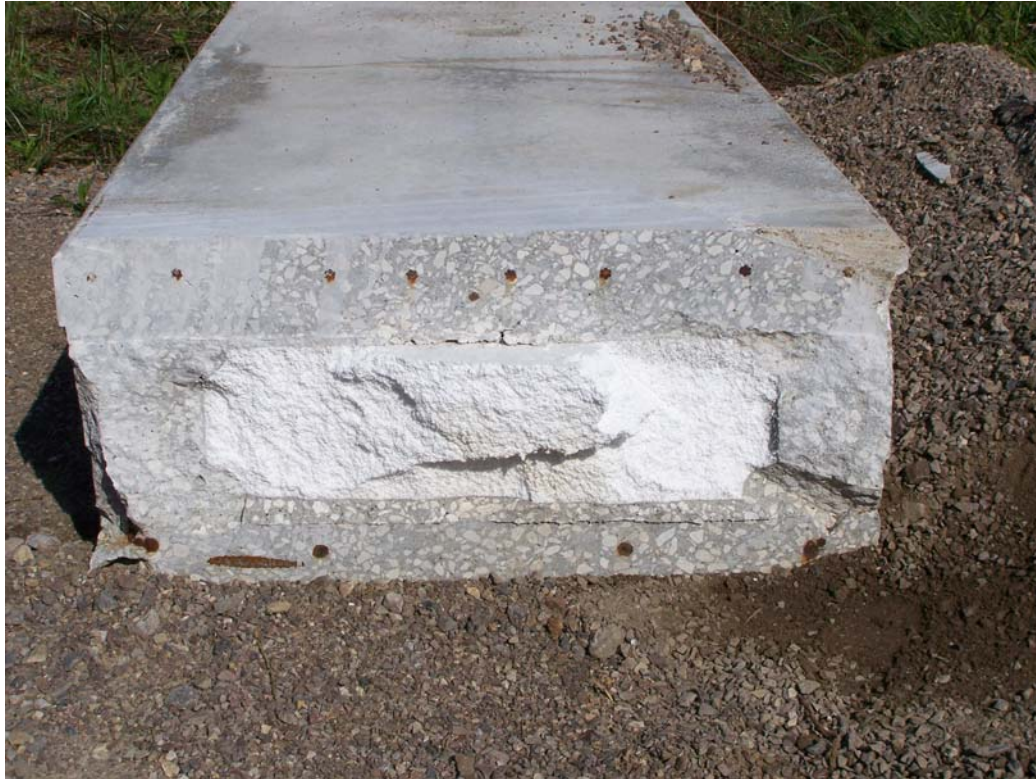
Fig. 11: Beam 4 North Section

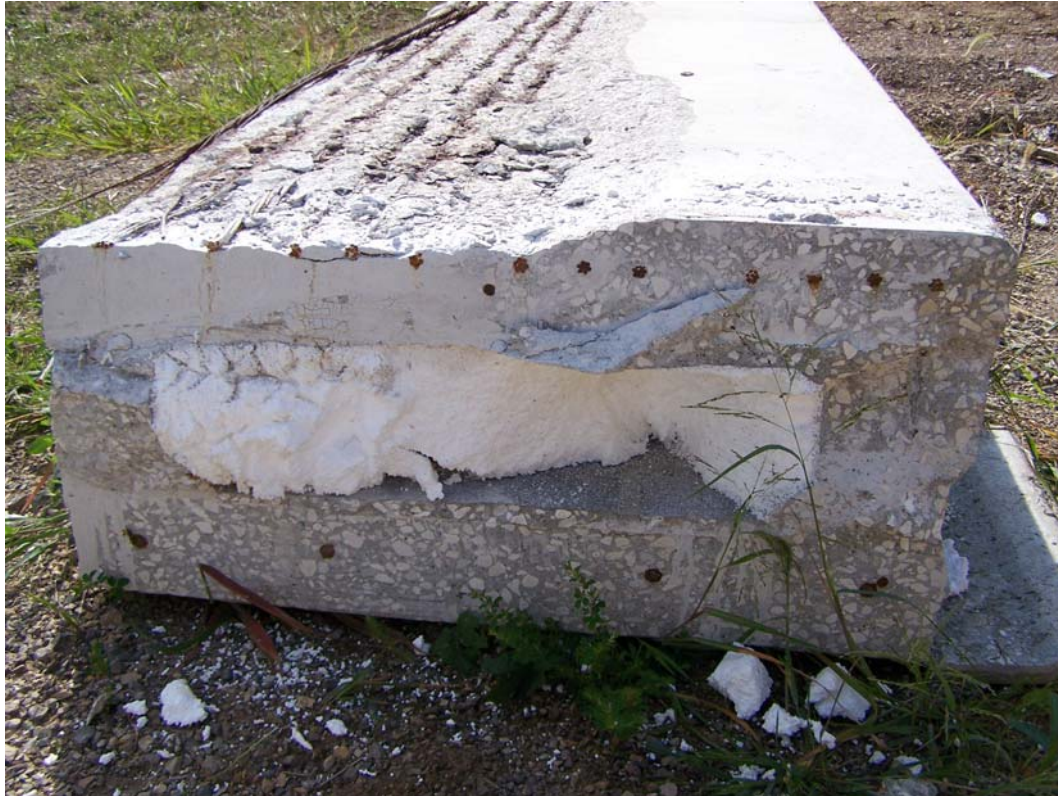
Beam 18 was also cut into approximately three equal length sections. The north section is shown in Fig. 12. As can be seen in the figure, numerous strands are affected by the spalled concrete and little to no cover exists for the majority of strands.

The measured dimensions for the bottom flange were within $1/8''$ of the specified $5''$ dimension. The widths of the webs at both sections revealed that the Styrofoam block was likely smaller than required. The East web at section 2 was slightly less than specified. This may have been caused by a shift in the Styrofoam block used to create the void.

The strand spacing deviated as much as $1/4''$ from the specified location for interior strands and those with concrete cover still existing. The strand spacing deviated from the specified spacing by as much as $5/16''$ for all strands including those that were exposed. The strands were positioned outside of the transverse reinforcement. The cover was in general agreement with the cover specified with the largest deviation being $\pm 1/16''$ for strands which did not have any concrete spalling.

Fig. 12: Beam 18 North Section

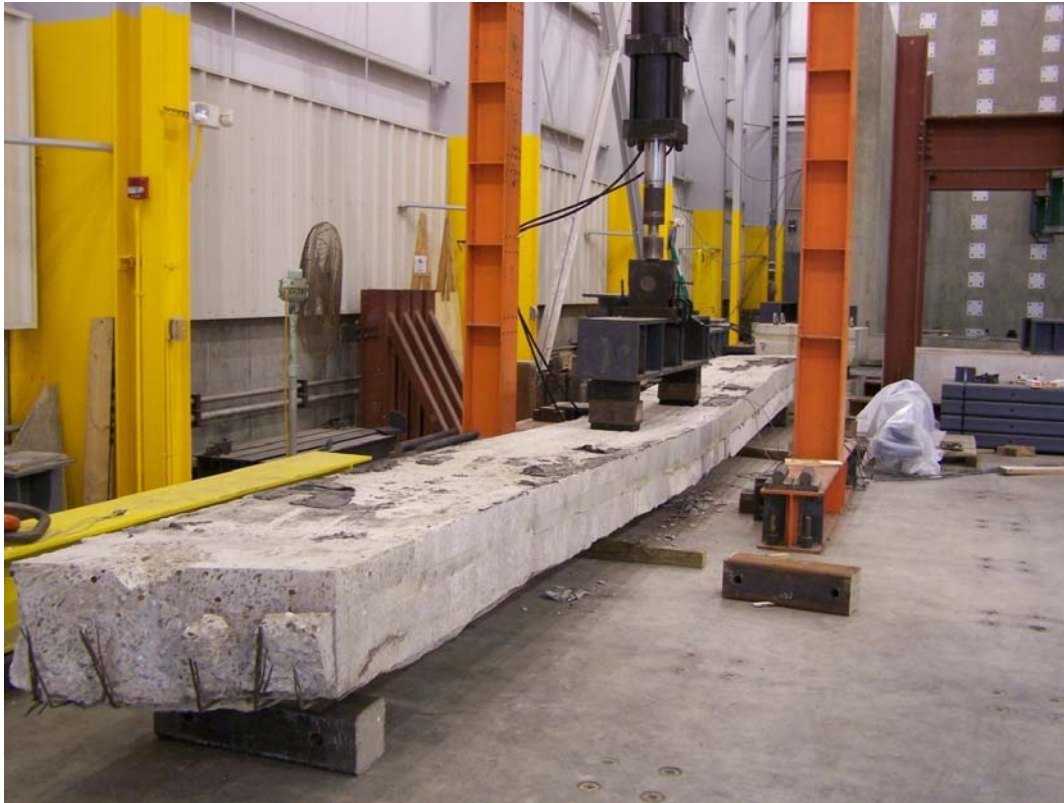
be determined for all 4 specimens. To date, one beam has been tested destructively, beam 16. The beam had a test span of 33' 5" in order to deal with the skew at the ends as well as to support the beam sound concrete. The beam originally had 14 strands. Of the 14, six were completely deteriorated. One was partially deteriorated with only 2 of the 7 wires intact.

The testing of beam 16 is shown in Figs. 13-15. Fig. 13 shows the significant deflection the beam underwent during the test. Figs. 14 and 15 show the bottom of the beam with corroded strands as well as strands that were not corroded but exposed due to spalling concrete from the applied loading.

Fig. 13: Destructive Test of Beam 16

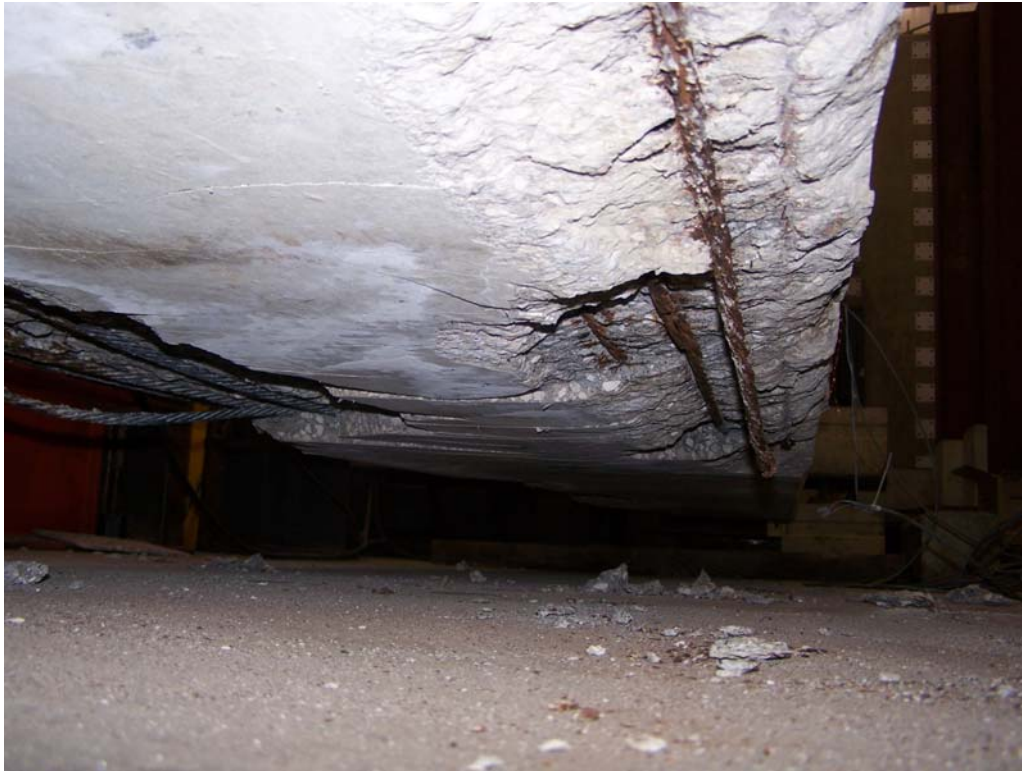
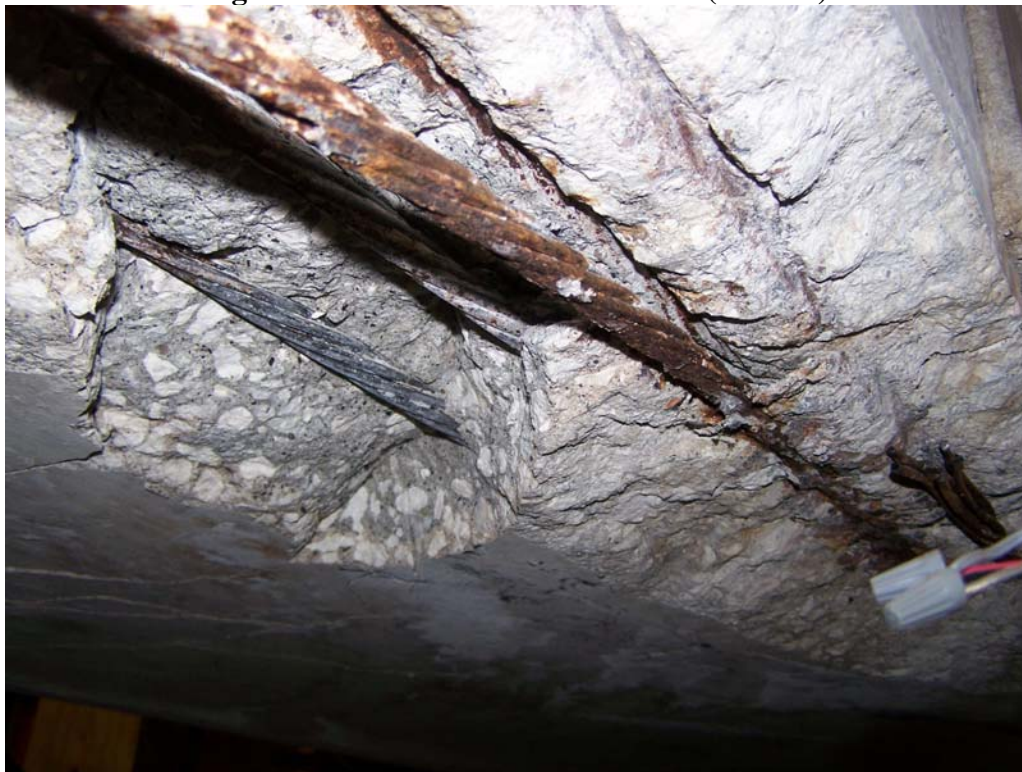
Fig. 14: Destructive Test of Beam 16 (Bottom)

Fig. 15: Destructive Test of Beam 16 (Bottom)

After testing, it was found that two more strands embedded in the concrete had large amount of corrosion, but appear to have been mostly intact when the test began. The beam held a maximum total load of approximately 40 kips (20 at each point) when the deteriorated strand began to rupture and concrete spalled of the bottom. In the end, the beam maintained a total load of 34 kips (17 at each point) and showed excellent ductility. The beam deflected to $L/36$ before the test was stopped when further deflection was not possible due to the height of the specimen in the test frame. Figure 16 shows the load-deflection plot of the beam 16. The slight increase in load at approximately 12" of deflection was due to the beam coming in contact with spalled concrete on the test bed floor. The dashed line in Fig. 16 is an initial assessment of the test using the Response program to predict behavior. This initial model used 5,500 psi concrete and assumed all concrete below the strands had been lost.

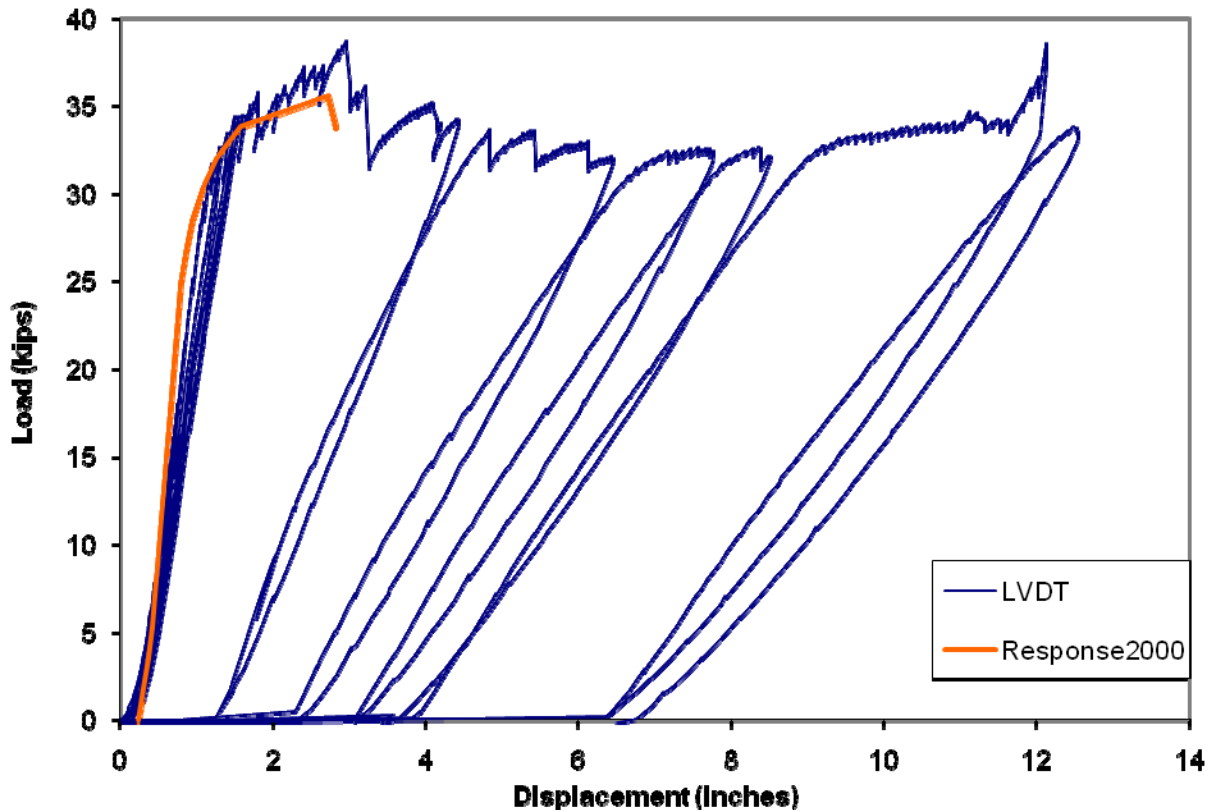
Fig. 16: Load-Deflection for Beam 16

The load of 34 kips was consistent with having 5 intact strands. Preliminary investigation show that deteriorated stand maintained some prestressing force. To estimate the effective prestress, the beam was loaded until a crack was visible and then the beam was unloaded. Clip gages were mounted across the crack and the beam reloaded. The data from the clip gages allow an accurate estimate of the effective prestress force and this technique has been used by others^{3,9,10}. The effective prestressing force was estimated at 178 kips, a force too large to be maintained by only 5 strands.
