SHAKE TABLE TESTING OF A FULL-SCALE FIVE-STORY BUILDING: SEISMIC PERFORMANCE OF PRECAST CONCRETE CLADDING PANELS

In April and May 2012, a landmark test of a five-story building constructed at full-scale and completely furnished with nonstructural components and systems (NCSs) was conducted at the University of California, San Diego (UCSD) Network for Earthquake Engineering Simulation (NEES@UCSD, 2013) facility. The project, coined *Building Nonstructural Components and Systems (BNCS)* was realized by a unique collaboration between Academe, Industry and Government and hundreds of individuals with expertise in structural and nonstructural design, earthquake engineering, and construction and management practices⁹. The full-scale building-NCS system was seismically tested in a base isolated and fixed based configuration on the Large High-Performance Outdoor Shake Table (LPOSHT) at the UCSD-NEES facility. Wrapping the exterior of this building were two types of façades, namely light weight metal stud balloon-framing overlaid with a synthetic stucco finish (first three floors) and precast concrete cladding panels (PCC panels) (two upper floors).

This paper will focus on the PCC panels

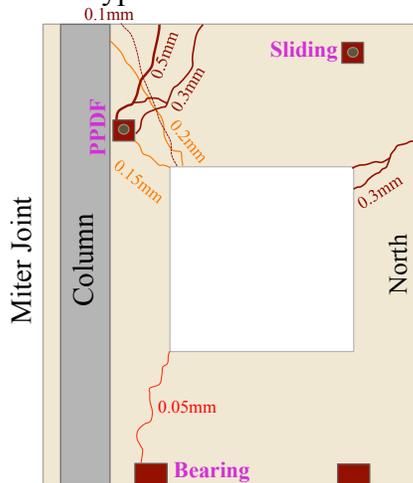
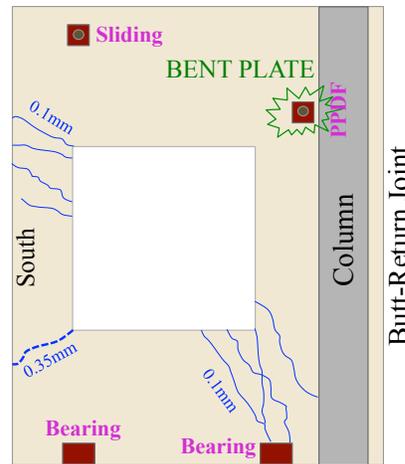
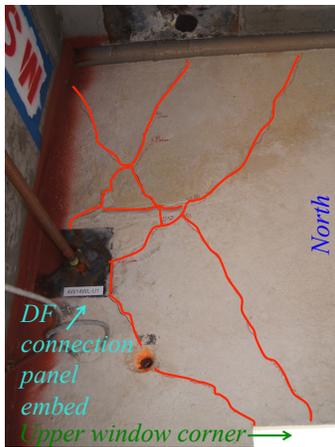
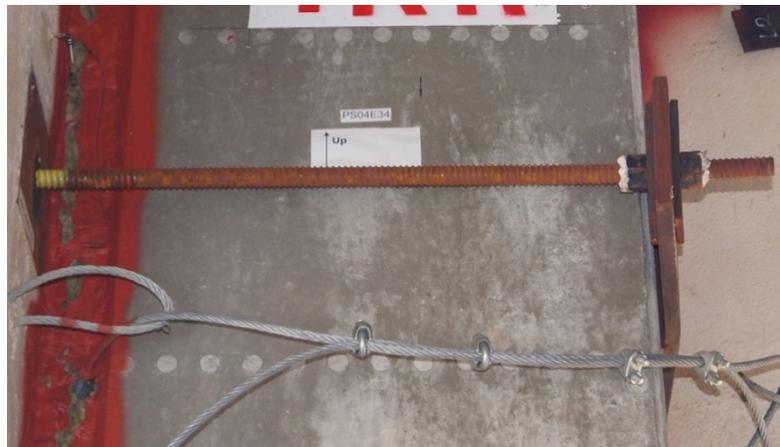
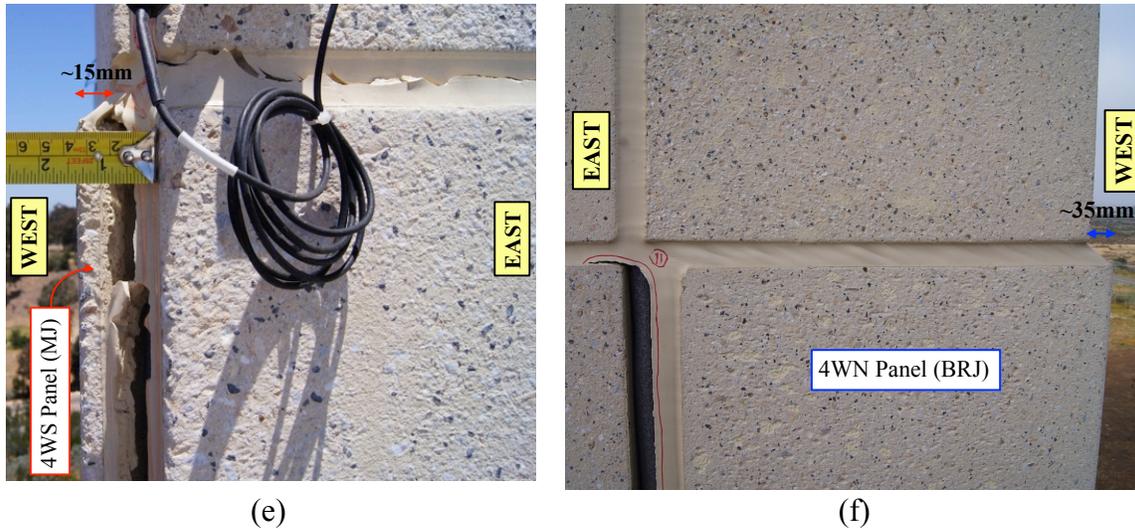
As can be seen in Fig. 7a, the damage to panel 4WS (MJ panel) was mainly characterized by a network of cracks forming in the panel close to the corner connection embed. Cracks of average width = 0.2mm spanned from the corner of the window up to the corner connection embed and upper edge of the panel and formed at an early stage (after FB-4:ICA100; a motion resulting in ~0.7% IDR at this level). New cracks at this same location formed during FB-5:DEN67 and FB-6:DEN100, when IDRs of respectively 1.1% and 1.2% were achieved. In the interior these cracks were almost perpendicular to the old ones and pretty wide (up to 0.5mm) while the exterior crack that formed was parallel to the previous cracks and thinner (0.1mm). The final crack pattern, shown in Fig.7c, seems to indicate that the upper corner of the panels was folding outward when pushed by the IP panel. During the last inspection this same type of cracks (but much thinner and less developed) was observed basically in every OP panel close to a miter joint while it was never observed in an OP panel close to a butt-return joint confirming the relevance of the type of joint in the determination of the damage pattern. The plate of the corner connection of panel 4WS was closely inspected after the final motions and it did not look visibly bent. If it did plastically deform, the amplitude was small, on the order of a few millimeters.

The damage to panel 4WN (BRJ panel) was characterized by the bending of the ductile plate of the corner connection. A permanent bend was observed after FB-5:DEN67 while a much more visible bending deformation was observed after FB-6:DEN100 (Fig.7d). No cracks in the panel close to the corner connection embed were observed. This panel was the only one where a visible bending of the plate was observed.

Since the only parameter considerably different between these two panels were the corner joints, it is possible to conclude that this different behavior is due to this. Namely it is possible to conclude that the presence of a BRJ gives stiffness to the corner thus reducing flexural distortion in the panel and forcing the ductile fuse in the connections to absorb the deformation. On the other side in the MJ panels the most flexible part of the corner system is not the ductile fuse but the corner of the panel itself and it that ends up getting damaged.

During the last two motions several cracks formed in the sections of the panels far from the corner connection as observed in Fig. 7a and b. The crack pattern suggests that impact with the IP panels created a folding of the upper-outer section of the panel while the bottom of the panel and its inner side remained basically fixed. The cracks in the MJ panel (4ES) were very similar, in terms of thickness and length, to the ones typically observed in many other OP panels confirming that they were created by the typical deformation of these panels. In contrast, the cracks in the BRJ panel (4WN) were many more than what was typically observed.

The upper portions of both the southern and northern panels on the west side observed a permanent westward misalignment with respect to the bottom of the panels on the 5th floor and consequently severe damage to caulking was also observed. The southern MJ panels had a permanent westward misalignment of ~15mm (Fig. 7e). Since the plate of the connection did not visibly bend, the misalignment was likely created by some plastic deformation of the panel itself, as confirmed by the thick cracks on the interior of the panel. The upper portion of the BRJ panel ended up with a permanent displacement of 40mm (Fig. 7e). Fifteen of the total 40mm can be attributed to the final plastic deformation of the plate in the connection while the remaining 25 were likely due to plastic deformation in the panel. No permanent misalignment was observed at these same locations on the east side of the building, however, the damage to the caulking confirmed that some type of elastic deformation occurred during the motions.

Fig. 7 Observed damage to corner connection areas of the panels (a) crack pattern in the 4WS panel (section A-A in Fig. 3), (b) crack pattern in the 4WN panel (section B-B in Fig. 3), (c) cracks net close to the embed of the corner connection is panel 4WS after FB-6:DEN100, (d) bending of the panel in the corner connection of panel 4WN after FB-6:DEN100, (e) permanent displacement of panel 4WS, (f) permanent displacement of panel 4WN. (a) and (b) represent schematics of the elevation of these panels. (parts a-d on prior page).

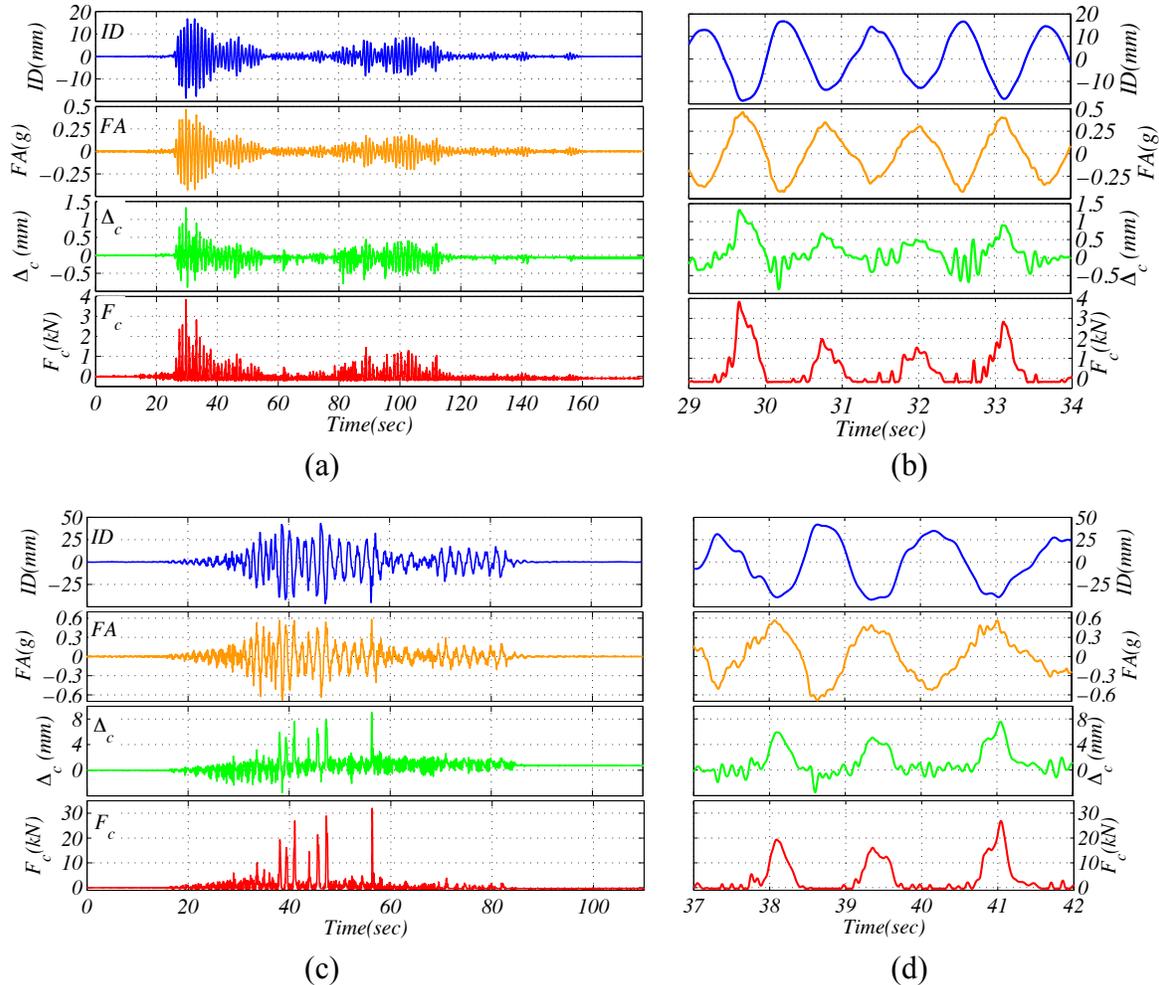
Fig. 8 Time history of FA, ID, Δ_c and F_c in panel 4ES (a),(b)recorded during FB:3-ICA50 (entire time history and zoomed view of strong motion period), (c),(d)recorded during FB:5-DEN67 (entire time history and zoomed view of strong motion period).

From the time histories recorded during FB-3-ICA50 (Fig. 8a and b) nearly perfect synchronization between the structure and panels is observed. The difference in behavior during the eastward and westward motion can be clearly seen: when the ID is in the eastward direction (positive) the corner joint is enlarging and the rod does not take extra tensile force while when the ID is directed westward (negative) peak tensile forces and positive displacements are recorded. The impact phenomenon (as explained in Fig. 4) can be observed for FB-5:DEN67 (Fig. 8c and d): during this test both time histories of F_c and Δ_c exhibit large spikes in the positive direction created when the IP and OP panels push against each other. The peak force actually measured at this corner during the design motion was 32kN, which is three times the design force F_p used for the body of the connection. Moreover, it is 10% larger than the capacity of the ductile fuse (= 29kN). These forces were not short duration/high frequency impacts, but rather their energy was concentrated in the frequency range below 5Hz. These same spikes were recorded also during FB-6:DEN100.

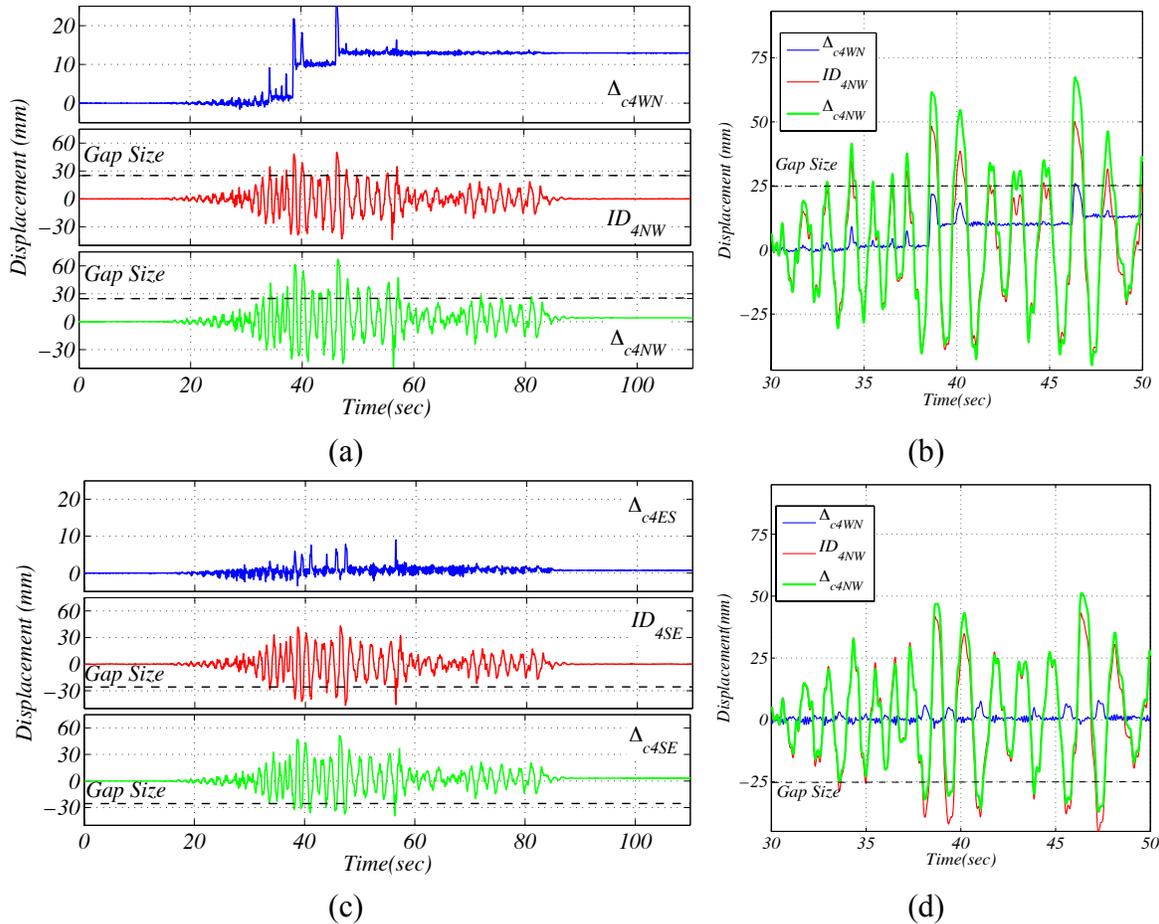
These three displacements for the NW corner of the 4th floor (where the plate plastically bent) recorded during FB-5:DEN67 are presented in Fig. 9a and b. Fig. 9b shows clearly that no displacement in the connection is recorded before the joint gap closes: the first movement of the connection is recorded at second 33 when the ID gets equal to 25mm (exactly the gap size for the BRJ). Up to this point the displacement of the IP panels and the ID are very similar. The first permanent bending of the corner connection in the OP panel occurs at second 38 when ID reaches 50mm: at this point the corner connection absorbed 20mm of total displacement of which 10mm were elastic and 10mm were plastic. The pushing action of the OP and IP panels against each other seems to affect also the movement of the IP panel, in fact the movement in the eastward direction in the IP panel (the direction of pushing) becomes larger than the ID. This might have been caused by a plastic deformation of the rods in the sliding rod connections of the IP panel. This IP panel ended up with an eastward residual displacement of 4mm.

The same plots for the SE corner are shown in Fig. 9c and d. In similar fashion, no deformation of the corner connection is recorded until the gap in the joint completely closes ($ID = -25mm$). It can be seen that, even if the ID were similar, the behavior in this corner is completely different: in this case when the OP panel impacts the IP panel (when the building is moving westward) the effect is a deformation of the IP panel. In fact, when the OP panel pushes against the IP panel the displacement absorbed by the IP panel connection is less than the ID meaning that the panel was not moving rigidly with the bottom slab but rather its upper portion was deforming in the direction of motion of the top slab. In this case Δ_{c4ES} remained smaller than 9mm and was mainly elastic.

Fig. 9 Displacements recorded at the corners during FB-5:DEN67: (a),(b) close to NW corner at the 4th floor (entire time history, zoomed view), (c),(d) close to SE corner at the 4th floor (entire time history, zoomed view).

The different damage level and recorded behavior of the OP panels in the west and east side of the building can be explained considering the type of IP panels installed on each side: panels with sliding rod connections were installed on the west side while flexing rod connections were installed on the east side. Impacts between OP panels at the corner occurred on both sides but only panels on the west side got damaged. A hypothesis for this behavior is as follows:

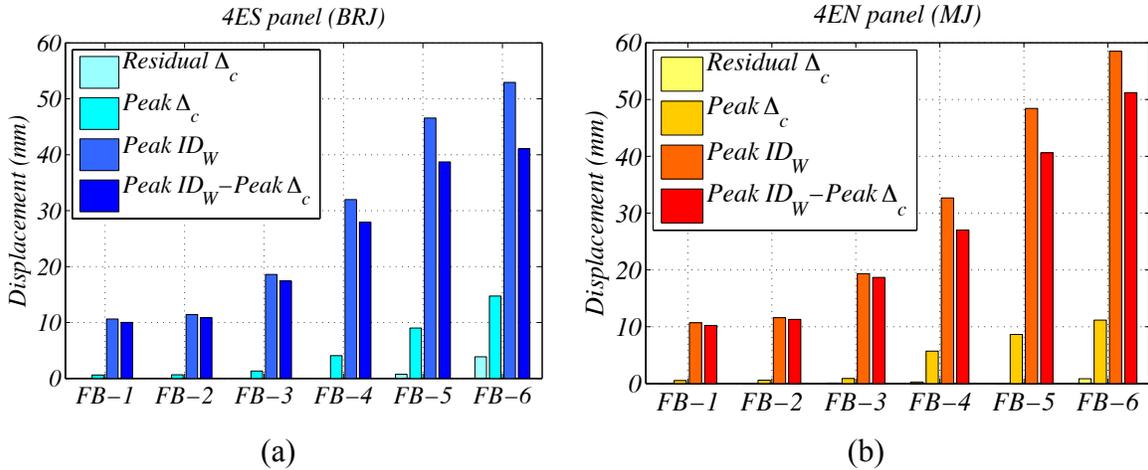
The residual Δ_c and the peak values of Δ_c , ID_w and $ID_w - \Delta_c$ recorded during each motion for the two corners under consideration are shown in Fig. 10. The peak values of ID and Δ_c confirm that during the first three motions no impact occurred as peak Δ_c were of the order or 1mm. A small impact probably occurred during FB-4:ICA100, in fact the ID reached more than 30mm and Δ_c of 4-5mm was recorded in both connections. During the design motion (FB-5:DEN67) the ID recorded was roughly twice the gap size (~50mm) confirming the inevitability of impacts. The peak connection displacement Δ_c reached 9mm, however, for both connections it was mostly elastic displacement. During the last motion the total ID in the southern side of the building was 53mm. For the BRJ southern panel it can be assumed that 25 mm (=47%) were absorbed by the closing of the corner joint, 11mm (~20%) were absorbed by the elastic deformation of the plate, 4mm (7%) by the plastic deformation of the plate and 13mm (26%) by other mechanisms. In the MJ panel (4EN) in total 58mm of displacement were absorbed as follows: ~27mm (46%) by the closing of the gap, 10mm (17%) by elastic deformation of the plate and 1mm (2%) by a plastic deformation of the plate, leaving 20mm (35%) to be absorbed by other mechanisms. This plots also confirms that the maximum elastic deformation of the connection was ~10mm.

Fig. 10 Residual Δ_c , peak Δ_c , peak ID_w and peak $ID_w - \Delta_c$ recorded in all the FB motions in the (a) 4ES panel and (b) 4EN panel

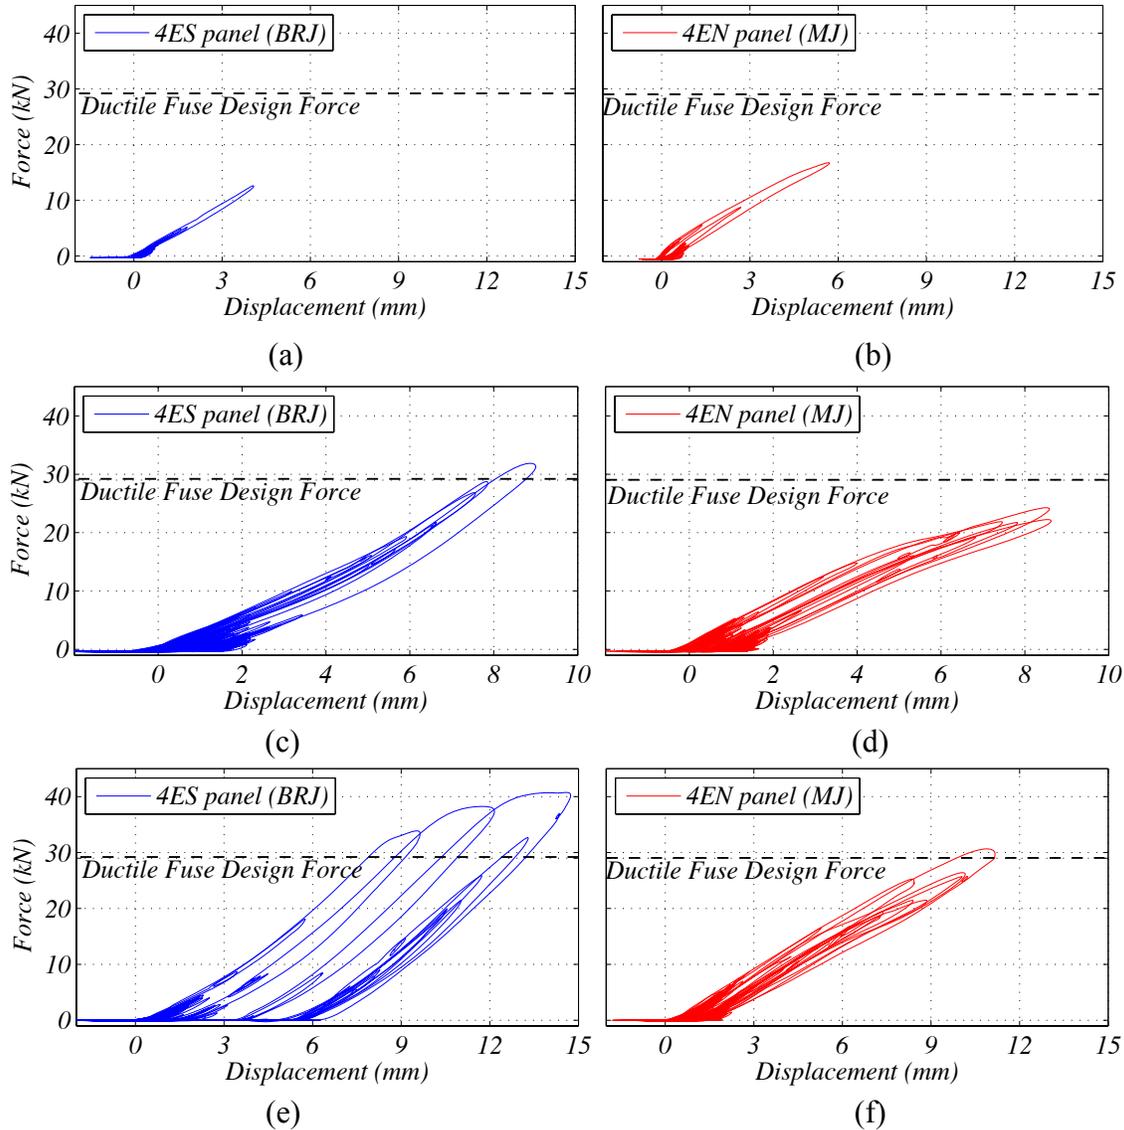
The force-displacement behavior recorded in the last three motions for the corner connection in panel 4ES (butt-return joint) and 4EN (miter joint) is shown in Fig. 11. During motion FB-4:ICA100 (Fig. 11a), the connection on the BRJ panel shows an almost perfect linear behavior while that of the MJ panel presents a bi-linear behavior with a change in stiffness at a displacement of 1mm and force of 3kN. Fig. 11c shows the displacement versus force for FB-5:DEN67. During this motion large impact forces were recorded in both connections, and these are also present in the hysteresis of the connection. In this case both connections showed a nonlinear behavior: the connection of the south side (BRJ) presents a stiffening trend especially when displacements are larger than 6mm, while the connection in the northern panel (MJ) still tends to soften for displacements larger than 5mm. This softening behavior of the panel-connection with MJ is attributed to the formation of cracks in the corner of the panel, while the stiffening behavior in the panel with BRJ is more likely attributed to the nonlinear behavior of the steel connection (the connection deformed 9mm with 0.7mm of residual displacement). During the final, MCE-target motion FB-6:DEN100 even larger impacts were recorded and the behavior of the two connections more significantly diverged. During this motion, the connection of the BRJ panel plate developed plastic bending (as confirmed by a 4mm residual displacement) and several broad hysteresis loops confirm the dissipation of energy through continued plastic rotation of the plate. The behavior shows a stiffening trend also in this case. The connection in the northern MJ panel on the other hand observed smaller displacements and also did not exhibit broad hysteresis but rather a nearly linear force-displacement absent observed softening observed. This is likely due to the fact that sources of inelastic behavior in this panel-connection were limited to crack development in the panel, and this had occurred, and stabilized, in prior motions. The smaller connection displacement can be attributed to the fact that the plastic displacement of the panel was above the connection level.

Fig. 11 Force-displacement response recorded in the 4ES and 4EN panels during (a),(b) FB-4:ICA100, (c),(d) FB-5:DEN67 and (e),(f) FB-6:DEN100
