EVOLUTION AND PERFORMANCE OF BOX BEAM BRIDGES IN INDIANA

Ryan T. Molley, MS, KPFF Consulting Engineers, Seattle, WA

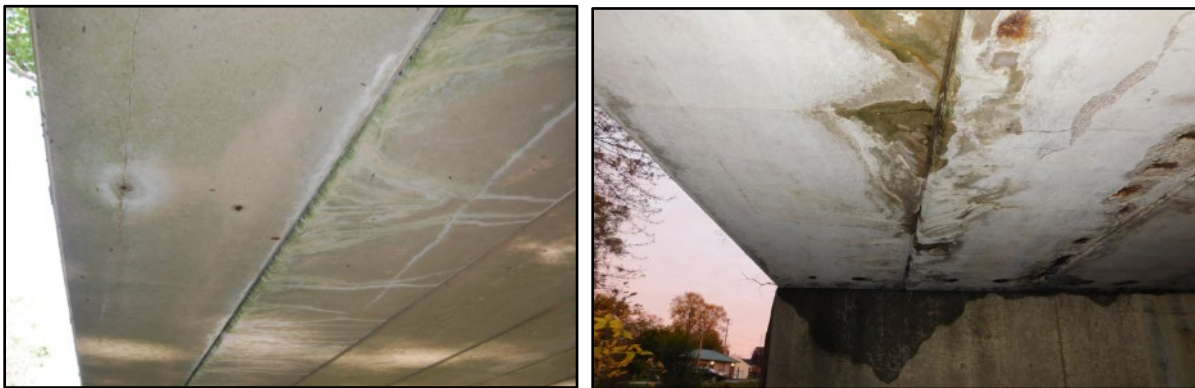
A combination of fractured shear keys and reflective cracking in the wearing surface leads to water seepage through the joints. Water staining on the bottom side of box beams near longitudinal joints was frequently observed. The Pond Creek bridge exhibited water staining and efflorescence at the exterior longitudinal joint. The staining revealed that the water was seeping through the joint and curling onto the bottom side of the first interior beam (Figure 8(a)). The Main Street bridge also had efflorescence and rust staining near the longitudinal joint (Figure 8(b)). In both cases, staining occurred between the exterior and first interior beams. This leakage may be an indication that the exterior shear keys are not performing as well as the interior shear keys. Rotation of the exterior beam may be a contributing factor.

Fig. 8 Water Staining at the Exterior Longitudinal Joint

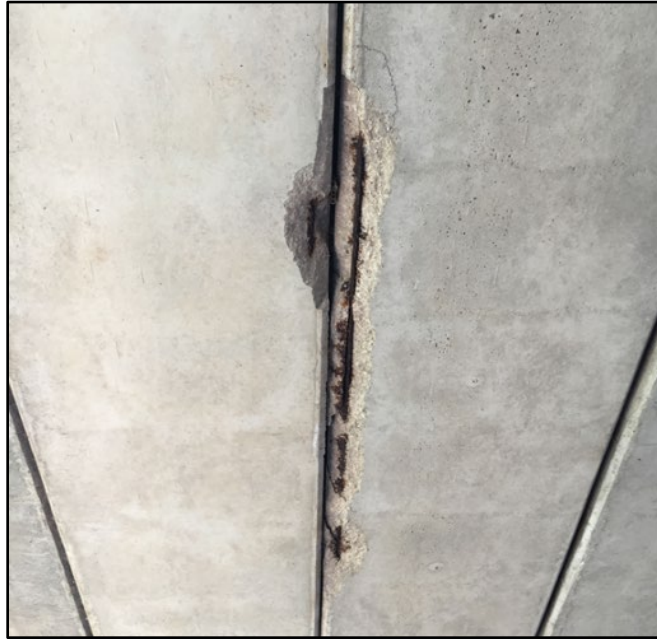
spalled concrete that occurred on both sides of a longitudinal joint. The spalled concrete exposed prestressing strands in the bottom corners of each box beam near the joint (Figure 9).

Fig. 9 Spalling Near Longitudinal Joint (Clear Creek)

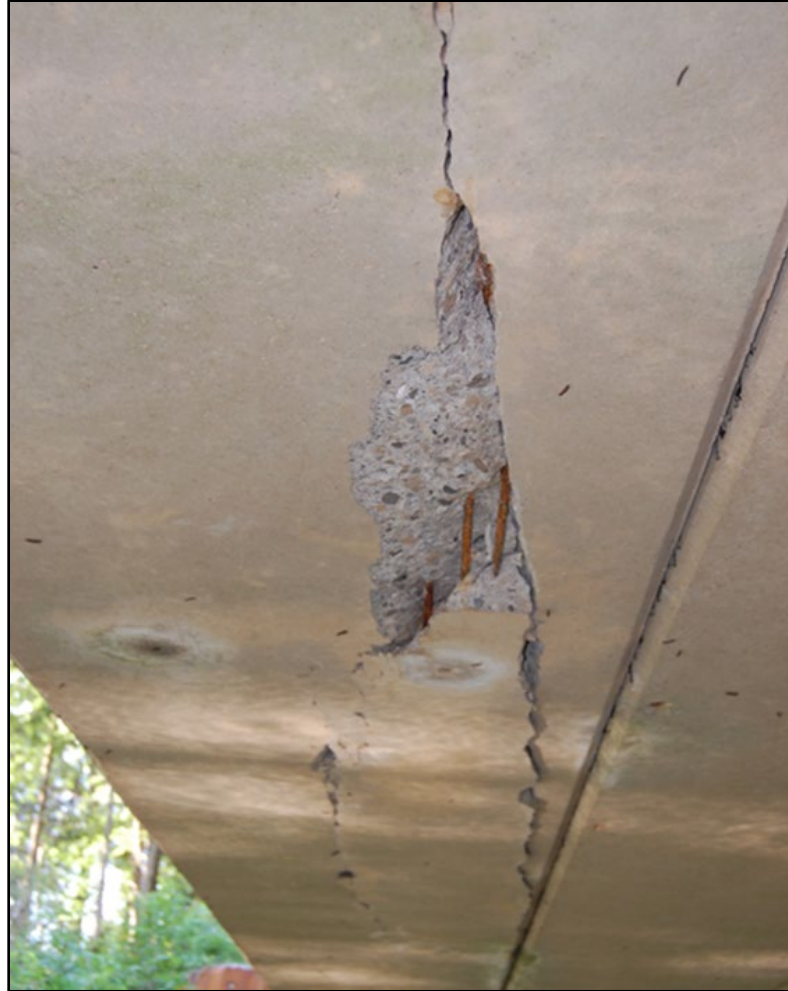
Longitudinal cracking was found on the bottom flanges of several adjacent box beams. Considering the bridges that were inspected, cracking usually occurred near midspan and was generally observed in the exterior or first interior beams. The three-span Rock Creek bridge had two locations of longitudinal cracking. One was on the first interior box beam of the middle span. Rather than being in the center of the flange, the longitudinal crack was closer to the joint with the exterior beam. This crack may be indicative of corrosion of the prestressing strand in the bottom corner of the beam. Longitudinal cracking was also observed on an exterior beam in one of the end spans of the Yellow Creek bridge. This crack was closer to the center of the bottom flange; however, the crack propagated toward the shear key as it extended toward the abutment (Figure 10). A large region of spalling was observed in the center of the crack and exposed three prestressing strands. A group of clogged drain holes was noted near the damaged location. Deterioration may have initiated due to standing water in the void, causing corrosion of the prestressing strands, ultimately resulting in cracking and spalling.

Fig. 10. Spalling and Exposed Strands (Yellow Creek)

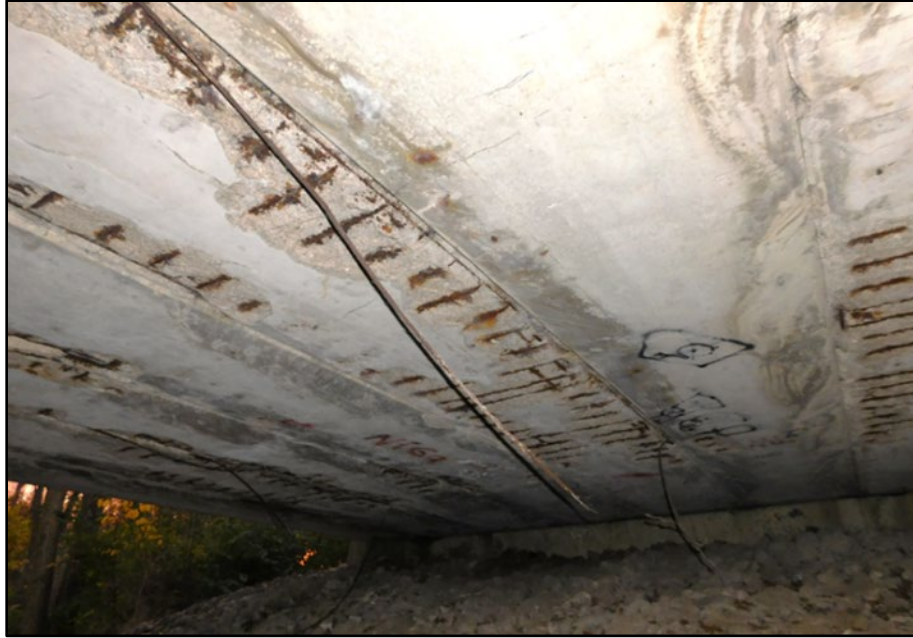
Corrosion of the reinforcement, both prestressing strands and stirrups, was frequently observed during the inspections. The worst case of corrosion was observed on the Main Street bridge as shown in Figure 11. Spalling of concrete exposed a large number of stirrups and prestressing strands. In one span, prestressing strands had fractured and debonded from the concrete, leaving them hanging from the underside of the beams (Figure 11).

Fig. 11. Fractured Prestressing Strands and Corroding Shear Reinforcement (Main Street)

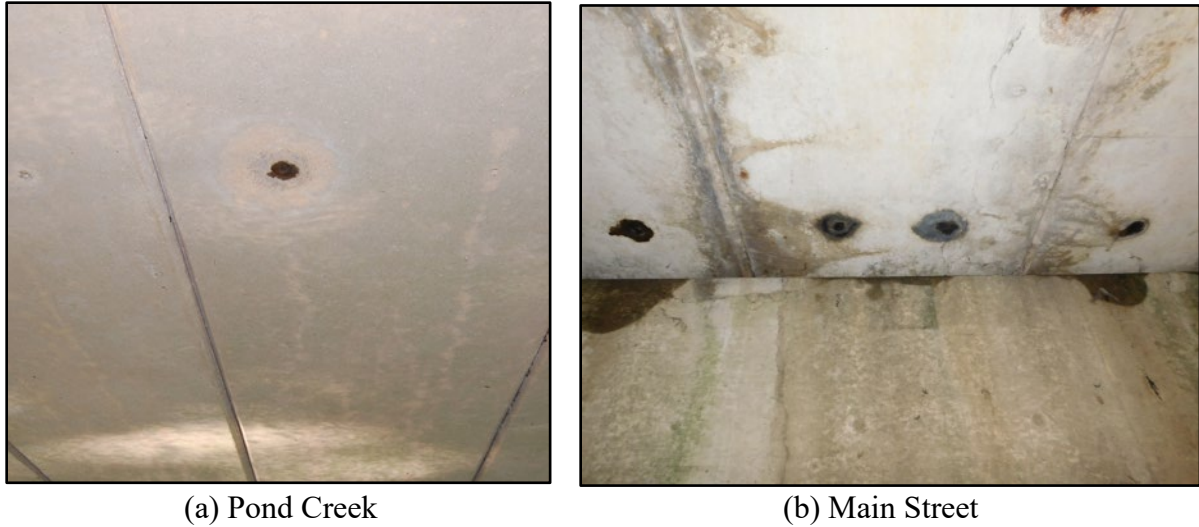
Internal cardboard forms were used in the fabrication of older box beams in Indiana. Because cardboard is susceptible to degradation upon contact with moisture, remnants of the cardboard can build-up around drain holes and prevent drainage. Therefore, standing water can accumulate in the box beams and accelerate deterioration. Furthermore, this added dead load reduces the live-load carrying capacity of the bridge. In many cases, staining and efflorescence were observed around the perimeter of drain holes. As an example, brown-colored staining was observed around the drain holes of the Pond Creek bridge (Figure 12(a)). In contrast, the staining around the drain holes on the Main Street bridge was black in color (Figure 12(b)). For a number of the bridges, it was clear that water was being retained in the voids due to the clogged drain holes. In many cases, the clogged drain holes allow slow release of water while the drainage capacity of others is questionable.

Fig. 12 Staining and Residue Around Drain Holes

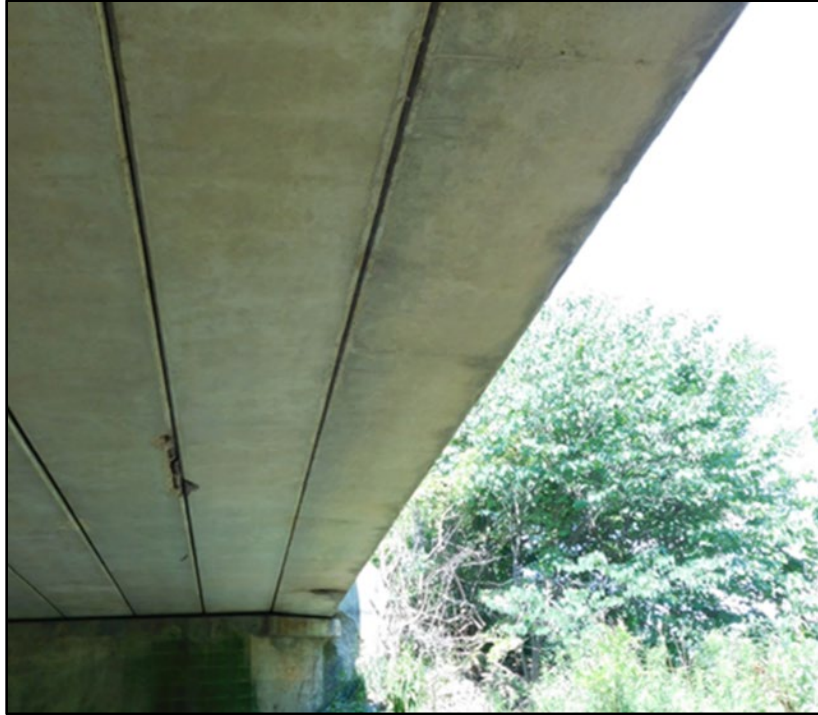
Rotation of the exterior beam was observed at the Clear Creek bridge. The exterior beam on the west side appeared to have rotated away from the bridge (Figure 13). In this case, there was no staining at the bottom of the joint, and both the exterior beam and the first interior beam appeared to be in good condition. For this bridge, it is believed that the differential rotation may have been caused by improper seating on the bearing pads. Referencing previous inspection reports, this rotation appears to have been in place since the reconstruction in 1980.

Fig. 13 Rotation of Exterior Beam (Clear Creek)

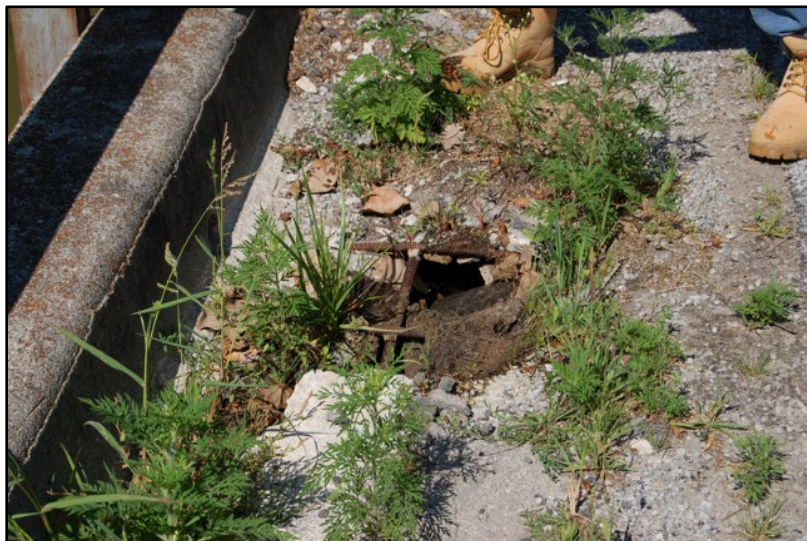
For the Rock Creek bridge, deterioration in the form of a hole in the top flange of an exterior beam was discovered. The deterioration was so significant that the void of the box beam could be observed. Standing water, spalled concrete, and small wildlife were found in the void. A longitudinal bar and stirrups were also exposed (Figure 14).

Fig. 14 Opening in Top Flange of Exterior Beam (Rock Creek)

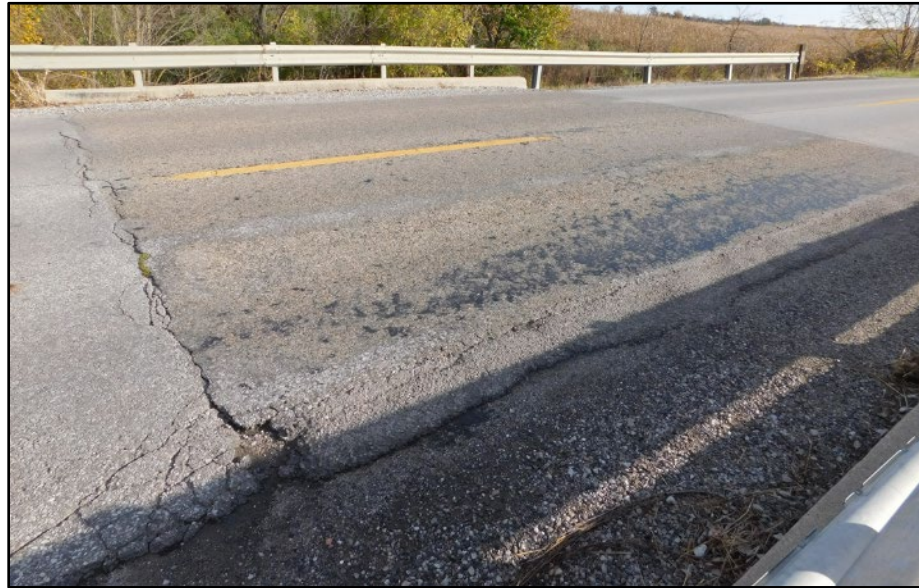
Many of the box beams in Indiana have a thin bituminous wearing surface over the driving path. In many cases, the bituminous wearing surface does not extend to the curb of the bridge. Rather, the asphalt discontinues at the edge of the design lane and gravel covers most of the shoulder (Figure 15). As there are no waterproofing membranes on most of these bridges, chloride-laden water can easily migrate through the gravel shoulder and penetrate the exterior box beams of the bridge, leading to deterioration.

Fig. 15 Discontinuous Bituminous Wearing Surface and Reflective Longitudinal Cracking (Beal-Taylor Ditch)

Reflective cracking was also commonly observed in the wearing surface, especially over the exterior joint. These reflective cracks at the joints also allow penetration of moisture and chlorides into the top surface of the beams (Figure 15).
