# Notes on Post-Tensioned Lift-Slabs

by Harold Omsted\*

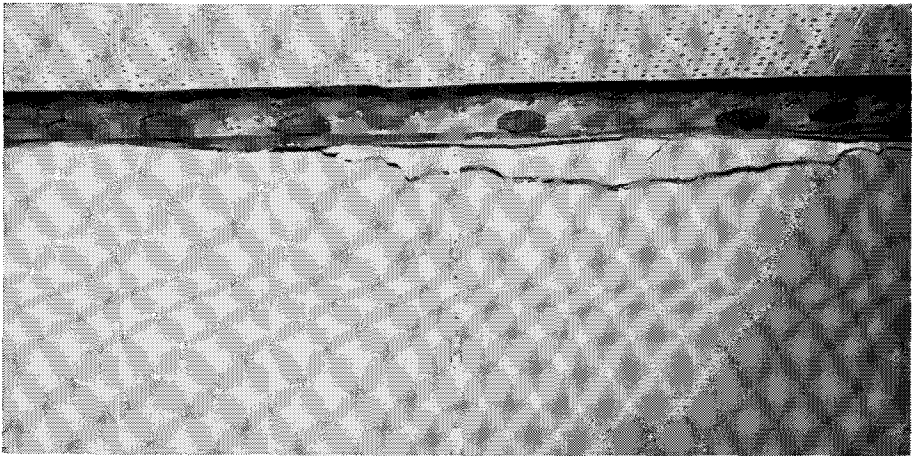
**Fig. 5—Damage to shear wall due to insufficient anchorage to roof slab.**

On one of our lift-slab schools this was neglected. The connection detail between slab and a trans-

verse shear wall efficiently transmitted any shear, but was incapable of resisting the upward arching of the roof slab. The top of the wall cracked off and extensive repairs must be made. Figs. 5 and 6 illustrate damage to this wall. In order to prevent the arching at this shear wall, it was necessary to develop an uplift force of 3,800 lbs. on each of the shear connectors which are spaced 4'-0" on centers. While this force is easily manageable through a proper design detail, it must not be neglected.

to the slab in such a way that movements of the order of  $\frac{3}{8}$  in. can be accommodated. The variable crack at the top of the partition should be concealed by an appropriate molding secured to the slab. Interior shear walls, which develop seismic shear from the roof slab, must be connected to the same with a detail which is capable of developing tension as well as shear.

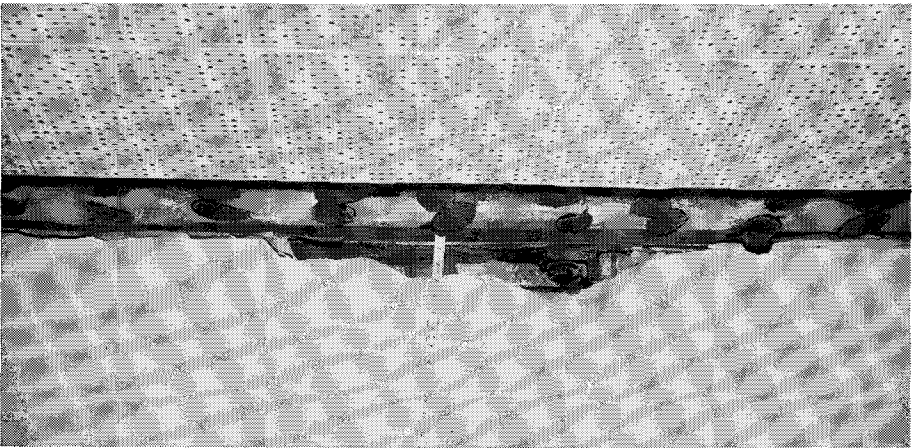
**Fig. 6—Shear connection consisting of short steel angle bolted to insert in lift slab could not develop any uplift force.**

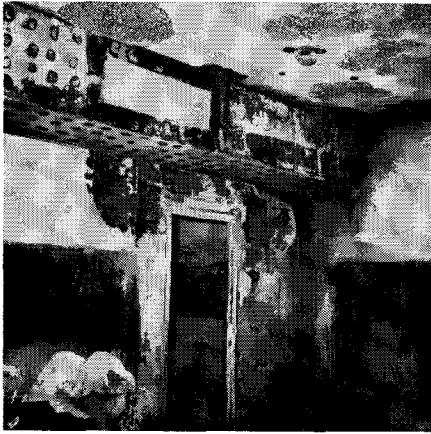
Fig. 7—Steel stud partition having metal lath and plaster between Rooms 20 and 21 was completely bare of plaster around top of steel door frame which was warped.

tected with minimum cover of 1½ in. of lightweight aggregate concrete. This proved to be adequate in two recent fires at one of our schools. Both fires were started by arsonists. The first one was hot enough to melt the aluminum frames of the window wall and to fuse copper wires for electric fixtures. The peak temperature was estimated at nearly 2000°F., and the duration of the fire at one hour. Everything combustible within two rooms was virtually consumed. Extensive spalling of the slab soffits occurred in both rooms, and a few of the tendons were actually exposed for a short distance. On one cable the wires were actually exposed for a length of 3 ft., but some of the lubricating compound between the wires was still soft; proving beyond reasonable doubt that the spalling must have occurred when the stream of water from the fireman's nozzle hit the hot ceiling. Lift-off tests on all tendons in the affected area revealed no loss of tension in any cable. Figs. 7 through 10 show fire damage in this building.

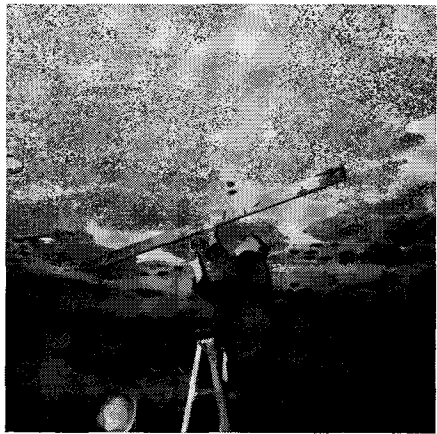
Fig. 8—Checking depth of spall of lightweight concrete at ceiling of Room 21. Maximum depth of spall was 1¾ in. over a spot one ft. square; average depth was ¾ in. over west end.

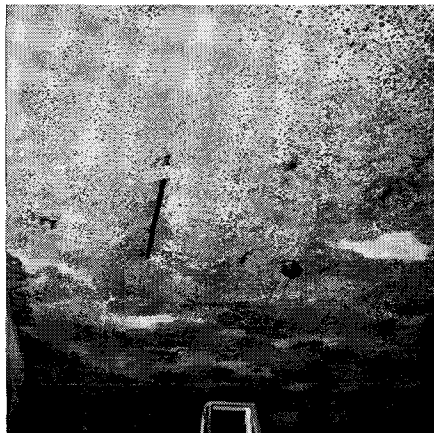
Fig. 9—Ceiling at west end of Room 21. One 3-ft. length of tendon having a 1½-in. cover of lightweight concrete was exposed by spalling.

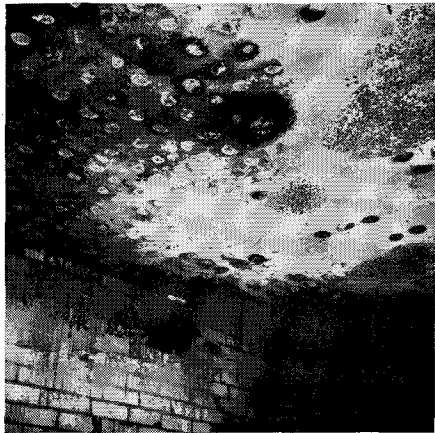
Fig. 10—Clay brick east wall was spalled to a depth of ¾ in. over 2-ft. diameter spot even though the adjacent lightweight concrete ceiling slab did not spall.
