Special Report on

Performance of Precast Concrete Structures During Rumanian Earthquake of March 4, 1977

This report is based on observations the author made when he visited Bucharest between March 19-22, 1977.

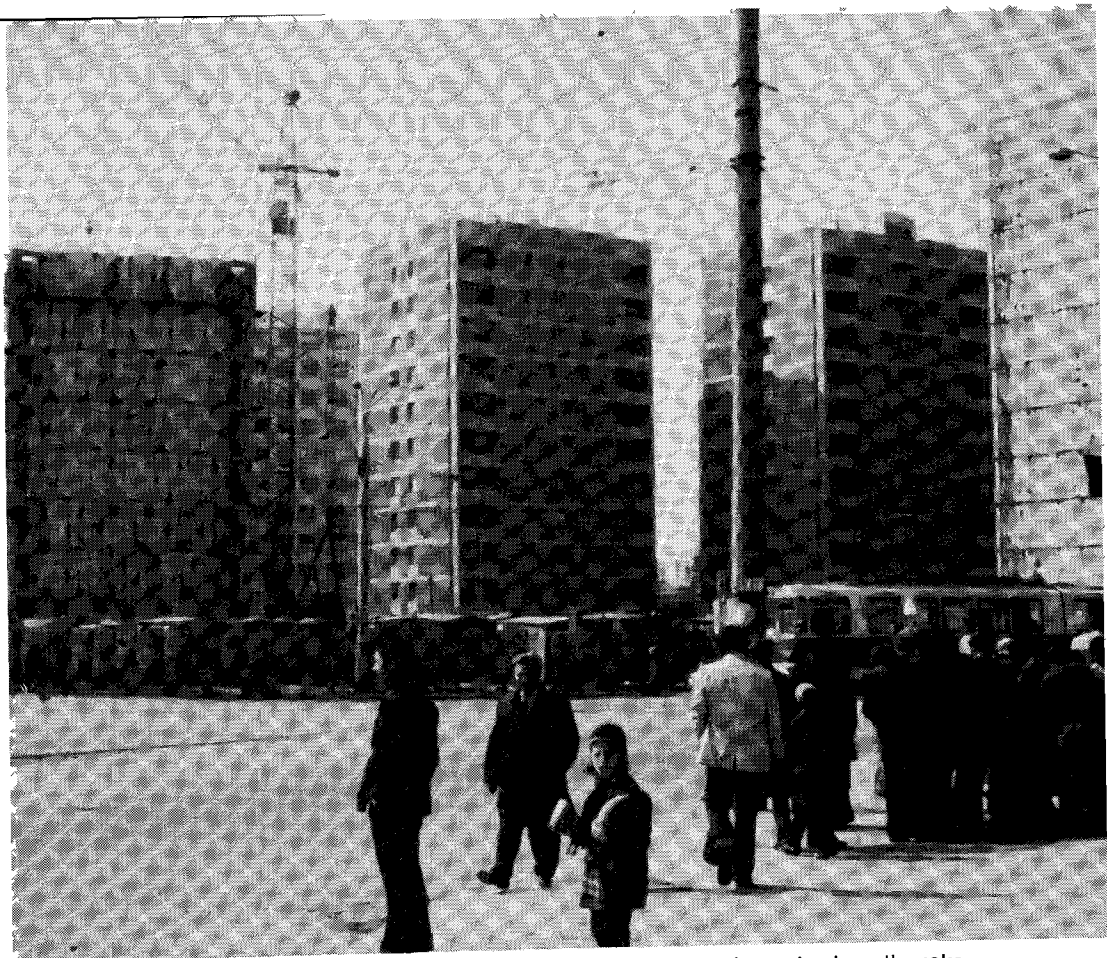
Typical high rise residential precast buildings (Bucharest) survived earthquake.

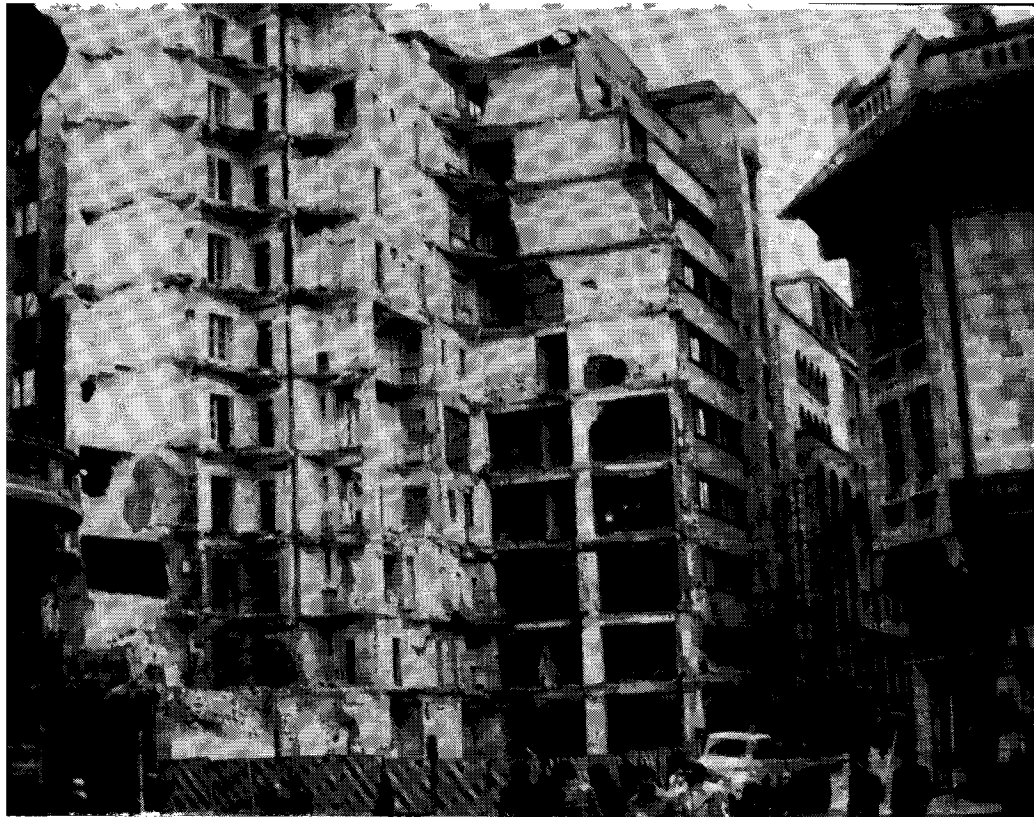
Many pre World War II buildings suffered serious collapse. At the time of construction, seismic design criteria were not established.

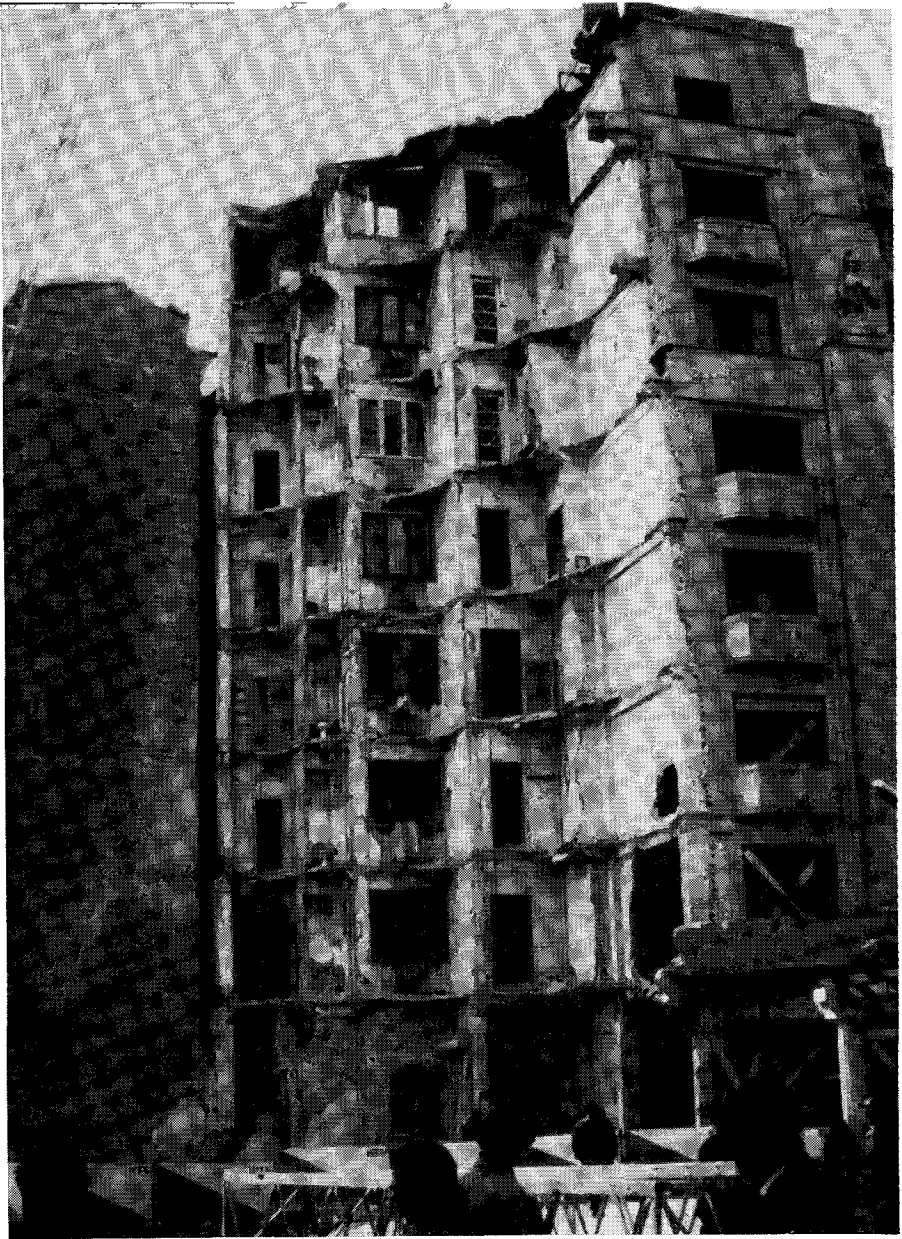
Most casualties occurred in older buildings such as this.

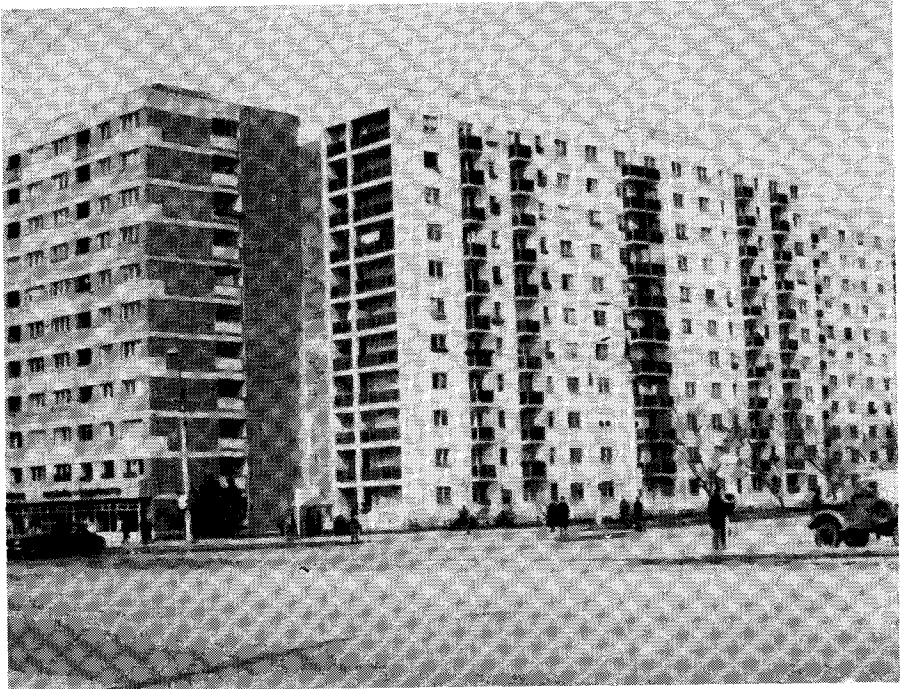
Precast buildings designed to withstand quakes held up well.
