Some Recent Corrosion Embrittlement Failures of Prestressing Systems in the United States

Morris Schupack

Schupack Suarez Engineers, Inc.
South Norwalk, Connecticut

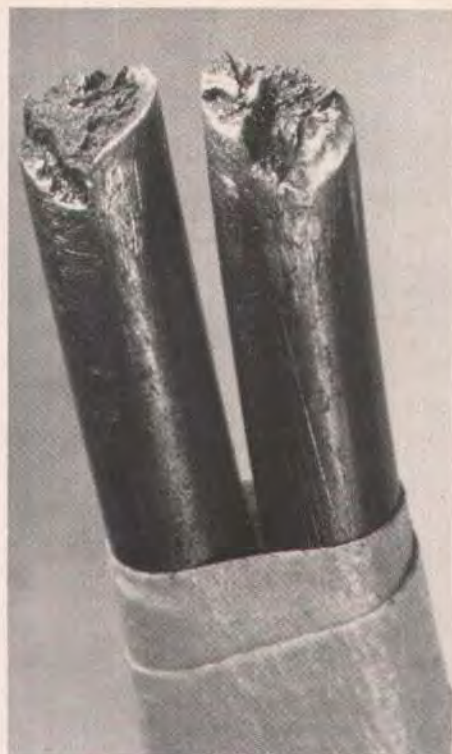
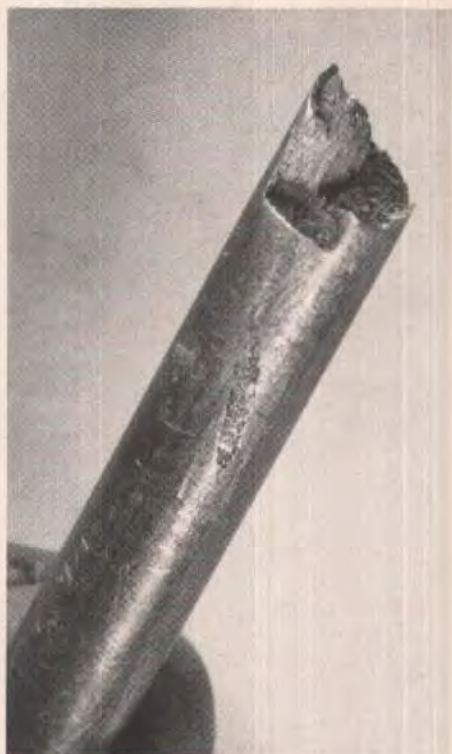
Fig. 1. Typical failure mode without surface attack.

Metallurgical examinations, by many different laboratories, failed to give definitive answers. Some samples of broken wires had enough evidence of corrosion to warrant labeling the failures stress corrosion cracking. Other samples did not show evidence of corrosion pits or surface attack. Fig. 1 shows a typical failure mode without visible surface attack. Many cracks, primarily oriented in the transverse direction, formed near the point of failure, as can be seen in Fig. 2.

ring at an angle of about 45 deg. to the longitudinal axis of the wire. It has been shown in the laboratory⁵ that high strength steel wire stressed in H_2S solutions forms cracks which tend to be aligned at 45 deg to the direction of the tensile stress. The preferred crystallographic orientation of the steel in the wire causes this unusual crack orientation. It was, therefore, assumed that hydrogen sulphide embrittlement of the high strength steel most likely caused these delayed failures.

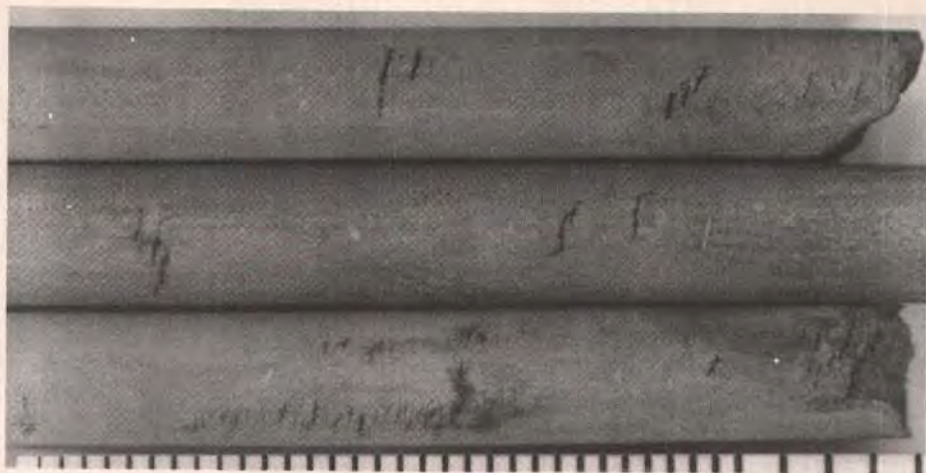
Fig. 2. Etching in acid disclosed many surface cracks.

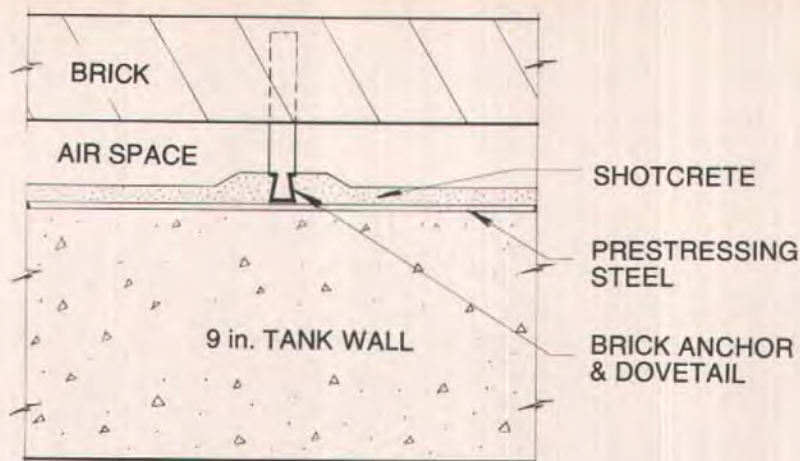
Fig. 3. Horizontal section through tank wall.

The brick anchor detail of these tanks (see Fig. 3) was the same one which had been used in the Owl's Head tank. Apparently to facilitate construction, the galvanized brick dovetail anchor was wired directly onto the wrapped wire and then the shotcrete was placed. This whole problem would have been avoided if $\frac{1}{4}$ in. (6 mm) of shotcrete separated the dovetail from the prestressing wire.

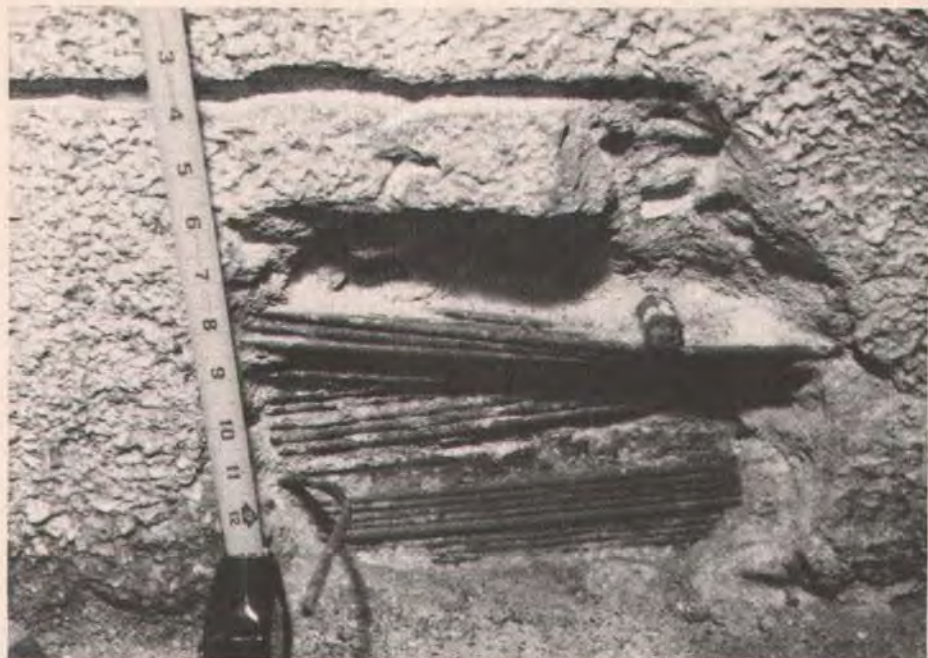
Fig. 4. Corroded wires bundled around a pipe. Shotcrete protection did not penetrate bundle and was not bonded to tank wall.

vertical lines of corrosion extending the full 16-ft (5 m) height of the dovetail. Of the 103 0.212-in. (5.4 mm) wires installed in that height, anywhere from 20 to 55 wires had failed or were so far corroded that they could not be counted on to provide any dependable ultimate strength. Frequently the top 6 ft (2 m) of wall had no effective reinforcement remaining.

The corrosion of the wires was induced by leakage of sewage material, liberating hydrogen sulphide, which came through the pipe openings. It was evident that corrosion occurred where the sludge material had access to the wire because it was not protected by sound shotcrete.

This illustrates the fact that, if the wire is properly protected and there is no direct access of the corrosive medium to it, prestressing steel does not tend to corrode. By avoiding the bundled wires, by making sure that the construction procedures were such that bond could be obtained between the shotcrete and the core wall, and by having the wires spaced adequately so that each one could be properly encapsulated in dense shotcrete, this problem could have been prevented.

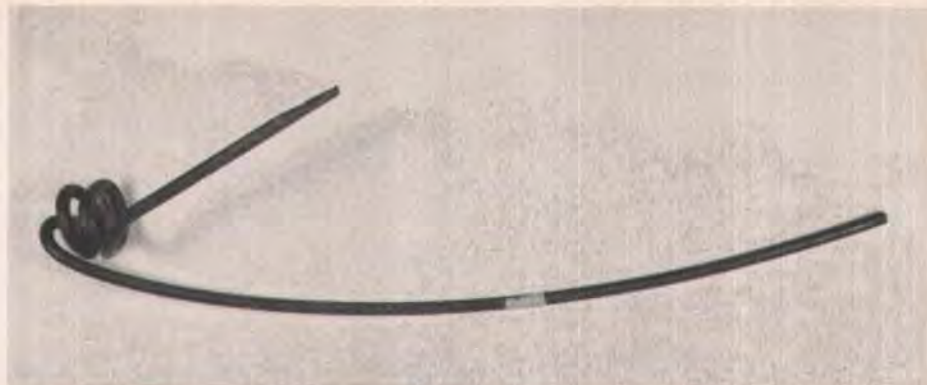
Fig. 5. Failed end of a longitudinally cracked wire with a bend test. This wire actually has a longitudinal crack going through the bend and for most of its length.

Fig. 5 shows a piece of a wire which had failed in the structure. The top end of the wire exemplifies a typical brittle failure associated with a longitudinal split. The bend test performed on the wire indicates that no embrittlement occurred away from the splitting failure. However, by examining the wire closely with a 20-power magnification, it was found that the wire had a continuous longitudinal crack extending practically from one end to the other. The tape near the end of the wire of Fig. 5 indicates how far the crack was visible.

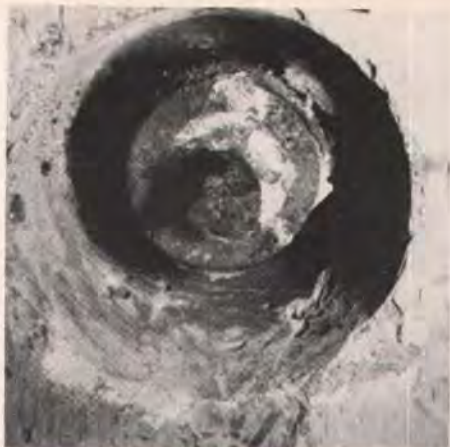
Fig. 6. Corroded end anchorage for 0.6-in. (15 mm) strand in a formed pocket.

The anchorage pocket (see Fig. 6) was packed with a mortar which may or may not have contained calcium chloride. Analysis of the pocket filling material indicated chloride contents of up to 0.22 percent by weight of concrete. These pockets were filled mostly in the winter, and it is unknown whether any winter protection was provided. Some of the anchorage pocket mortar plugs appeared to have shrunk away and were loose. In some cases, the plug could be pulled out as a cone. Products of corrosion could be found at the surface of a number of anchorage pockets.

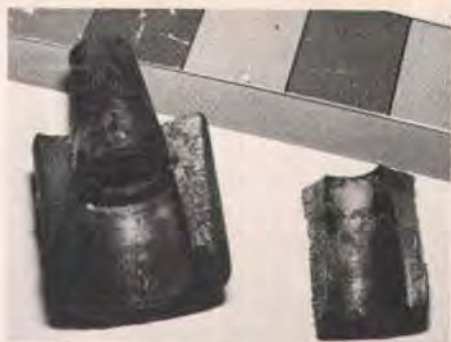
Fig. 7. Failed barrel of 0.6-in. (15 mm) strand anchorage showing longitudinal failure surface.

The barrels suffered longitudinal cracking (see Fig. 7). The appearance of the failure surface is also shown. It was reported by one metallurgical investigator that the failure was due to stress corrosion. Another investigator found no stress corrosion, but only a decrease in barrel area with the resulting higher bursting stresses causing failure.

Based on an analysis of the barrel, it is difficult to see how the amount of corrosion shown could have reduced the section to the point of causing a failure. The failure may have emanated from a corrosion stress raiser which may have propagated into a longitudinal crack. This may or may not have been a stress corrosion failure.

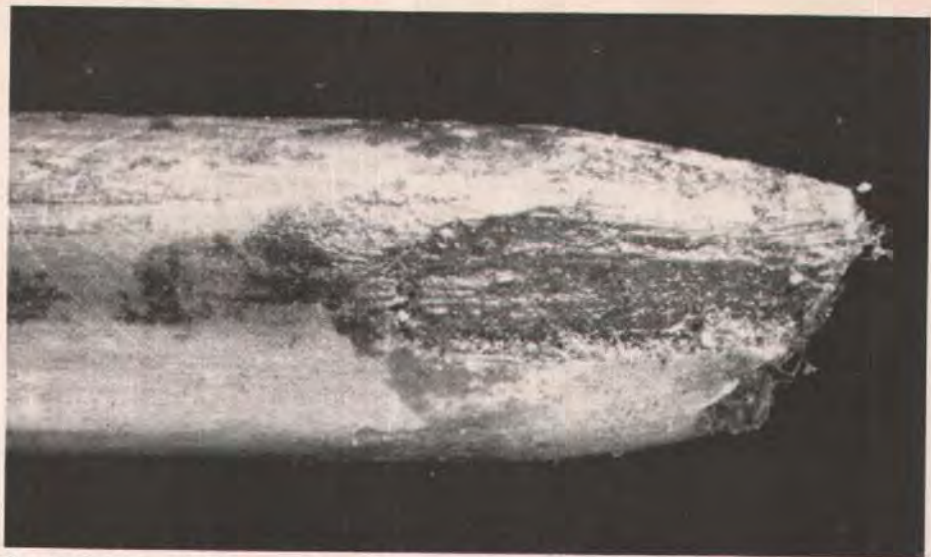
Fig. 8. Surface of wire sample adjacent to fracture showing elongated corrosion pits which intersect the fracture.

Fig. 8 shows typical corrosion observed on the surfaces of the wire samples.

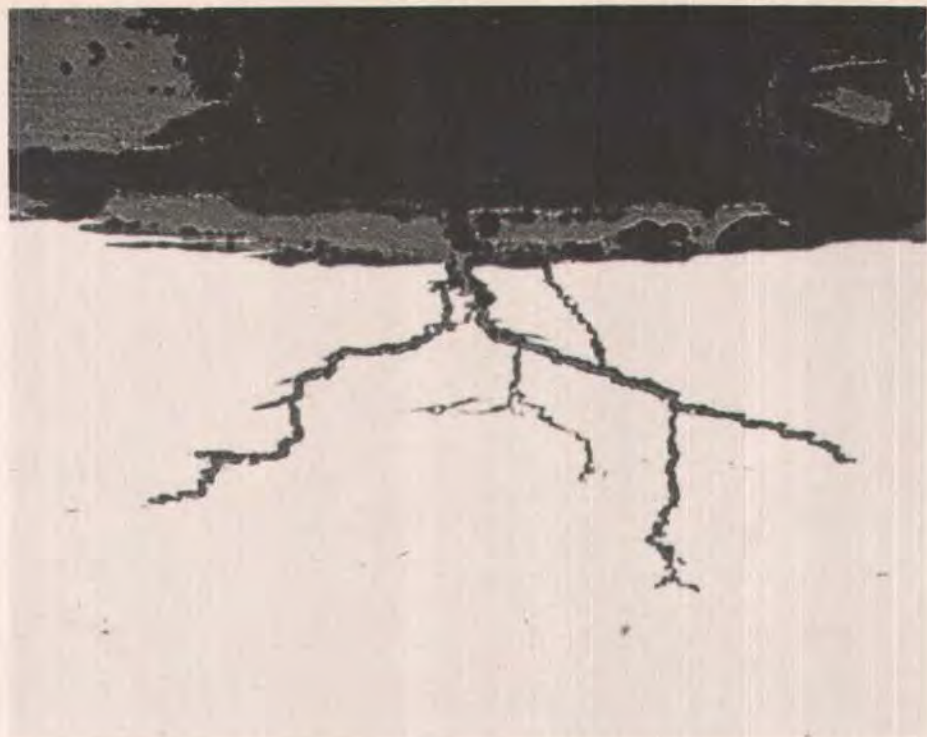
Fig. 9. Photo micrographic of longitudinal cross section taken through corrosion pit on surface of sample. Typical branching and stress corrosion cracks emanating from the corrosion pit (top) of the wire are clearly evident.

The general appearance of the brittle fracture profile was characteristic of stress corrosion cracking. This was confirmed by examination of the microspecimen taken through pitted areas adjacent to the fracture which clearly exhibited branching cracks typical of stress corrosion cracking. These cracks are shown in Fig. 9.
