The Cause of Cracking in Post-Tensioned Concrete Box Girder Bridges and Retrofit Procedures

Walter Podolny, Jr.

Bridge Division
Office of Engineering
Federal Highway Administration
Washington, D.C.

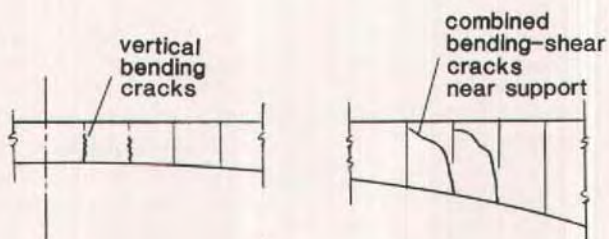
Fig. 3. Flexural cracks.

In areas near the support the effect of shear will be superimposed upon the flexural stresses producing, after initial vertical cracking, cracks that are inclined and become more and more diagonal in the webs, which may indicate insufficient shear strength (Fig. 3).

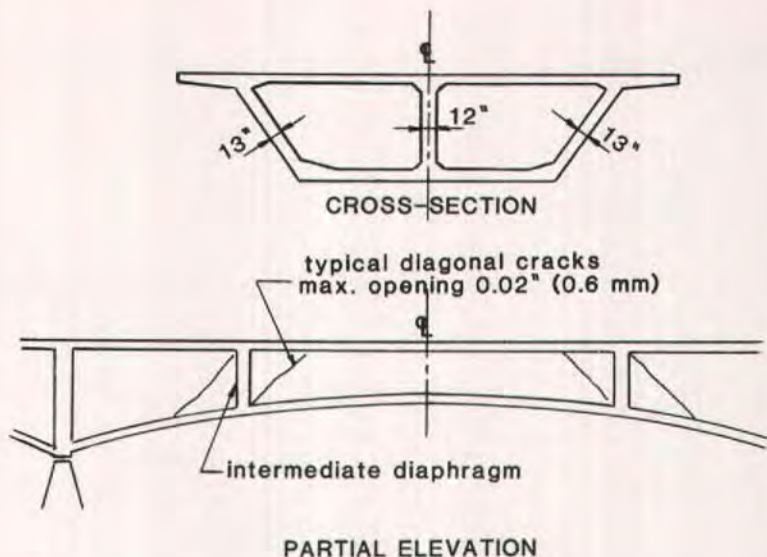
Fig. 7. Web cracking of center web.

vertically curved tendons in the bottom flange. Vertical prestress was applied in the webs to control shear stresses. Diagonal cracking was observed in the center web, only near the intermediate diaphragms, with a maximum crack opening of 0.02 in. (0.6 mm). In addition there was cracking in the bottom flange.

A complete investigation of the problems encountered revealed that cracking was the result of the superposition of several adverse effects, any of which might have been harmless if considered separately:

1. The computation of shear stresses failed to take into account the adverse effect (usually neglected) of the vertical component of continuity prestress in the bottom flange of a girder with variable depth. The curvature of continuity tendons distributed in the bottom flange is such that a downward reaction is produced at the webs that is additive to the shear in the web (see above).

Repair of shear cracks in the web of the structure illustrated in Fig. 7 was accomplished by adding vertical prestress

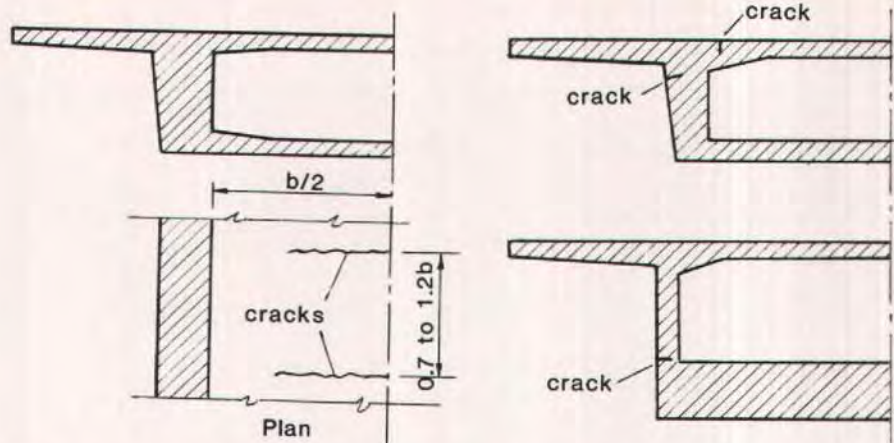
Fig. 17. Thermal shrinkage cracking.

the bottom thin flange will cool faster and attempt to shrink at a faster rate than the webs and is therefore being restrained. To relieve tensile strains, produced by restraint of the webs, the thin bottom flange has no other alternative but to crack (Fig. 17a). In a transverse section, large differences in thickness can produce restraining moments which can produce horizontal cracks in the webs (Fig. 17b).

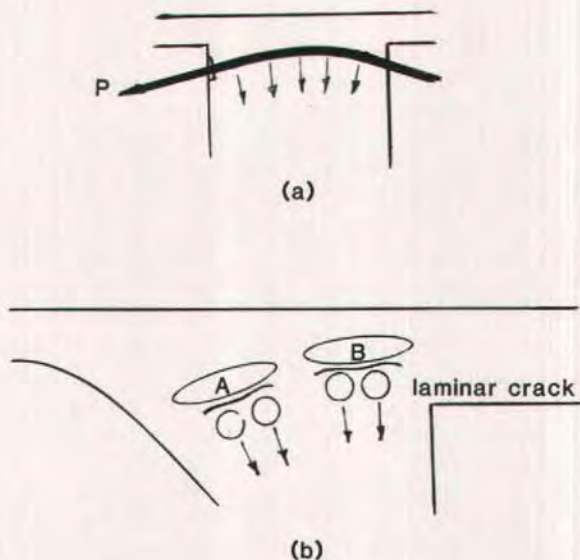
Fig. 55. Diaphragm cracking from tendon curvature.

In addition, a splitting crack may develop as a result of multi-strand compaction in the zone of curvature as discussed above. It appears that the laminar crack either by itself or in conjunction with the splitting crack, over a period of time will propagate to the surface and produce spalling. Spalled areas of the deck have been as large as 3 x 3 ft (1 x 1 m). The spalled surface in two projects were located generally over the

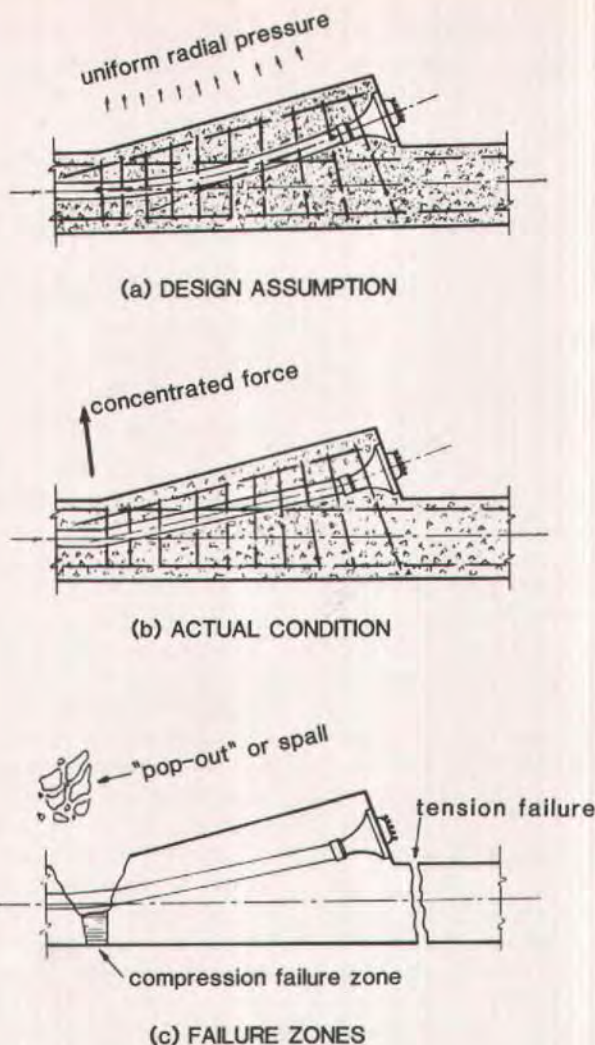
Fig. 59. Anchorage blister failure.

This then leads to a spalling or "pop-out" failure (Fig. 59c). The concrete area in the slab forward of the blister is then reduced, leading to a compression fail-

The design of blisters requires, in addition to reinforcement for anchorage bursting stresses, adequate reinforcement for shear and bending between the blister and the flange or web interface. Consideration should be given to Sections 11.7 and 11.9 of the ACI Building
