Response of Spun Cast Concrete Poles to Vehicle Impact

The response of spun-cast reinforced and prestressed concrete poles to vehicle impact is studied in a series of eleven full-sized tests. It is observed that the poles fail due to shear upon impact. Ways to control the impact resistance by different means are discussed.

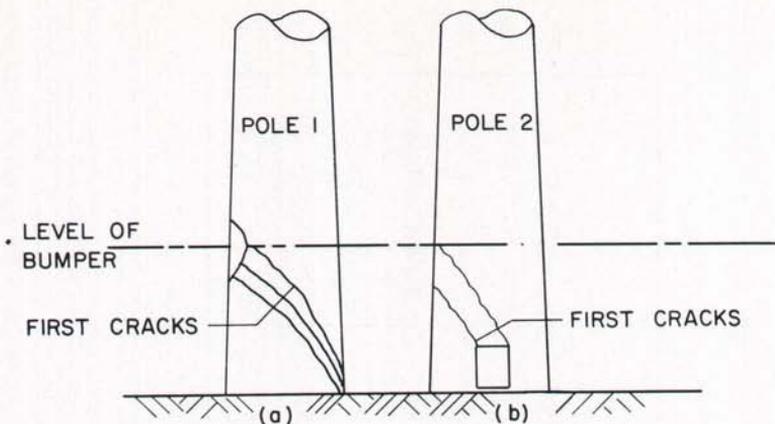
Fig. 7. Failure pattern of Poles 1 and 2 at beginning of destruction of pole.

In the zone at the bumper level, first a number of diagonal cracks formed (Fig. 7a) and then the concrete disintegrated into many small pieces and the pole, still in a vertical position, was moved horizontally approximately 1.50 m (4.9 ft) with one layer of the pole after another being destroyed by the still moving vehicle.

Pole 2 was similar to Pole 1 except that it had a small opening [100 mm wide \times 180 mm high (3.9 \times 7.1 in.)] at ground level. The test vehicle reached a maximum speed of 50.4 km/hr (31 miles per hr) at impact. Again, the softer metal parts of the car collapsed and wrapped around the pole before the pole showed any sign of destruction. Upon impact of the engine block, two inclined shear cracks starting from the corners of the blockout were first visible (Fig. 7b).

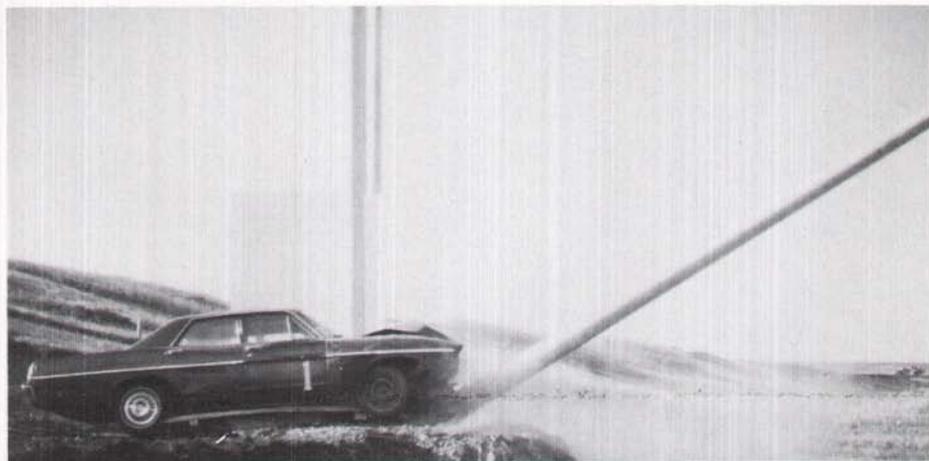
Fig. 8a. Test Pole 1 falling away from car.

At the instant the car came to a halt, the pole was falling away from the car (Fig. 8a) and broke at three points upon hitting the ground. The length of the shattered zone (Fig. 8b) was measured after the test to be 1.28 m (4.2 ft). The impact resulted also in the destruction of the concrete pad and measurements (as far as they were possible) indicated that the pad together with the pole was moved forward approximately 150 mm (5.9 in.).

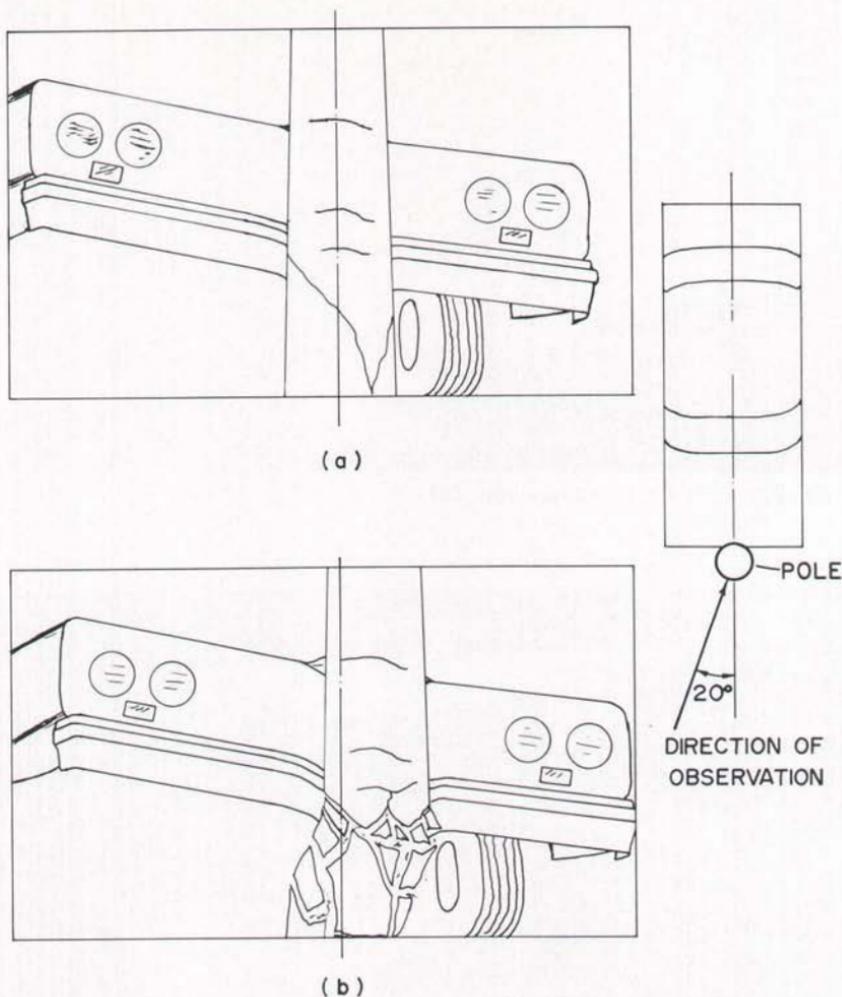
Fig. 9. First cracks (a) and shear failure (b) of Pole 3.

First, three horizontal cracks appeared at the level of the bumper and simultaneously, a shear crack formed as shown in Fig. 9a. Subsequently, a shear failure occurred in

the bottom zone (Fig. 9b).

upon impact. It is apparent from Figs. 9b and 10b that the cause of the initial failure of the pole was shear which is indicated by the diagonal crack which formed in the bottom zone.

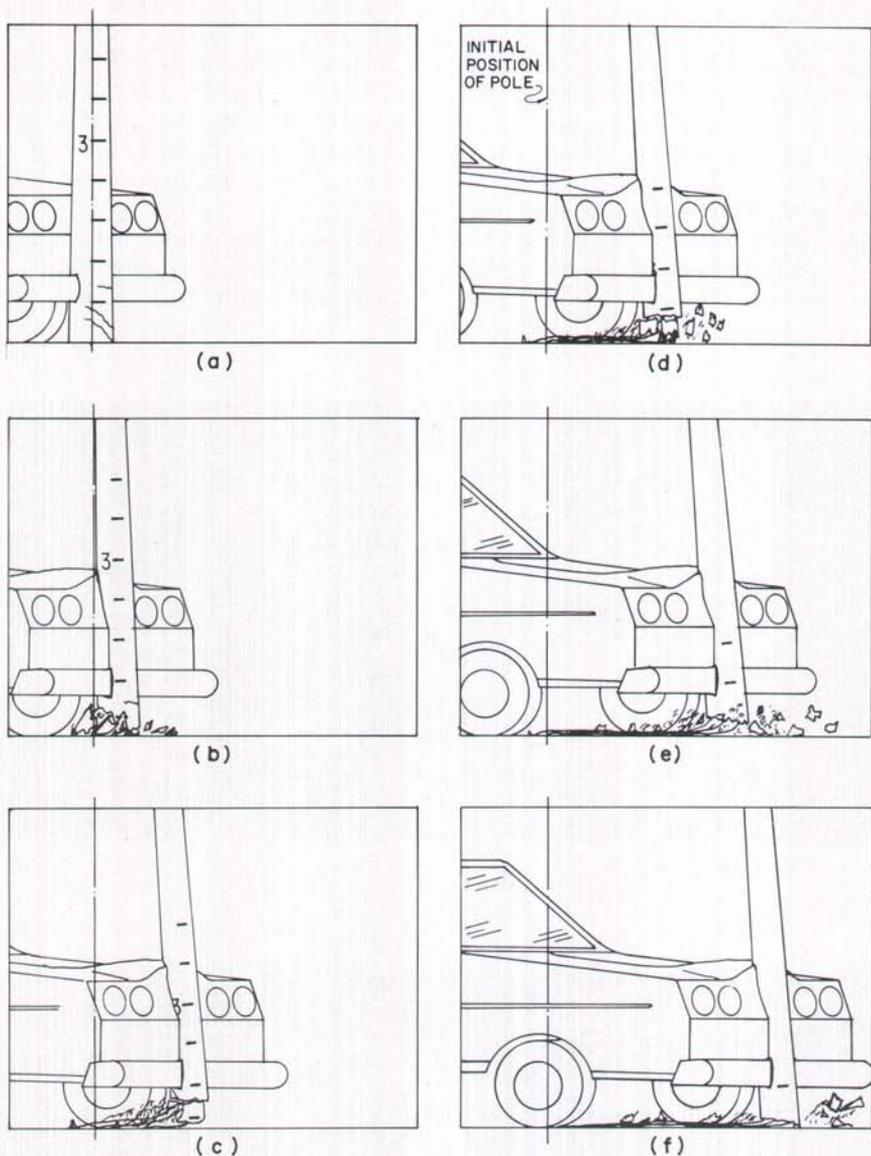
Fig. 10. Sequence of failure of Pole 3.

The sequence of events is depicted in Figs. 10(a) to (f). As a convenient reference, the initial position of the pole centerline is indicated by a broken line. Steps 1 to 6 are described as follows:

1. The bumper of the car is hitting the pole and the first cracks form.
2. The first layer of the pole at ground level is sheared off [horizontal movement

about 0.15 m (0.5 ft).

3. A second layer of the pole is being sheared off in the plane of one of the initial flexural cracks. Each layer is destroyed by the reinforcement which cuts the concrete to pieces [horizontal movement 0.55 m (1.8 ft)].

4. Another layer of concrete is being destroyed [horizontal movement 0.75 m (2.5 ft)]. The pole leans towards the car.

5. Another layer of concrete has disintegrated and the pole is now horizontally displaced by 1.15 m (3.8 ft). The pole is

leaning more towards the car.

6. The car has come to a complete halt after the pole has been moved horizontally by about 1.45 m (4.6 ft). The pole is now in near vertical position again (and subsequently falls away from the car).

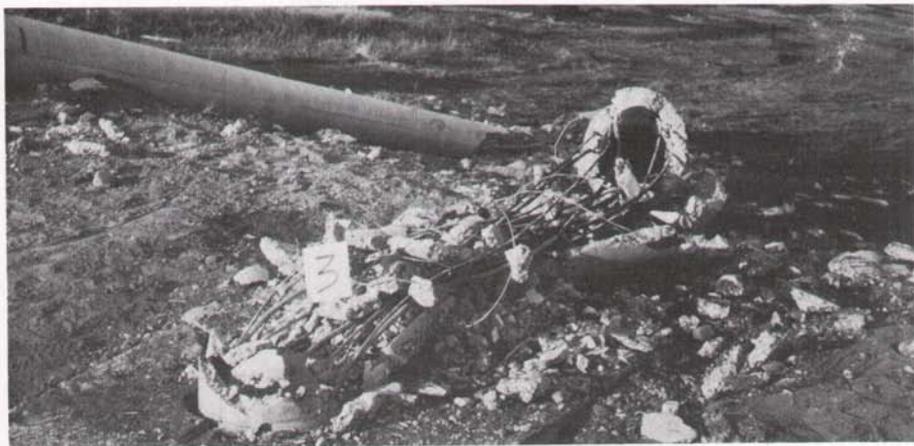
Fig. 11. Pole 3 after the test.

After the test it was observed that none of the prestressing wires or reinforcing bars were broken and they were well anchored in the undamaged part of the pole below ground level.

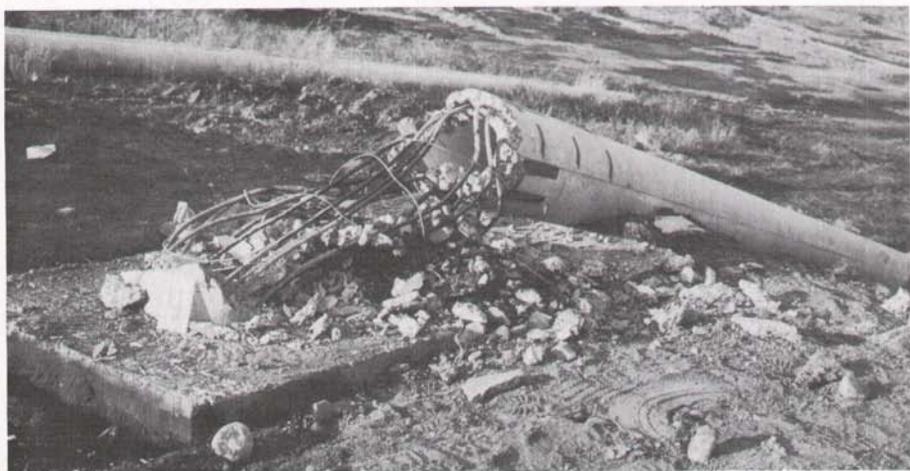
Fig. 12. Pole 4 after the test.

Pole 4 was reinforced with twelve 12.7 mm ($\frac{1}{2}$ in.) bars and had a wall thickness of 64 mm ($2\frac{1}{2}$ in.). The vehicle was released at a level 4.5 m (14.8 ft), resulting in the smallest test speed of 33 km/hr (21 miles per hr). The failure is similar to Test 3.

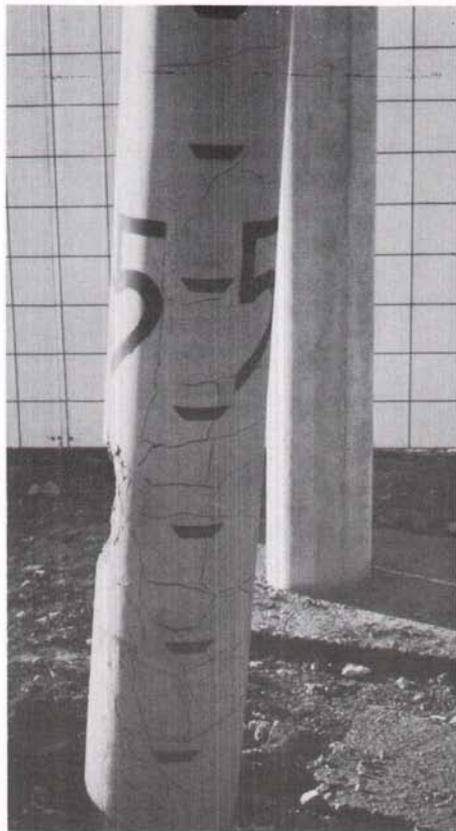
Fig. 13. Pole 5 after the test.

This pole did not break at the level of the impact zone but at a level 4.75 m (15.6 ft) above ground. The pole showed severe cracking over a height of 1.50 m (4.9 ft) and

surface damage at the level of the car bumper (see Fig. 13).

The cracks shown in Fig. 13 were traced with a black felt pen to make them more visible. It must be assumed that these types of cracks are those which form first in all the tests but are not visible from a distance when filmed.

The fact that this pole did not collapse at the impact zone may be attributed to the following two factors: First, the wall thick-

ness of this pole was 68 mm (2.7 in.) which is slightly more than that of the previous test poles, and second, the concrete pad, which at the time of the test was only 48 hours old, split in three parts and allowed the pole to move 120 mm (4.7 in.) at ground level.

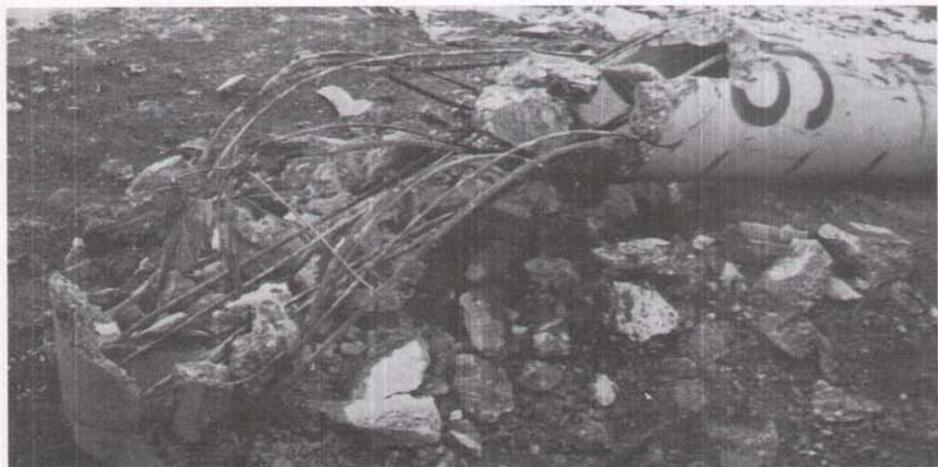
Fig. 14. Pole 6 after the test.

Pole 6 was almost identical to Pole 5. The only difference was the wall thickness, 64 mm (2.5 in.) compared to 68 mm (2.7 in.). The test conditions were also similar in that a similar car hit the pole at approximately the same speed [40.2 km/hr (25 miles per hr)]. This pole, however, collapsed in the bottom zone in the previously described manner over a length of 1.24 m (4.1 ft) (see Fig. 14). It must be assumed that the smaller wall thickness and the rigid support at the level of the concrete pad (which was frozen to the ground) were responsible for the difference in behavior.

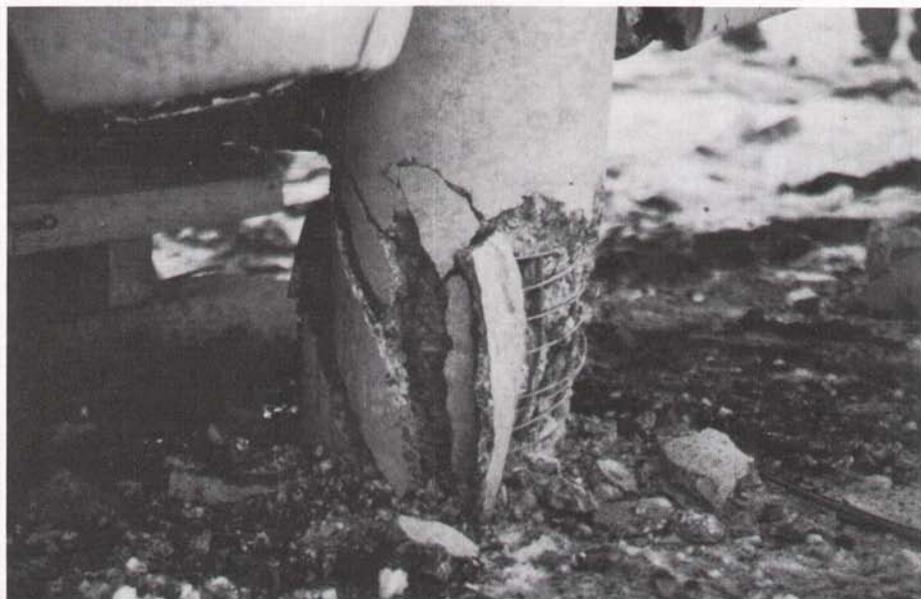
Fig. 15. Pole 9 after the test.

This pole was the second one which did not break. The bottom zone between the level of the bumper and the ground was, however, severely damaged as shown in Fig. 15.

Note that the shell outside the closely spaced spirals spalled off and shear cracks similar to those described in Tests 1 and 3 were evident.

Although the pole did not fall it was easily pulled down because of the severe damage it suffered upon impact. It appears that two factors have contributed to preventing collapse of this pole: first, the closely spaced spirals, which provide an effective type of shear reinforcement and, second, the slightly slower vehicle impact velocity.

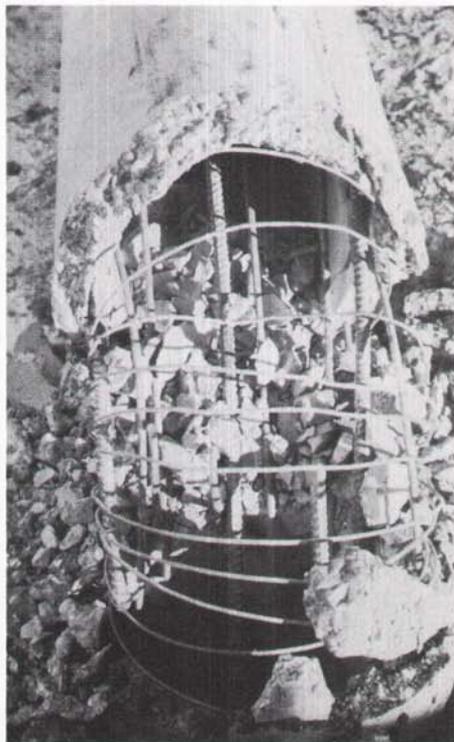
Fig. 16. Pole 10 after the test.

Upon impact, only the zone between the level of the bumper and the ground broke and consequently the horizontal movement of the pole was relatively small [about 0.30 m (1 ft)]. Subsequently, the pole fell away from the car.

It is apparent that the presence of the closely spaced spirals confined the destruction of the pole to a relatively small zone and for this reason, the vehicle came to a halt within a relatively short distance resulting in a relatively high deceleration of 65.2 m/sec (214 ft per sec) = 6.6 g. The failed pole is shown in Fig. 16.

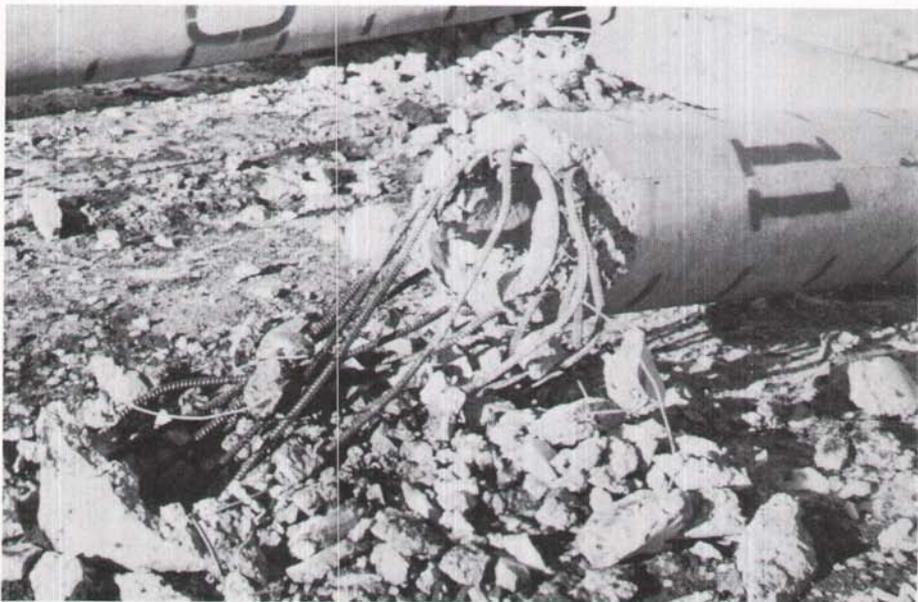
Fig. 17. Pole 11 after the test.

This test failed in the way depicted in Fig. 10. The test data are summarized in Table 3.

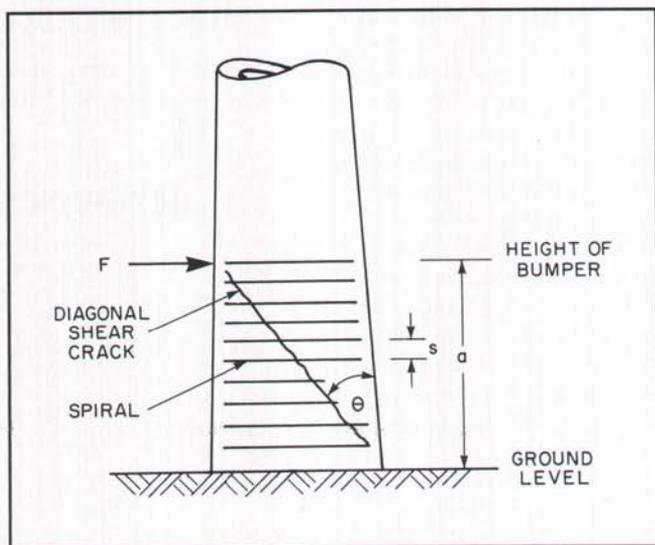
Fig. 18. Critical shear crack between bumper and ground level.

This force is assumed to be equal to the shear force in the critical zone. Assuming a diagonal shear crack as shown in Fig. 18, corresponding to the crack pattern shown in Fig. 7a, the shear resistance according to the Collins-Mitchell approach (Ref. 2) is approximated by (omitting the ϕ factor):
