First Impressions of Earthquake Damage in San Francisco Area

James K. Iverson, PhD, P.E.

Principal
The Consulting Engineers Group, Inc.
Napa, California

Presents a preliminary report on the performance of structures during the October 17, 1989, San Francisco area earthquake. Primary emphasis is placed on the behavior of precast and prestressed concrete structures.

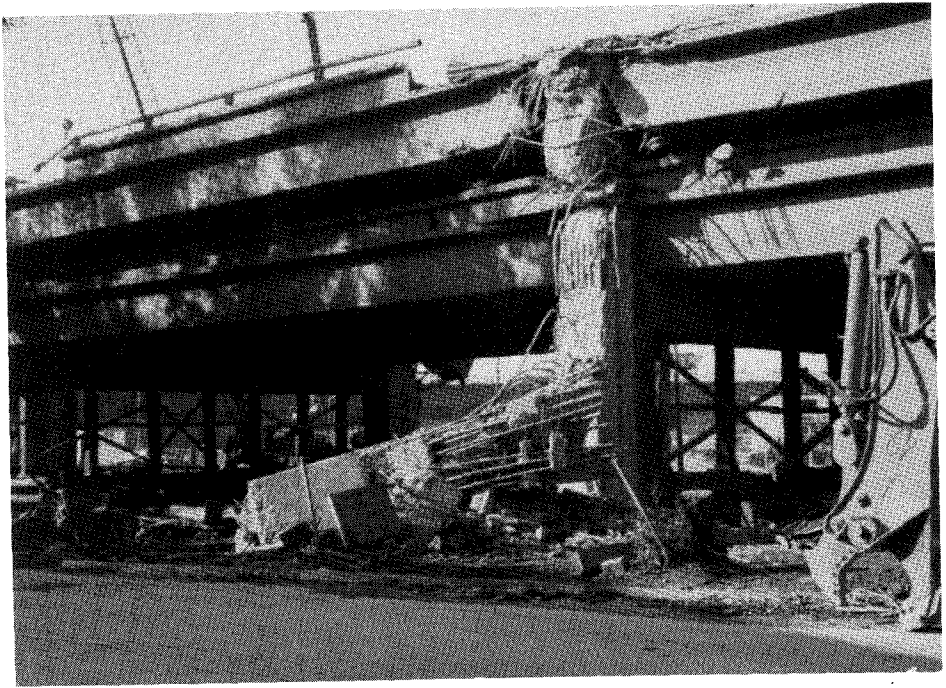
Fig. 3. Collapsed portion of I-880.

The overpass collapse has been widely reported in the media. Fig. 3 shows typical collapsed column sections and the sandwiched deck sections. Initial reports have noted that the mid-1950s standard bridge design and detailing of the columns and pier bents may have contributed to the collapse. Several of the other elevated highway structures accessing the Bay Bridge on the San Francisco side, also experienced damage and have been closed.

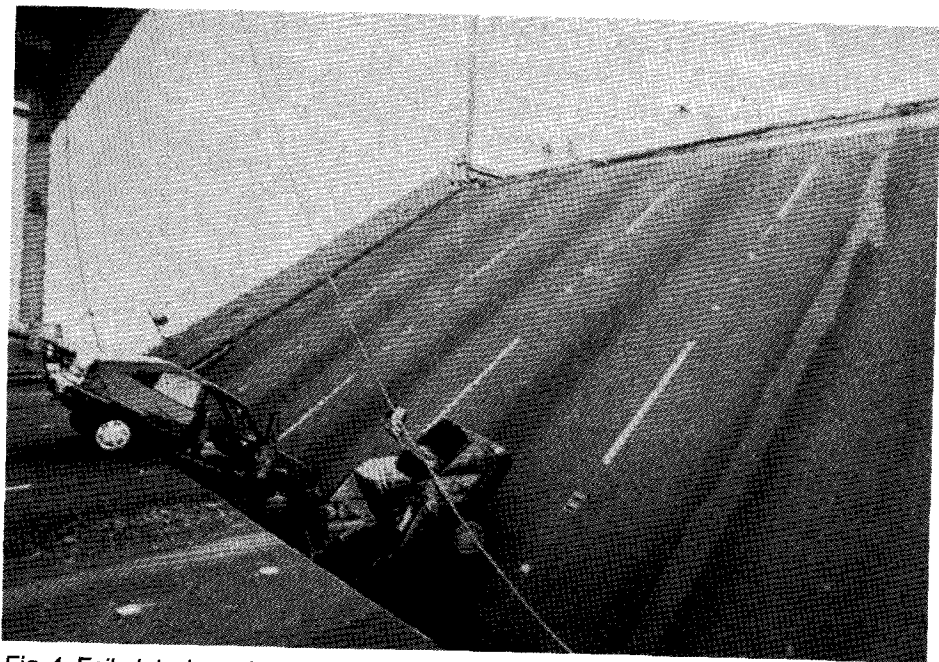
The Bay Bridge which carries I-80 from Oakland to San Francisco and provides the main access to the city, experienced damage to two of its deck sections as shown in Fig. 4, which is taken from the earthquake report in ENR.* By the first week in November replacement units were already under construction

Fig. 4. Failed deck section of Bay Bridge (from *Engineering News-Record* report).

and the contractor targeted completion of the work by the Thanksgiving holiday. Basalt Precast, located in Napa, working around the clock, finished casting 42 stay-in-place prestressed concrete deck panels for the repair. The panels were in place on the bridge by November 6. The Bay Bridge was reopened to full service on November 18.

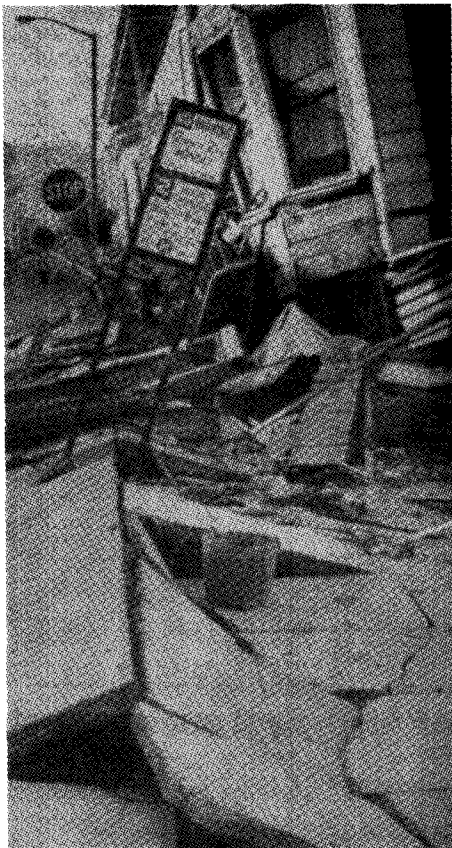
Heavy localized damage was noted in several areas of Oakland and San Francisco and is attributed to poor soil conditions. An example of this was the devastation of the Marina residential area, which was also widely reported on television. One such view is shown in Fig. 5. Only blocks away from these heavily damaged homes, identical structures experienced only minor cracking and many are occupied today.

Fig. 5. Damage to homes and pavement in the Marina area of San Francisco.

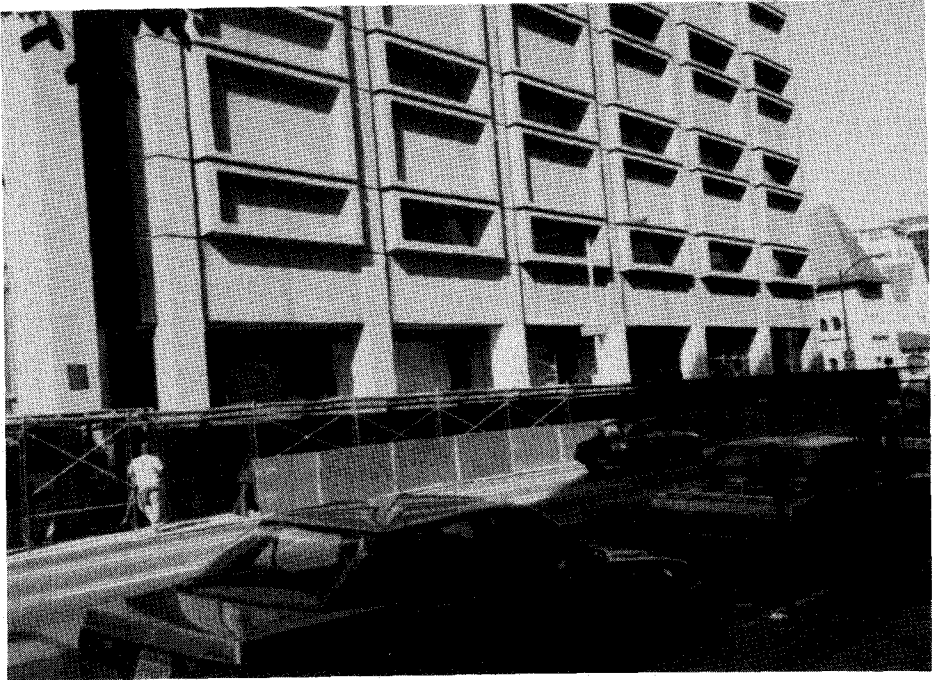
Fig. 7. Telephone Exchange Building, Oakland.

The two structures with cracking are in Oakland, and both contain telephone functions. One is a telephone exchange building located in downtown Oakland only slightly over a mile (1.62 km) from the collapsed I-880 structure. It is reported that the telephone exchange equipment has operated continuously throughout the earthquake and the recovery period. A view of the building is shown in Fig. 7.

The cracking is apparently limited to column covers on the lower level steel columns. No damage was observed in

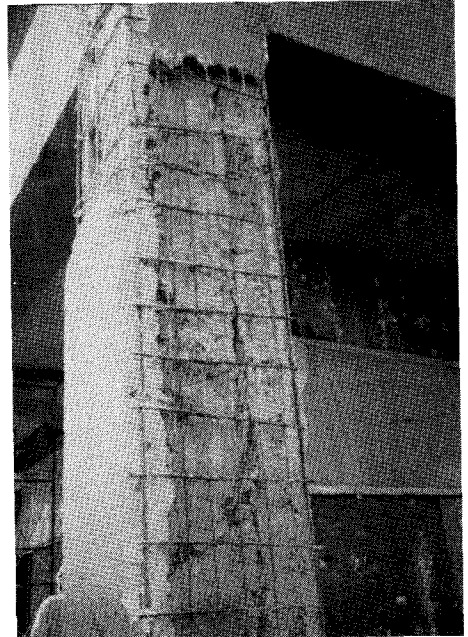
the upper level panels. The column covers are already under repair and the corner column is shown in Fig. 8. Note that these column covers were concrete filled, which leaves little allowance for story drift between the steel columns and concrete cladding.

A concrete shear wall at the first level in this structure also experienced cracking and can be seen in the background of Fig. 8. This dual system structure functioned as expected, with the stiffer concrete shear walls taking loads at lower displacements and the more flexible steel frame taking greater loads at larger movements when the shear wall has cracked.

Fig. 8. Corner column under repair.

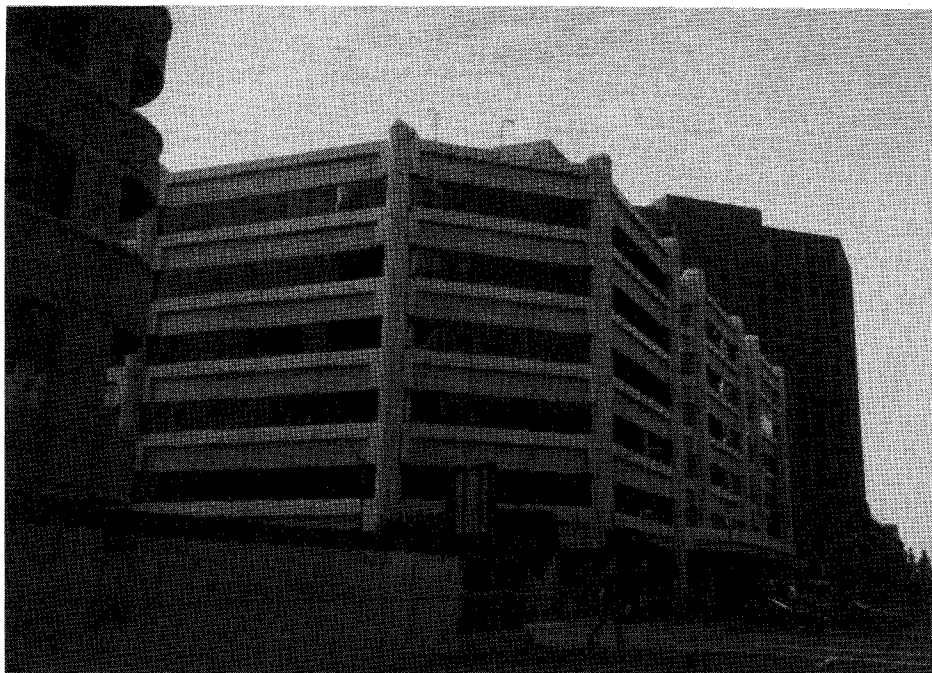
Fig. 9. Trans Pacific Centre, Oakland.

The second building experiencing cracking in the cladding is a few blocks from the first structure and is called the Trans Pacific Centre. It contains offices of several companies including AT&T. This steel structure is clad with glass fiber reinforced concrete panels. A view

All of the cladding damage is apparently associated with large movements at seismic separation joints in the structure. At the locations where cracking occurred there are dual columns and the structure is divided into independent portions which react separately to earthquake motions. Movement between these independent building sections caused most of the cracking.

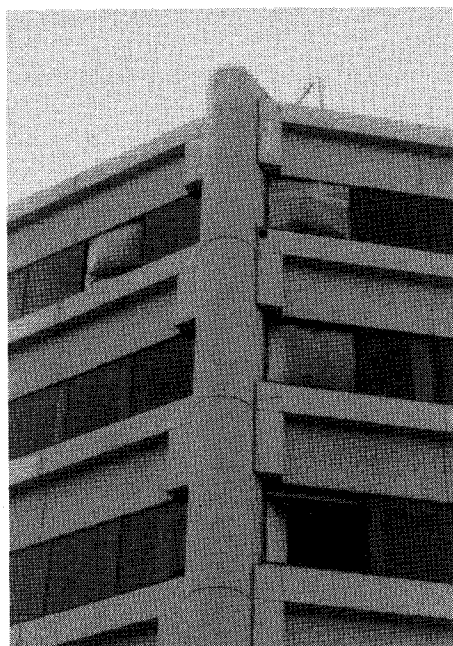
Fig. 10. Panel cracking.

of the building is shown in Fig. 9. The closeup in Fig. 10 shows cracking along the edges of panels near a corner of the building and Fig. 11 shows an opened seismic joint at a column cover.

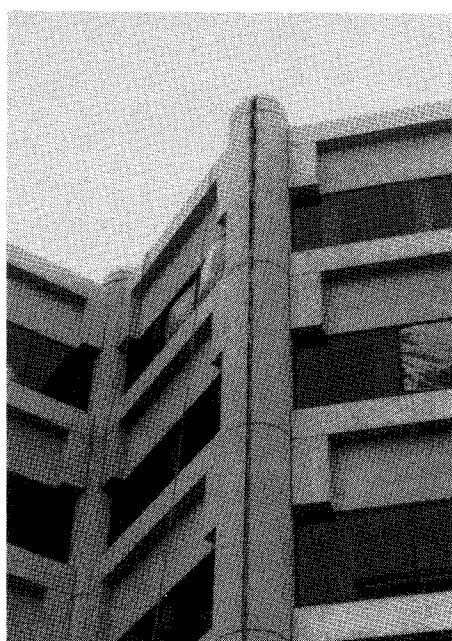
Fig. 11. Opened seismic joint.

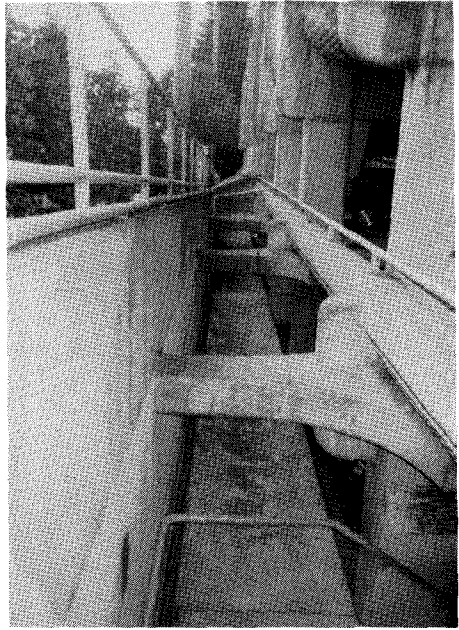
A two-story garage in Berkeley near the University of California campus was an exception, with a precast single-tee frame and post-tensioned slab, with diaphragm ties to adjacent retaining walls. Fig. 12 shows a view of the concrete ties. Only minor cracking in the ties was noted.

Fig. 12. Diaphragm ties between garage and retaining wall in Berkeley.

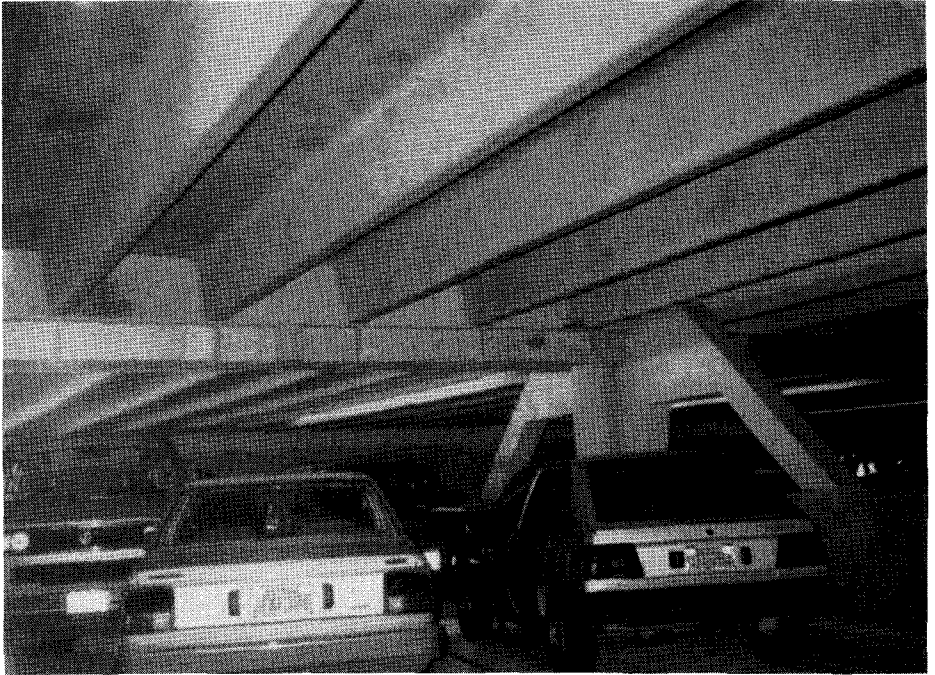
Fig. 13. Parking garage in Oakland.

Oakland and located on Telegraph St., had several earlier repairs from previous cracking at the beam seats at the double-tee bearings and to increase lateral bracing. This garage is shown in Fig. 13. It survived the earthquake exceptionally well.

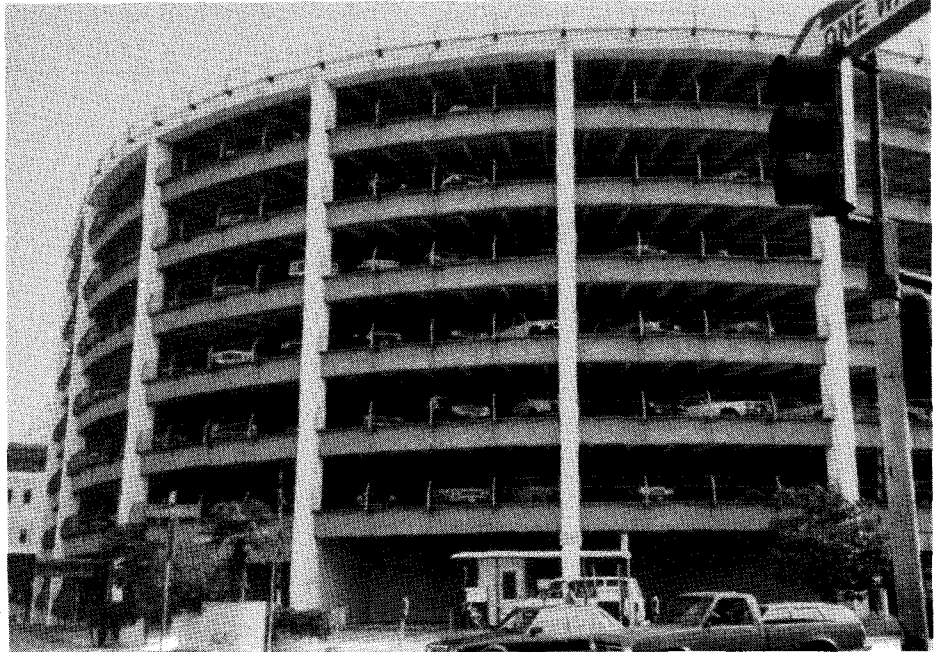
Fig. 14. Circular parking garage in Oakland.

A circular garage utilizing pie-shaped double tees is shown in Fig. 14. This unusual structure had no apparent damage and was practically full of automobiles at the time of review.

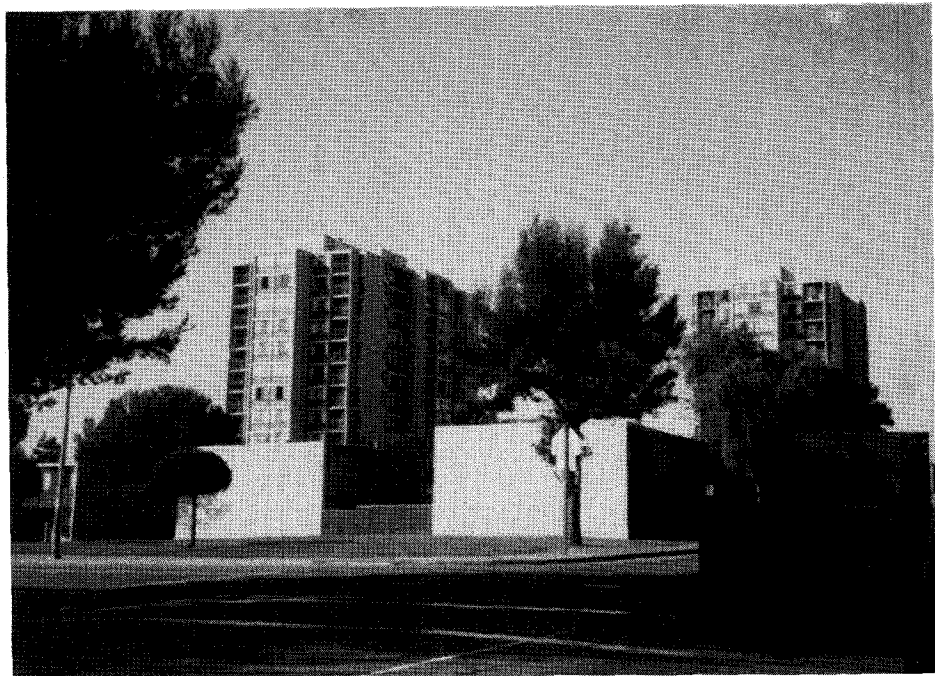
Fig. 15. Housing buildings.

Within about a half mile (0.8 km) of the I-880 collapse, a housing development project utilizing reinforced concrete block and prestressed hollow-core slab construction was occupied and showed no signs of cracking. Fig. 15 shows two of the 12-story structures from this housing development and a closeup of the exterior is shown in Fig. 16.
