Building and Rebuilding of Philadelphia's Walnut Lane Memorial Bridge

PART 1: A History of Design, Construction, and Service Life

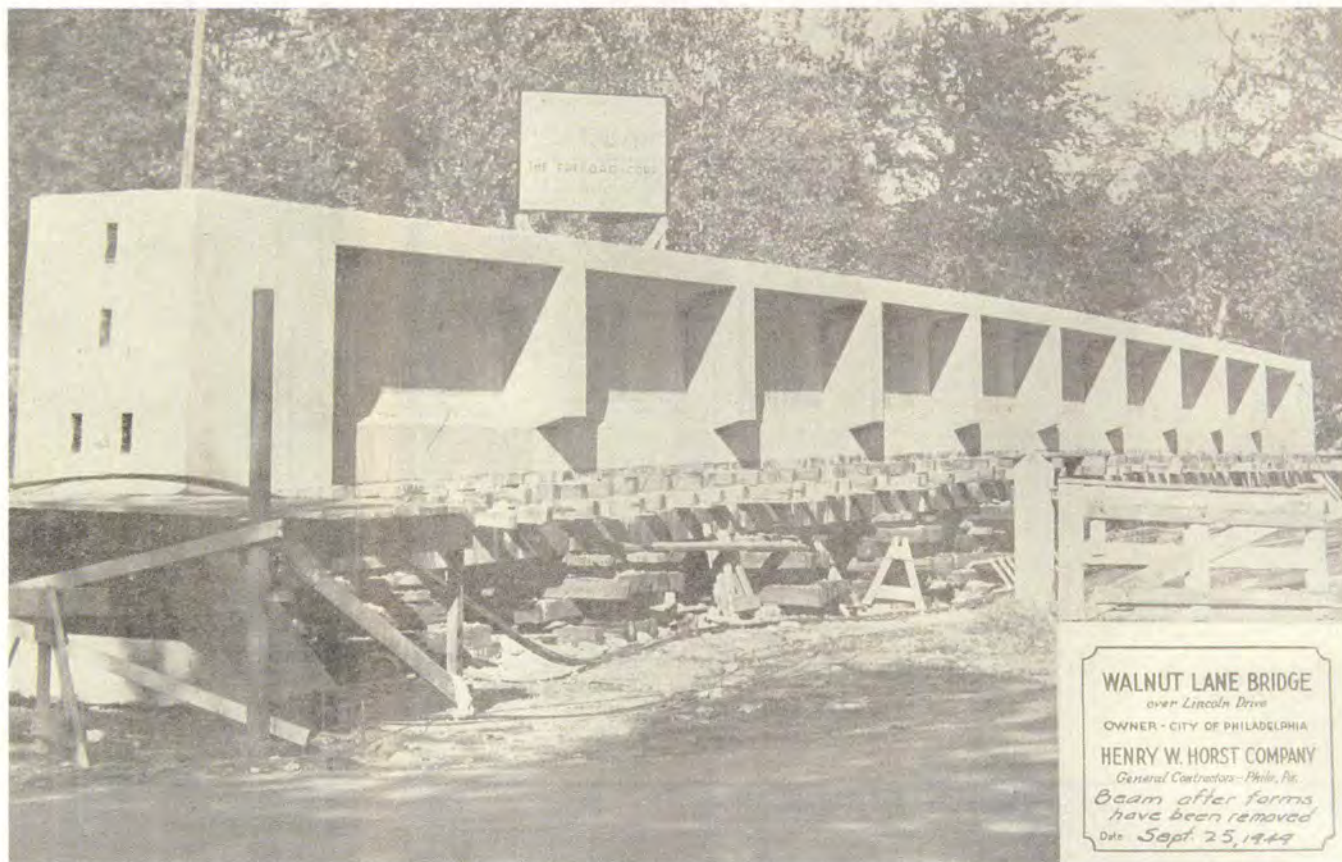
Fig. 9. Appearance of the first test girder after removal of the forms. Note that diaphragms were cast as part of the main span girders.

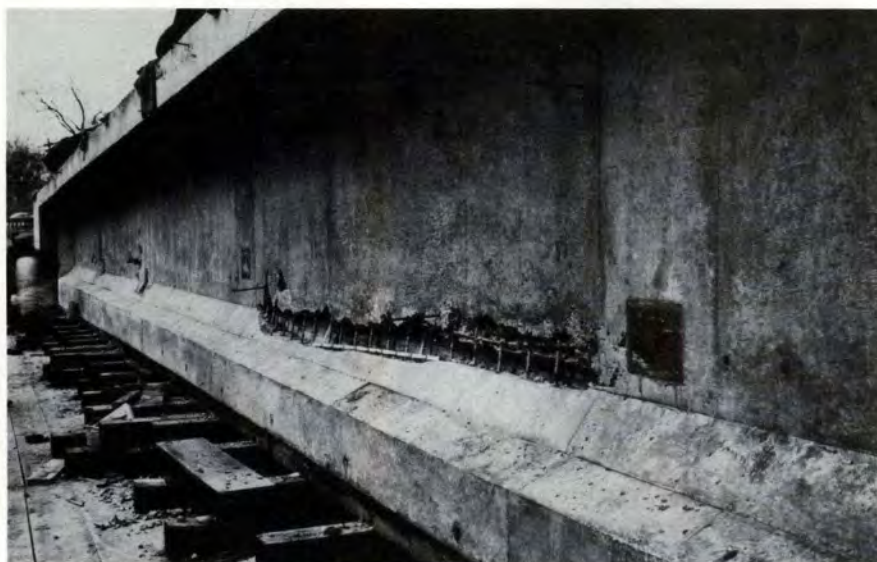
Fig. 10. Appearance of south side of first girder cast, after removal of forms. Note reinforcement displacement.

To diminish the placing problem, windows for placing and vibrating concrete had been built into the forms at regular intervals along the girder, where the bottom flange joined the web. That the subcontractor had not mastered the concrete placing techniques required for low slump concrete was evident when the forms were removed after casting the first bridge girder, the south fascia girder (see Figs. 10 and 11). Honeycombs, cold joints in the web and bottom flange, large and small holes, discontinuities, and local displacement of the reinforcing steel and chases were found throughout the entire length of the girder. The sight was appalling.

Serious consideration was given to rejection of the girder. After evaluating the alternatives, it was decided to restore the girder and to proceed with prestressing. Since the highest concrete stresses would occur during the stressing operations, the stressing would, in effect, test the structural capabilities of the girder.

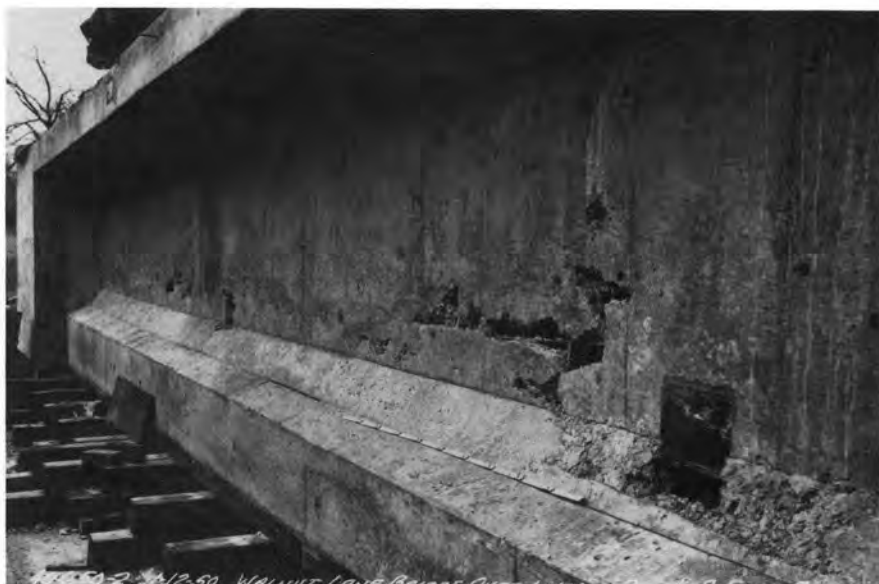
Fig. 11. Honeycombs in the first 160 ft (49 m) girder cast in 1949 for the Walnut Lane Memorial Bridge.

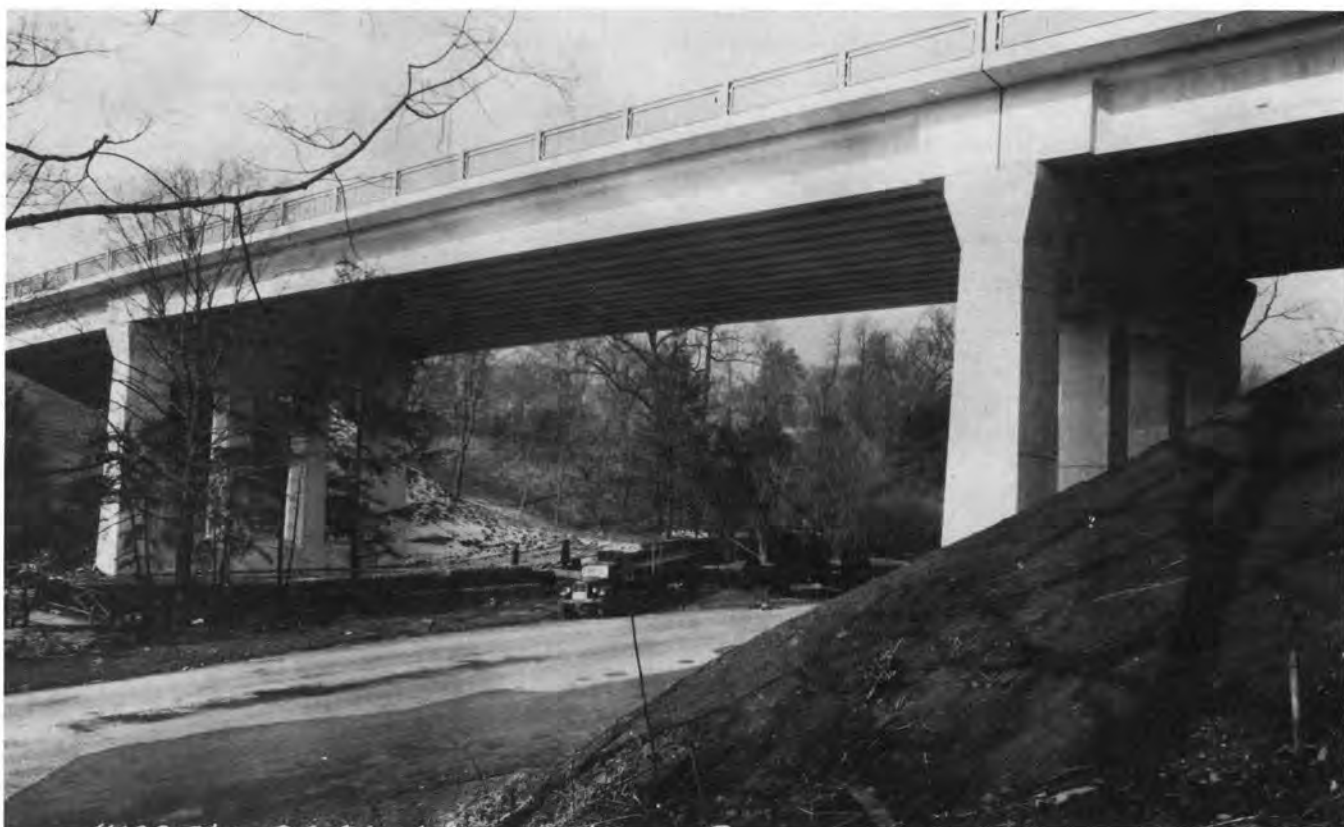
present in the girder. The prestressing operations were, therefore, carefully carried out and critically observed. There was no indication of potential structural distress; the origin of distress which was to come later was unexpectedly found to be elsewhere in the girder. Fig. 12 shows the rehabili-

Fig. 12. Appearance of the south fascia girder after restoration and erection in 1950.

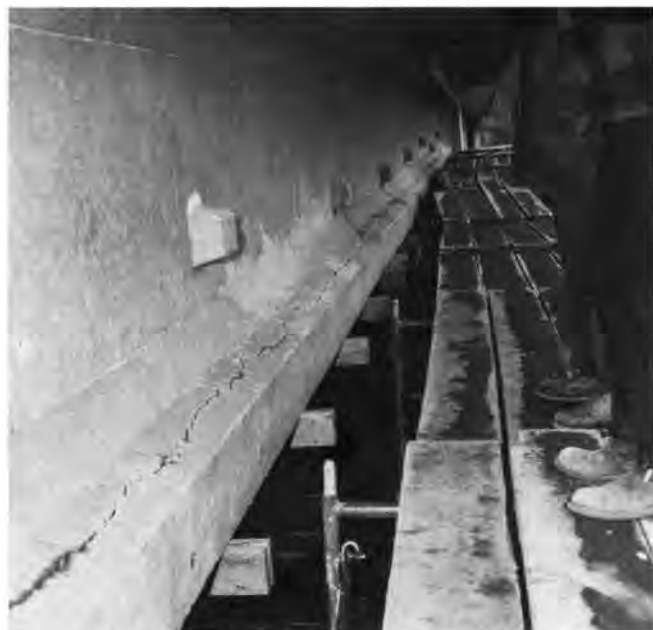
Fig. 13. Longitudinal crack in bottom flange of south fascia girder (1968).

This particular crack (see Figs. 13 and 14) now extended the full length of the center span, varying in width from $\frac{1}{4}$ to $\frac{1}{2}$ in. (6 to 13 mm). In places, it was $2\frac{1}{2}$ in. (64 mm) deep. The average distance from the crack to the vertical face of the flange was about 5 in. (127 mm). The crack in question appeared to extend downward into the area of the prestressing tendon. Furthermore, the other longitudinal crack, which was located in the soffit of the bottom flange, appeared to extend upward into the same area of the prestressing tendon.

Rainwater flowing down the vertical face of the web of the girder could penetrate into the upper crack and, upon freezing, exert an outward force. With alternating freezing and thawing cycles over the years, the outer portion of the concrete flange was likely to spall off the girder sooner or later, especially since there was no conventional reinforcing steel, such as stirrups, in the bottom flange.

In other words, there was nothing to hold the outer chunk of concrete to the main body of the girder except the bond between it and the grout injected into the wire cavity. It was imperative that this bond — or whatever remained of it — be preserved and its effectiveness maintained to prevent spalling off of the outer portion of the flange.

Epoxy Injection — The contractor was directed to inject epoxy into all visible cracks and to try to fill all voids in the chases. This first prestressed concrete bridge in the United States became the site of the first major pressure injection epoxy repair project in the eastern United States, using the structural concrete bonding process licensed by Structa-Bond, Inc., Philadelphia, Pennsylvania, for the Adhesive Engineering Company of San Carlos, California.

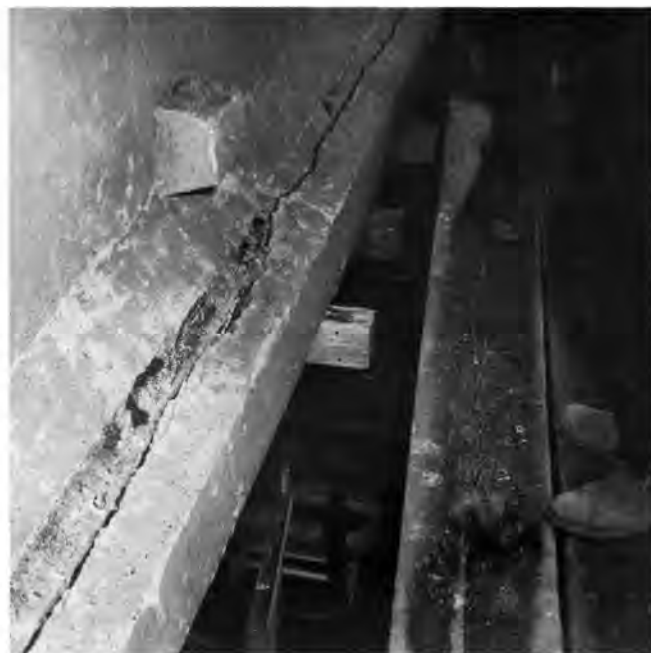
Fig. 14. Close-up view of crack shown in Fig. 13.

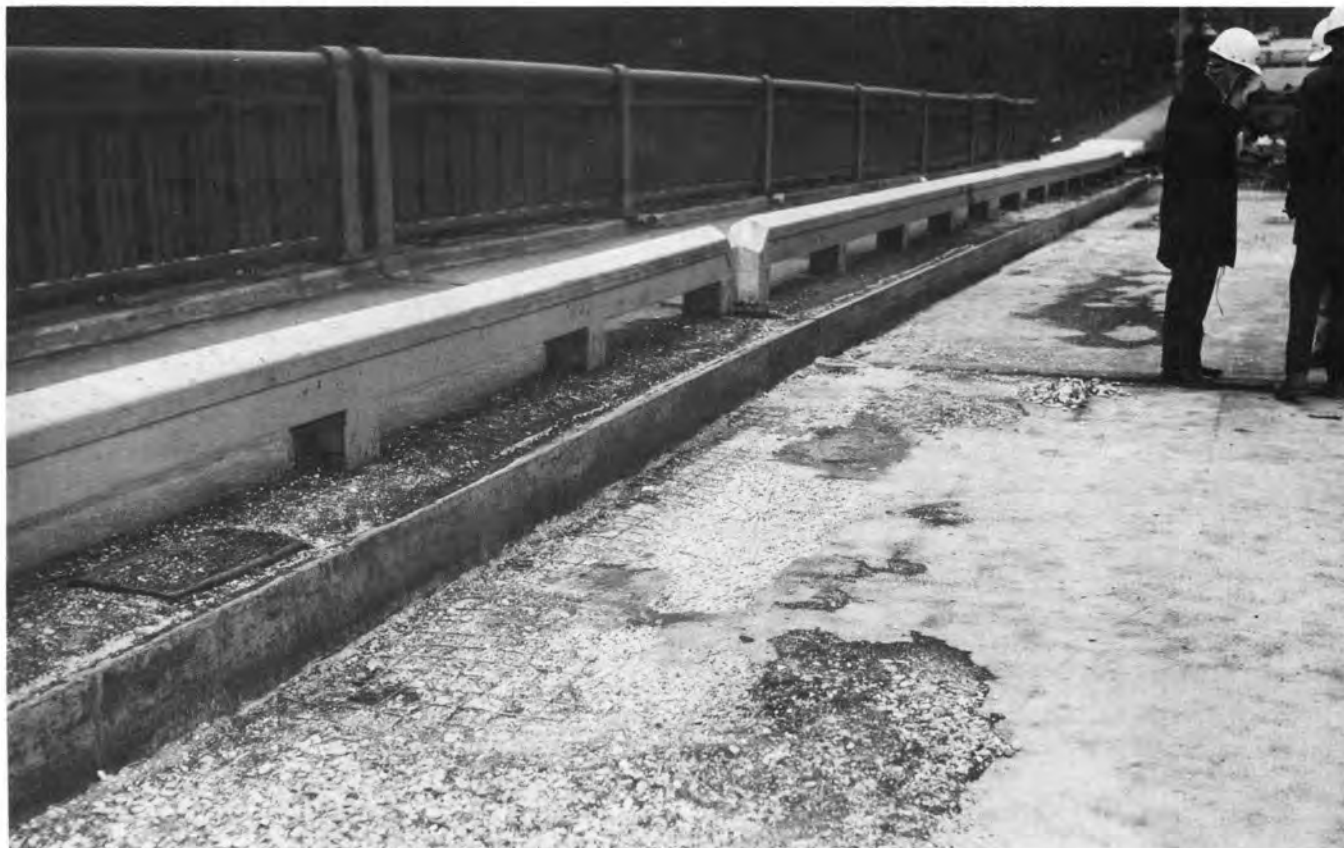
Other Repairs in the 1960s — Other work performed during this 1968-69 repair project included removal of the bituminous deck planking, which had contributed to the deterioration of the cast-in-place concrete wearing surface (Fig. 15) because the planking was not impervious and had

Fig. 15. Deterioration of concrete wearing surface in low point area of roadway, near joint.

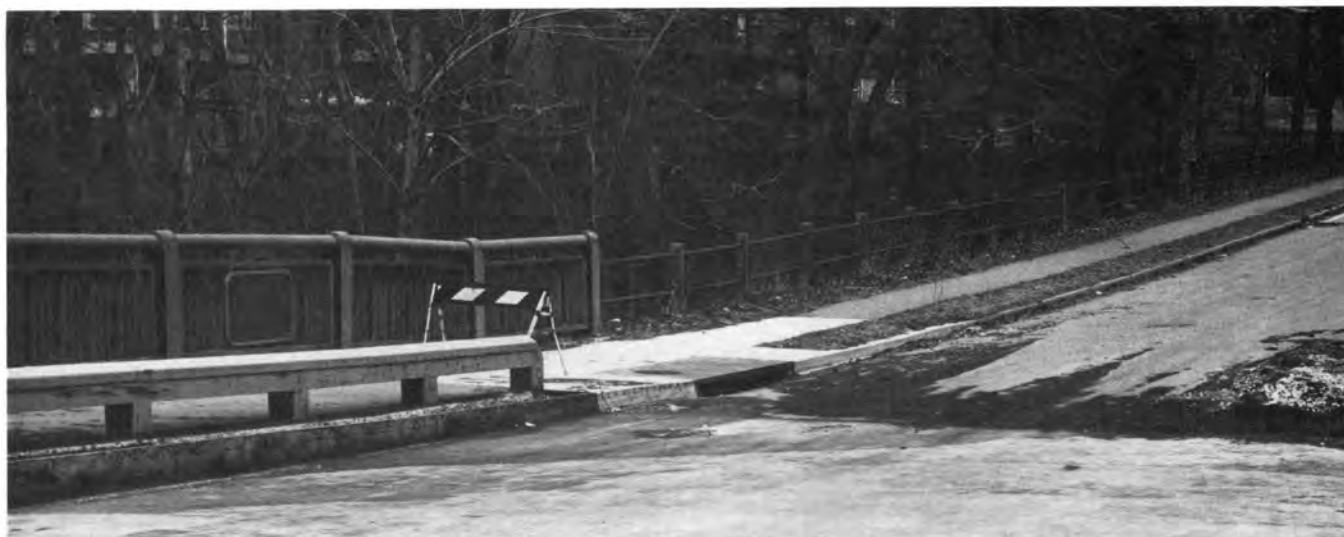
Fig. 16. Condition of abutment joint at roadway's low point, where water and snow collected. Note repair work.

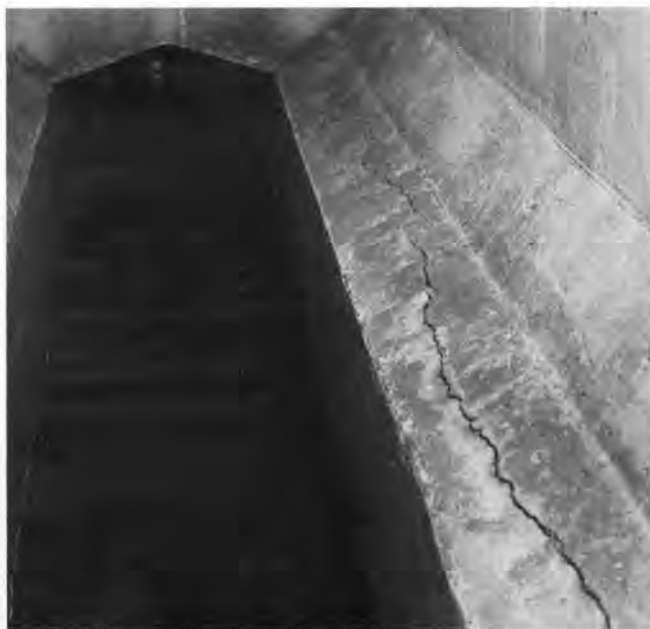
Fig. 17. Continued growth of major cracks noted in the 1970s.

PennDOT district personnel. In 1973, new cracks were observed in both fascia girders, and girder monitoring was scheduled three times a year. Continued growth of major cracks (Fig. 17) was noted along with new hairline diagonal cracking on one end of the south fascia girder (Fig. 18).

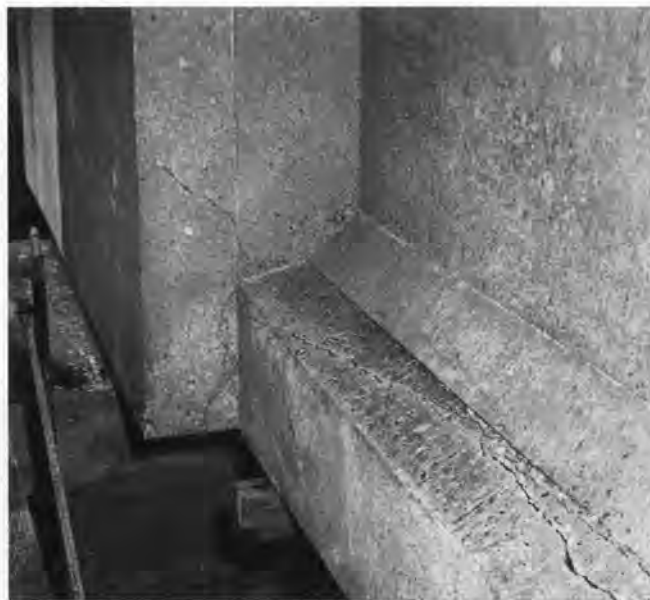
Fig. 18. New hairline diagonal crack appeared in end block of fascia girder.

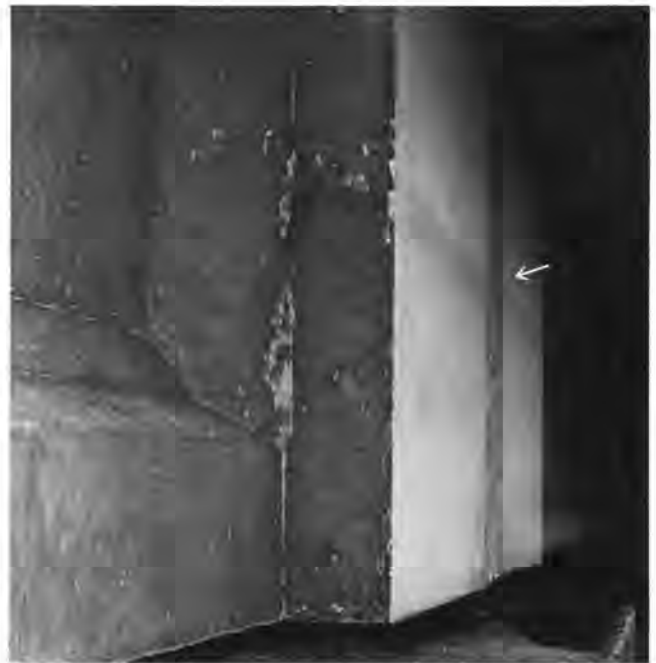
Fig. 19. Opened joint at contact between girder end block and cast-in-place concrete encasement protection over tendon anchorages.
