Performance of Precast/ Prestressed Concrete Building Structures During Northridge Earthquake

Observations are reported of the performance in the January 17, 1994, Northridge, California, earthquake of buildings in which precast/prestressed concrete components were utilized. Ground motions recorded during the earthquake are discussed in relation to fault movements, observed responses at building sites, and prevailing building code design requirements. The results of field observations of parking garages, cladding for buildings and foundations for residences are reviewed. For garages, the performance of structures utilizing primarily precast/prestressed concrete components is compared with that of garages utilizing other materials. It is concluded that, with the exception of buildings in the immediate vicinity of the epicenter, engineered structures, including those with precast/prestressed concrete components, generally performed well. Parking garages, particularly those with large plan areas, did not perform as well as other types of buildings. The greatest damage was in collector elements funneling lateral forces to the vertical elements of the lateral load resisting system and

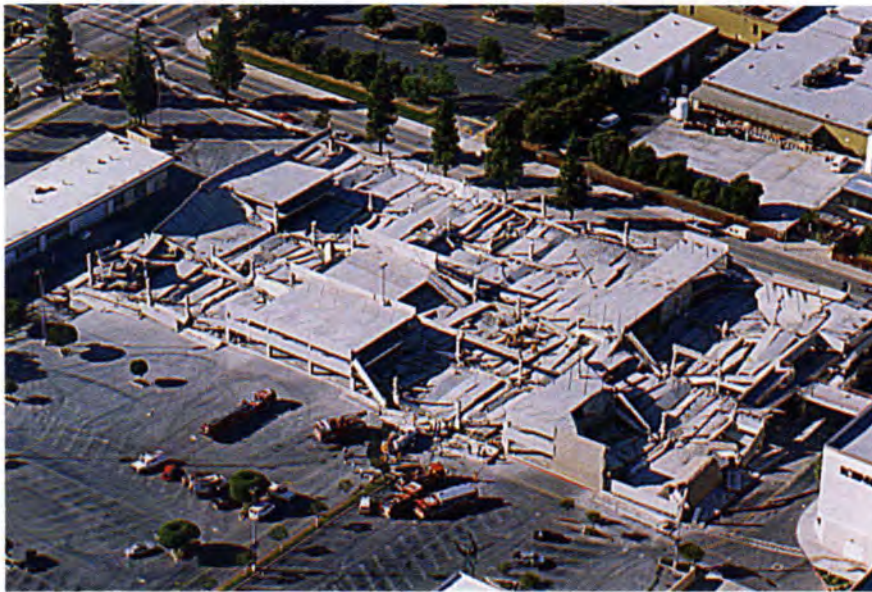
Fig. 3. Partially collapsed southwest garage at Northridge Fashion Center (Garage 1). (Courtesy: Los Angeles Times).

Shown in Fig. 3 is a *Los Angeles Times* photograph of the partially collapsed Northridge Fashion Center South Garage, Garage 1 of Table 1, on the morning after the earthquake. Shown in Fig. 4 is the north face of a similar garage (Garage 2) which suffered a partial collapse in the northeast corner only (left side of the photograph). Lateral movements of the gravity load column have caused vertical cracking over the depth of the spandrel panel at the thinner cutout section where it crosses that column at the first supported floor.

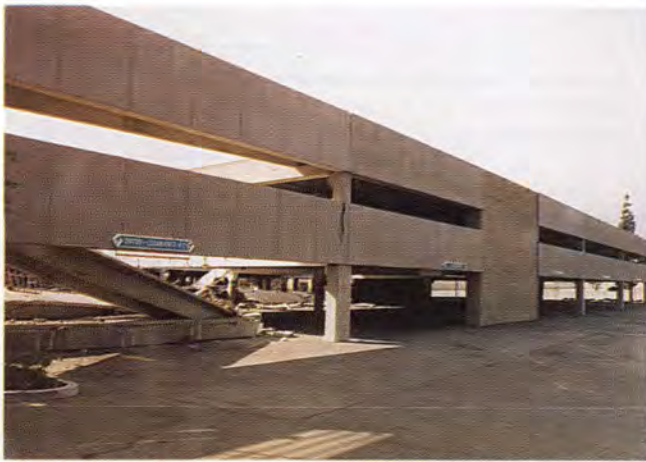
Fig. 4. North face of northwest garage at Northridge Fashion Center with partially collapsed area at left (Garage 2).

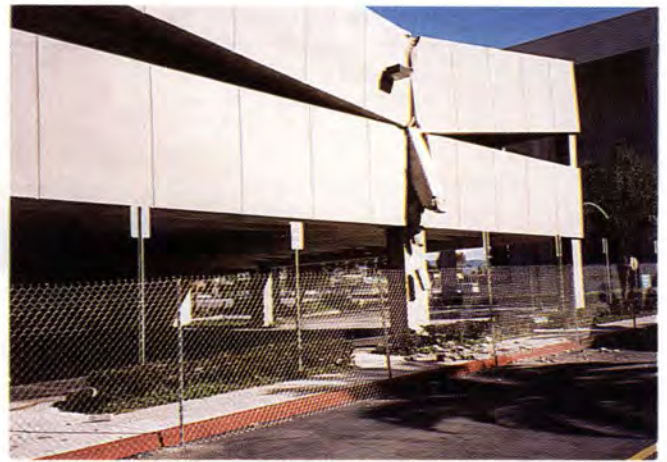
Fig. 5. Collapse of second-story portion of precast concrete column on south face of northwest garage at Northridge Fashion Mall (Garage 2).

Similar cracks were visible for nearly every north-south column line. Shown in Fig. 5 is the sheared second-story column on the south end of the gravity column and beam system on the north-south shear wall line at the eastern end of the garage. The inserts that attached the upper level spandrel panels to the sides of the column can be seen to have pulled out of the panels. Shown in Fig. 6 is the collapsed northeast quadrant of Garage 2.

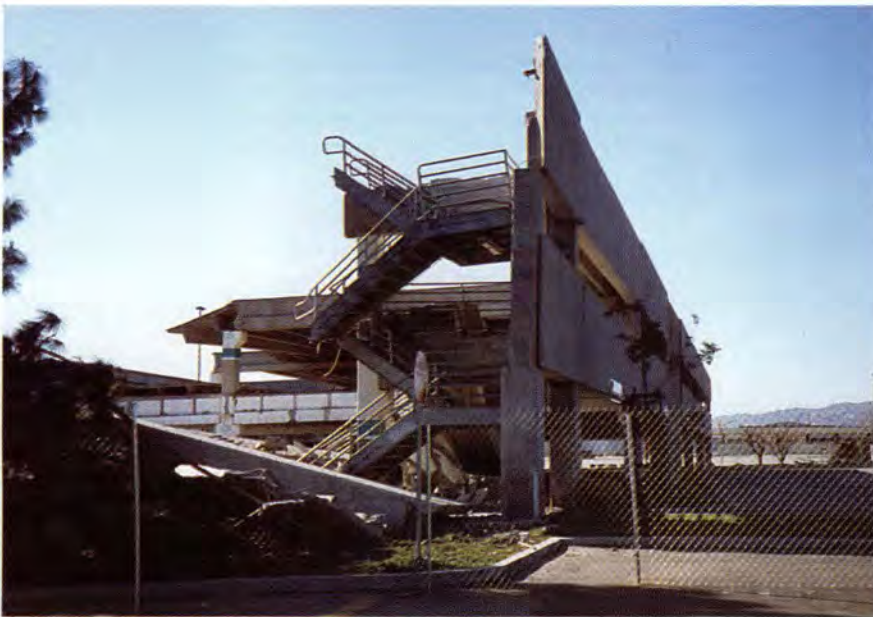
Fig. 6. Collapsed northeast corner of northwest garage of Northridge Fashion Center showing precast concrete column, spandrel panel and floor details (Garage 2).

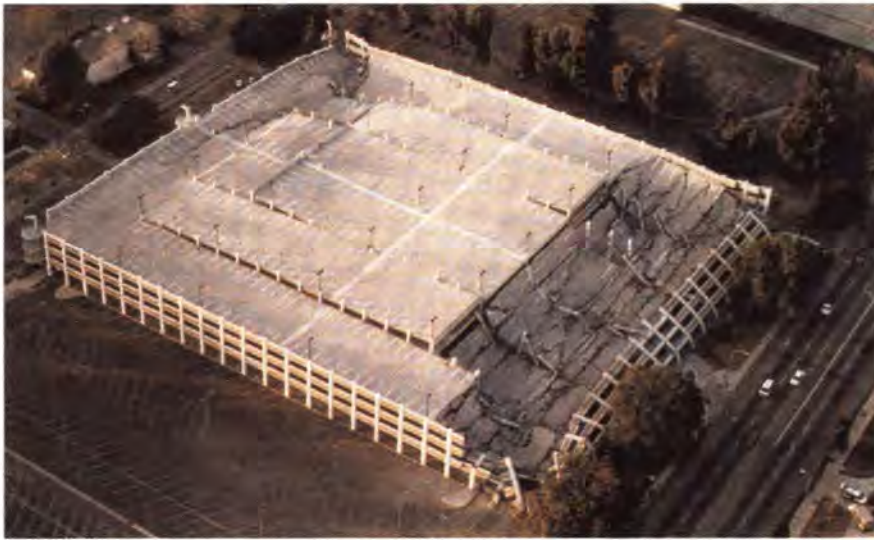
Fig. 7. Partially collapsed garage at CSU-Northridge looking north (Garage 5). (Courtesy: *Engineering News-Record*).

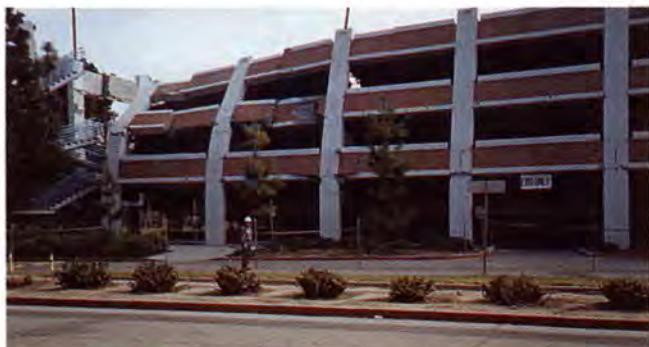
Fig. 8. Northwest corner of CSU-Northridge garage showing gravity load column trees separating from each other as diaphragm fails (Garage 5).

Fig. 8 shows the northwest corner of the garage. The non-connected spandrels of the column trees nearest the corner are separating from one another at midlength. The connected spandrels on the right have functioned as intended with hinging in the spandrels at the column faces.

pulled those trees inward, perpendicular to their strong axis. The movements were large enough that the unbonded tendons of the slabs often fractured. In Fig. 8, many anchors from all three floors can be seen to be missing. They

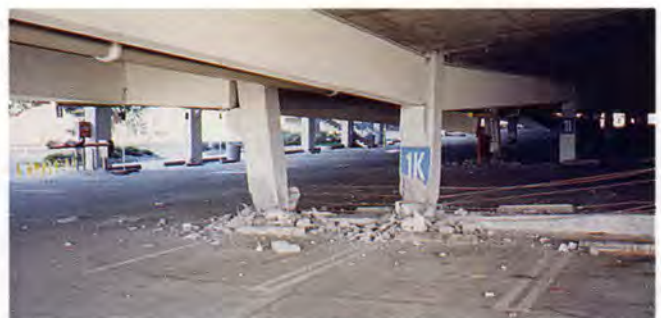
Fig. 9. Gravity load interior columns, southwest corner, CSU-Northridge garage showing crushing of column bases and incipient failure of floor due to loss of support for transfer beams (Garage 5).

columns, particularly those in the corners of the structure, in combined compression and bending. Shown in Fig. 9 is the condition of those columns in the partially collapsed southwest corner of the garage. As the bottom of those

columns disintegrated, the beams supported by them rotated vertically downward, dropping from the columns' haunches and causing the structure to sag inward. The slabs, being tied directly to the exterior column trees,

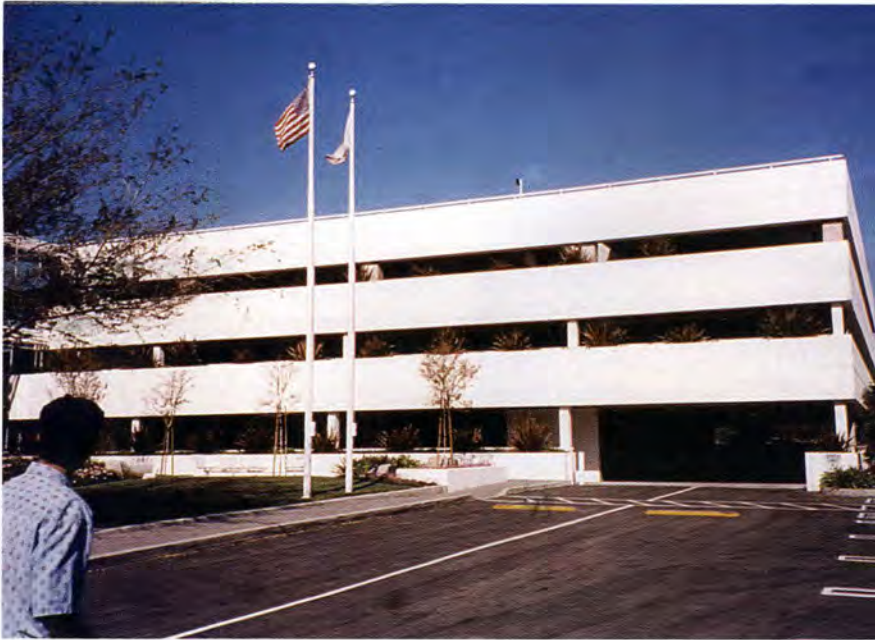
Fig. 10. Undamaged Litton Industries garage, Chatsworth, about 1 mile (1.6 km) east of epicenter (Garage 20).

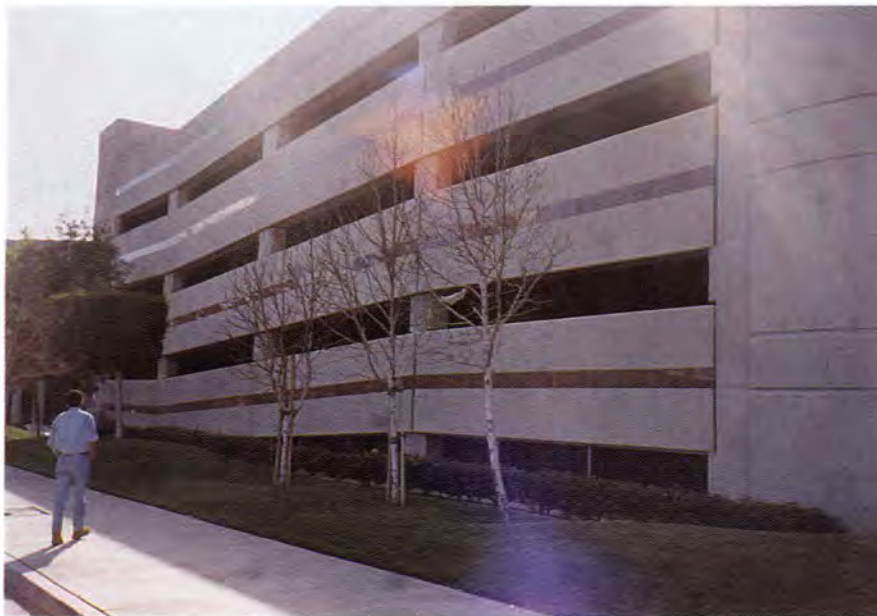
Fig. 11. Coldwell Banker garage, Granada Hills, with mildly damaged column haunches and cracked filler walls about 3 miles (5 km) east of epicenter (Garage 21).

is the mildly damaged Garage 21 located about 3 miles (5 km) east of the epicenter. It had structural systems with characteristics very similar to those of Garage 20. There were four supported floors of parking and damage consisted of spalling or fracturing of the cast-in-place column haunches, cracking of the concrete filler walls and loosening of an exterior panel.

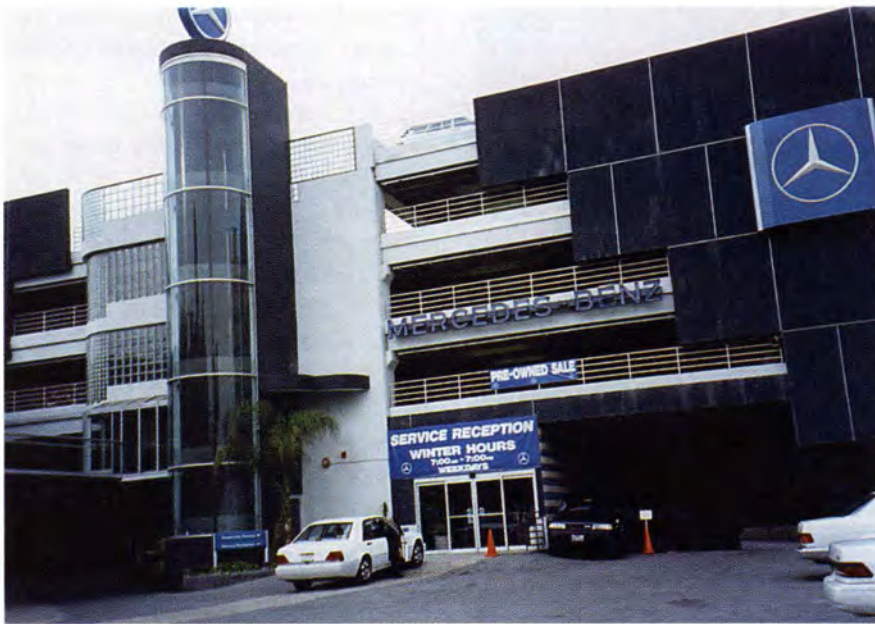
Fig. 12. Auto Steigler Parking, Encino. Only minor cracking occurred (Garage 28).

components, in close proximity to the epicenter, that were visited were Garages 22, 23, 24, 25, 26, 27, 28 and 30. One of those garages (Garage 28) is shown in Fig. 12. That garage was located close to where the very strong CSMIP Tarzana record was obtained. Yet the structure suffered only minor cracking and a few spalls in the cladding. The garage was fully operational after the earthquake.

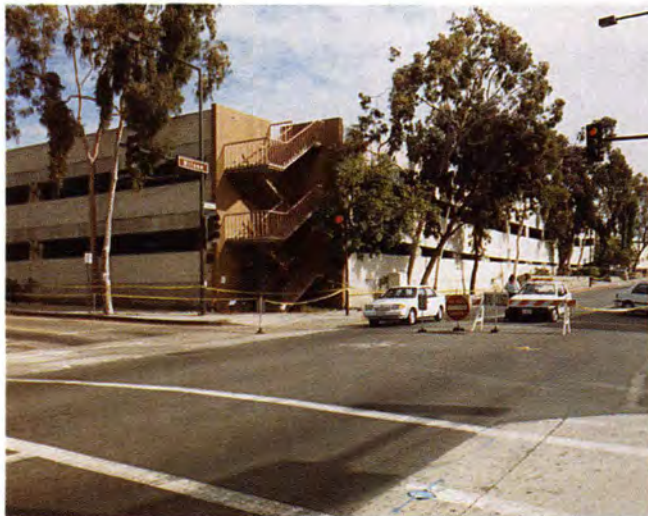
Fig. 13. Glendale Fashion Center (southwest corner). Lower story columns on right have shortened markedly compared to upper story columns (Garage 6).

In Glendale, four garages (Garages 6, 7, 8 and 25) were examined. The southwest corner of Garage 6 is shown in Fig. 13. This three-level structure had cast-in-place exterior walls and columns, and double tees connected to precast ledger beams supported on circular cast-in-place columns and a central zig-zag shear wall with an east-west longitudinal axis. Heavy exterior, masonry faced, spandrels converted the exterior columns into "short columns" that fractured and crushed. In Fig. 13 the lower story columns on the right hand (south) face of the building have shortened markedly by comparison to the upper story columns of the same face.

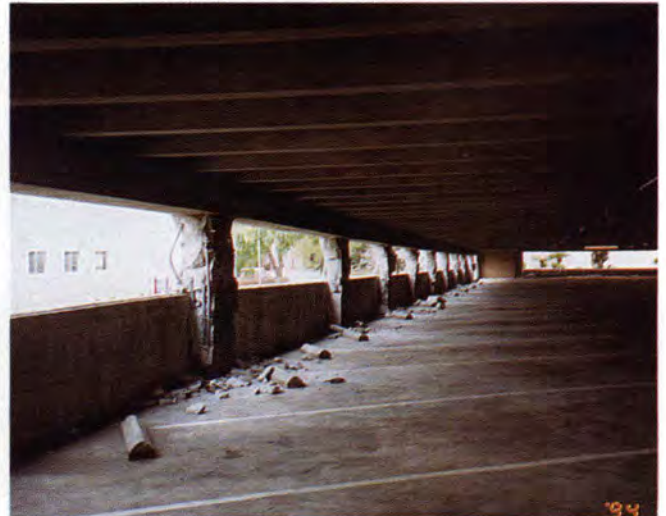
Fig. 15. Glendale Fashion Center. Interior view along north face shows double tee floor and column cracking/bar buckling along north face (Garage 6).

north face is shown in Fig. 15. The spandrels framed only part of the cross section of the column, and column ties were inadequate allowing the vertical bars to buckle over the full height of the column after loss of concrete cover.

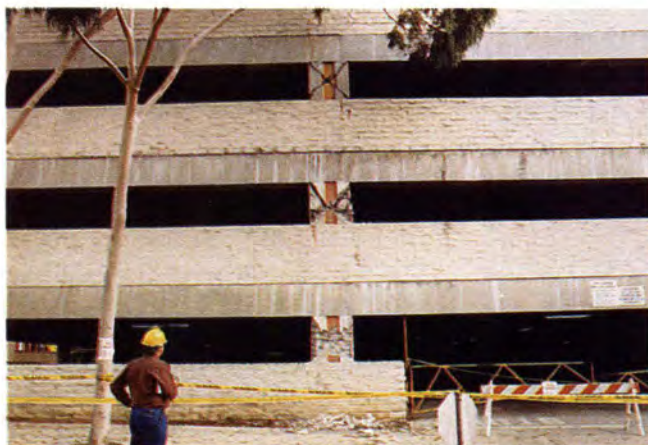
Fig. 14. Glendale Fashion Center. Note "short column" cracking on west face (Garage 6).

In Fig. 14, a column on the west face of the building shows typical "short column" diagonal cracking at its top increasing in intensity and transitioning to crushing at its bottom. An interior view of the columns along the

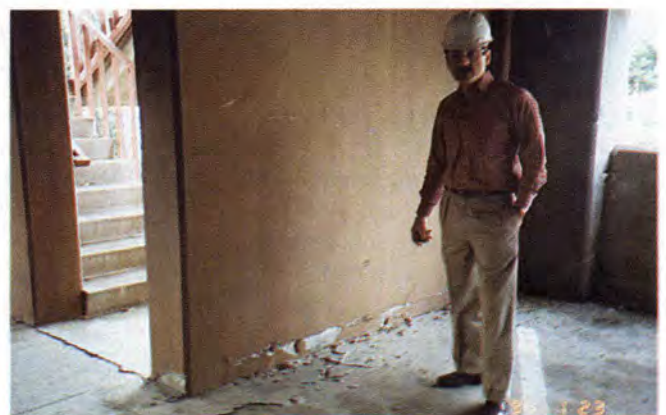
Fig. 16. Glendale Fashion Center. Note failure of shear wall construction joint and of connection of diaphragm to shear wall in northwest corner of second supported level (Garage 6).

Shown in Fig. 16 are conditions in the northwest corner of the second supported floor where it was connected to the shear wall. The construction joint in the wall immediately above that level had slipped and the connection of the topping to the wall had failed. At that location, the longitudinal axis of the double tee was parallel to the longitudinal axis of the wall.

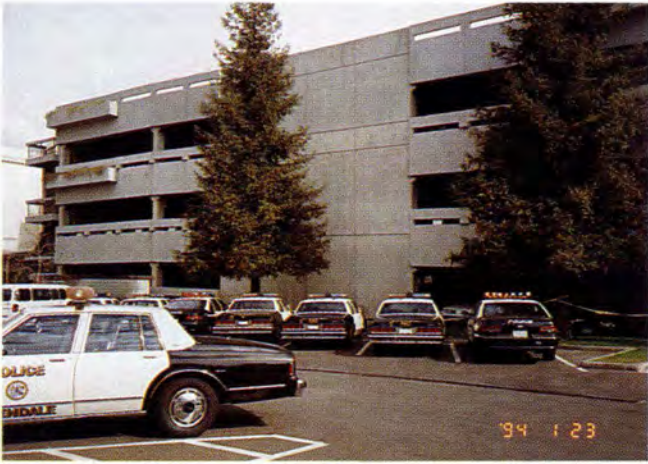
Fig. 17. Glendale Civic Center Parking. Undamaged west face (Garage 7).

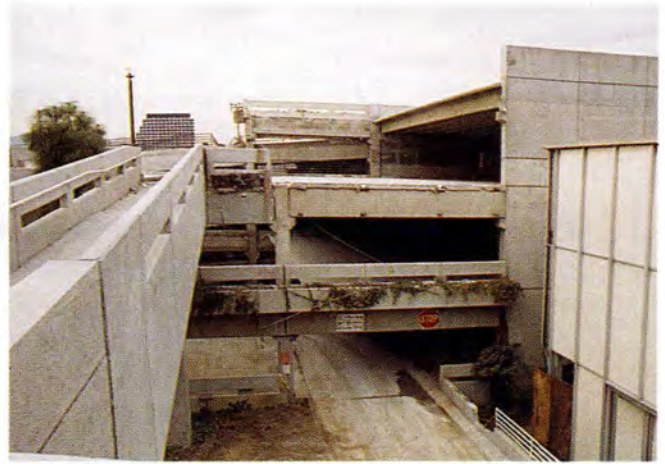
Fig. 18. Glendale Civic Center. Collapsed roof and floor areas on east side (Garage 7).

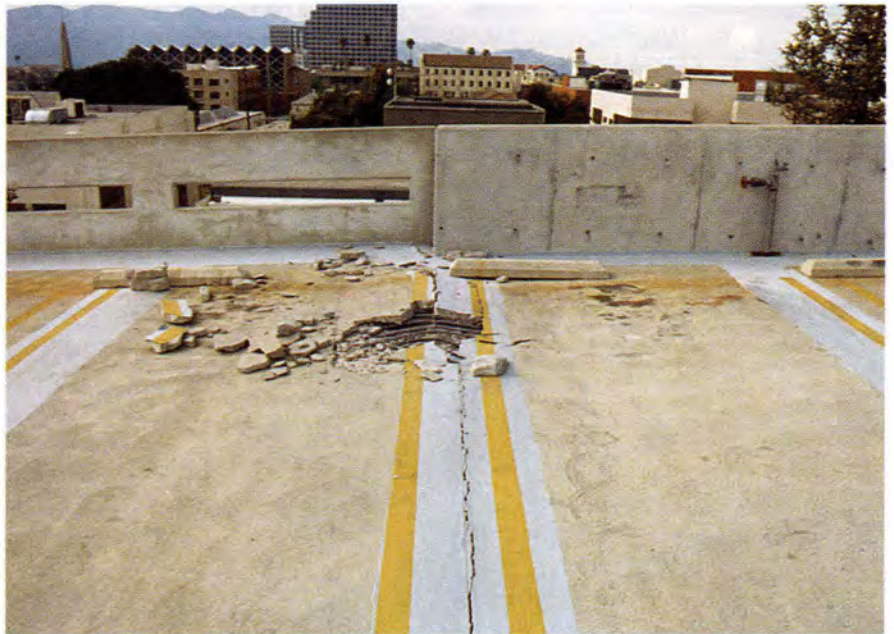
Fig. 19. Glendale Civic Center. Fracture line extending across diaphragm to area of crushing and bar buckling on west side (Garage 7).

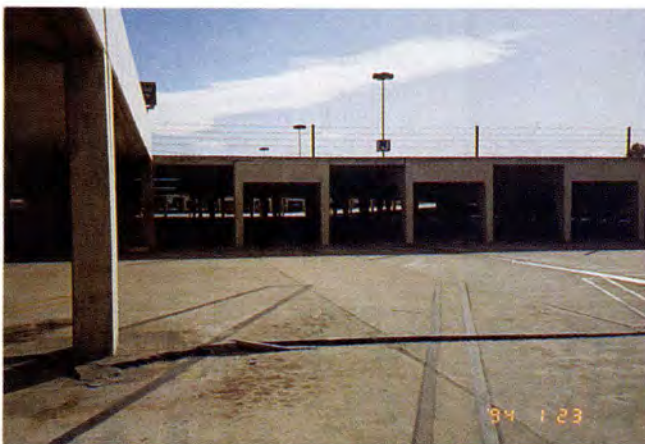
Fig. 20. Glendale Galleria, Columbus Avenue Parking. Roof level shows precast concrete "Conrad tables" and settlement at joint line (Garage 8).

Shown in Fig. 20 is part of the top of Garage 8. This extensive structure used four-legged precast concrete "Conrad Tables" as the basic structural unit. Those tables were stacked up to three floors in height and a cast-in-place one-way post-tensioned slab spanned between them. At the ground level, the tables were supported on pedestals many of which had spalled badly, as can be seen in Fig. 21. This allowed the tables to settle in places by up to 8 in. (203 mm). Such settlement is visible adjacent to the column on the left in Fig. 20.

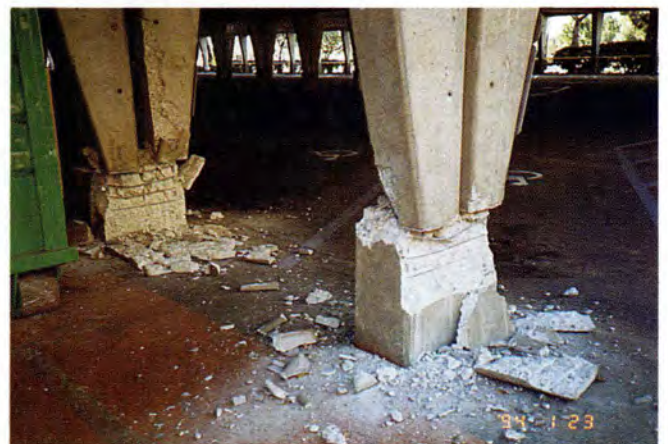
Fig. 21. Glendale Galleria, Columbus Avenue Parking. Spalling of cast-in-place pedestals caused settlement of tables (Garage 8).

tables and were anchored in the pedestals. The concrete and the confinement reinforcement in the pedestals was inferior to that in the table legs so that the legs ground the pedestals away.

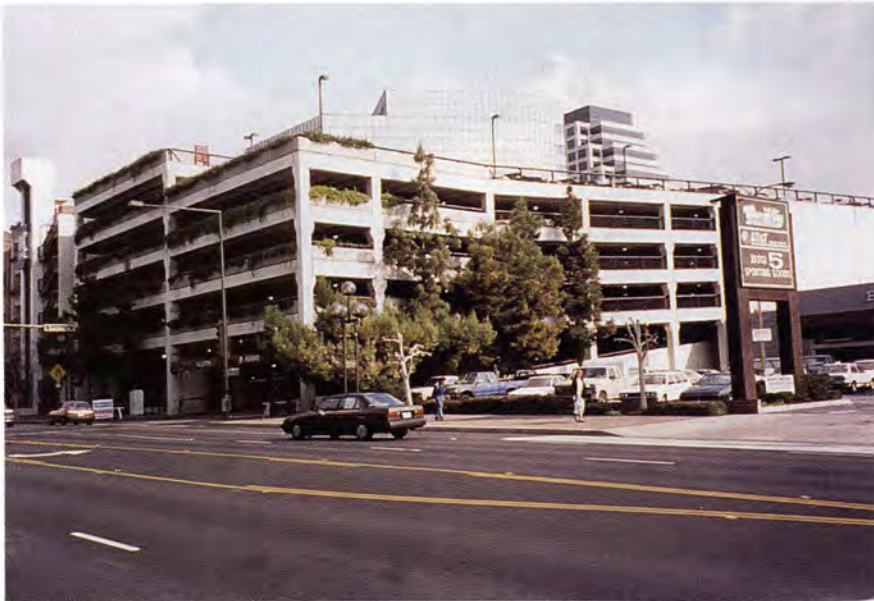
Fig. 22. Glendale Galleria, Central Avenue Parking. Note undamaged garage (Garage 25).

A fourth garage (Garage 25) in Glendale located across the street from the Galleria was visited. That five-level precast building is shown in Fig. 22. There was no observable damage to that building and it was in use at the time of inspection. According to local precast concrete manufacturers, there were an additional five garages utilizing precast concrete that suffered no damage.

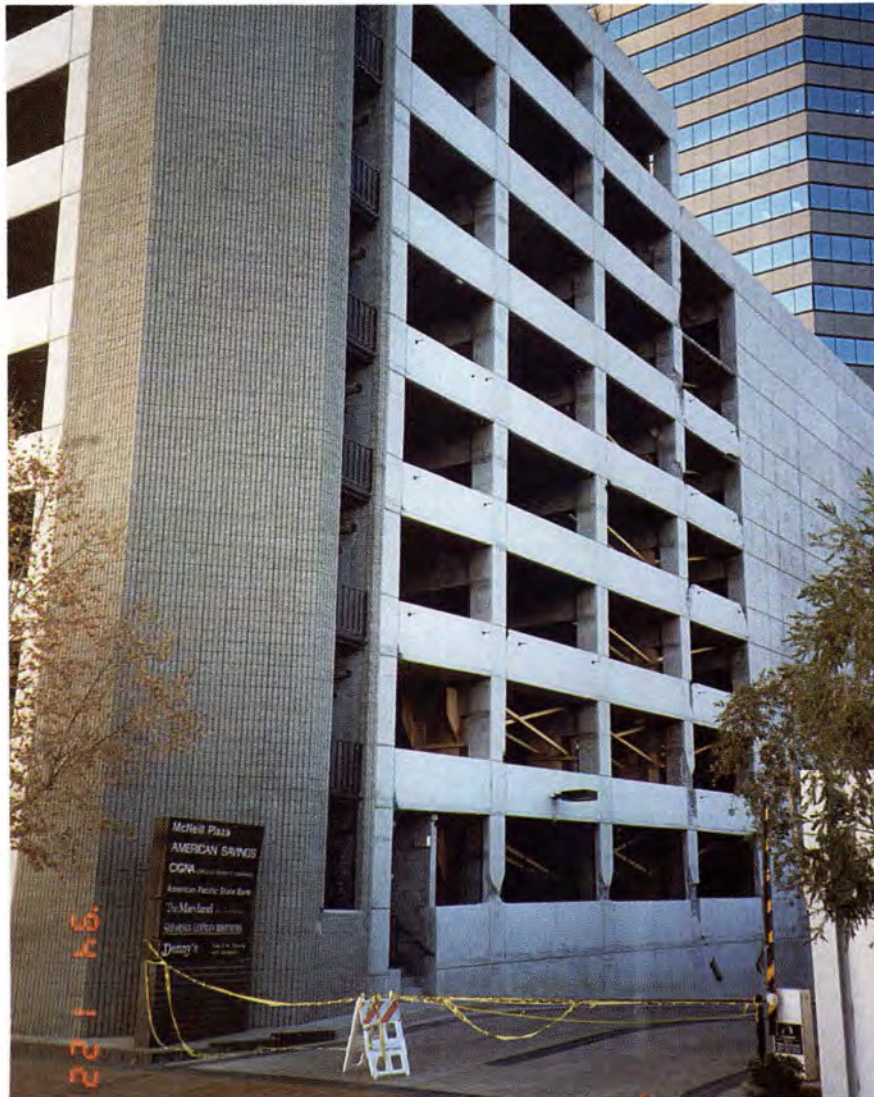
Fig. 23. Garage at southeast corner of Sepulveda and Ventura Boulevards. Damage is due to inadequate separation of precast cladding from columns (Garage 11).

Shown in Fig. 23 is the east face of Garage 11. This garage was tall and relatively narrow. Inadequate separation of the spandrel panels from the

columns had resulted in pounding between them, causing cosmetic damage to both the column and the panel. However, the vibrational effects had also been large enough to weaken the connection between the panels and the floor. In the upper right of the building, it can be seen that a panel is lost and in many bays wood bracing is providing a frame to which the panel could be attached while repairs were made.

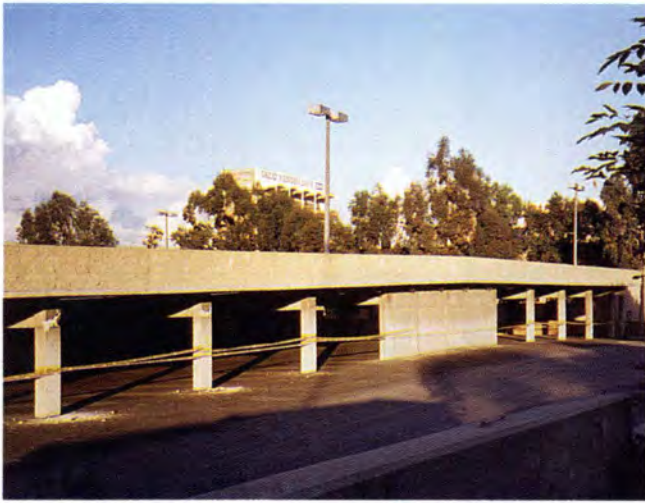
Fig. 24. Sherman Oaks Galleria-East Garage. South face shows form of garage and cosmetic damage at exterior beam-to-column connections (Garage 9).

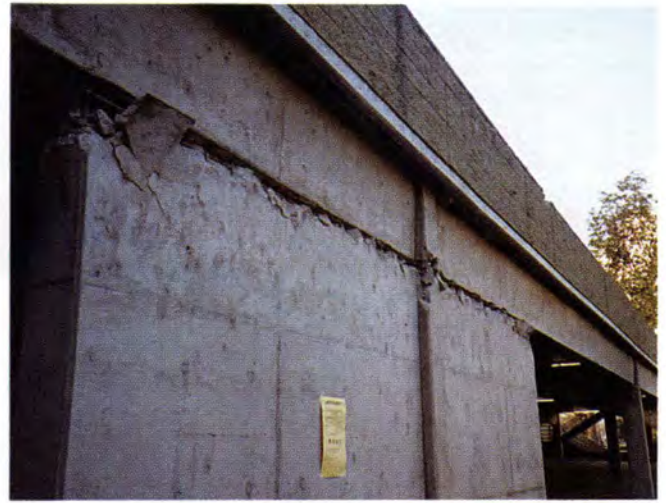
Fig. 25. Sherman Oaks Galleria-East Garage. East face shows failure at shear wall to frame connection and yellow tagging of structure (Garage 9).

along the length of its connection with the shear wall and buckling of the boundary element bars of the wall and the vertical bars of the central column. However, the garage was usable and was yellow tagged.

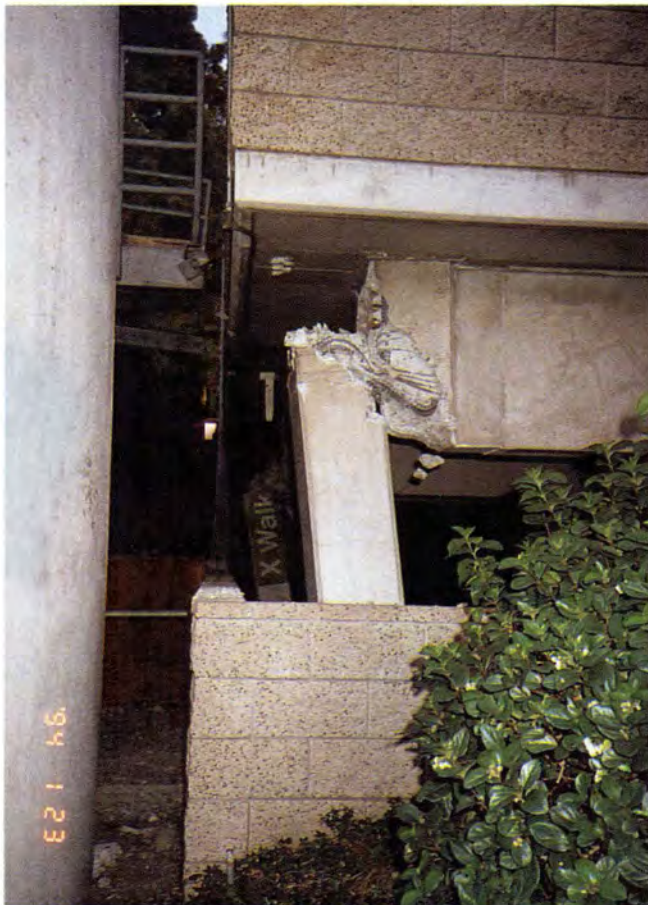
Fig. 26. Sherman Oaks Galleria-South Garage. Note fracture of exterior column in northwest corner of gravity load frame (Garage 10).

Shown in Figs. 26 and 27 are failures in Garage 10. This garage was of very similar construction to Garage 10, but with two supported floors and larger in plan. The building consisted of three separate structures with the western structure supported on piles and the central and eastern structures supported on spread footings. Fig. 26 shows the fractured exterior columns in the northwest corner of the building. Those fractures extended the length of the north face of the pile supported structure. At the interior wall to frame connection of that structure, the joint had fractured and the vertical bars had buckled more extensively, but in the same manner, as that shown in Fig. 25.

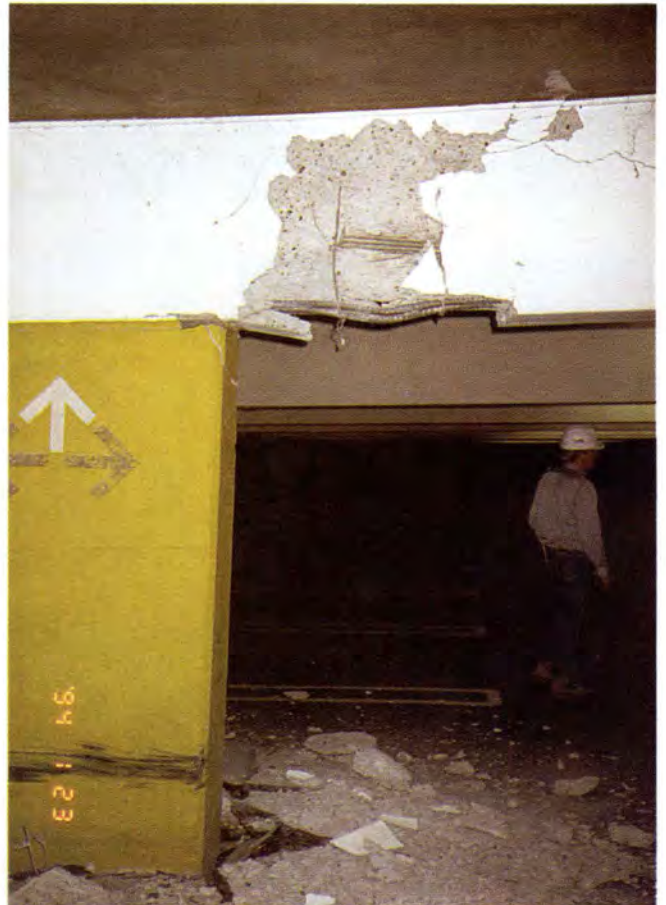
Fig. 27. Sherman Oaks Galleria-South Garage. Note damage to beam at connection to interior shear wall on spread footing (Garage 10).

Shown in Fig. 27 is the appearance of a typical beam to interior wall connection for the area where the wall was on spread footings. The uplift in the asphalt shows that the spread footings of the wall have rotated and the spalling of the beam shows that gravity load elements resisted considerable lateral load. The concrete spalling has exposed the prestressing tendons.

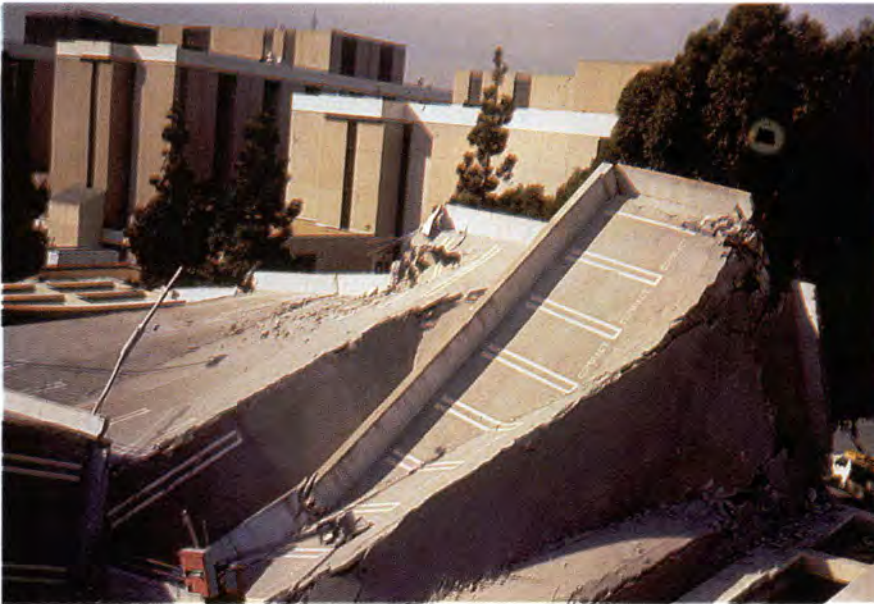
Fig. 28. Kaiser Permanente, West Los Angeles-East Garage. Shows a view of the collapsed structure looking west in a direction parallel to the frames (Garage 13). (Courtesy: Portland Cement Association).

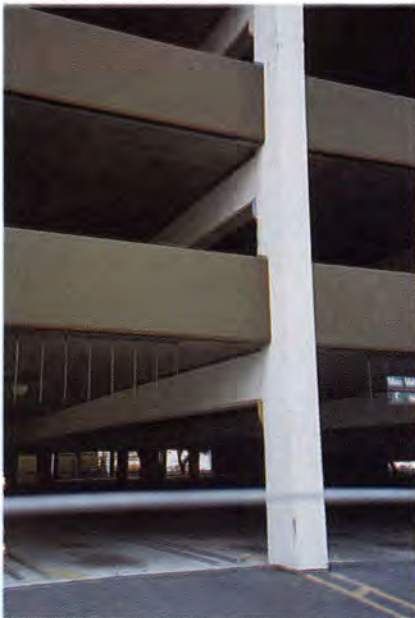
Fig. 29a. Kaiser Permanente, West Los Angeles-West Garage. Shows damage to exterior columns on north face (Garage 14).

age, as apparent from Fig. 29a, at the position where the precast column elements had been connected together, cracking of the north-south beams over their depth immediately above the face of the column haunch and damage to some of the spandrels due to pounding between them and the columns. More serious was the damage at the east shear wall (see Fig. 29b), where there had been uplift of the spread footing, tilting of the stairwell out from the building and significant damage of the connecting members between the stairwell and the building.

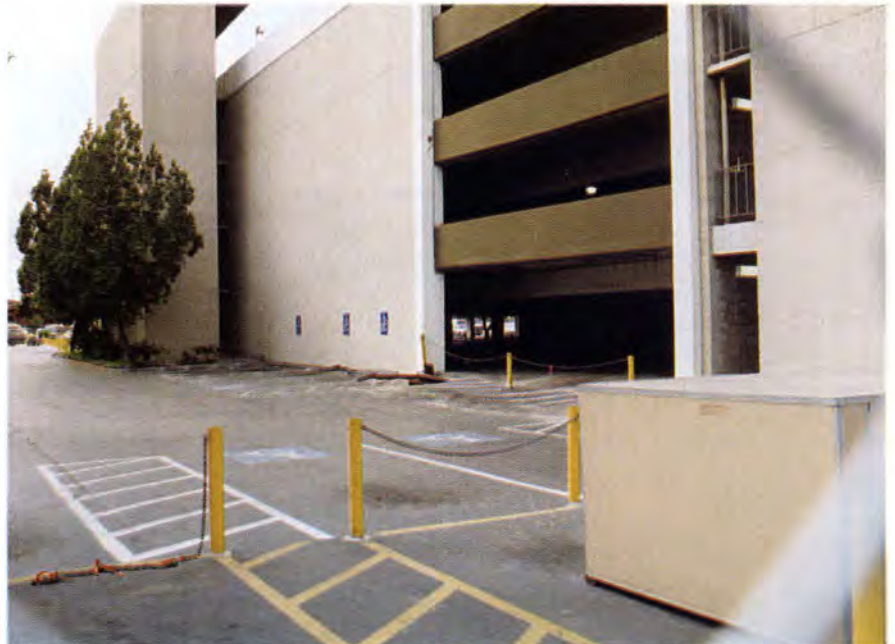
Fig. 29b. Kaiser Permanente, West Los Angeles-West Garage. Note uplift of spread footing of east shear wall and separation of stairwell tower from shear wall (Garage 14).

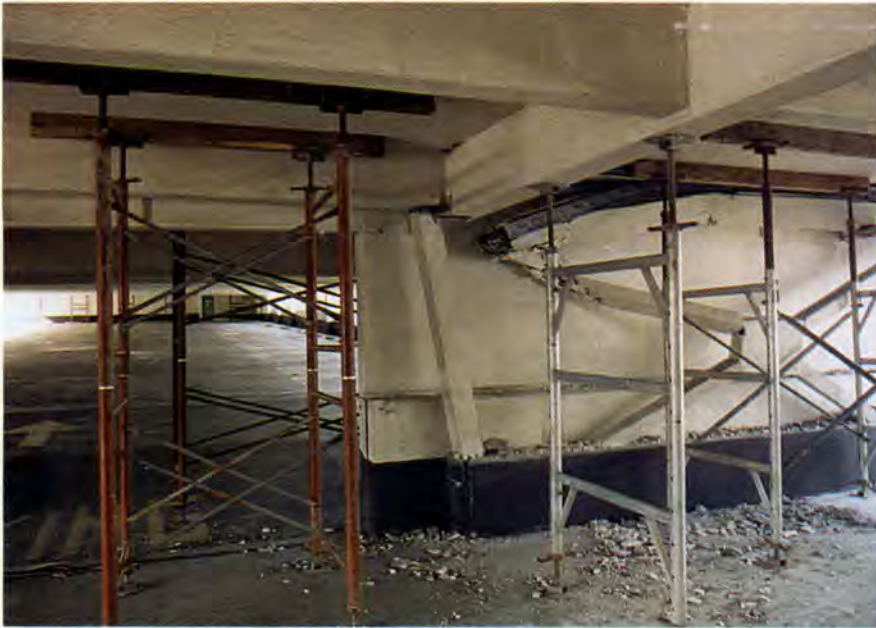
Fig. 30. St. John's Hospital, Santa Monica. Fracture and buckling of braced steel frame of center garage (Garage 18).

As shown in Table 1, the three garages had very different structural systems. The system that performed the worst was the central braced steel frame garage. Its buckled bracing and fractured columns are shown looking north in Fig. 30. The system that performed the best was the oldest, the reinforced concrete garage connecting to the hospital. The shear walls of the northern most garage had either developed severe diagonal cracking or fractured along construction joints.

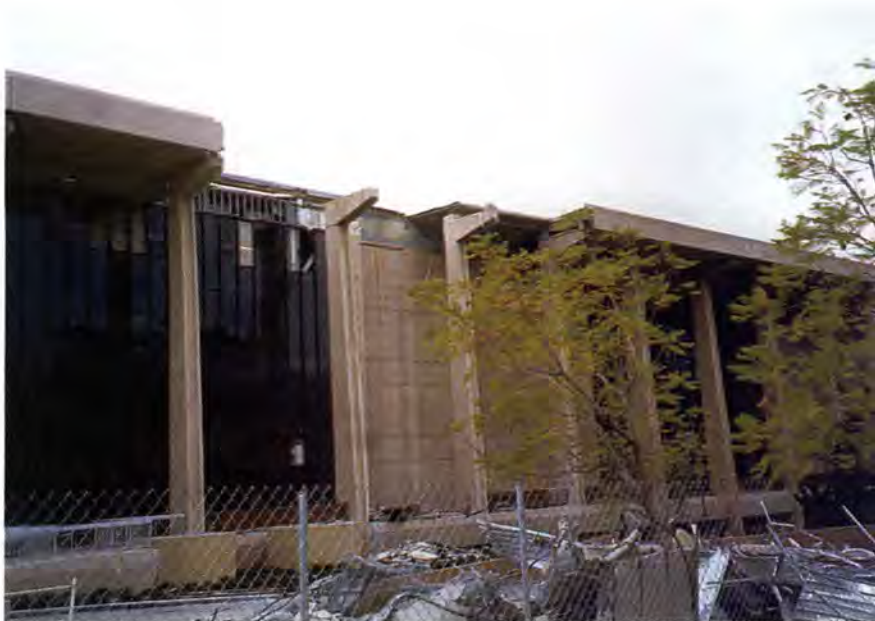
Fig. 33. Roof failure at Oviatt Library, CSU-Northridge.
