Case Studies in Structural Repair of Pretensioned Concrete Products

Alan S. Hoback, Sc. D., P.E.

Alaa I. Hermiz

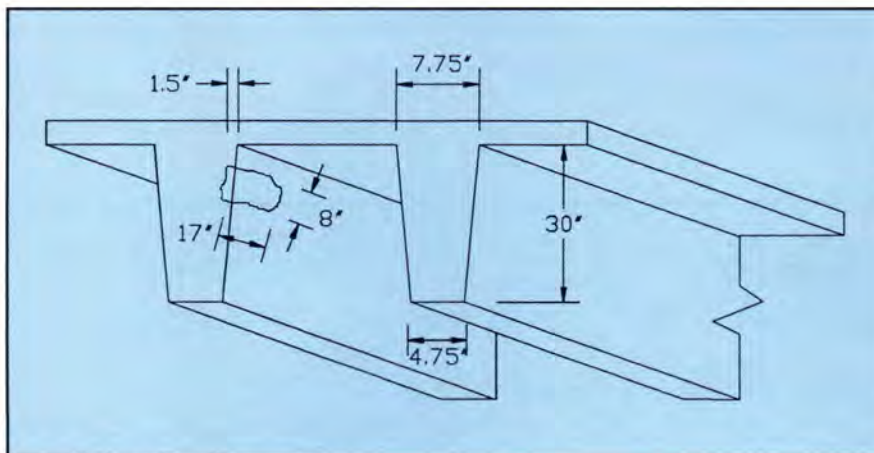
A double tee stored in the fabrication plant was damaged when a storage yard tractor accidentally hit the double tee. The tractor hit the interior side of the stem causing a spall on the upper third of the stem as shown in Fig. 1. The stem was 30 in. (762 mm) high and the width varies from 4.75 in. (121 mm) at the bottom to 7.75 in. (197 mm) at the top.

The collision caused a spall 1.5 ft long x 8 in. wide x 1.5 in. deep (457 x 203 x 38 mm). An investigation revealed that there were no cracks in the stem or flange and no reinforcing steel was exposed. The pretensioning

Fig. 1. Spall in a double tee stem.

It was found that the spall did not affect the bearing capacity or the shear or anchorage strength of the double tee. The spall was patched using the following procedure:

First, all loose concrete and dust were removed. Then, the area was thoroughly saturated with water to prevent absorption of water from the repair mix. A bonding agent was brushed well onto the surface.

The concrete mix was placed in layers of less than 0.5 in. (13. mm) thickness and consolidated by hand tamping. Each layer was placed after about 10 to 15 minutes. The patching concrete was fast curing reaching 3000 to 5000 psi (21 to 35 MPa) in 24 hours

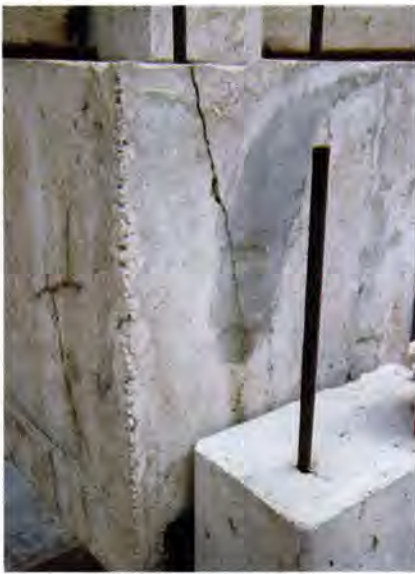
Inverted tee beams and double tees were used to construct a water treatment basin in the Detroit, Michigan area (see Fig. 2). A few weeks after erection, it was noticed that three of the inverted tee beams were cracked in the bearing area on one end of each beam as shown in Fig. 3. All the cracks were located solely on the east end bearing area of the beam. The cracks were found in different directions on each beam and where the bond between the prestressing strands and concrete had been released.

The reason these beams were cracked was that water froze in the sleeves provided for the connections with the columns. The problem did not arise on the other beams and on the other ends of the damaged beams because all the other sleeves were covered with duct tape. Fabricators and erectors should be aware that water freezing inside a tube or duct is a problem. Rainwater and curing water can be kept out of sleeves by capping the ducts with tight fitting plastic caps or by grouting the ducts.

Fig. 3. Inverted tee beam cracks.

All of the strength checks were satisfactory, so the cracks were repaired by epoxy injection. Note that the high-pressure injection can squeeze the epoxy out of the member through invisible cracks. Therefore, to seal the surfaces it is necessary to apply a sealant (such as Bondo) generously on and around the visible cracks as shown in Fig. 4.

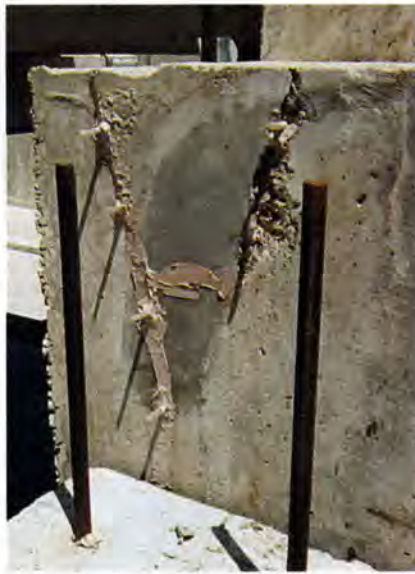
Fig. 4. Sealing cracks.

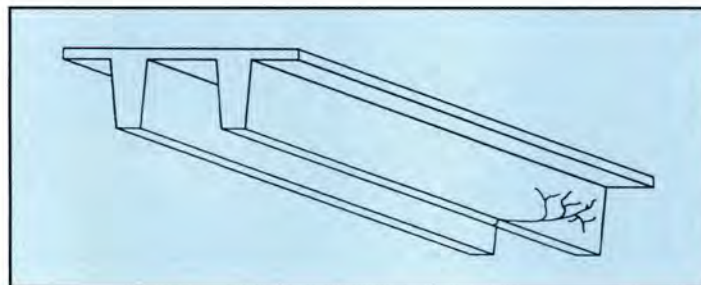
A double tee at a water treatment basin in Detroit, Michigan failed (see Fig. 2). The double tees were required to support soil for a golf course. The double tee did not collapse but 1 in. (25 mm) wide shear cracks formed (see Fig. 5).

There were three reasons why the beam failed. First, the top of the double tee was used as a stacking area for the soil. The soil rose 8 to 12 ft (2.4 to 3.6 m) high. Second, heavy machines and bulldozers were used to distribute the soil on the slab. Their weight and the impact load exceeded the double tee's capacity. Third, the soil was compacted by at least 30 to 40 percent over the specification limit. The double tee was required by contract documents to support 4 ft (1.2 m) of soil but was designed to carry only 6 ft (1.8 m) of soil in anticipation of the uncertainties illustrated above.

Fig. 5. Shear cracks in double tee.

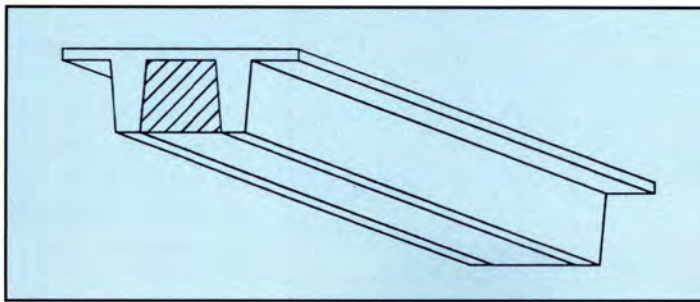
Fig. 6.
A cast-in-place
repair option.

The second option was to cast-in-place a filler beam as shown in Fig. 6. This is costly because it is hard to pump the concrete into and vibrate the concrete inside the basin.

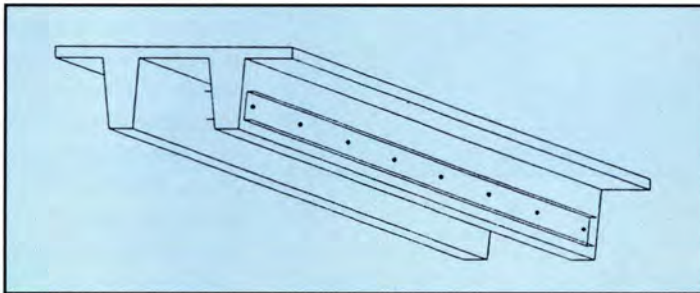
Fig. 7.
A steel channel
repair option.

channels and connecting bolts were galvanized because no exposed steel is allowed in the high humidity basin.

The third option was to strengthen the broken stem of the double tee with two steel channels as shown in Fig. 7. This was the most cost-effective method because it was easy to design and construct. The beam was jacked up and the cracks were epoxied. The

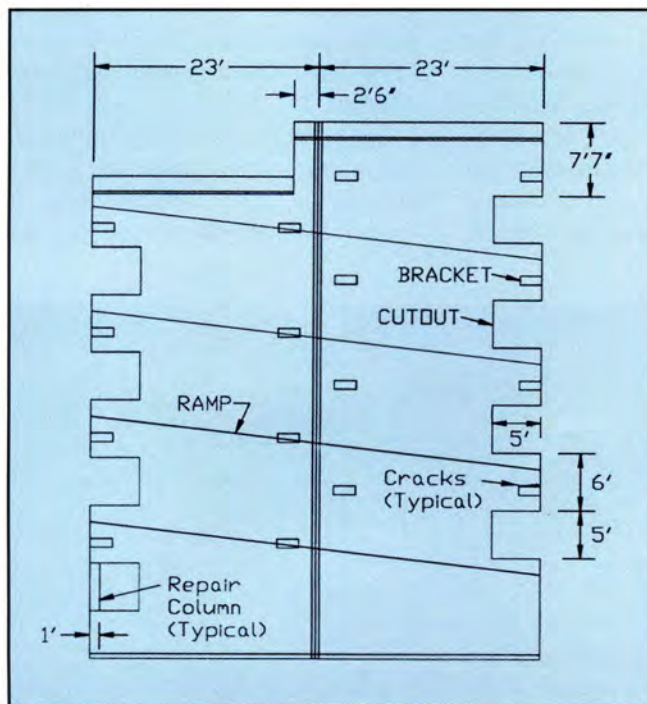
The shear walls are shown in Fig. 8. The walls had 5 x 5 ft (1.52 x 1.52 m) cut-outs to reduce a driver's blind area. Brackets to carry ledger beams were inserted on top of each opening. A plan view of the ramp is shown in Fig. 9.

Fig. 8. Elevation view of shear wall.

The repair options were either to enlarge the cantilever area or to add columns in the cut-outs. It was more economical to cast 1 ft (0.305 m) wide columns in the cut-outs. An example of this is shown in the bottom left cut-out of Fig. 8.

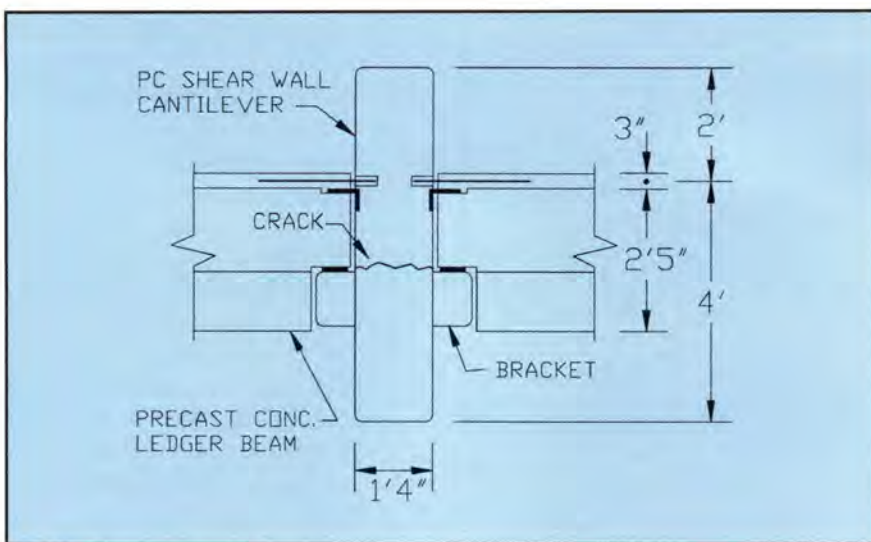
Fig. 10. End view of shear wall cantilever.

The shear walls cracked at the top of the brackets as shown in Fig. 10. Some double tees carried by the ledger beams were cracked due to induced torsion. The projection of the shear wall acts as a cantilever. This failed to carry the superimposed dead load. The cracks did not affect the strength of the main portion of the shear wall.

The load was carried alternately through the columns and walls until it reaches the foundation. The columns partially reintroduced the blind area although much visibility was still available. The columns were cast by jacking the cantilever up. Note that all cracks in the shear walls and double tees were epoxy injected.

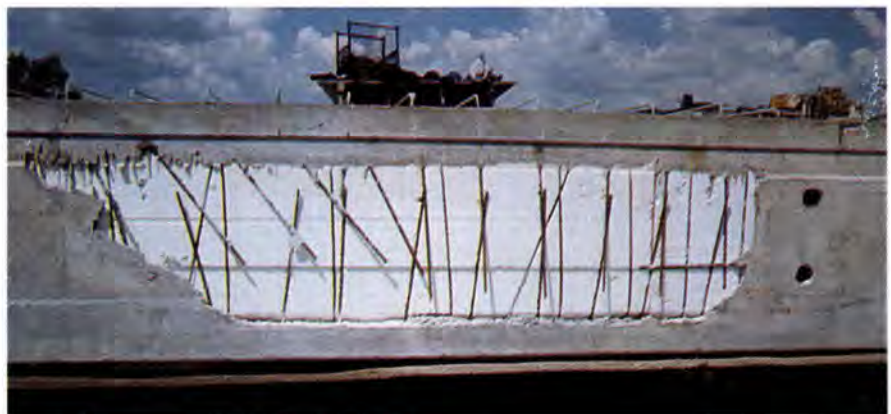
A manufacturer began casting large bridge box beams 4 x 4 x 120 ft (1.22 x 1.22 x 36.6 m). A casting problem occurred in the production of the first beam. Upon removal of the forms, it was noticed that there was no concrete cover along a 25 ft (7.6 m) segment and in two smaller areas (see Fig. 11).

crete. The voids shifted because an insufficient number of cover clips were provided. Holes were drilled to find the cover in other places. The cover varied from the design value of 6 in. down to 1 in. (152 to 25 mm).

Fig. 11. Exposed voids in a box beam.

To validate the strength of the beam, a load test would have to be done. Based on these considerations, the beam was judged not repairable and a replacement was cast.
