Restoration of a Vintage Limestone Portico with Architectural Precast Concrete

David B. Tigue, P.E., S.E.
Associate, Senior Project Engineer
Raths, Raths & Johnson, Inc.
Willowbrook, Illinois

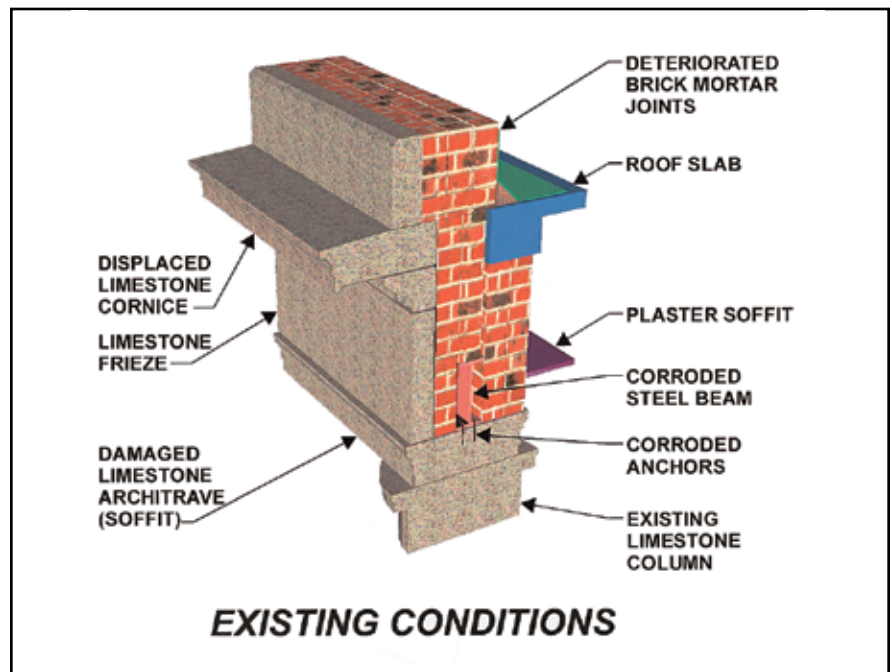
Fig. 2. Existing cornice construction consisting of limestone and brick masonry supported on steel beams spanning between massive limestone pillars.

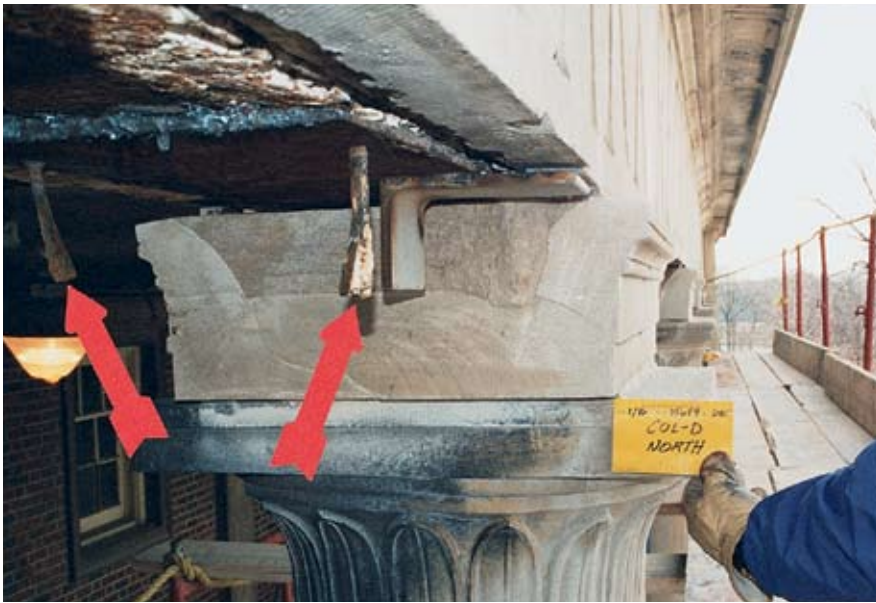
Fig. 3. Damaged limestone soffit that was cut and removed. Arrows indicate metal anchors used to hang the limestone soffit from the supporting steel beams.

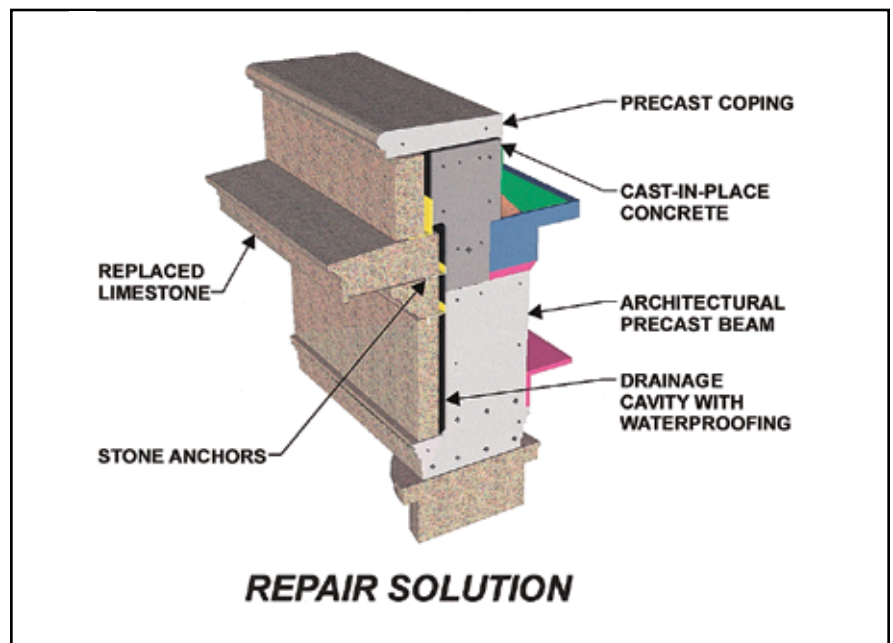
Fig. 4. Repair solution consisting of new architectural precast beams used to re-support ornate, carved limestone pieces.

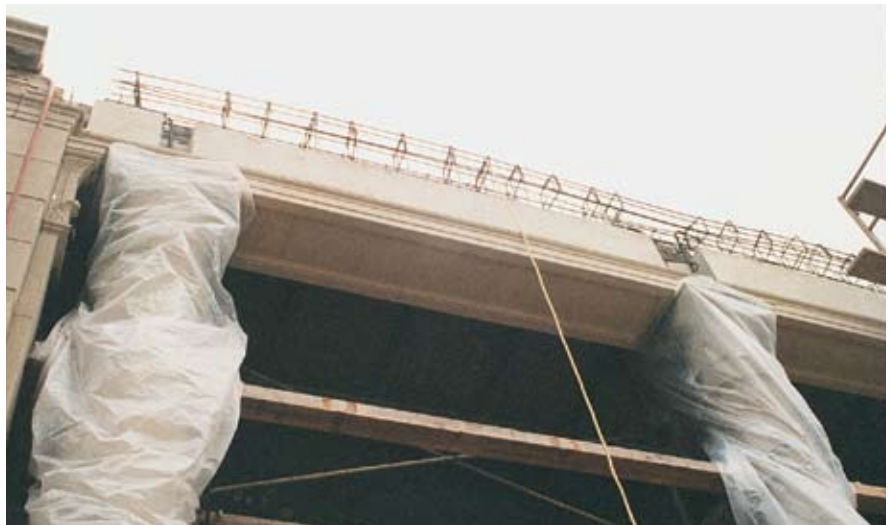
Fig. 5. Erection of the new precast beams. The beam soffits were cast with the same shape, color, and texture as the original damaged limestone soffit.
