Observations From the Bhuj Earthquake of January 26, 2001

S. K. Ghosh, Ph.D.

President
S. K. Ghosh Associates, Inc.
Northbrook, Illinois

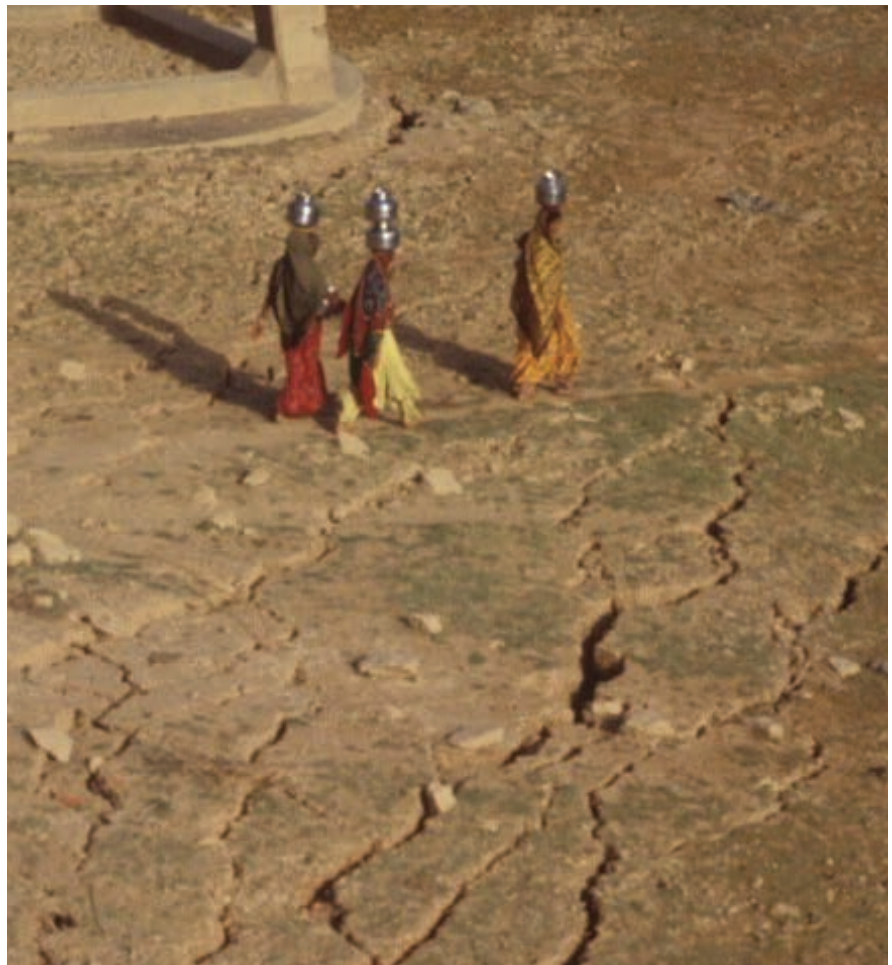
On February 14, almost 3 weeks after the Bhuj earthquake, ground water was observed to be bubbling out at one location near the village of Lodi. There were reports from that and other locations of geysers, several feet tall, erupting after the earthquake. The groundwater coming up near Lodi was sweet, as evidenced by algae growing on already accumulated water, whereas the groundwater in that part of Gujarat is typically salty. Ground failure and liquefaction were quite widespread (see Figs. 3 and 4).

Fig. 3. Ground failure caused by earthquake. Courtesy: MAE Center.

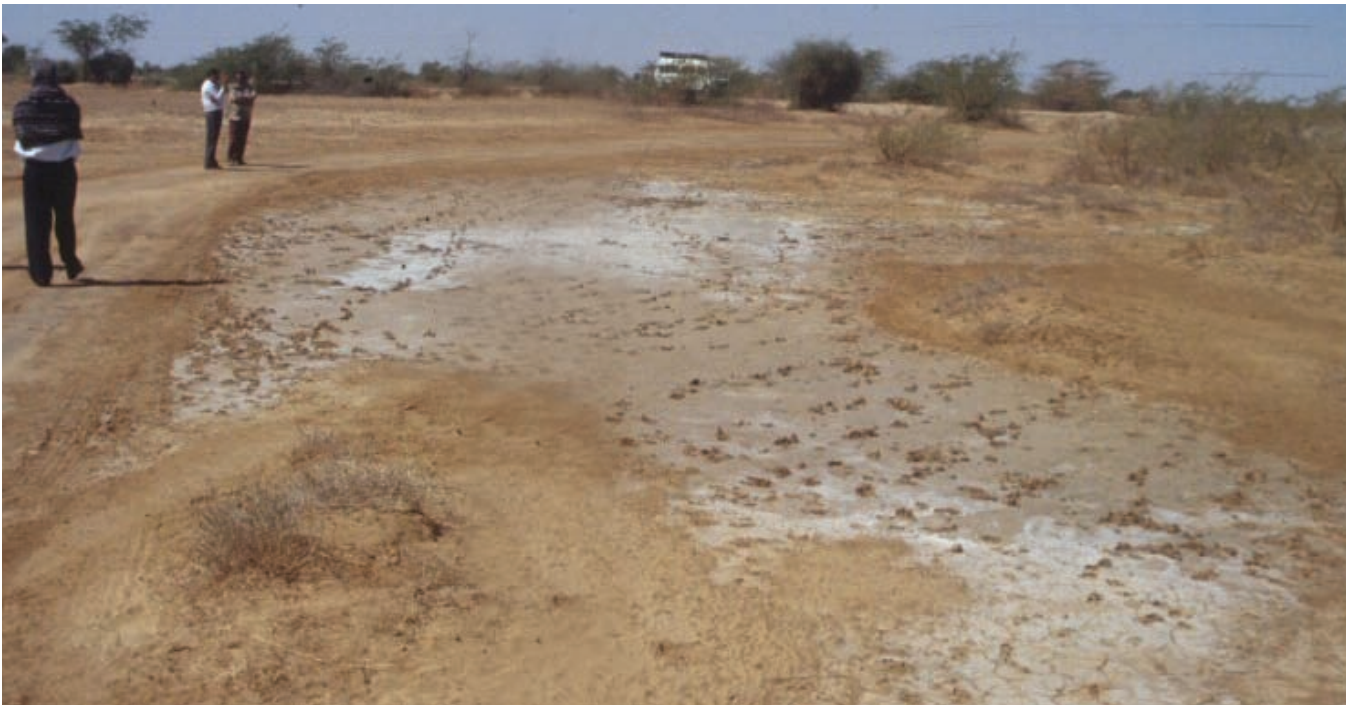
Fig. 4. Liquefaction caused by earthquake. Courtesy: MAE Center.

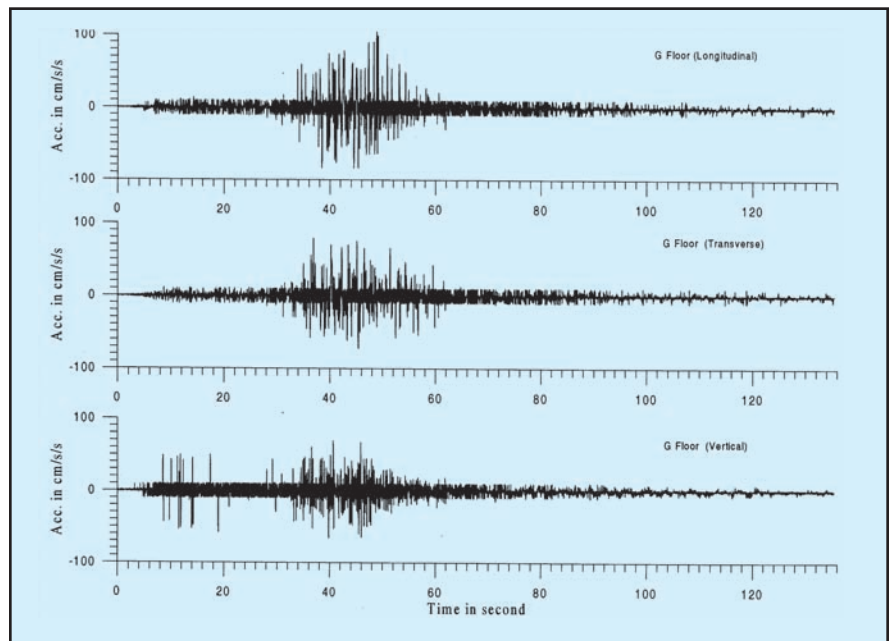
The only strong motion instrument in the entire area affected by the Bhuj earthquake was in the basement of a multi-story building in Ahmedabad, approximately 155 miles (250 km) away from the epicenter. The recorded peak ground acceleration was 0.1g (see Fig. 5).

Fig. 5. Accelerogram recorded at basement of a building in downtown Ahmedabad.

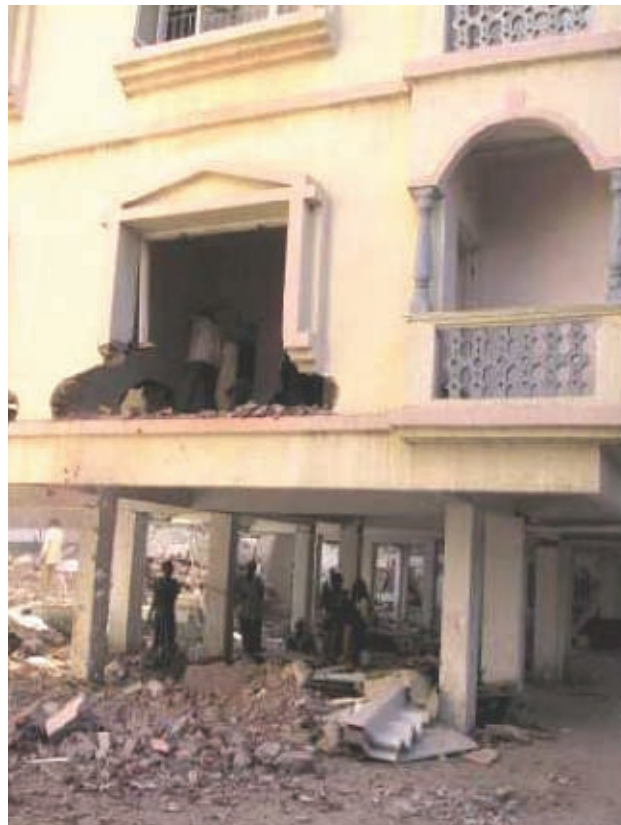
Stiffness Discontinuity or Soft Story – In virtually all Indian cities, the multi-story residential buildings of the type described above have open ground stories for parking of automobiles, because the small lots on which such buildings are typically built do not allow for open parking (see Fig. 6). This means an almost total absence of infills at the ground level, thus creating a very distinct stiffness discontinuity or a soft story.

Virtually all the earthquake-induced deformations in such a building occur in the columns of the soft story, with the rest of the building basically swaying uncontrollably. If these columns are not designed to accommodate the large deformations, they may fail, leading to a catastrophic failure of the entire building, as was the case with many buildings in Ahmedabad and elsewhere.

Fig. 6. Typical soft-story residential building. Courtesy: Tiziana Rossetto, Imperial College, London.

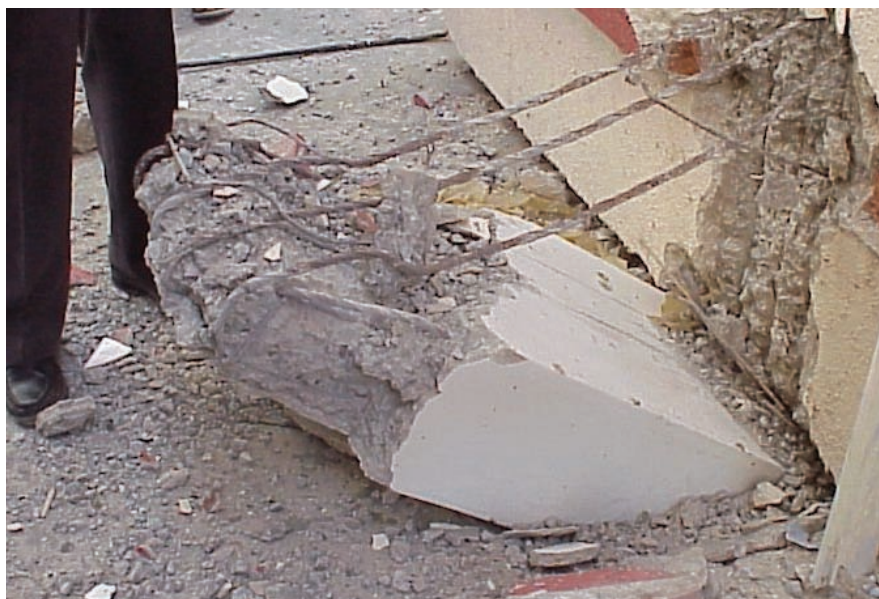
Non-Ductile Detailing – Goel² has reported: “The columns for low-rise residential buildings, up to ground plus four stories (G + 4), rest on shallow isolated footings located about 5 ft (1.52 m) below the ground level. For taller buildings, say up to ground plus ten stories (G + 10), the column foundations are still open footings located at a depth of 8 to 10 ft (2.44 to 3.05 m); sometimes the foundation may also have tie beams. The column sizes for low-rise buildings (G + 4) are about 9 x 18 in. (230 x 460 mm) with ties consisting of smooth No. 2 mild steel bars at a spacing of about 8 to 9 in. (200 to 230 mm). The beams tend to be much deeper to accommodate large spans and overhangs, giving rise to strong beam-weak column construction. The column sizes for taller buildings tend to be a little bigger, usually 12 x 24 in. (300 x 600 mm) with No. 3

deformed steel ties at a spacing of 8 to 9 in. (200 to 230 mm). The beam size in taller buildings may be similar to the column size. These ties always end up with 90-degree hooks.”

The large deformations that take place in soft story columns also impose extreme shear demands on them. The meager lateral reinforcement described above not only provides poor confinement; the shear strength available is also quite low. As a result, many ground floor columns failed in a brittle shear mode, or in a combined shear plus compression mode, bringing down the supported buildings (see Fig. 7). Many times, in columns that had

Fig. 7. Non-ductile detailing of column. Courtesy: MAE Center.

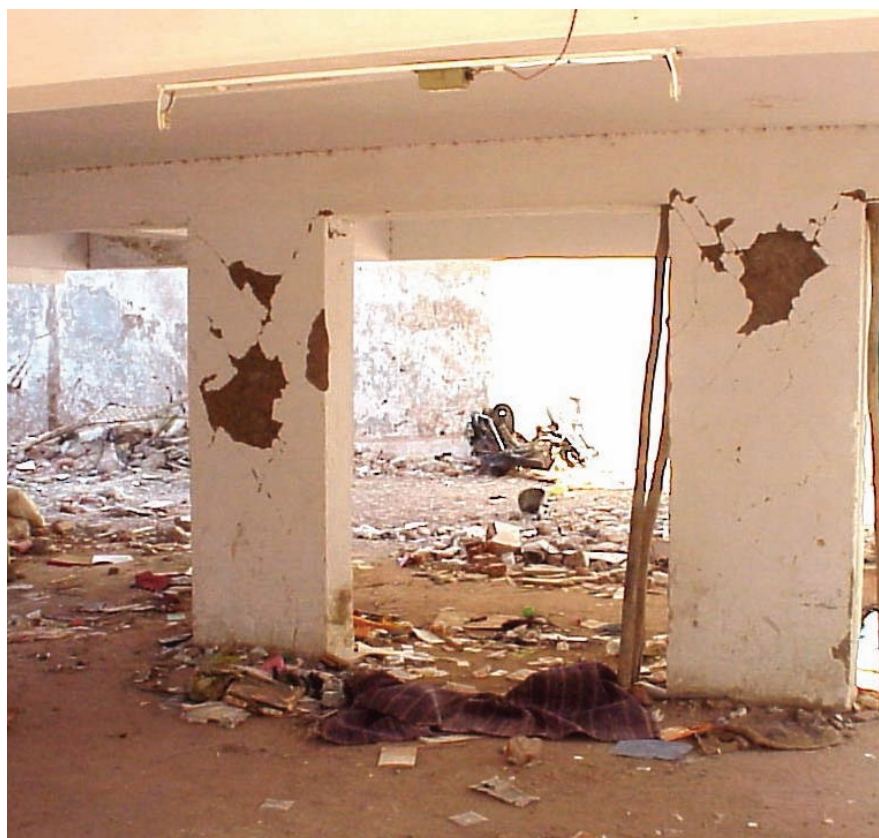
not failed, diagonal shear cracking was evident (see Fig. 8).

Fig. 8. Shear cracking of column. Courtesy: MAE Center.

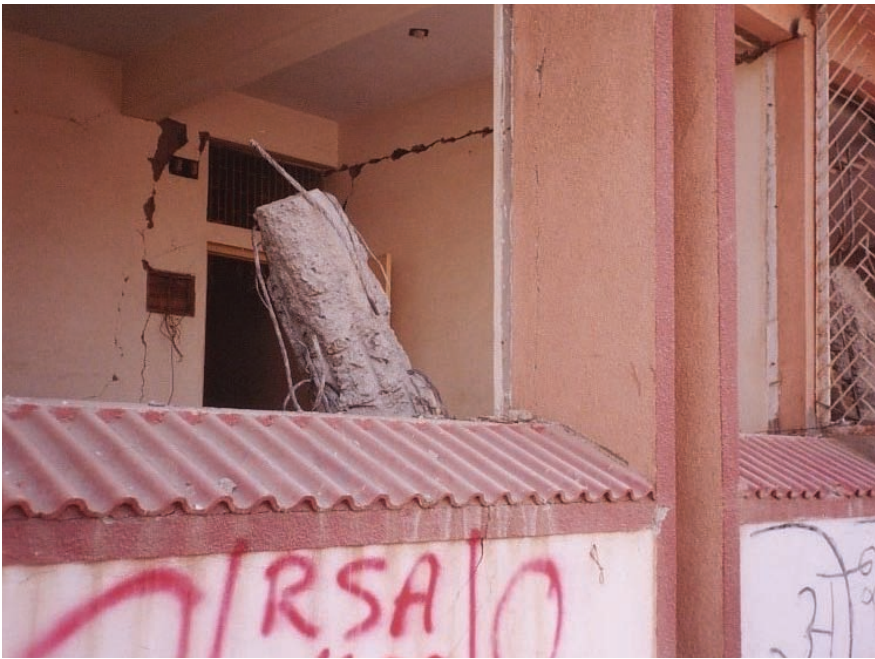
Fig. 9. Ground level column punching through floor slab of a building.

esting case of several ground-story columns in a building (in which the soft ground story had collapsed) having punched through the first suspended slab (see Fig. 9).

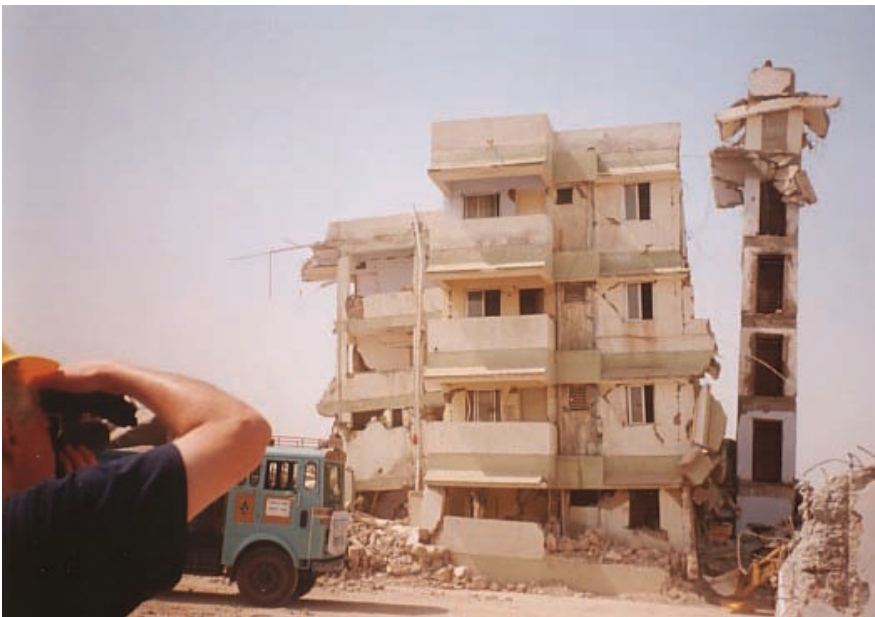
In another case, the shear core of a building had completely separated from the rest of the building (see Fig. 10). The right wing of the building had collapsed. The left wing was still standing up.

Fig. 10. Core separated from rest of building.

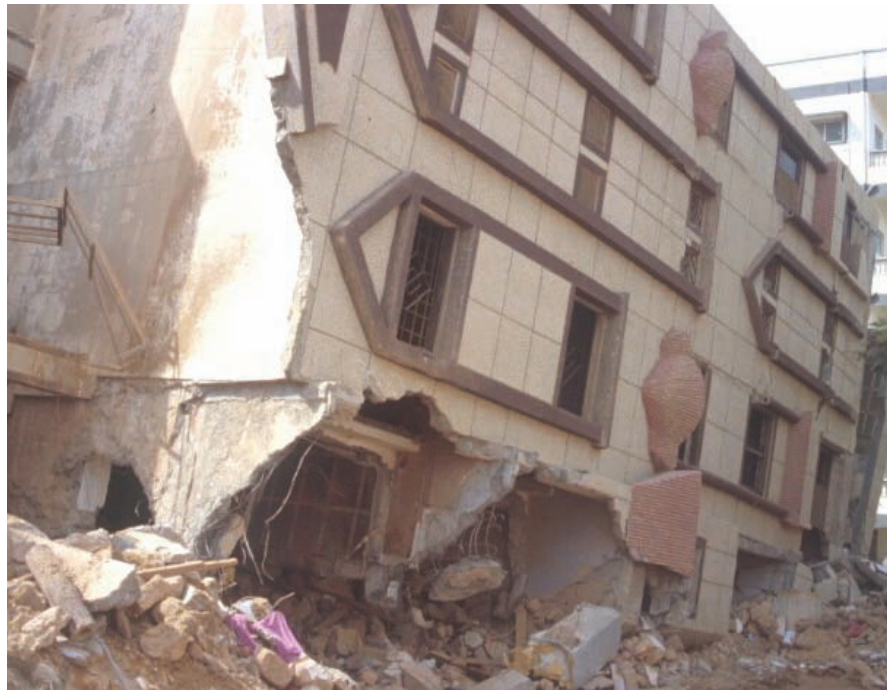
Finally, in Bhuj, one example of a very few overturned buildings was observed (see Fig. 11).

Fig. 11. Overturned building.
