Observations from the February 27, 2010, earthquake in Chile

S. K. Ghosh and Ned Cleland

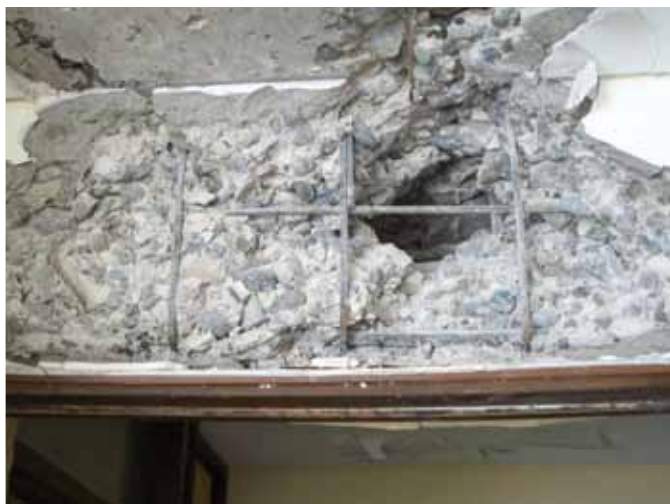
Figure 5. Damaged coupling beam in Viña del Mar, Chile.

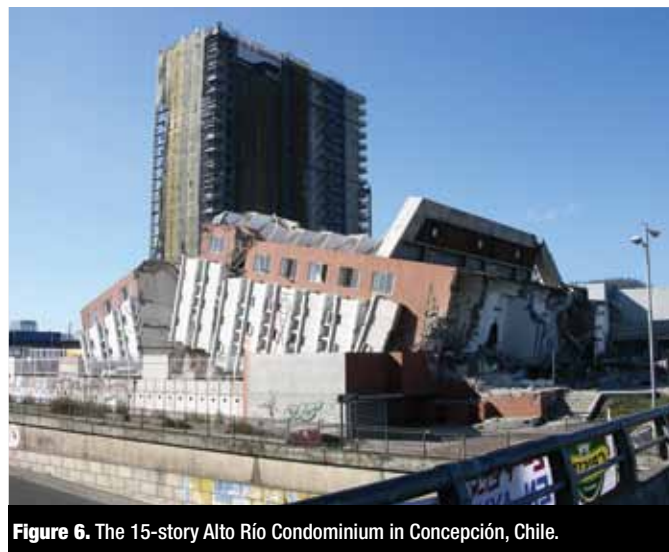
Figure 6. The 15-story Alto Río Condominium in Concepción, Chile.

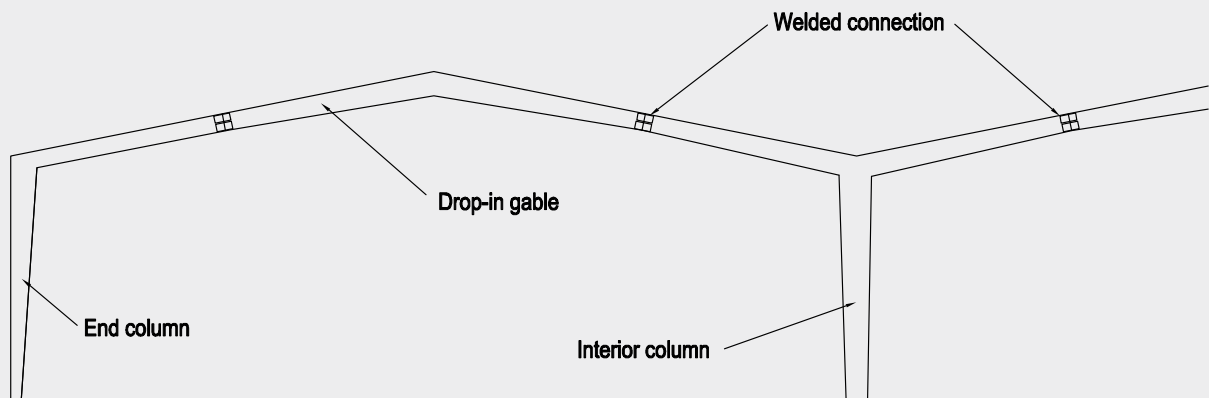
Figure 9. Gable frame system.

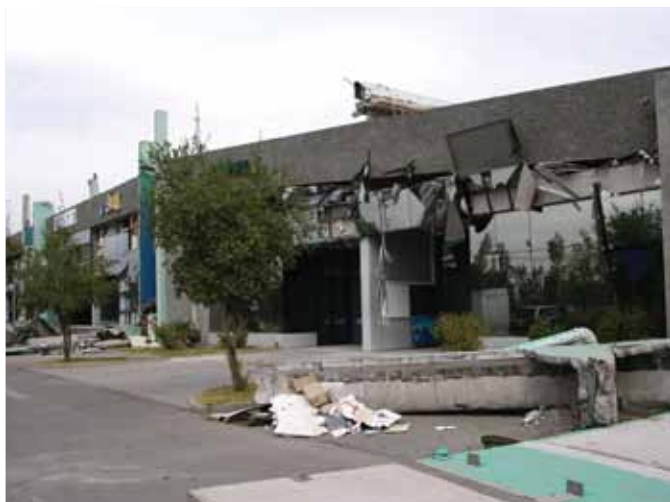
Figure 12. Front elevation of an office and warehouse building showing failed beam-column framing.

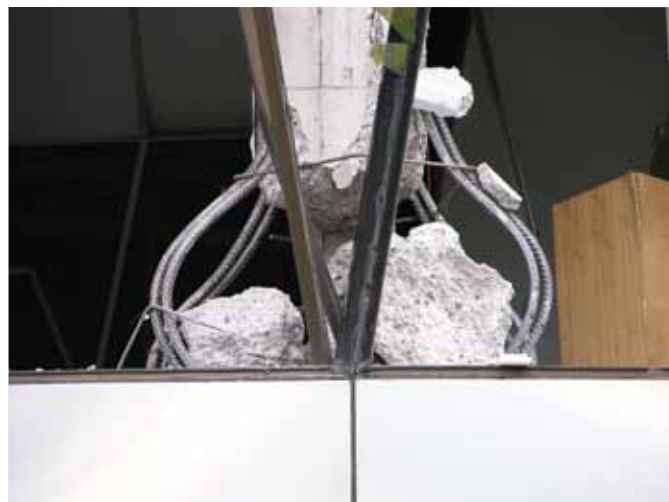
Figure 14. Reinforced concrete column with bar buckling and lack of confinement.

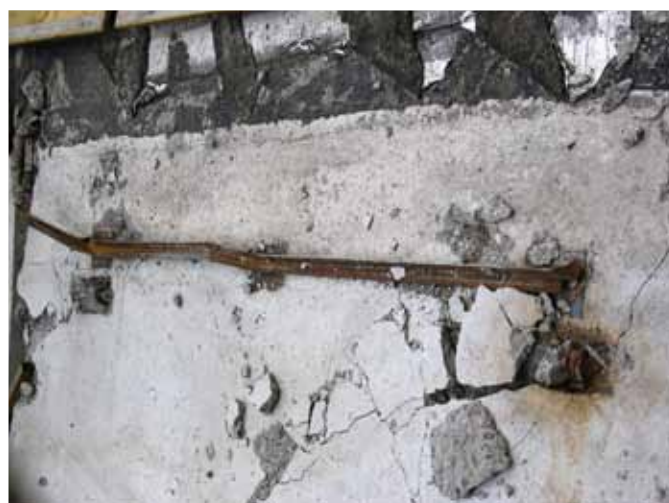
Figure 15. Bent and broken connection angle that failed to hold walls to edge beam at roof.

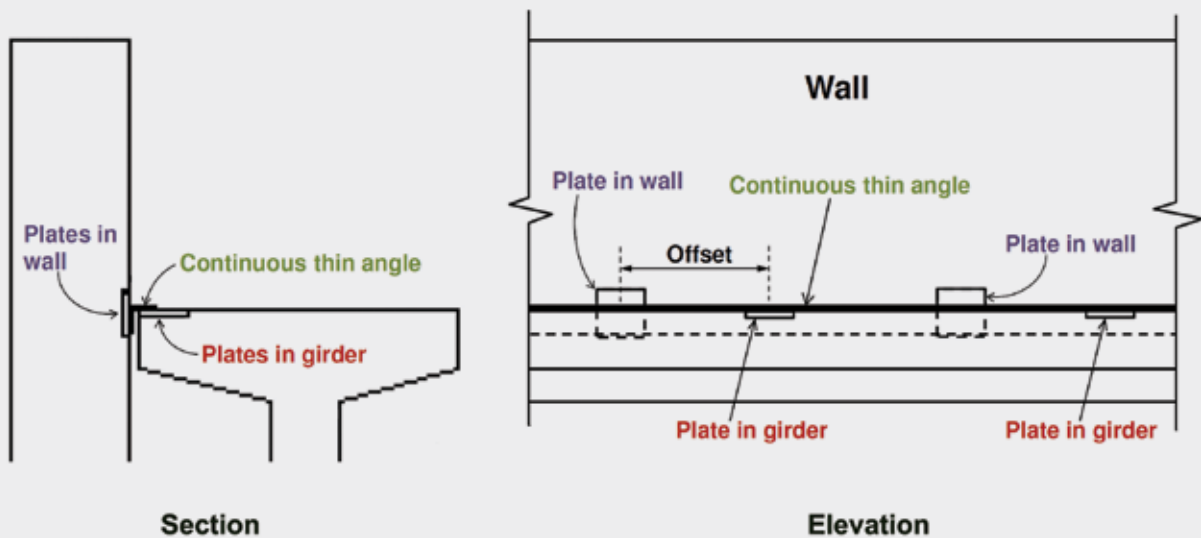
Figure 16. Misaligned wall-girder connection that failed.

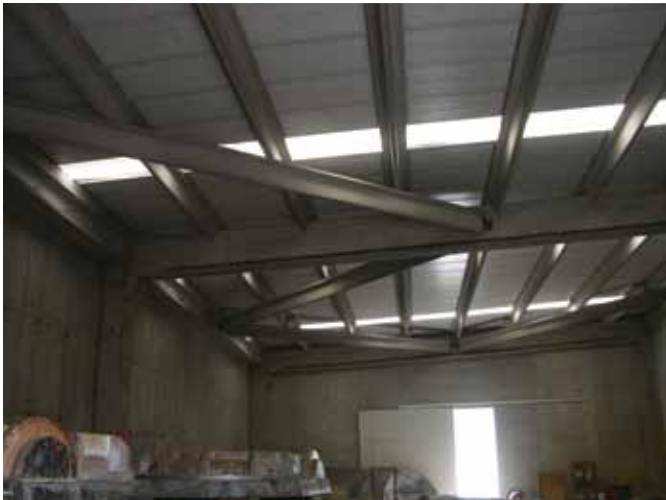
Figure 18. Diagonal precast concrete bracing for precast concrete girder roof framing in an industrial building that did not experience structural damage during the earthquake.

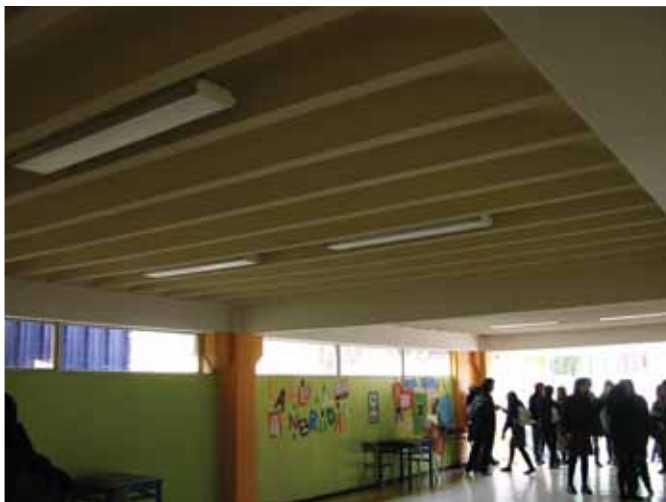
Figure 19. Total-precast concrete school framing system used in more than 40 schools that experienced no damage from the earthquake.

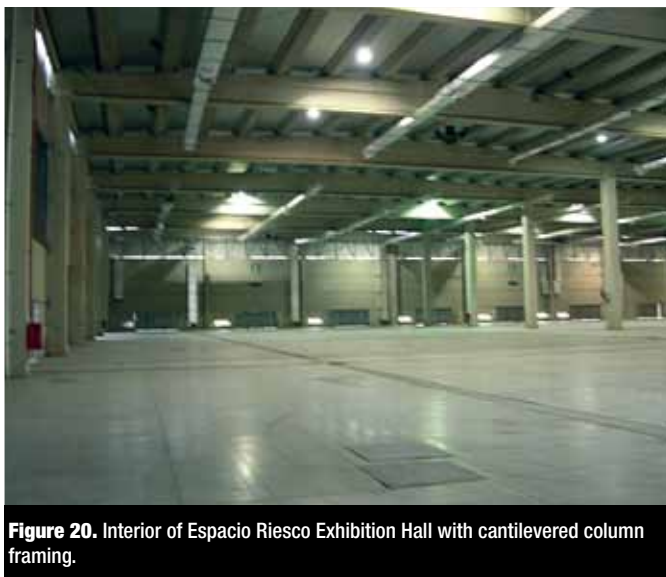
Figure 20. Interior of Espacio Riesco Exhibition Hall with cantilevered column framing.

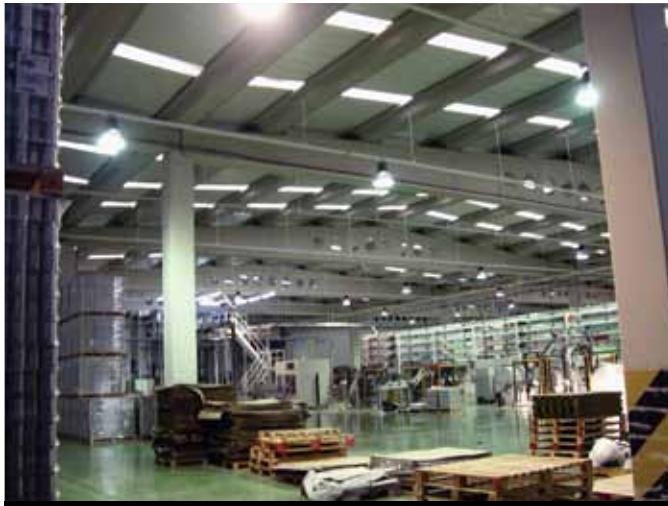
Figure 21. Interior view of the roof framing at a can factory.

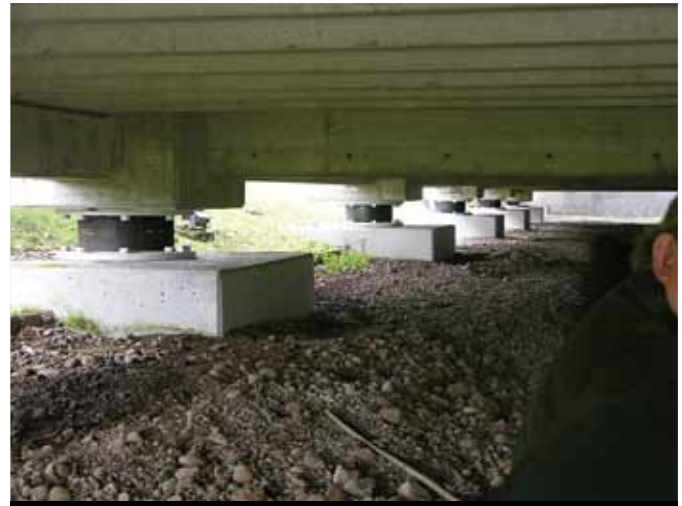
Figure 22. Base isolation bearings at Weir Vulco.

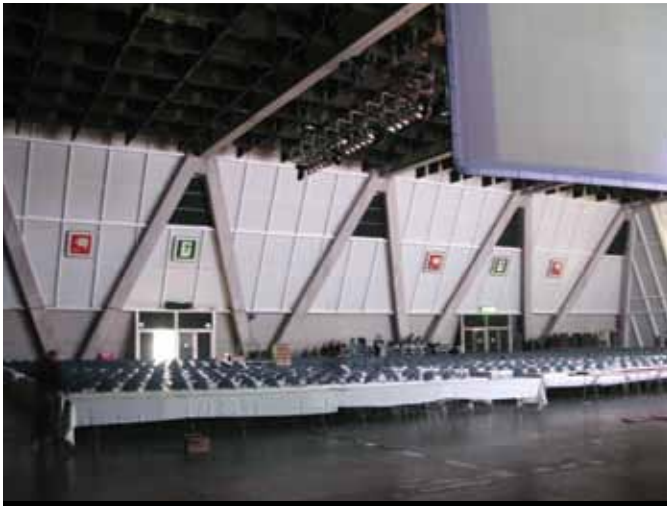
Figure 23. Interior view of a convention hall with tilted braced frames.

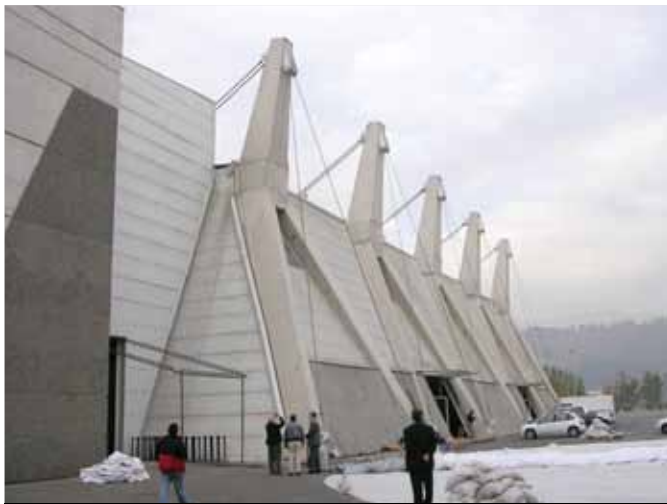
Figure 24. Exterior view of a convention hall with braced frame and cable-stay supports.

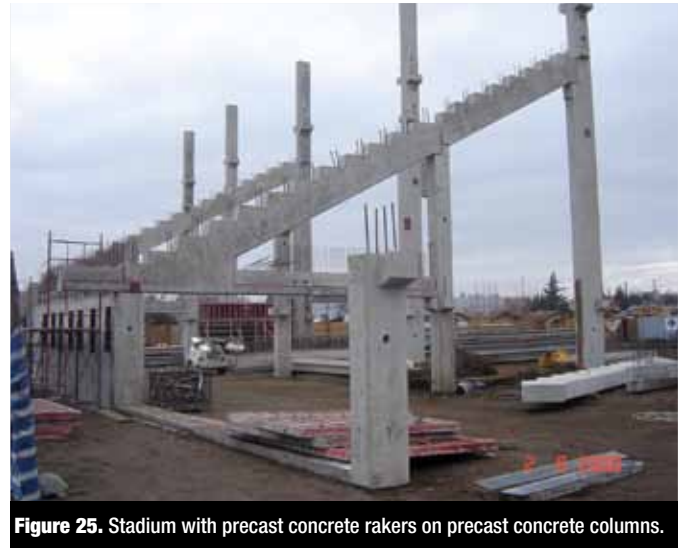
Figure 25. Stadium with precast concrete rakers on precast concrete columns.

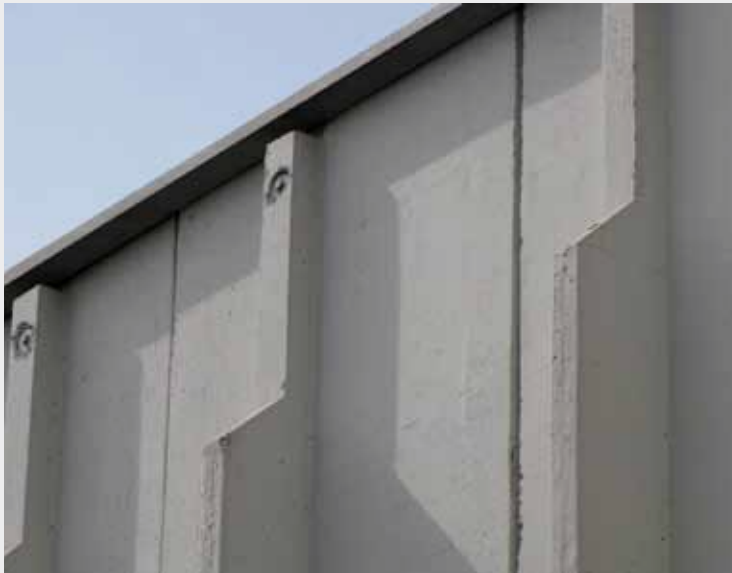
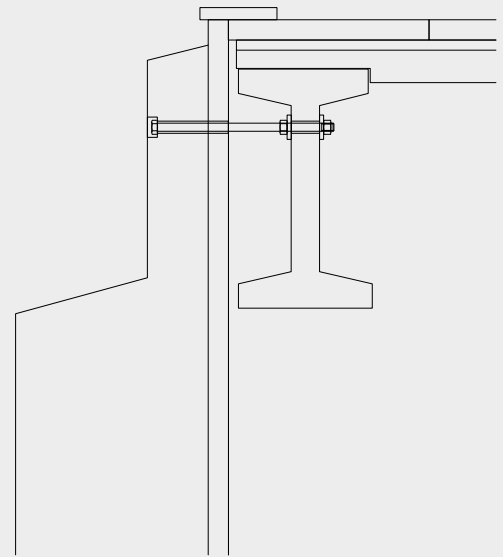
Figure 26. Double-tee panel connection to perimeter beams used in industrial buildings.

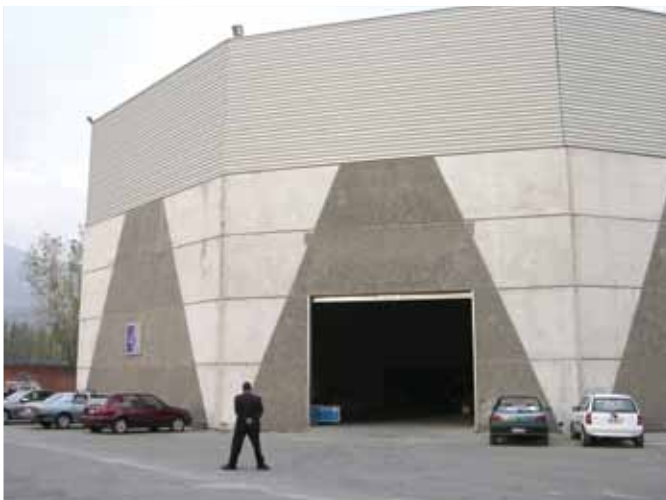
Figure 27. Annex of Preansa Convention Hall uses horizontal precast concrete panels.

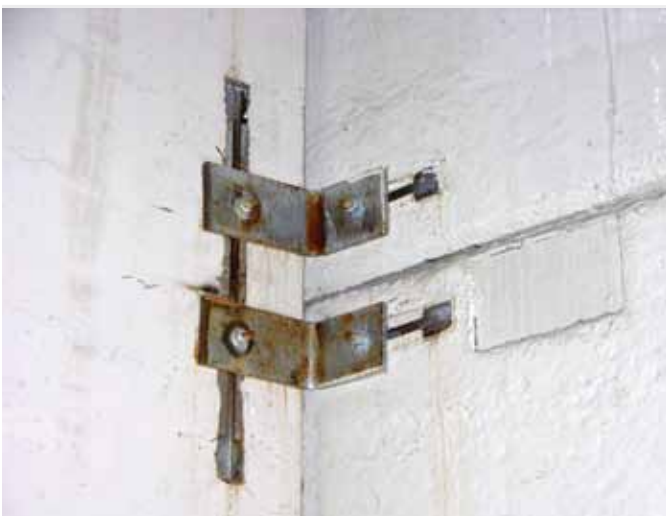
Figure 28. Slotted inserts to connect wall panels to concrete columns and the deformation of the slotted inserts due to the earthquake load.

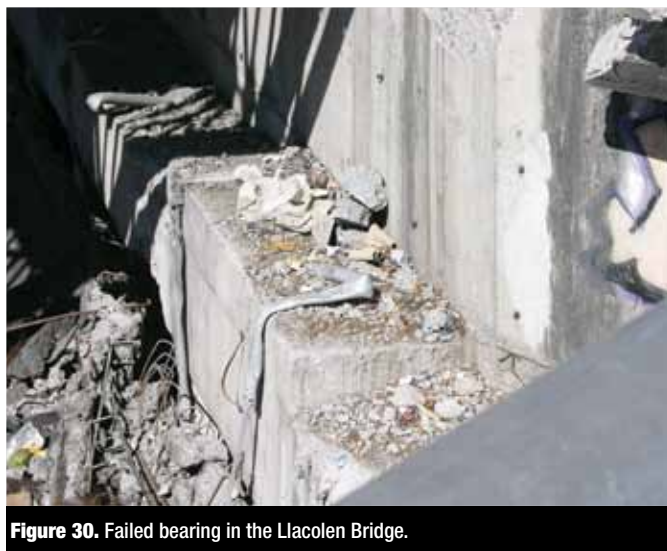
Figure 30. Failed bearing in the Llacolen Bridge.

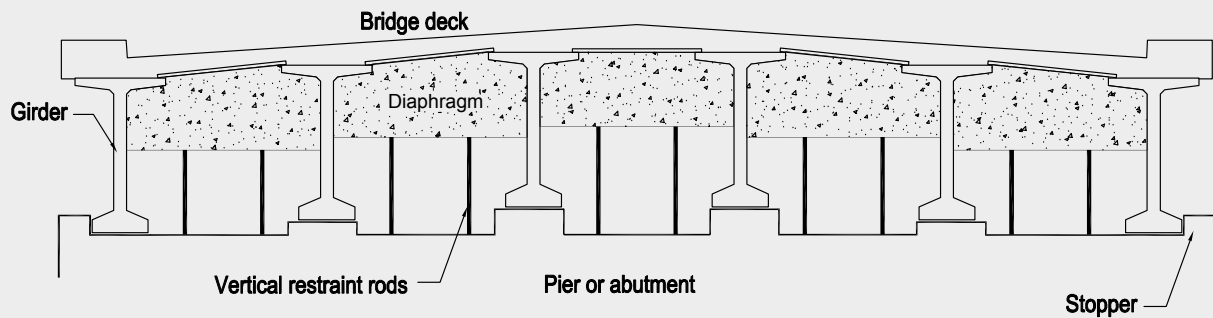
Figure 31. Bridge section at the Bio Bio River crossing with partial diaphragms, vertical restraint bars, and end stoppers.

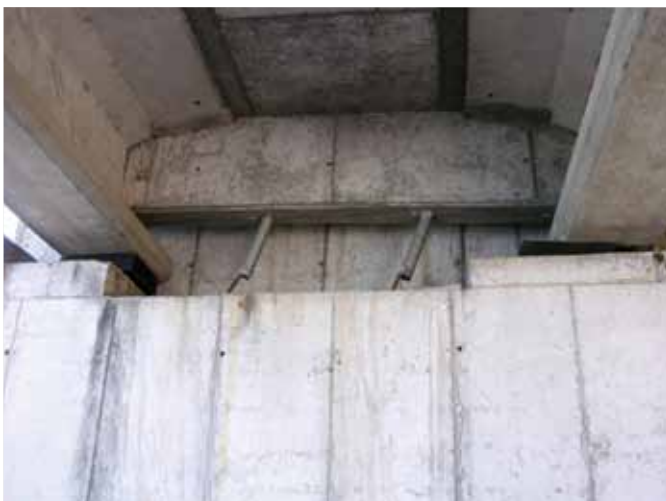
Figure 32. Lateral displacement due to earthquake forces of the Bio Bio River bridge with partial diaphragms and vertical restraint bars.

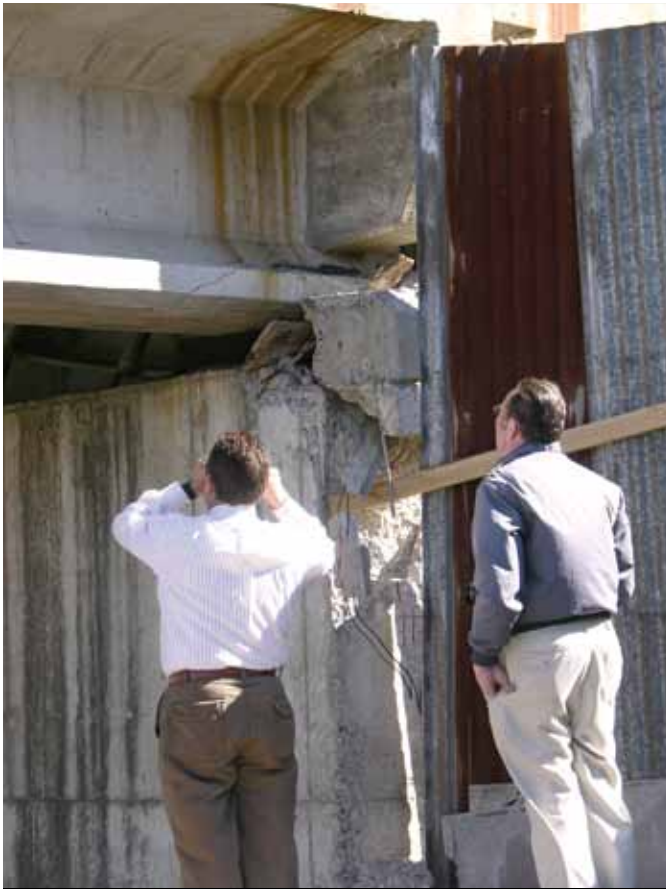
Figure 33. Failed stopper at the abutment of the Bio Bio River bridge, with a crack in the bottom of the girder.
