Lateral capacity and repair of corrosion-damaged pile bents, part 3: Carbon-fiber-reinforced polymer application and strength testing

Gray Mullins, Rajan Sen, Jethro Clarke, Tristen Mee, Amanda Lewis, and Malaak Araujo

- This is the final paper in a three-part series that explores the effects of corrosion damage on pile bents and demonstrates the effectiveness of carbon-fiber-reinforced polymer (CFRP) repair of severely corroded piles.
- This paper reports a study of the lateral load capacity of a one-third-scale pile bent bridge constructed with five piles that had exhibited greater than 96% cross-sectional steel strand loss and were repaired with CFRP material to restore bending resistance.
- Test results also demonstrated the suitability of numerical modeling to predict the strength gain from CFRP wrap repairs.

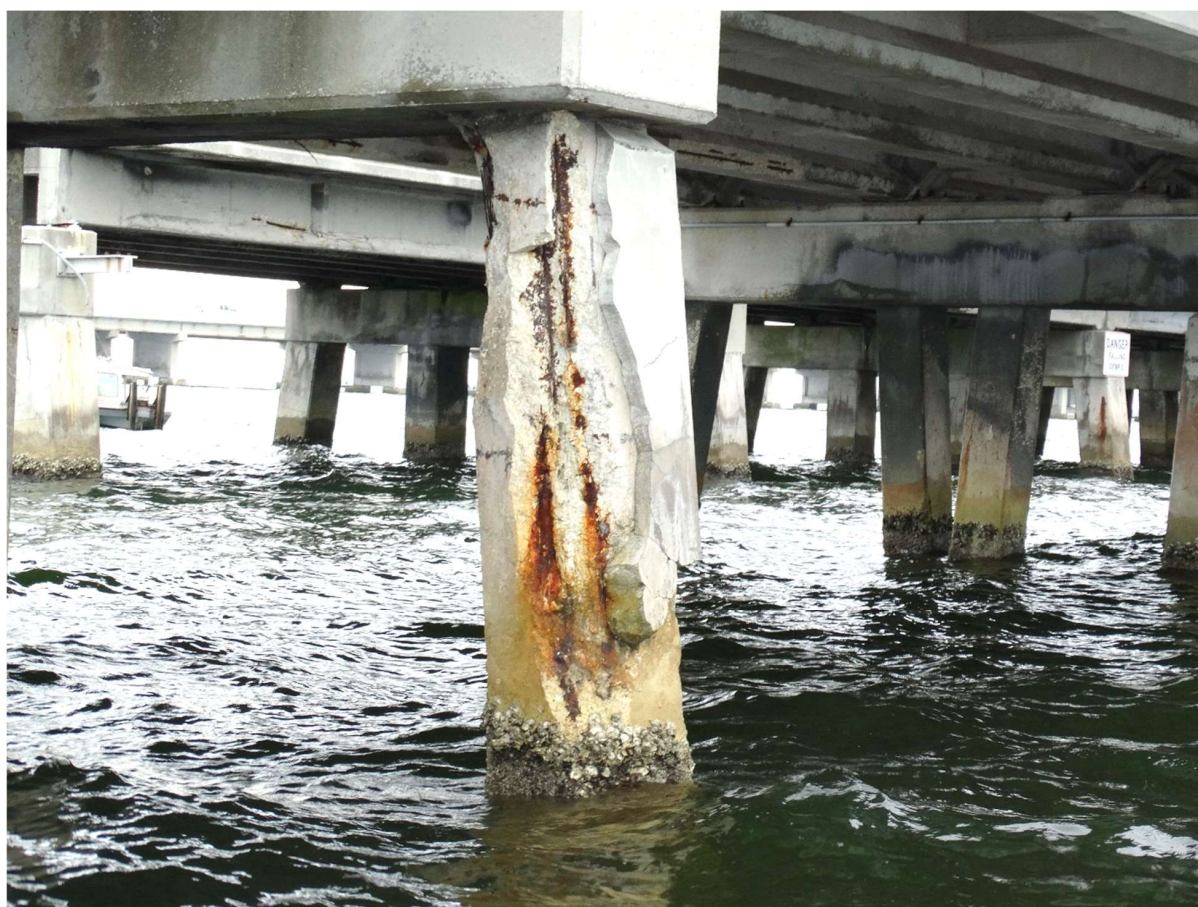
Like many areas of civil engineering, pile repair strategies have evolved to reflect owners' experiences of successes and failures, as well as a steady stream of research findings. In the late 1990s, FDOT classified pile jacket repairs as structural or nonstructural. In nonstructural repairs, a removable or stay-in-place form was installed around the pile, and the annulus that was formed around the pile was filled with concrete, mortar, or epoxy. Structural repairs included a reinforcing cage, whereas nonstructural repairs did not.⁶ At that time, an overwhelming majority of repairs to FDOT bridges were nonstructural; however, very soon thereafter, it was found that stay-in-place forms masked the true state of the repair and continued corrosion deterioration went undetected. Nonstructural pile jackets were also found to fall off easily without the necessary confinement to withstand corrosion expansion forces beneath the unreinforced jacket (**Fig. 1**).

Figure 1. Failed nonstructural pile jacket repair. This repair method was commonly used from the 1970s through the 1990s.

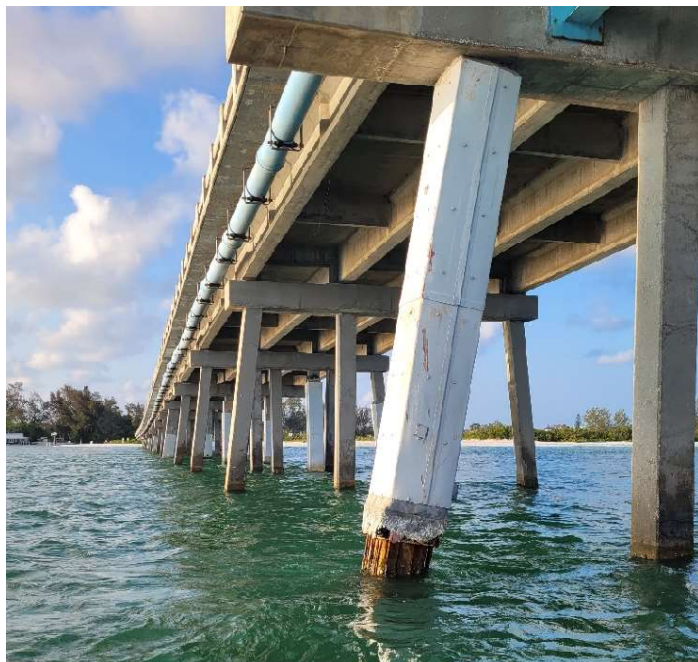
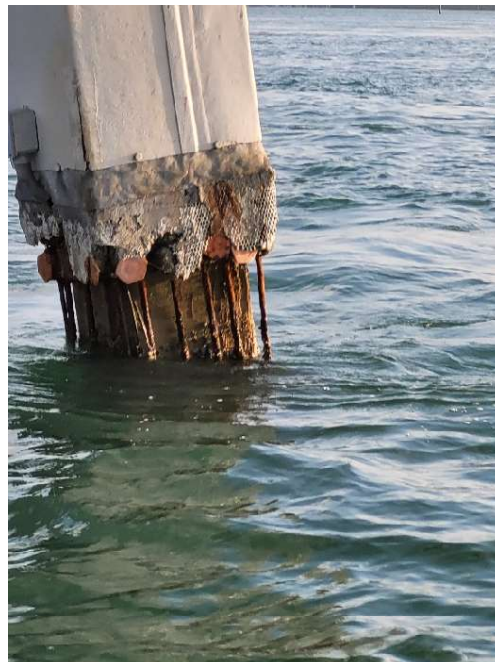
Figure 2. Structural pile jacket repair installed circa 2021 and the same pile, three years later.

have an approximate life of 10 years,⁷ but they do not always last that long. **Figure 2** shows a structural pile jacket with cathodic protection approximately three years after installation with the segment exposed to tidal flow missing.

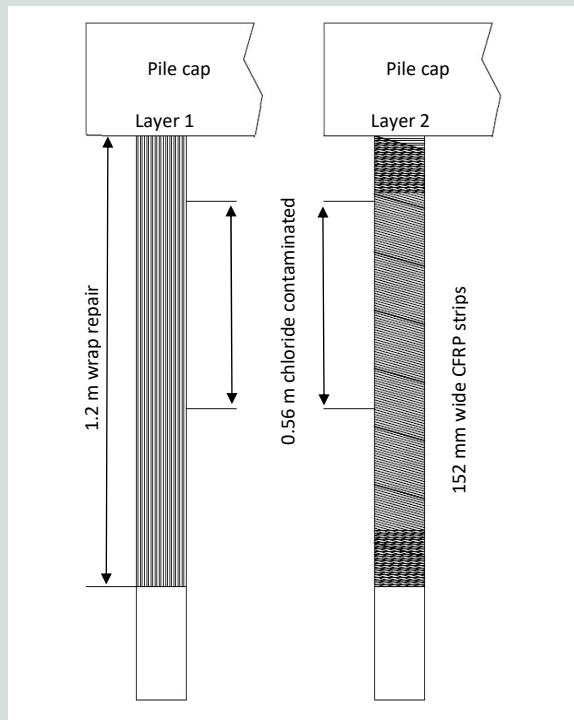
Figure 3. Repair scheme for severely corroded one-third-scale piles. Note: CFRP = carbon-fiber-reinforced polymer. 1 mm = 0.0394 in.; 1 m = 3.281 ft.

The design of the CFRP repair for the 152 mm (6 in.) square concrete prestressed piles established in part 2 of the research program called for one layer of a commercially available uniaxial fabric aligned longitudinally, followed by one layer of the same material applied as a transverse spiral wrap (**Fig. 3**).² The properties of the CFRP wrap material incorporated the manufacturer-recommended two-part epoxy as the adhesive; use of this adhesive requires the fabric to be fully saturated. **Table 1** lists the properties of the repair material. Confinement provided by the spiral wrap material was based on a transverse fiber slope of 1:4 or a 38 mm (1.5 in.) drop along each of the 152 mm sides. Hence, a 152 mm wide strip of fabric would touch side by side with subsequently applied spiral wraps once a full revolution was completed around the 610 mm (24 in.) pile top perimeter (4 sides \times 38 mm drop/side = 152 mm).

The CFRP repair design called for one layer of a uniaxial material longitudinally aligned followed by one layer of the same material transversely aligned (Fig. 3). Longitudinal material was precut into pieces measuring 1.2 m (4 ft) long and 0.63 m (2.1 ft) wide. The length was based on the extent of crack damage, and the width was based on the sizes of the pile sides, which in some cases were slightly more than the nominal dimension of 152 mm (6 in.). Some lateral overlap of

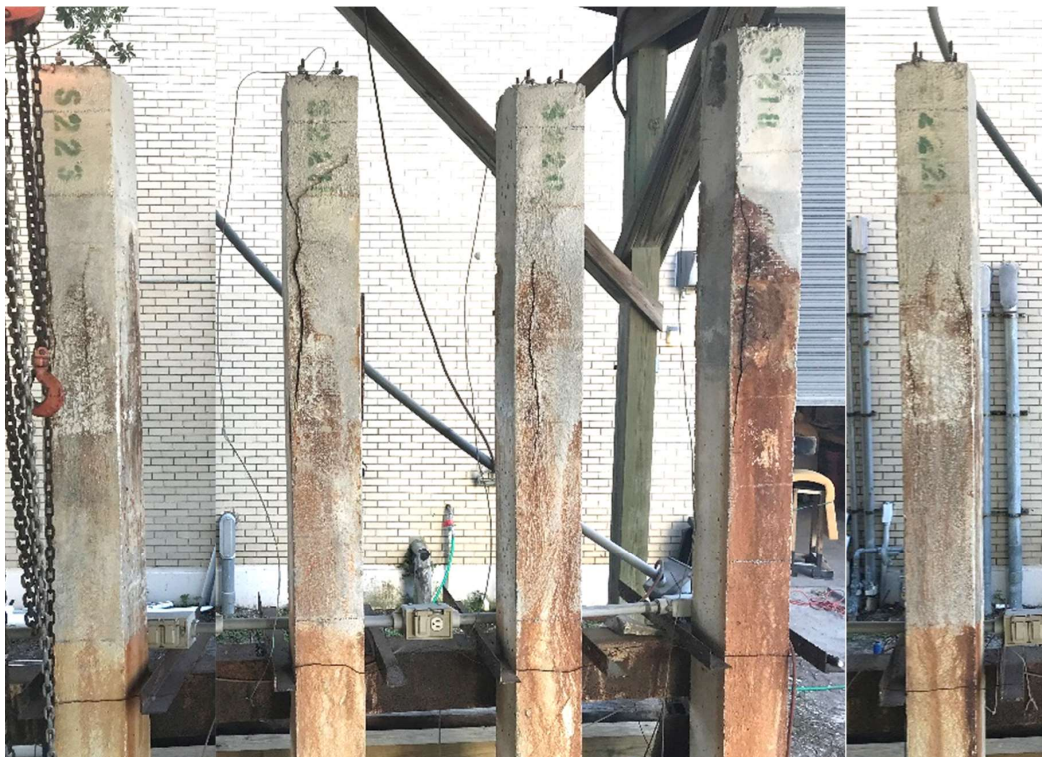
Figure 4. Condition of piles 1, 2, 3, 4, and 5 at the start of part 3 of the research program, 20 years after they were cast. The piles are shown from left to right, looking at the east side.

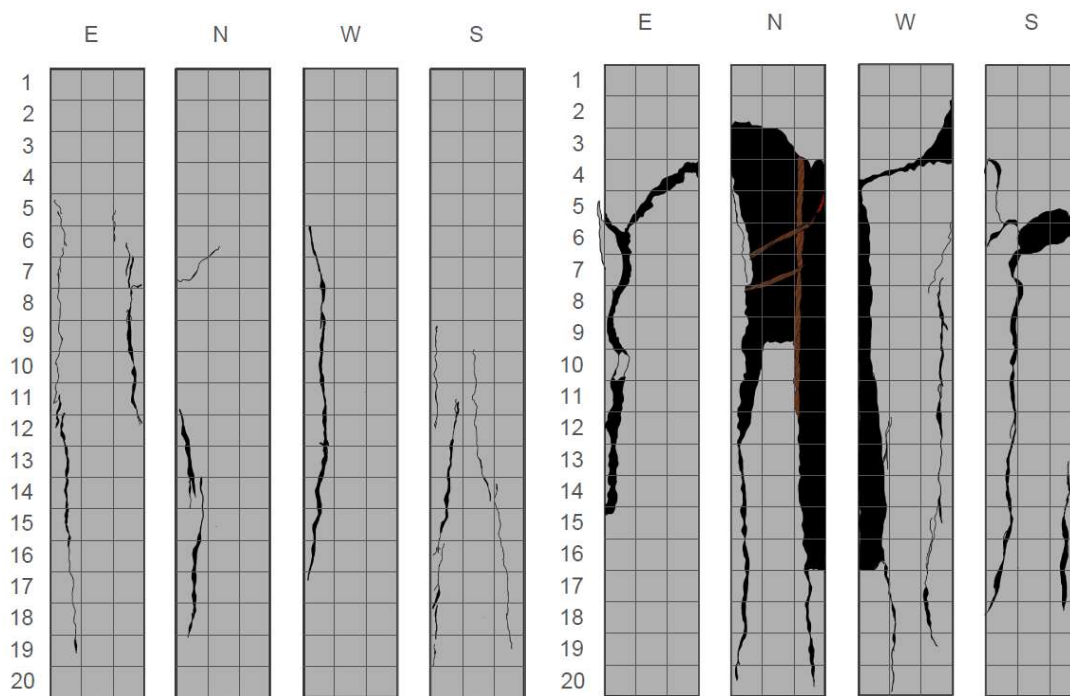
The condition of each pile was assessed using crack mapping, acoustic hammer tap testing, and surface potential measurements. In part 1 of the research program, the average maximum crack width in the piles increased progressively from 0.5 mm (0.02 in.) in the specimens with 10% steel loss to 3 mm (0.1 in.) in the piles with 50% steel loss.¹ Twenty years later, the average maximum crack width in all five piles used in part 3 of the research program had increased to 15 mm (0.59 in.) with a range of 8 to 28 mm (0.3 to 1.1 in.). The number of cracks had not increased, but the length of cracks had increased from 760 mm (30 in.) in the piles with 50% steel loss to 910 mm (36 in.) in the piles used in part 3. As discussed in the original paper in this series, the original chloride-contaminated damage zone was only 560 mm (22 in.).¹ **Figure 4** shows the condition of the five piles used in part 3 prior to repair. **Figure 5** shows example maps of cracks for the piles in the best and worst conditions (piles 5 and 2, respectively). Black regions denote open cracks or missing regions of cover. Each side of the piles was divided into 50.1 mm (2 in.) square regions (3 regions wide and 20 long) for the assessments.

The investigators determined that piles 3 and 5, which had narrower crack widths than the other three piles, could be candidates for either cover removal or epoxy crack injection prior to wrapping because the overall shapes of these two piles had not changed by expanding corrosion products. The other three piles were deemed unsuitable for epoxy crack injection; hence, cover removal with subsequent form-and-pour cover restoration would be required.

Figure 5. Crack surveys of pile 5 and pile 2. Black regions denote open cracks or missing regions of cover. Of the five piles used in this study, pile 5 was in the best condition and pile 2 was in the worst.

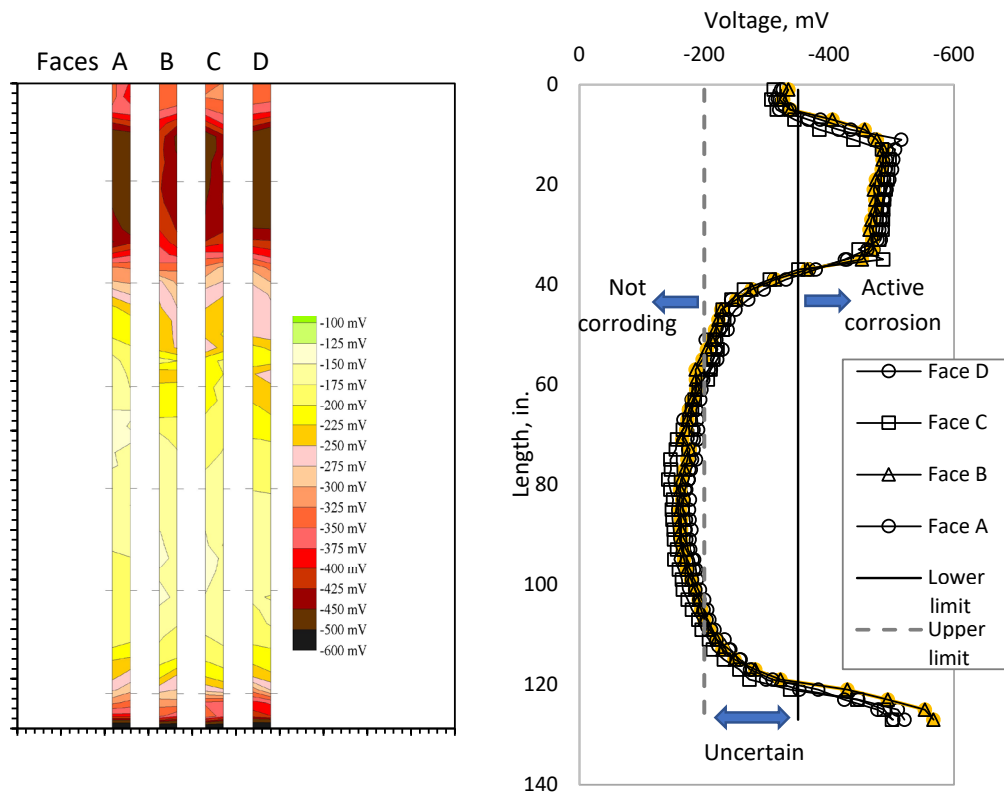
sition. All profiles showed active corrosion in the damage zone and at the pile bottom and nowhere else. Full details about the corrosion and crack mapping can be found elsewhere.¹²

Figure 7. Typical surface potential contours and profiles. Note: 1 mm = 0.0394 in.

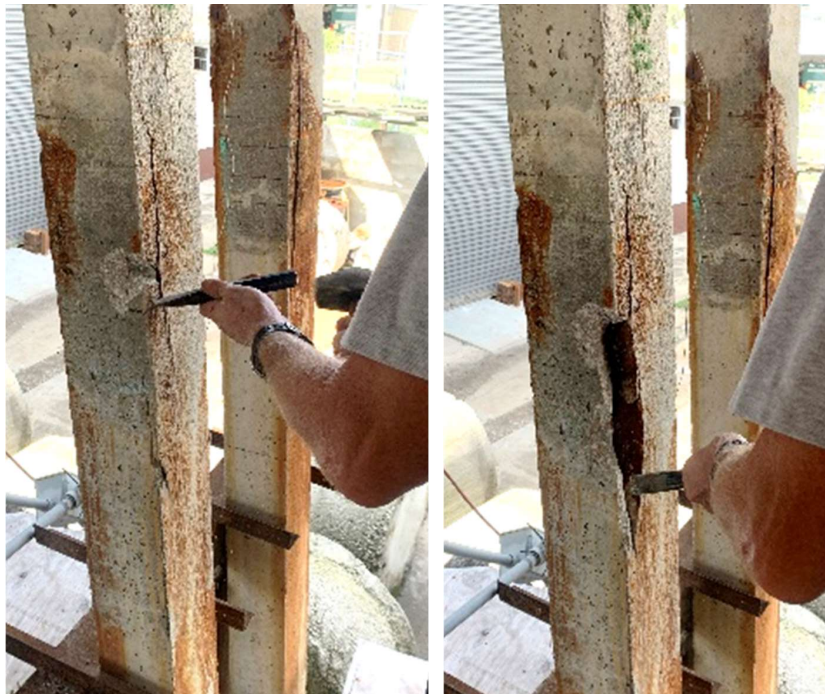
Figure 8. Concrete cover removal of pile 3, which was originally intended to be repaired by epoxy injection.

Piles 3 and 5 were candidates for either cover removal or epoxy crack injection prior to wrapping. When epoxy crack injection is used, the cracks are sealed at the surface with an epoxy putty. Then, an injection port is installed at the lowest point of each crack and a low-viscosity epoxy is pumped through the port to fill the crevices. The tops of the cracks are left open to identify when the cracks are filled and to prevent hydraulic pressure, which can dislodge delaminated portions of the cover. Investigators considered the number of epoxy injection ports that would be needed (one per crack) as well as the ease with which all cover material had been removed from piles 1, 2, and 4, and decided to remove the covers from piles 3 and 5 instead of pursuing epoxy crack injection. **Figure 8** shows the first two blows used to remove the cover on pile 3. Complete delamination of the concrete cover was confirmed in all piles, so the option to form and pour the cover replacement was appropriate.

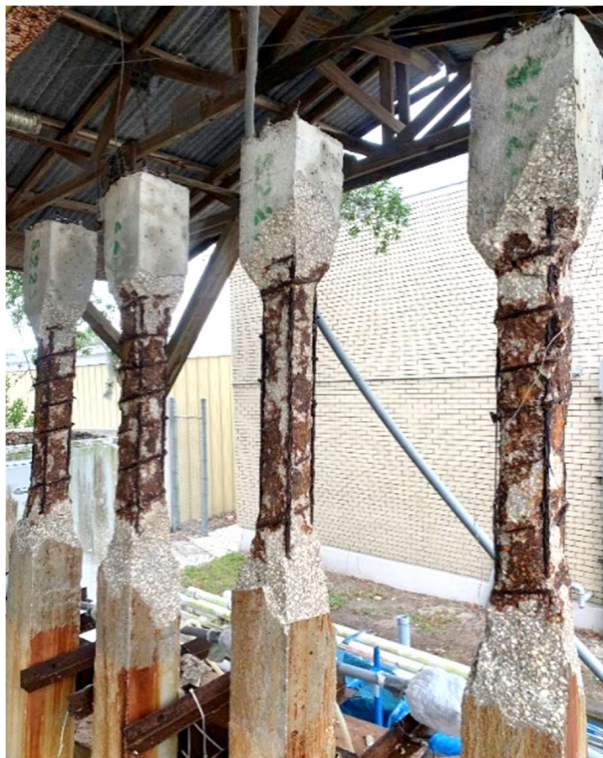
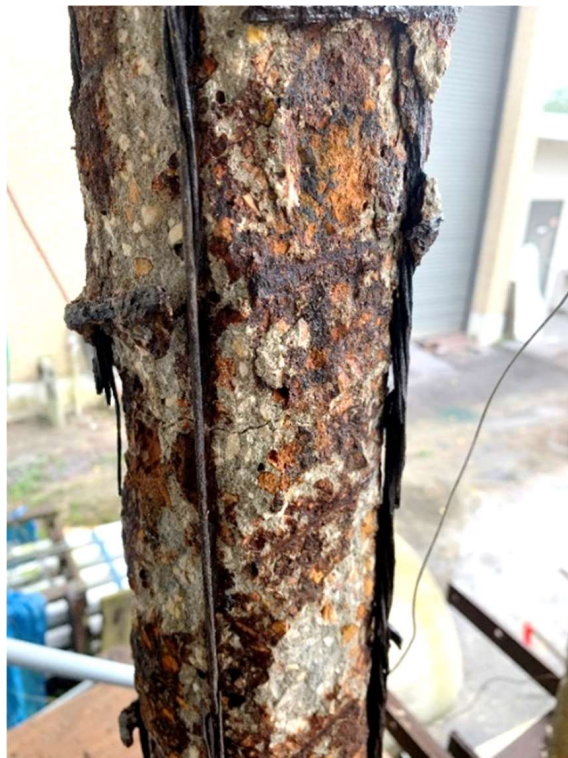
Figure 9 shows the state of the piles immediately after cover removal. The remaining reinforcing steel was sparse. Stirrups were mostly gone, and none were continuous around a pile. In most cases, one of the seven prestressing strand wires remained but was badly corroded. Vestiges of the other six wires were rare. Investigators estimated that less than half of one wire diameter in each strand represented the remaining steel cross section, making the steel loss greater than 96%.

Figure 9. Condition of piles immediately after cover removal.

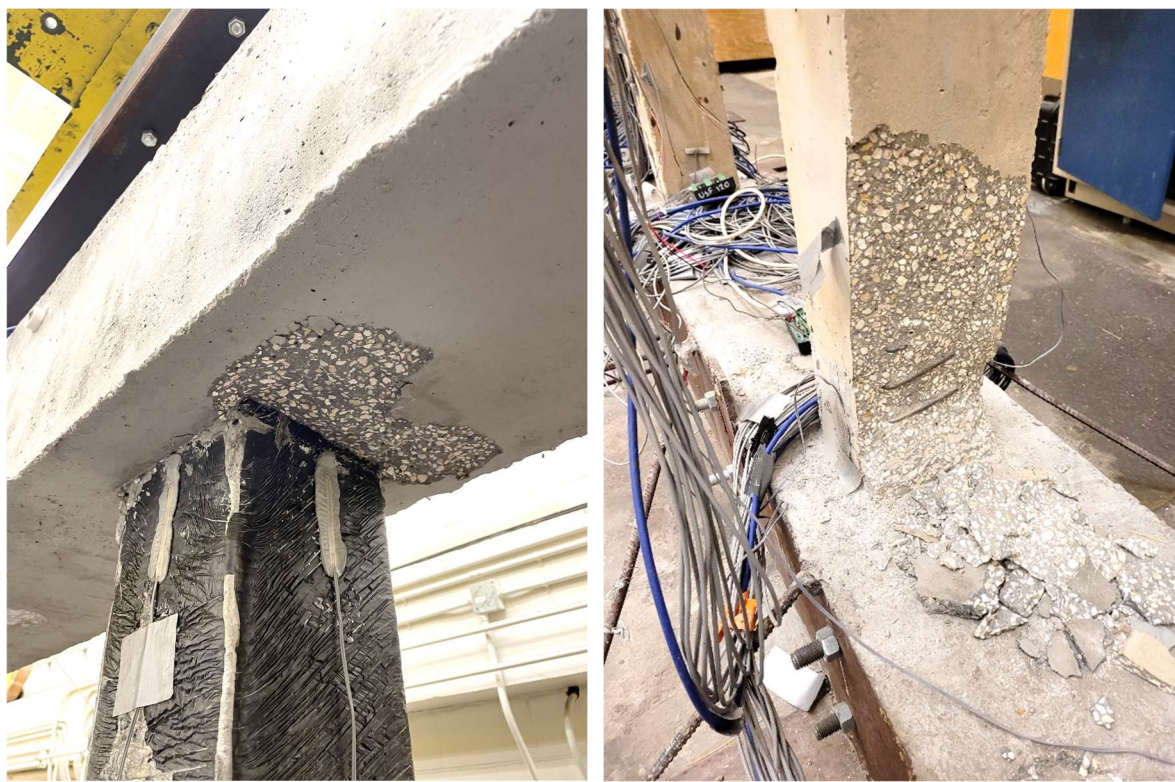
Loading was continued to the extent of the 152 mm (6 in.) hydraulic actuator stroke, which resulted in 142 mm (5.59 in.) of pile cap movement. No pile failures were observed in the repair zone. The bottom side of the pile cap directly adjacent to piles 2 and 4 broke away from the cap on the leading (tension) side of the pile, leaving a swept-out appearance that indicated partial loss of pile-to-pile-cap fixity. The footing with more embedment retained fixity, and all piles exhibited concrete crushing and spalling on the leading (compression) side of the piles. No concrete failures in the floor footing were observed. **Figure 22** shows failures in the cap and in a pile above the footing.

Figure 22. Leading face of pile 4 after loading, cap and pile spalling.
