I-90 EASTON BRIDGE REPAIR

Evan Grimm, PE, Washington State Department of Transportation, Olympia, WA

Precast concrete girders were used to replace a bridge span over eastbound I-90 that was severely damaged by an over-sized truck load near the city of Easton, Washington. The damaged span was to be replaced under an emergency contract that required the bridge to be operational in 45 days. WSDOT met that challenge using non-standard precast prestressed deck bulb tee girders, which made the accelerated construction possible and limited temperature-sensitive construction in the freezing and snowy mountain region. The bridge design and construction moved rapidly within the short time frame using in-place production tools. Working directly with the precast concrete industry, the bridge design office streamlined the fabrication and construction schedule of the replacement span.

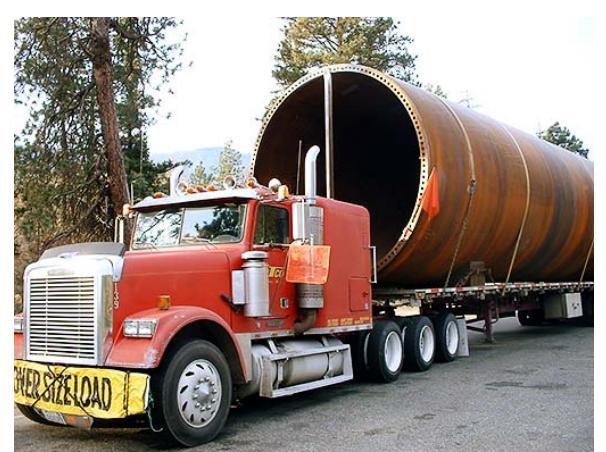
Fig. 3 Oversized Load After Impact

The collision occurred at 4:35 AM on October 31, 2007. A truck traveling at more than 60 mph smashed into the bridge with a large diameter pipe secured to the trailer (see Figure 3). It punched through the bottom flanges and webs of the girders at midspan across the entire bridge. The collision was so loud that a resident from the nearby city of Easton claimed to have heard it. Fortunately no one was injured during the accident.

Often during high-load bridge collisions in the state of Washington the load falls off the truck trailer after striking the first or second girder. In this case however the pipe section sliced through all six girder bottom flanges and webs, and the pipe remained attached to the truck and undamaged by the impact.

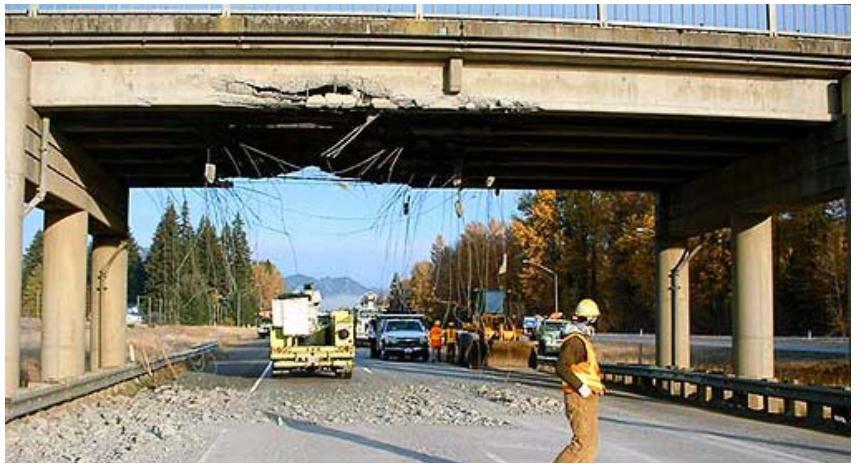
Fig. 4 Bridge Damage

The bridge span was damaged beyond repair as shown in Figure 4. The photo shows spalled concrete with large pieces sitting on I-90. Exposed and broken prestressing strands can also be seen hanging from the bridge. Figure 5 is another view of the damage, in which the radial curvature of the pipe can be seen in the broken girders. Washington State Department of Transportation (WSDOT) engineers from the Bridge Preservation Office arrived on the scene quickly and determined that the bridge should remain closed to traffic and that the girders could not be repaired.
