SPECIAL REPORT

Lessons Learned from the Kobe Earthquake — A Japanese Perspective

Hiroshi Muguruma Ph.D.

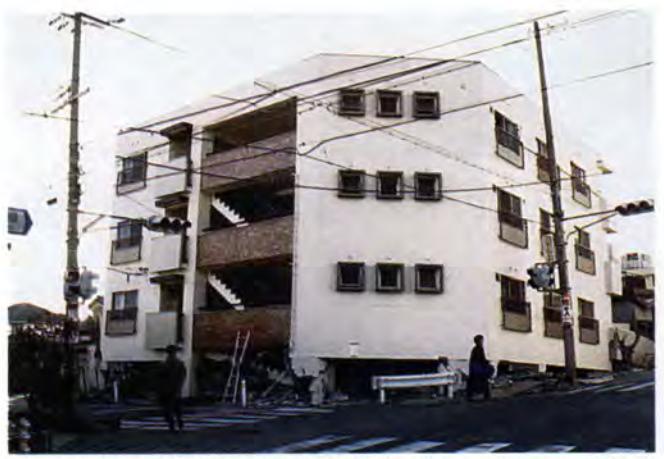
Fig. 10. A pre-1981 apartment building that collapsed at the soft first story.

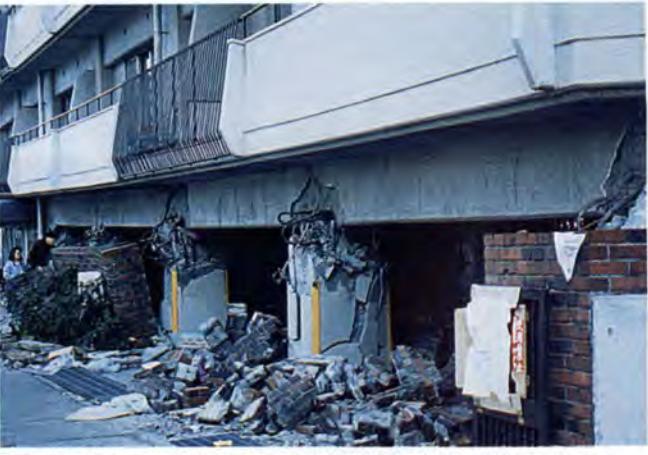
Fig. 11. A pre-1981 apartment building that collapsed at the soft first story.

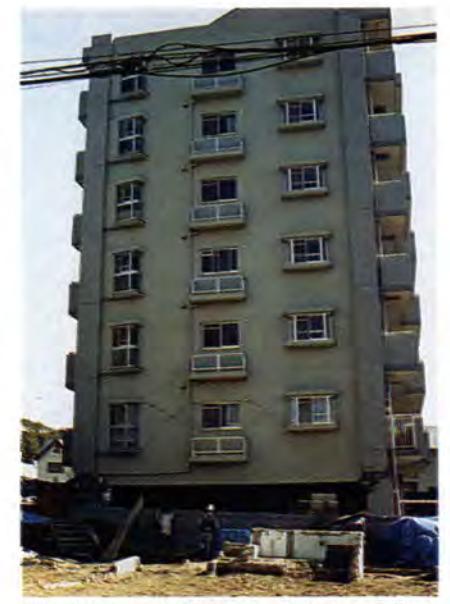
Fig. 12. A post-1981 apartment building that collapsed at the soft first story.

quirements collapsed in the open first story (see Figs. 12 and 13). The collapse calls attention not only to a uniform distribution of story stiffness along the height of buildings but also to an excessively weak story, compared to the other stories, even if it has greater story shear strength than that specified by the code.

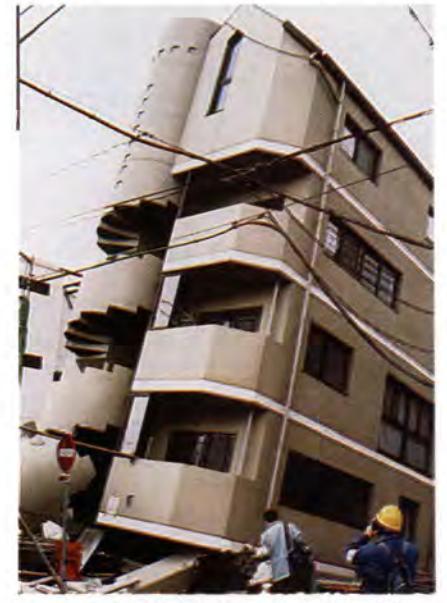
Fig. 13. A post-1981 apartment building that collapsed at the soft first story.

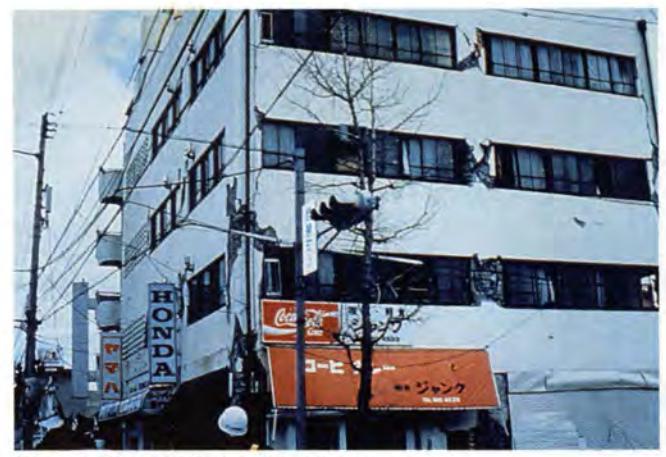
Numerous columns and walls were observed to fail in shear. Such failures were pointed out in past earthquakes. This kind of damage can be attributed to short columns, insufficient shear reinforcement, no cross-tie or supplemental ties, and inadequate construction (see Figs. 17, 18 and 19).

Fig. 17. Shear failure of short columns.

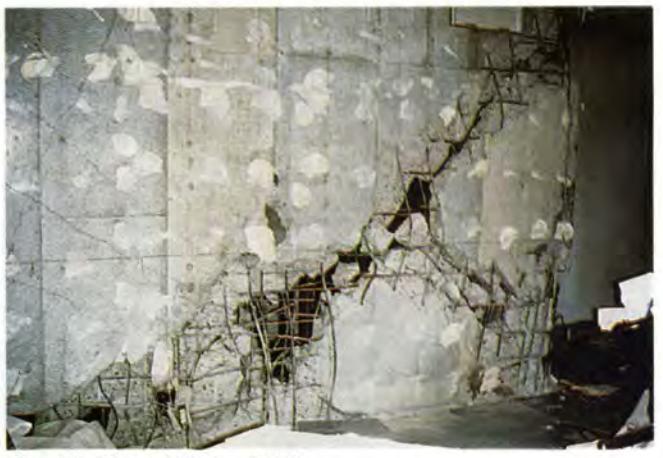
Fig. 18. Shear failure of walls.

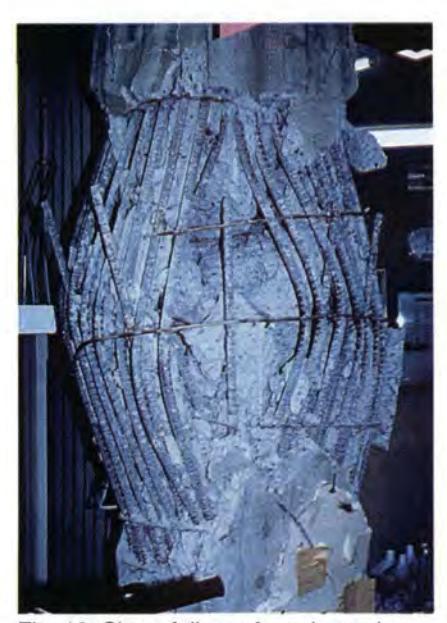
The observed damage to the columns in the Kobe earthquake and other past earthquakes indicated that a 90-degree hook followed by relatively short extensions cannot prevent columns and walls from failing in shear. A 135-degree hook of transverse reinforcement and sufficient extensions must be provided, as required in the current codes. Use of closed ties and cross-ties is recommended, especially when the column section is large and ductility demand is high. Even a 135-degree hook was found ineffective in some cases because of spalling of cover concrete.

Brittle fracture at the bent was observed in the transverse reinforcement. This may be due to the poor quality of 9 to 13 mm (0.35 to 0.51 in.) diameter bars.

Fig. 19. Shear failure of a column due to inadequate transverse reinforcement.

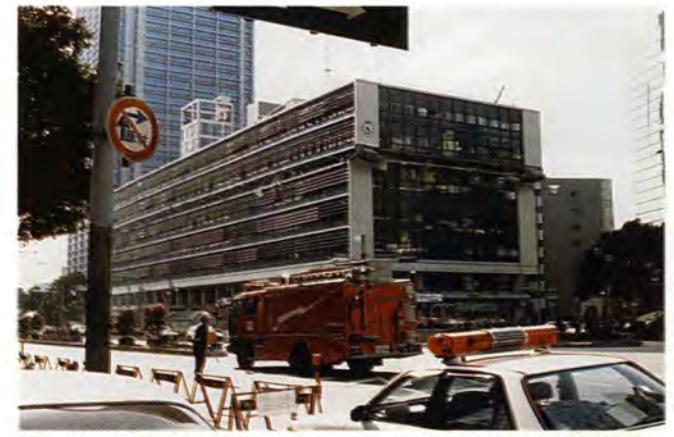
A conspicuous mode of failure of reinforced concrete buildings in the earthquake is the story collapse at a midheight story (see Figs. 20, 21 and 22). Several reasons described below are potentially responsible for these collapses:

Fig. 20. Kobe City Hall, which collapsed at the sixth floor.

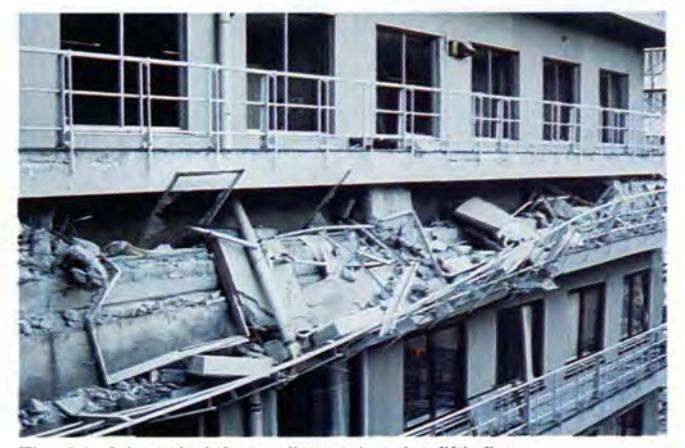
Fig. 21. A hospital that collapsed at the fifth floor.

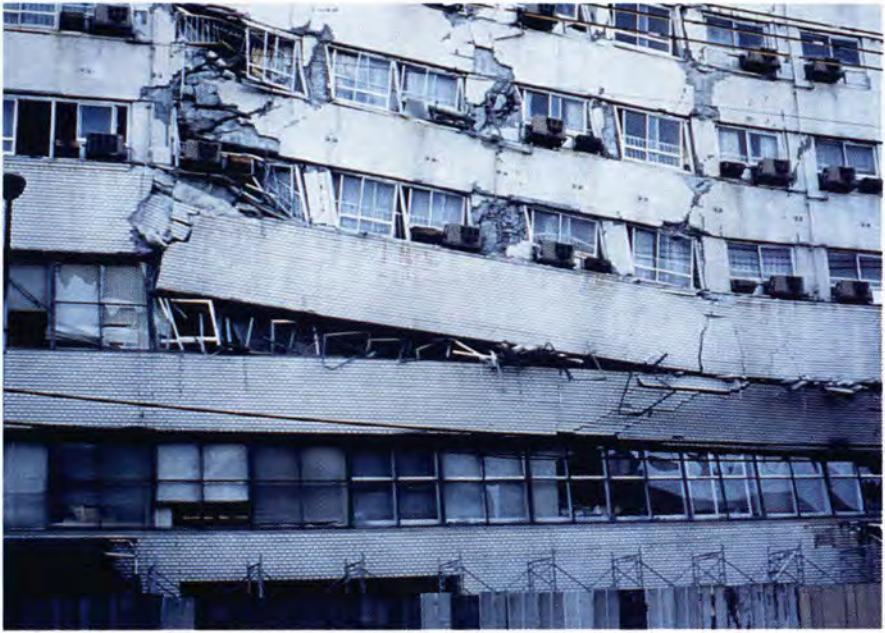
One building had a structural wall on one side of the perimeter in the first floor. The other three sides were open. The building sustained damage in columns on the open sides due to torsional response. Members susceptible to larger force and deformation demands due to plan eccentricity need to be designed recognizing their actual stiffness and strength properties and the impact of these properties on torsional response. Buildings should be as regular as possible.

Fig. 22. An apartment building that collapsed at the third story due to torsion resulting from eccentricities of stiffness and mass.

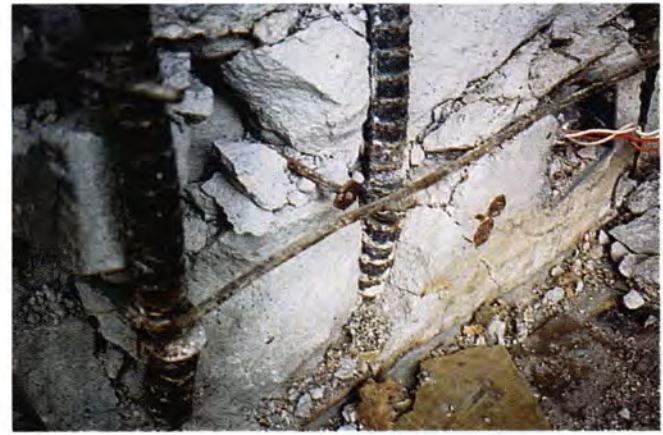
fracture in the earthquake (see Fig. 24). Investigation is needed to identify the causes of the fracture.

Fig. 24. Failure of gas-pressure welded reinforcement splices.

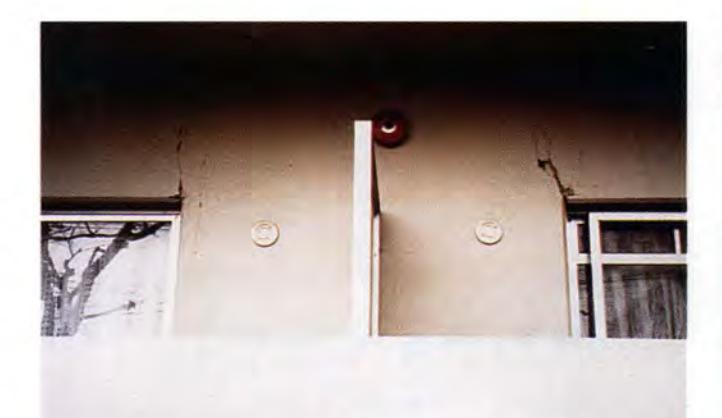
Fig. 27. Cracks at the beam-to-column interface — an indication of the formation of beam sidesway mechanism (building pictured in Fig. 25).

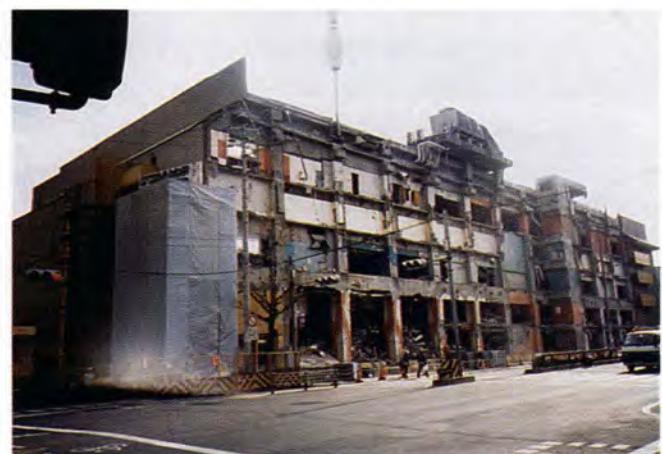
Fig. 28. Prestressed concrete building with extension of steel tumbled down.

The most devastating damage of a concrete structure was found in a fourstory bowling arena that was built in 1973. The building had an extension made of steel in the front, half of which completely tumbled down (see Fig. 28). The beams of the fourth story are 37.2 m (122 ft) cast-in-place prestressed concrete. The total beam

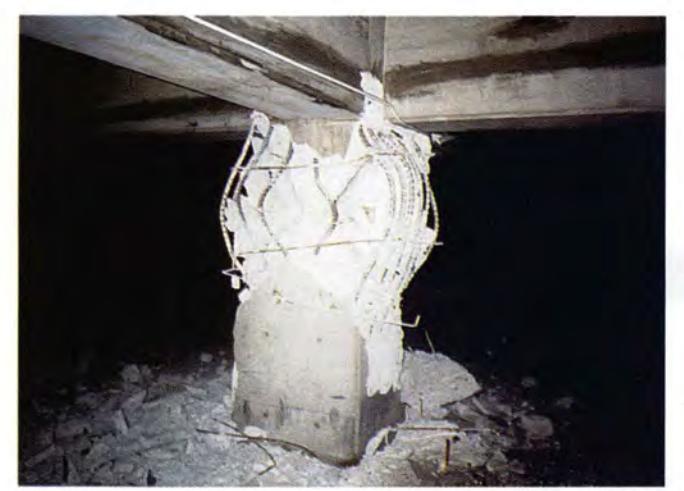
Fig. 29. Shear failure of a column in the second floor of the building shown in Fig. 28.

Almost half the inner reinforced concrete columns and several peripheral columns in the second story failed in shear (see Fig. 29). The column section was 1000 x 1000 mm (39.4×39.4 in.) with a clear height of 4 m (13 ft). The third story had columns only on the peripheral frame. Therefore, the vertical load of the fourth story was mainly transmitted to the peripheral columns in the second story.

A small column axial load resulted in reduction of shear resistance. This, as well as insufficient transverse reinforcement, may be a reason for the column failure. Several severely damaged columns were observed in the first floor as well. The spacing of the transverse reinforcement of D13 of the columns was 150 mm (5.9 in.).

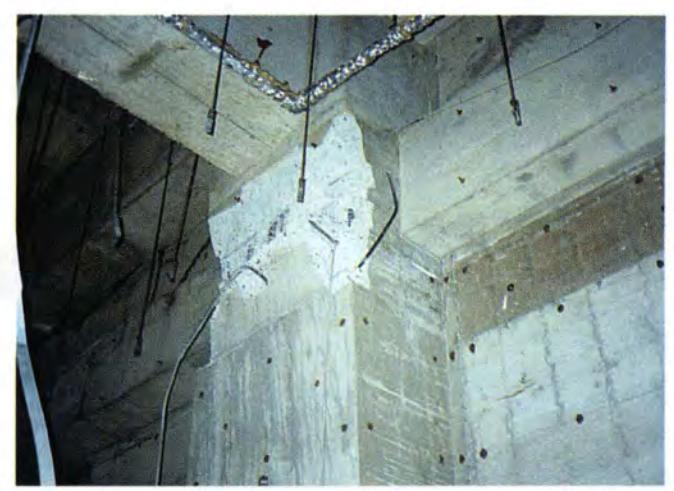
Fig. 30. Damage to a column that supported a prestressed concrete beam.

The most typical type of damage to prestressed concrete building structures was found in this building: a column failure prior to yielding of the prestressed concrete girders and beams that frame into the column. Fig. 30 shows the top of a column in the third floor that a prestressed concrete beam was framed into. Immediately below the beam, the column had its cover concrete spalled off.

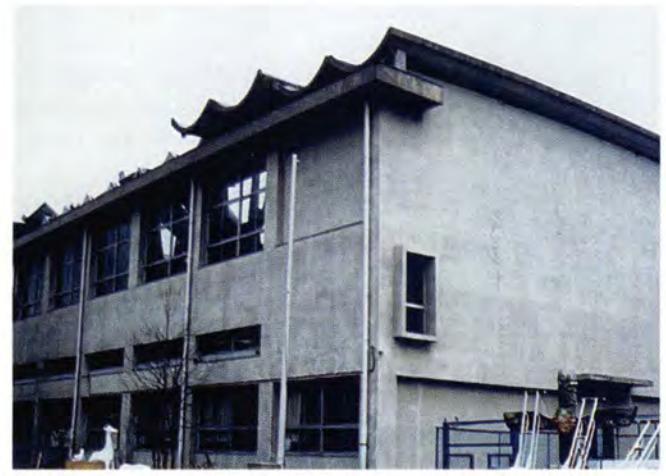
Fig. 31. A gymnasium of an elementary school in which precast, prestressed concrete roof shells fell down.

The newer one was a gymnasium of an elementary school (see Fig. 31). The building had 17 precast, prestressed concrete panels as the roof. The roof panels were supported by the pillow beams at both ends through a rubber plate. Steel bolts were used to

A relative movement between the panel and the pillow beam is considered to be about 100 to 150 cm (39 to 59 in.). The failure of the reinforced concrete columns would trigger off the drop of the roof panels. The precast panels were installed to absorb the distance change between the supports. However, the reinforced concrete frame that supported the panels was so flexible that the movement seemed to exceed the margin.

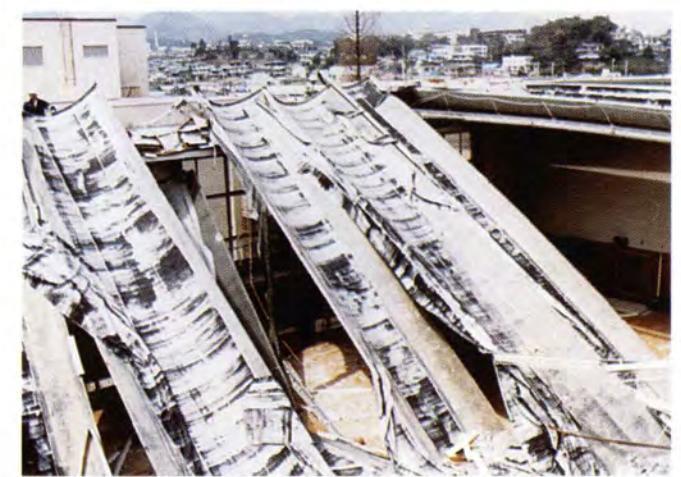
Fig. 32. Seven pieces of the precast, prestressed concrete roof shells fell down.

fasten them. Seven pieces fell down on to the ground (see Fig. 32). In some cases, one end of the panel was left on the top peripheral beam. The columns on the third floor failed in flexure at the place where some of the longitudinal reinforcing bars terminated and the number of the bars was reduced (see Fig. 33).

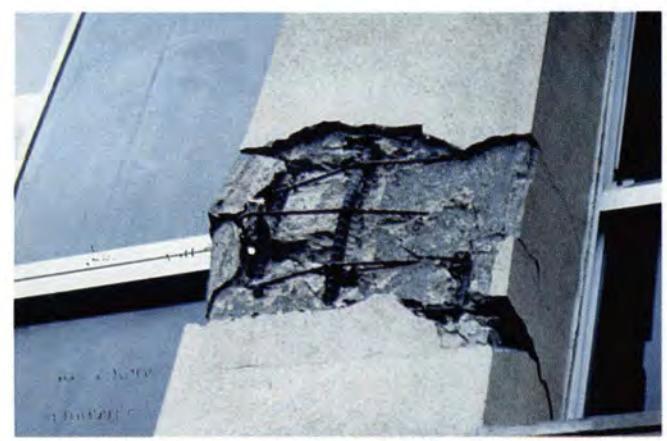
Fig. 33. Damage to a column of the gymnasium shown in Fig. 31.

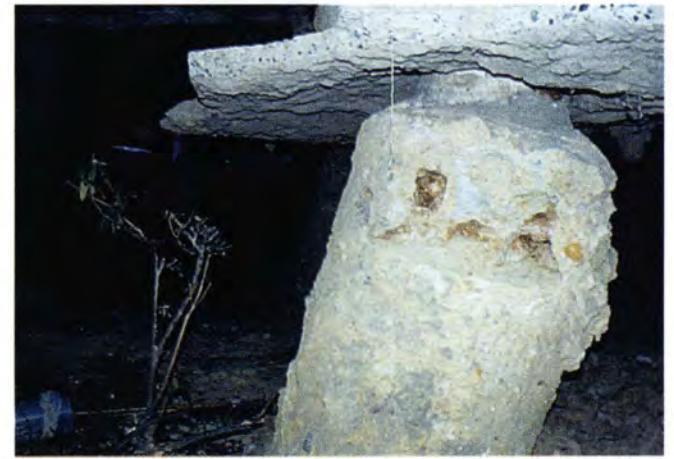
Fig. 34. Damage to a pile.

In the Kobe earthquake, large ground settlements and landslides exposed damage to foundations and piles (see Figs. 34 and 35). An effort to identify the damage to piles has also been made. Excavations for the inspection of piles with 8 and 10 MPa (1160 and 1450 psi) prestress levels revealed shear failures at pile caps. Nondestructive examinations by impact wave propagation indicated that the failure or severe cracks probably occurred at the middle or tip portion of the piles. It is anticipated that piles with 4 MPa (580 psi) average prestress will reveal severe damage, although their inspection has not started as of this date.

Piles are currently designed to resist elastically the seismic design load of 20 percent of the total weight of the superstructure, while superstructures are required to be designed plastically against the seismic design load corresponding to a base shear coefficient of 0.3 if they are ductile frames. Therefore, piles should be designed in the same way. Presently, precast, prestressed spun concrete piles are not provided with transverse reinforcement for resisting shear and for confinement of compressed concrete. It is also recommended that ductile piles with transverse reinforcement be used.

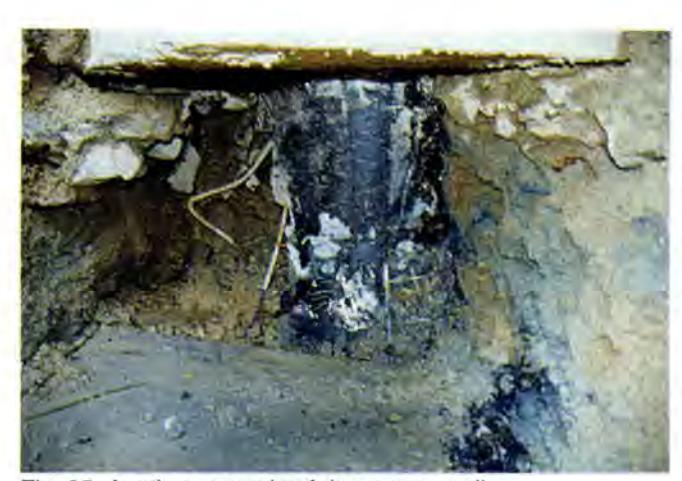
Fig. 35. Another example of damage to a pile.
