SPECIAL REPORT

Observations on the Performance of Structures in the Kobe Earthquake of January 17, 1995

S. K. Ghosh, Ph.D. Director Engineering Services, Codes and Standards Portland Cement Association Skokie, Illinois

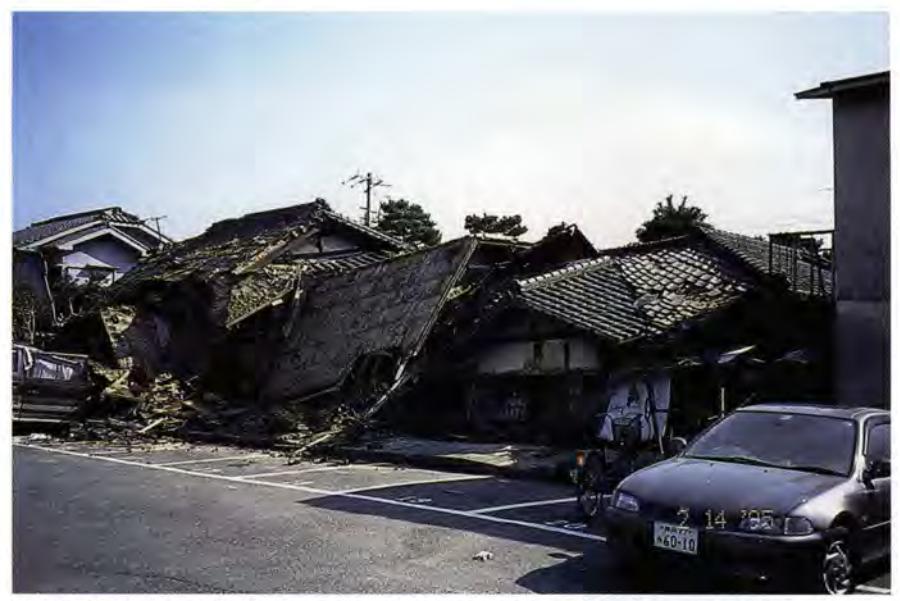
Fig. 3. Collapse of timber houses with heavy roofs and inadequate walls.

Most deaths and injuries occurred in one- or two-story houses accommodating one or a small number of families. Such houses in Japan are almost invariably built of timber post-andbeam construction (see Fig. 3). The roofing consists of ceramic tiles that, in older houses, are set in an insulating layer of clay or mud. Walls between the posts consist of either bamboo thatch (traditional Shinkabe construction) or a lattice-work of thin wood strips (more modern Okabe construction), with a thin layer of plaster on the outside. These types of walls obviously have a very poor resistance to lateral loads. The weight of the clay and ceramic tiles on the roof, combined with the inadequate walls, contributed to the total or partial collapse of many of these houses.

Also contributing significantly to such failures was the traditional Japanese practice of constructing wooden houses using interlocking

parts of wood, without the use of nails or other positive (non-wood) connectors. "Thus, during severe shaking, beams frequently pulled out of their socketed supports in columns or other beams, leading to the immediate caving-in of the supported story."5 Traditional houses built in recent years have had to comply with specifications requiring extensive nailing, the use of steel connectors, and provision of walls as a percentage of the total floor area. These and other newer houses, some of "2 by 4" or stud wall construction (imported from the United States) performed well.

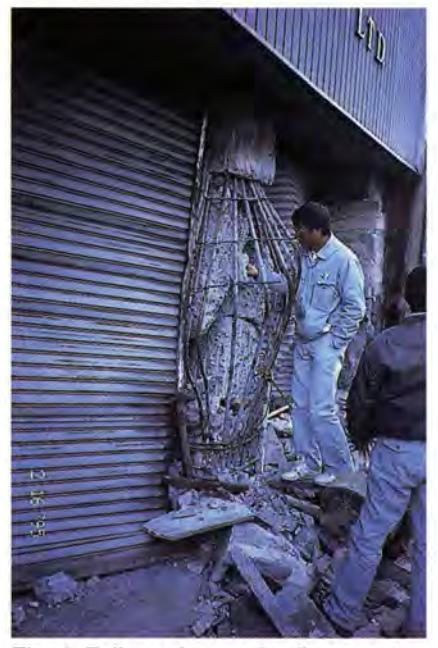
Fig. 4. Failure of a nonductile concrete column.

After residential construction, nonductile concrete columns were the second biggest factor in Kobe's devastation. Concrete columns built before 1971, when Japan changed its seismic design codes, were nonductile, i.e., deficient in transverse reinforcement that provides shear strength and confines the concrete in compression. Failures of these columns (see Fig. 4) were responsible for the total or partial collapse of buildings (discussed in the next section) and railway and highway bridges.

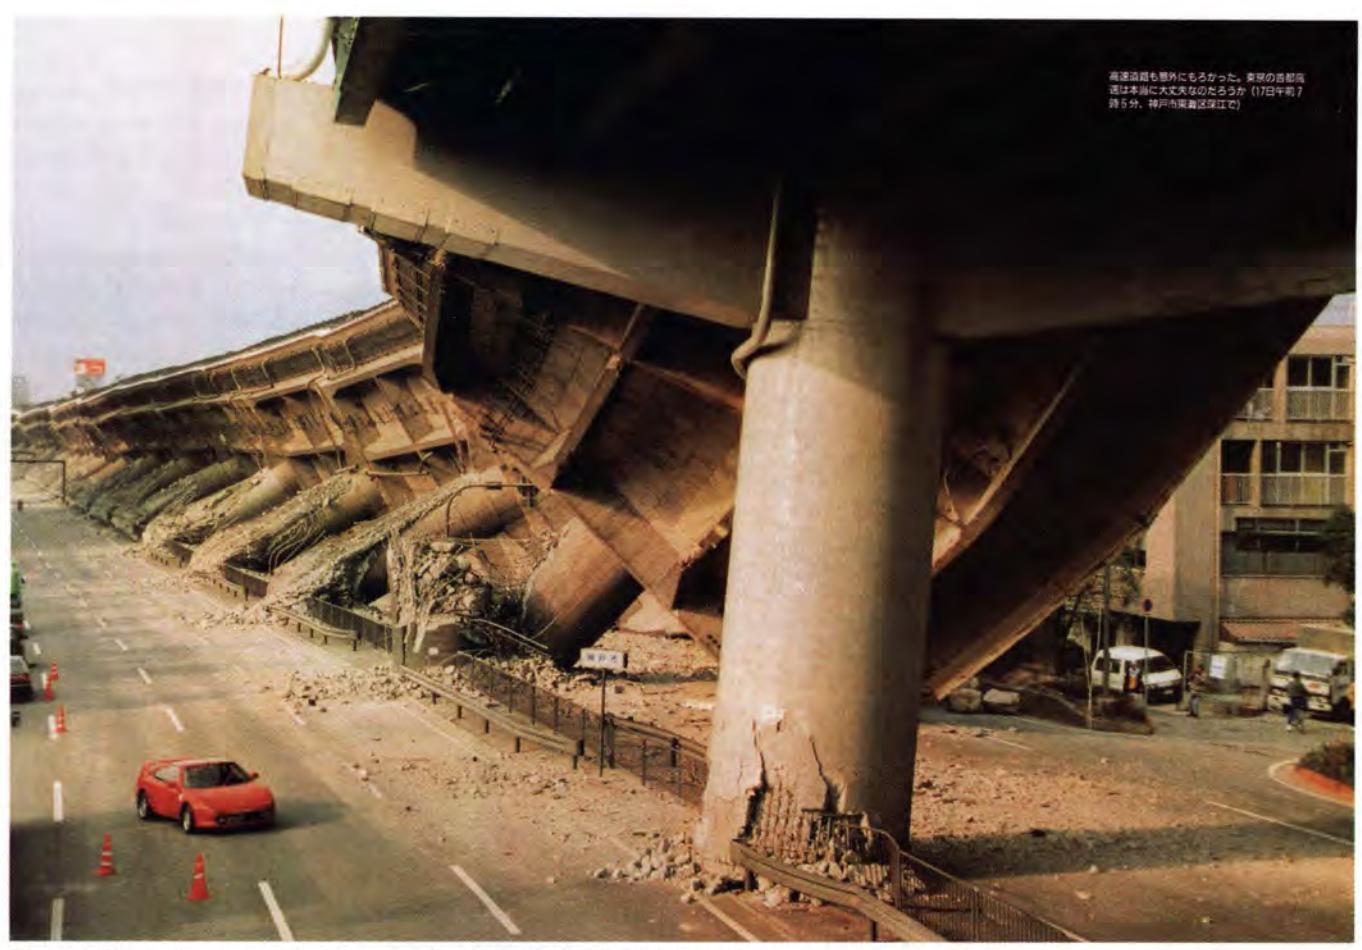
Fig. 5. Failure of a segment of the elevated Hanshin Expressway system.

A stretch of the Hanshin Expressway approximately 2000 ft (600 m) long in Nishinomiya, east of Kobe, suffered what is probably the most spectacular failure caused by the earthquake (see Fig. 5). The superstructure had changed from steel to

concrete in this stretch, thus increasing the mass considerably. The lower ends of the single column supports failed and allowed rotation of the deck until the edge was resting on the roadway below. The columns failed in shear at a location where flexural hinging had apparently occurred because of premature discontinuation of a significant portion of the longitudinal steel at a particular section.

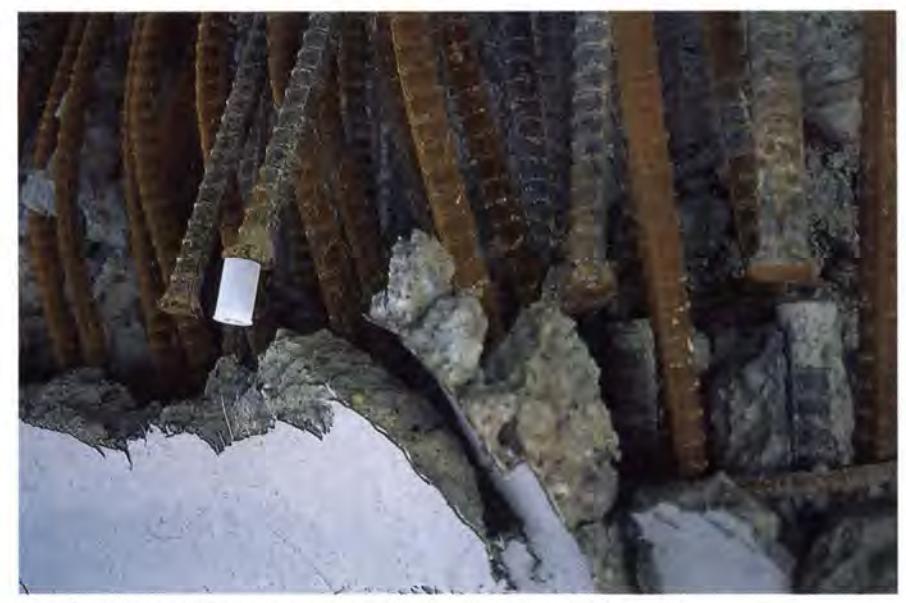
Fig. 6. Failure of "gas-pressure welded" splices in a bridge pier.

A fairly common feature of bridge column failure was the popping of "gas pressure welded" splices, which represent fairly common Japanese practice (see Fig. 6). These splices failed frequently in older bridges, less frequently in older buildings, and occasionally in new construction.

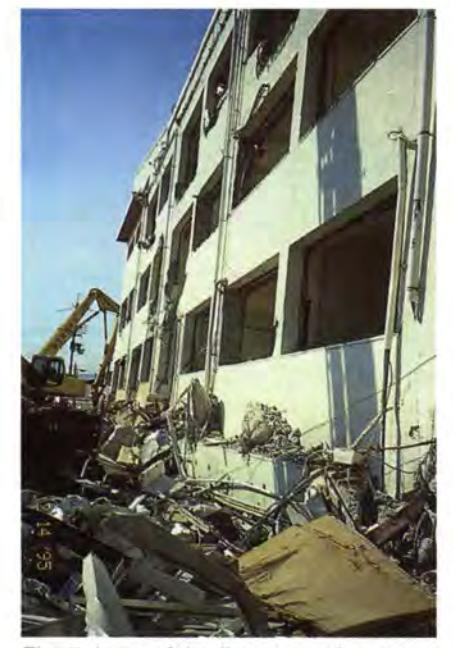
Fig. 7. Loss of the first story of a nonductile concrete frame school building.

Many of the story failures occurred in the first story above ground. This is

quite often a soft story because it is usually taller than the other stories and also because shear walls are quite often discontinued below this level to have open space for stores or ballrooms or other column free spaces. Sometimes, the building leaned without collapsing. Other times it collapsed (see Fig. 7).

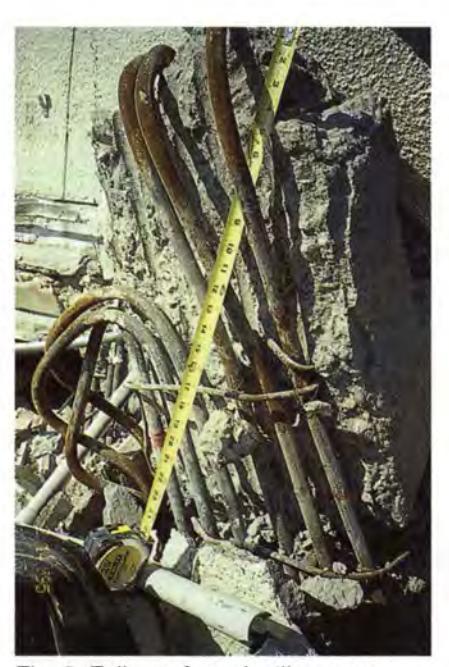
Fig. 8. Failure of nonductile corner column of building depicted in Fig. 7.

The nonductile columns not only lacked transverse reinforcement, but quite often contained smooth, rather than deformed, longitudinal bars (see Fig. 8), which apparently continued to be used in Japan after their use was discontinued in the United States. Also, soft-story failures were not limited to concrete buildings. Fig. 9 shows a wooden building that is leaning because of soft-story failure.

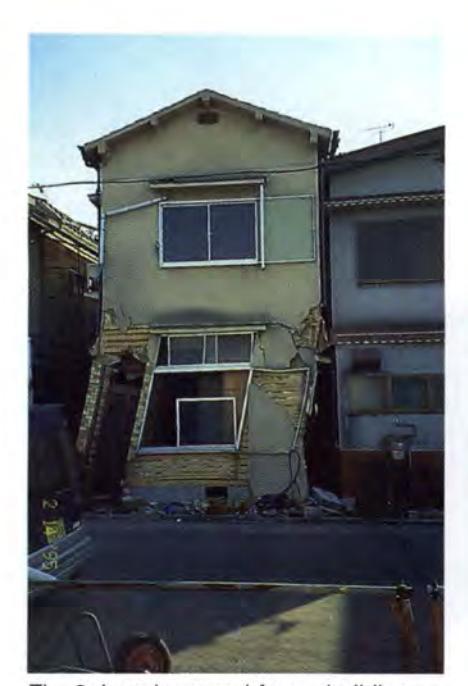
Fig. 9. Leaning wood-frame building with soft first story.

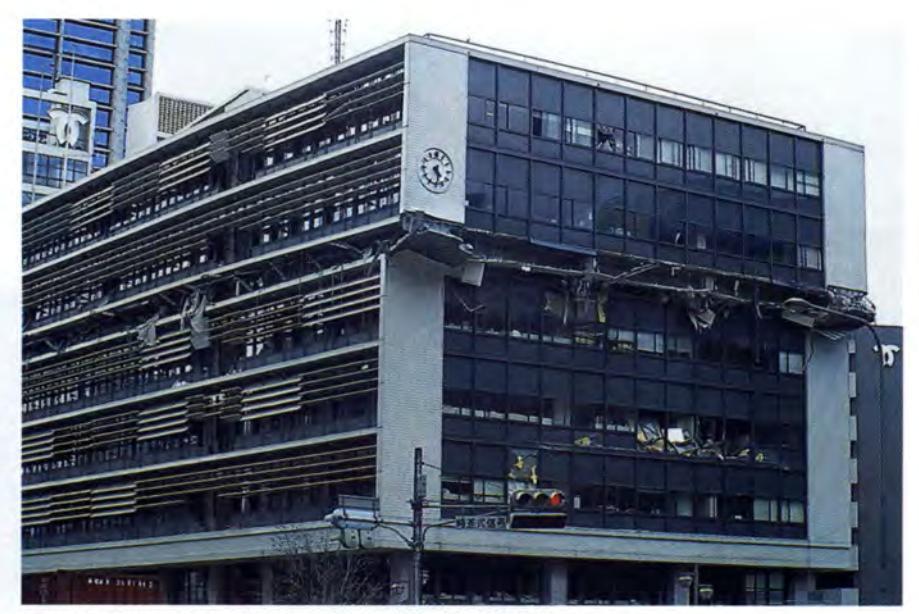
Soft-story failures also occurred at various locations along the heights of multistory buildings. Almost invariably, there was a stiffness discontinuity at the level that failed. The reasons could be discontinuation of shear walls, column section changes that used to be frequent in older designs, geometric offsets (setbacks) and other factors. Fig. 10 shows the Kobe City Hall, which pancaked in the first level above the location where SRC columns ended and RC columns began. Across a corner from the City Hall was a building that pancaked at

Fig. 10. Pancaking of floor in Kobe City Hall building.

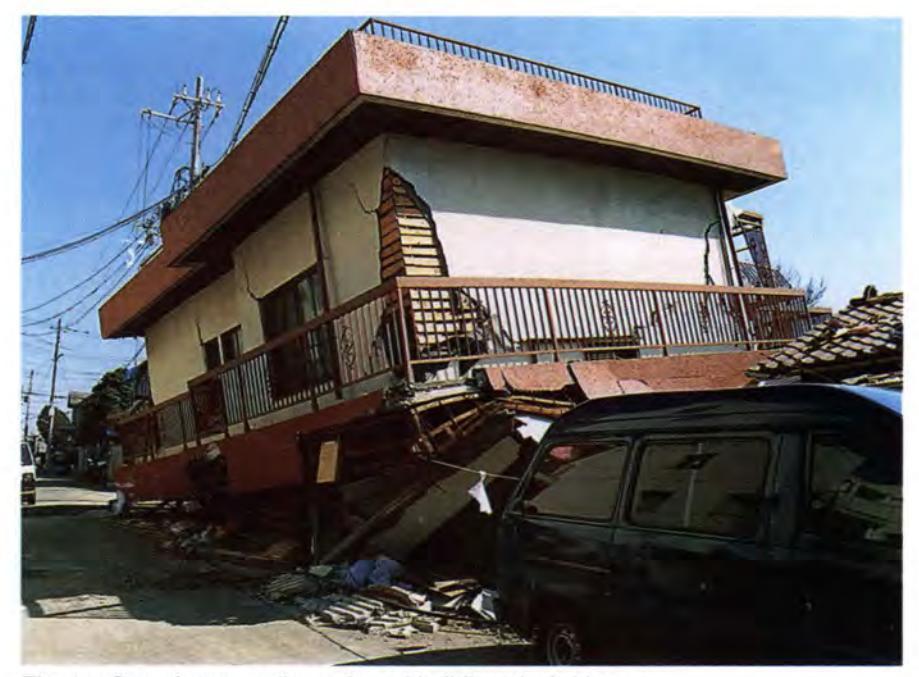
Fig. 11. One of many collapsed steel buildings in Ashiya.

Many older steel buildings dating back to the early 1960s, which were designed and constructed without much regard for seismic considerations, suffered a considerable amount of damage. "The potential ductility of these buildings is severely limited as the coldformed steel sections used for columns will typically develop local buckling prior to attainment of their plastic moment capacity."⁵ Many such buildings collapsed in Ashiya (east of Kobe) and other places (see Fig. 11). Others that survived often shed their cladding.

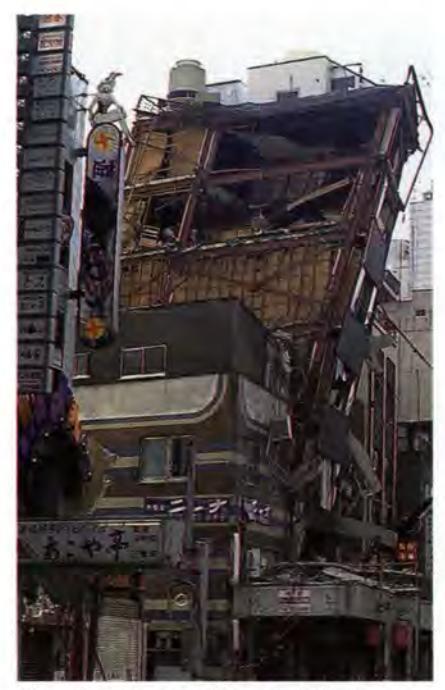
Fig. 12. Severely damaged steel braced frame building in Sannomiya district of Kobe.

A large number of braced frame buildings suffered damage, sometimes to the point of being rendered useless (see Fig. 12). Generally, frames with slender braces had the braces rupture in tension or buckle in compression; these braced steel frames performed quite poorly. Frames with more substantial braces also experienced brace buckling, gusset buckling and fractures.

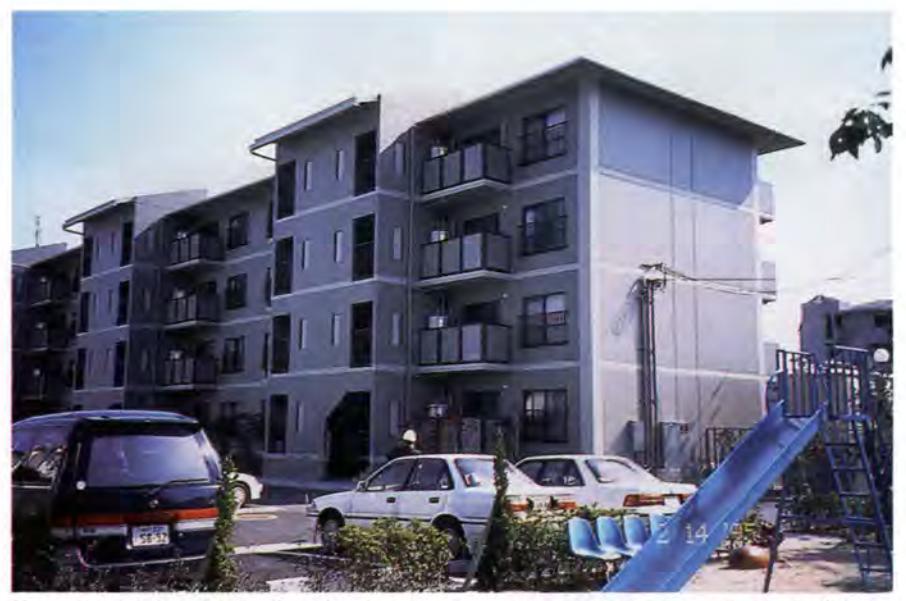
Fig. 13. Satisfactorily performing low-rise precast, prestressed apartment building in the Kobe area.

"The typical construction consisted of generally stiff, mid-rise shear wall structures utilizing NMB Splice Sleeve connections to tie the shear walls to the foundation system, and to connect the stacked shear walls to each other. This system permits ductility to occur, if required, in the grouted reinforcing bars encased by the NMB Splice Sleeve. The group inspected three of these structures (see Figs. 13 to 15) and found no damage in the precast concrete structures themselves, and only minor spalling or cracking in the cast-in-place concrete at the location of the splice to the foundation, in a few areas. These structures did not suffer any functional damage and were ready for continued occupancy immediately after the earthquake, except in certain cases where soil subsidence adjacent to the structure may have cut off some of the utility services connected to the building."

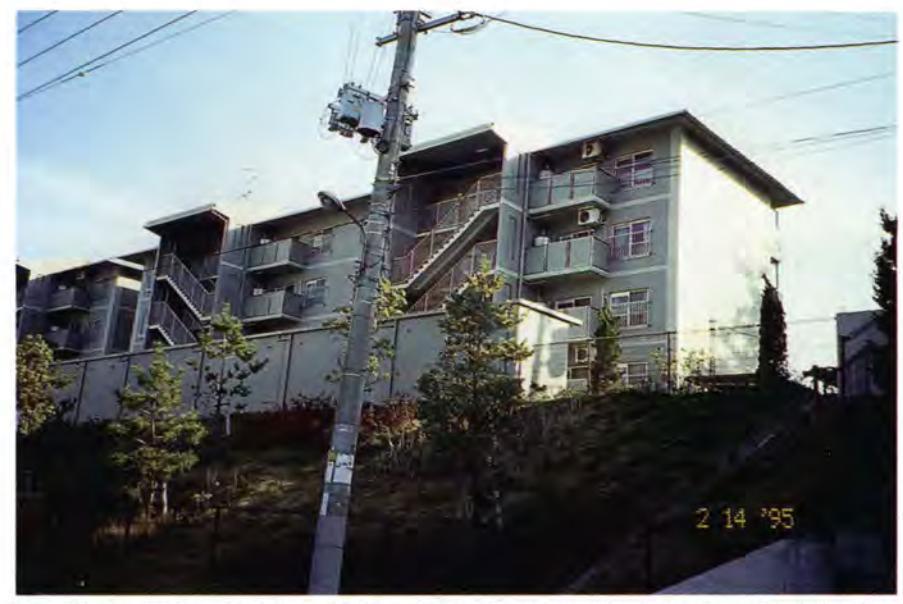
Fig. 14. A second undamaged low-rise precast, prestressed apartment building in the Kobe area.

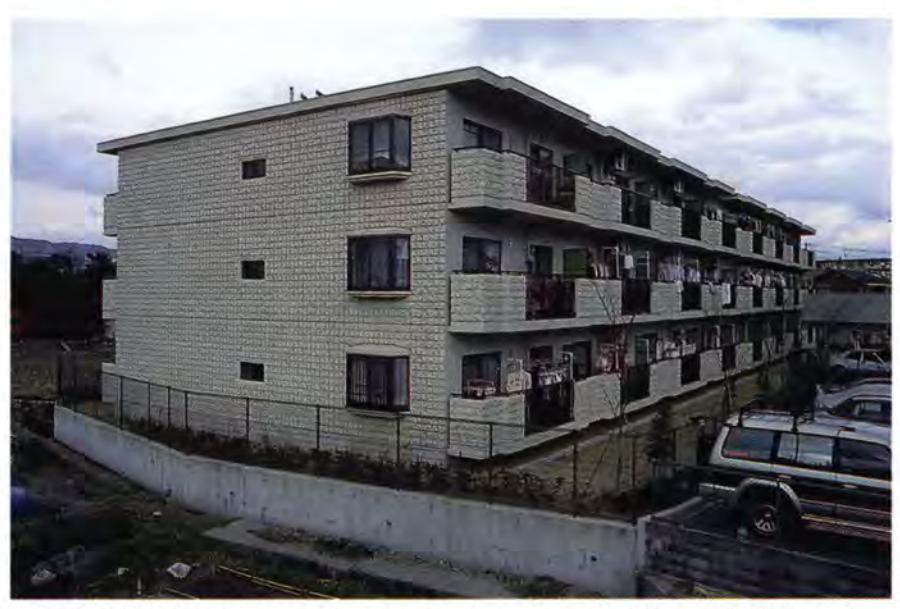
Fig. 15. A third low-rise precast, prestressed apartment building exhibiting good performance in the Kobe earthquake.

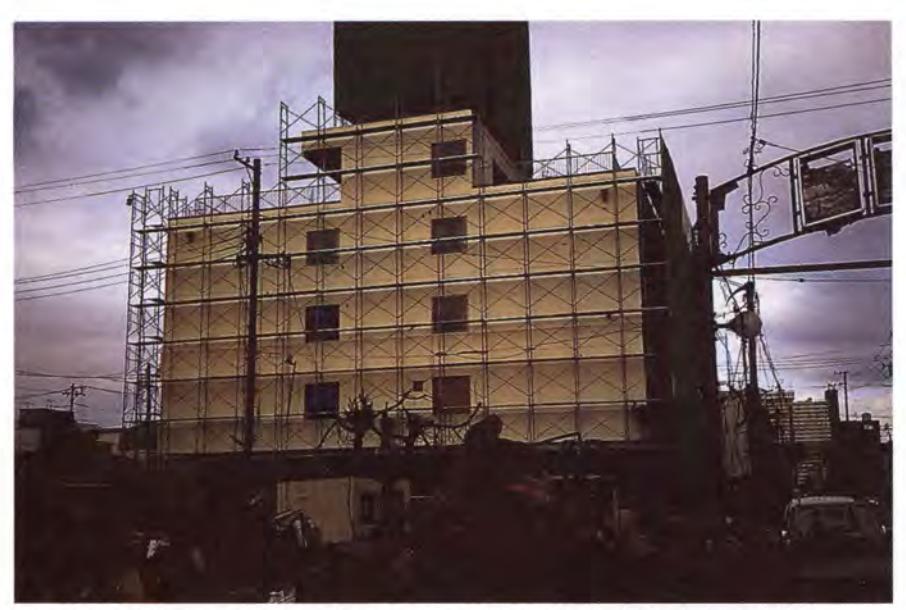
One impressive performance by a structure was the survival of the Takahashi Hospital in Nagata-ku (see Fig. 16). This five-story concrete shear wall structure not only survived the strong earthquake with no apparent damage, but also survived the intense fire that engulfed virtually everything around it. The hospital reportedly continued with normal operations immediately following the earthquake.

Fig. 16. Undamaged reinforced concrete shear wall hospital building amidst widespread fire damage at Nagata-ku.
