# Investigation of repair techniques for deteriorated end regions of prestressed concrete bridge girders

William B. Rich, Christopher S. Williams, and Robert J. Frosch

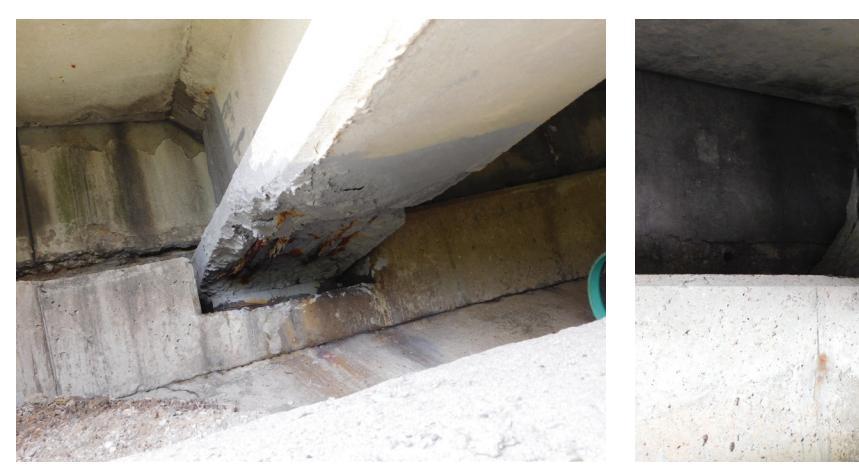
Deterioration of bottom flange

Deterioration within web

Figure 1. Prestressed concrete bridge girders with end region deterioration.

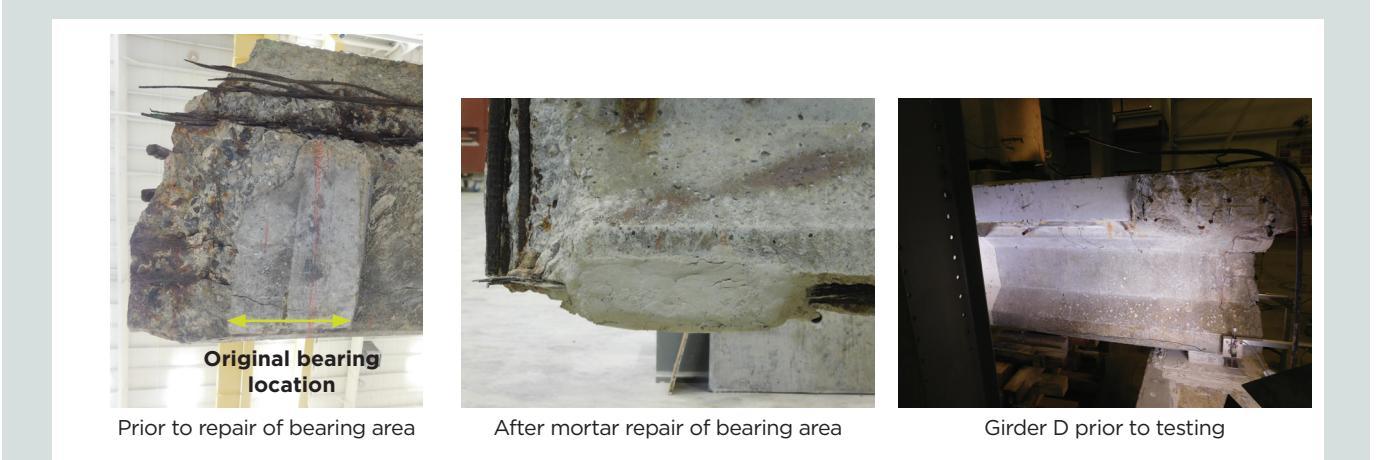
Figure 9. Reestablishing bearing area of girder D.

to reestablish the bearing area of the girder (**Fig. 9**) to permit testing. This was accomplished with the application of a prepackaged 6500 psi (45 MPa) fast-setting mortar mixture with low-shrinkage characteristics. To minimize the extent of the repair, the location of the bearing pad was shifted into the girder span by 4 in. (100 mm) from its original location while the shear span of the girder remained at 45 in. (1140 mm) (Fig. 3).

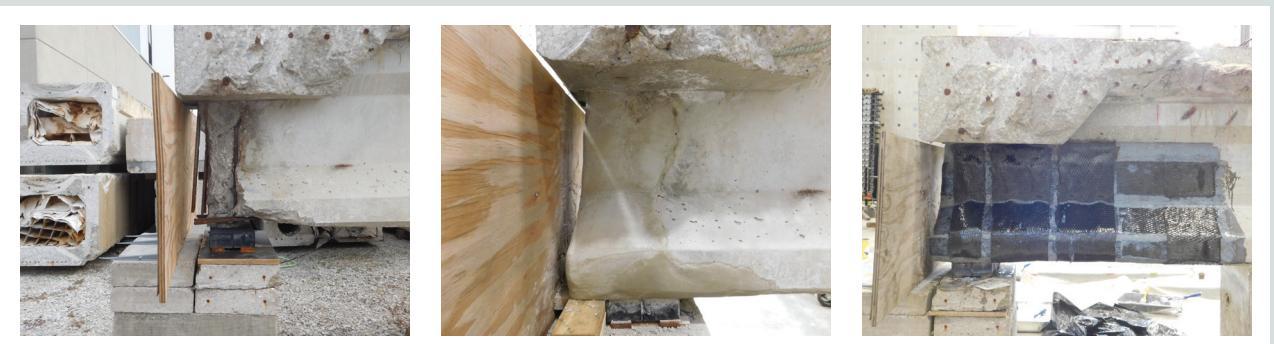
Deteriorated end region

#### Figure 10. Progression of externally bonded fiber-reinforced polymer (FRP) repair for girder R-EXT.

Figure 10 presents the progression of the repair for girder R-EXT. The repair began by using an electric chipping hammer to remove delaminated and loose concrete from the end region until sound concrete was reached. The regions where concrete was removed or had previously fallen from the specimen were then sandblasted to remove corrosion product and mitigate microcracking caused by the chipping hammer. Next, the original cross section of the girder was restored by applying the same fast-setting mortar used to reestablish the bearing area of girder D. After the mortar cured, the surface of the concrete and mortar to which FRP was to be applied was sandblasted to a concrete surface profile of 3, as defined in the International Concrete Reinforcing Institute's ICRI 310.2R-2013<sup>23</sup> and recommended by ACI PRC-440.2R-17.9 Anchor holes were then drilled at the locations in Fig. 5. In accordance with ACI PRC-440.2R-17, the edges of the anchor holes and the corners of the girder around which FRP strips and sheets were to be wrapped were rounded to a radius of 0.5 in. (13 mm) to reduce stress concentrations in the FRP.

After mortar repair

Completed FRP repair

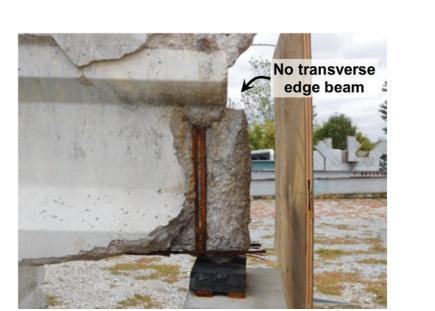
Deteriorated end region

Figure 11. Progression of near-surface-mounted (NSM) fiber-reinforced polymer (FRP) repair for girder R-NSM.

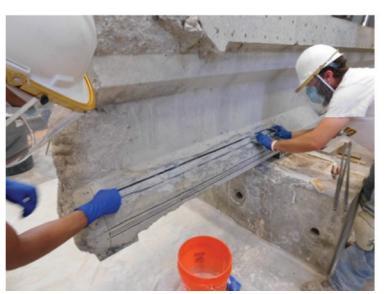
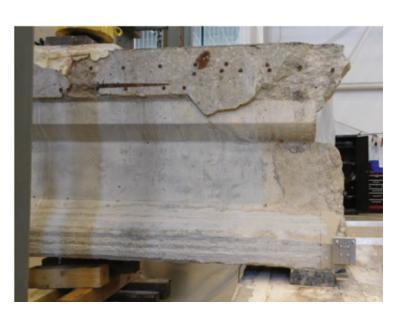
Inserting NSM strips

Completed FRP repair

**NSM FRP repair Figure 11** shows the repair procedure for girder R-NSM. First, unsound concrete was removed and the surface was sandblasted. Then, the cross section of the girder was restored with the same mortar mixture used for girders D and R-EXT. After the mortar cured, the NSM FRP strips were installed in accordance with the following procedure:

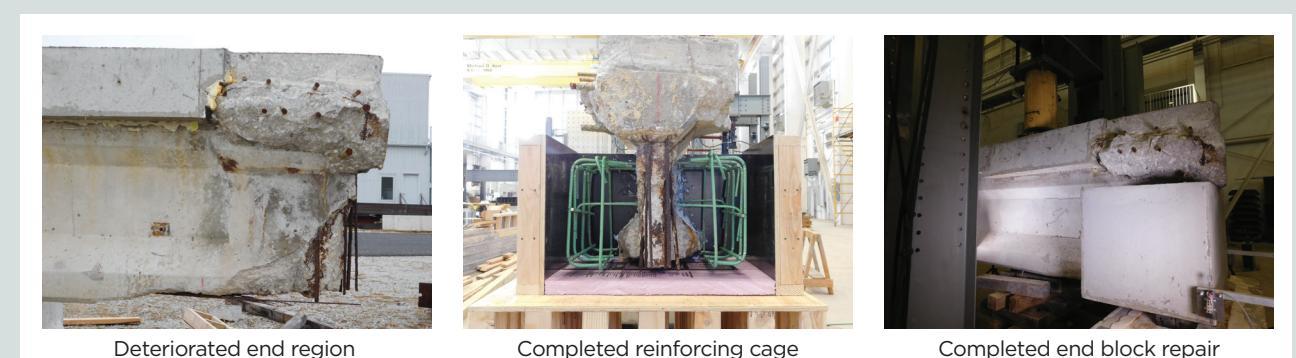
Completed end block repair

## Figure 12. Progression of end block repair for girder R-BLK.

End block repair Minimal surface preparation was performed on girder R-BLK before the end block was constructed. Figure 12 shows the state of the specimen after loose concrete was removed. Figure 12 also shows the reinforcing cage, which was fabricated in accordance with the details in

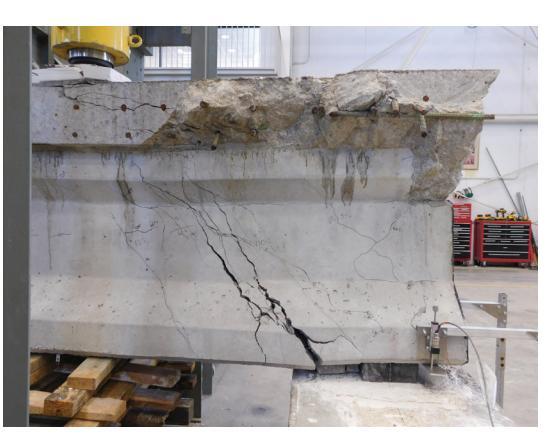
Control specimen (girder C)

Failure of the control specimen was characterized by the formation of a diagonal strut within the test region, corresponding to a crack angle of approximately 43 degrees measured from horizontal (**Fig. 14**). Diagonal cracking developed in the web of the girder at a shear of 98 kip (440 kN). The primary diagonal crack did not extend to the support but instead extended to a point at the bottom of the girder located inside the span from the bearing region. This occurred due to the lack of development of the prestressing strands in the bottom flange near the end of the girder. The load-carrying capacity decreased as the diagonal cracks widened, and widening of the cracks corresponded with slippage of the prestressing strands in the bottom flange at the end of the girder. The ends of the strands slipped approximately 1.25 in. (31.8 mm) into the girder by the end of the test. The relatively sudden loss in load-carrying capacity observed at a deflection of 1.24 in. (31.5 mm) was likely due to strand slip.

#### Figure 14. Control and damaged specimens after failure.

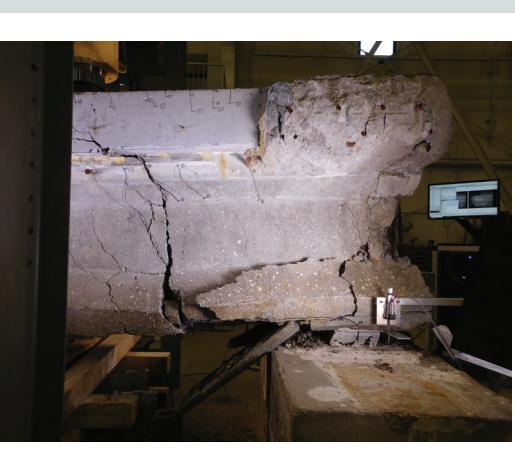
Damaged specimen (girder D)

For the damaged specimen, the primary failure crack (Fig. 14) initiated at the bottom of the component approximately 42 in. (1070 mm) from the end of the specimen at a shear of 61 kip (270 kN), propagated vertically through the web upon further loading, and finally propagated diagonally through the top flange and deck toward the load point. Failure was defined by an abrupt drop in the load-carrying capacity at a deflection of 2.43 in. (61.7 mm) (Fig. 13). By the end of the test, portions of the bottom flange on both sides of the web had detached from the specimen at the support (Fig. 14). This separation of the bottom flange began early in the test due to the deteriorated state of the girder. As indicated in Table 4, the ratio of the shear capacity of girder D to the capacity of girder C is 0.57.

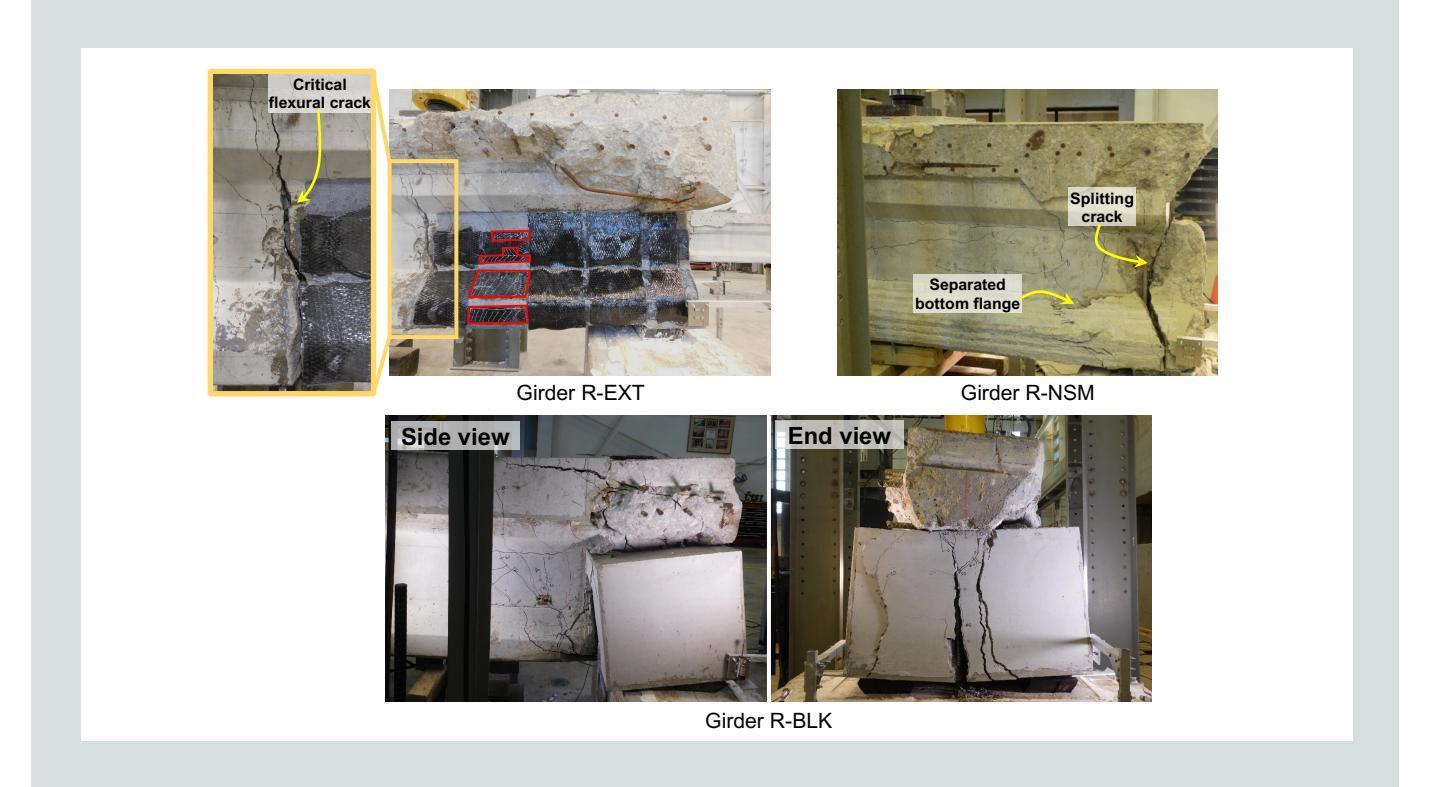
#### Figure 15. Repaired girders after failure.

Minimal FRP debonding from the concrete surface was observed after testing. It was confined to areas along the longitudinal strips that were not directly covered with patches or vertical FRP sheets. Figure 15 outlines the debonded areas on one side of the girder in red. No rupture of the FRP occurred.

The response curve of girder R-BLK presents an initial stiffness similar to that of girder C (Fig. 13). As loading increased, the end face of the girder R-BLK end block began to experience minor cracking at a shear of 8.9 kip (40 kN). At a shear of 44 kip (200 kN), cracking had propagated vertically through the full depth of the end block and extended longitudinally along the bottom of the block. This cracking led to the block eventually splitting into two pieces (Fig. 15). Outside of the end block, a diagonal crack initiated at a shear of approximately 53 kip (240 kN). Diagonal cracking extended from the bottom surface of the girder near the edge of the end block toward the load point, indicating the development of a diagonal strut. The load test was terminated after the interface between the end block and the original girder failed (that is, the end block separated for the concrete of the original girder), and the end block experienced significant rotation relative to the girder (Fig. 15).
