# Reduction of Joint Seepage and Cross-Grouting in Bridge Segments

**Nur Yazdani, Ph.D., P.E.**

**Moussa Issa, Ph.D., P.E.**

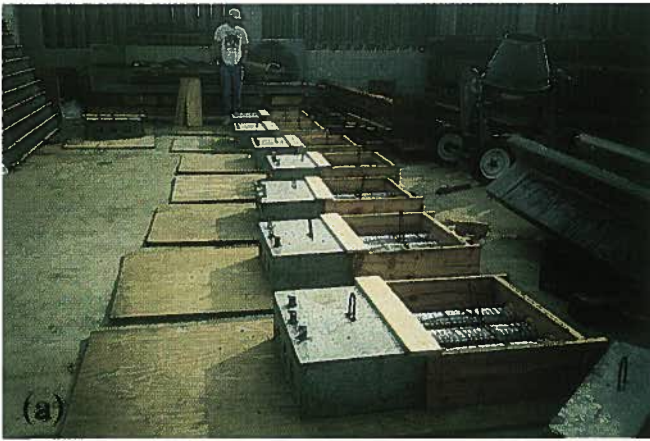
Fig. 3. Details of test setup: (a) Layout of casting cells in yard; (b) Assembly setup for the model segmental beams.

male ring was attached. In order to construct the top strip, a piece of wood was cut to dimensions that are half that of the top strip and attached to the respective bulkheads. The actual casting cells, shown in Fig. 3(a), consisted of three boards and one bulkhead bolted together and screwed down to a single sheet of plywood for the first pour. The match cast segment replaced the second bulkhead.

The segment assembly method used herein resembled the span-by-span technique of utilizing a support truss to assemble the segments of the span, including epoxy application and post-tensioning. The segments were spaced at a 300 mm (12 in.) distance to allow access to the faces for the application of epoxy, as shown in Fig. 3(b).

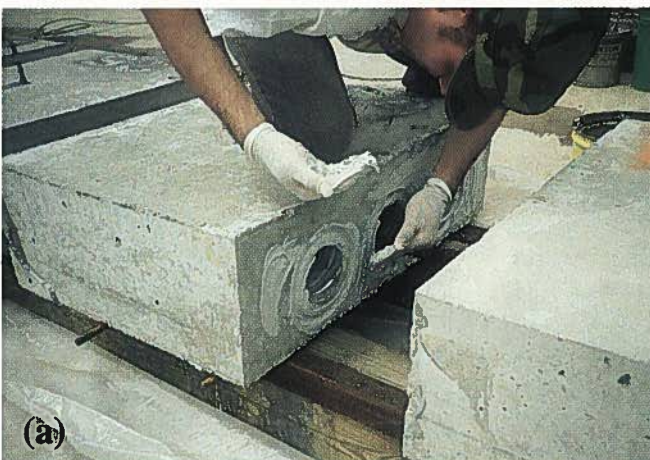
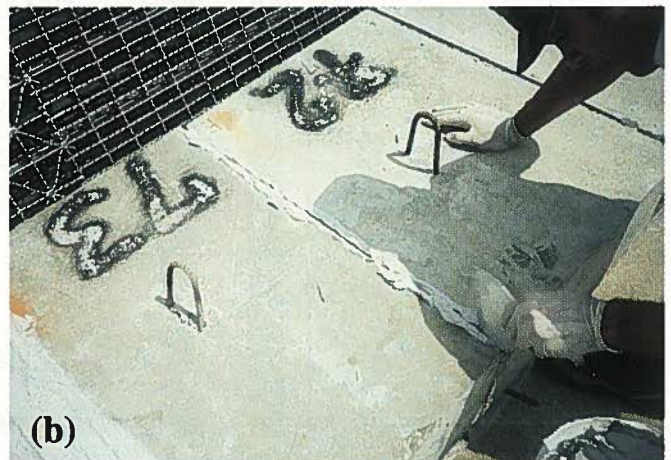
Fig. 4. Details of epoxy application: (a) Epoxy application on annulus and one face; (b) Epoxy application in a typical top strip.

In order to simulate field conditions, the joint faces of Beam 5 were coated with epoxy at an estimated average thickness of 2 mm (0.075 in.), with 12 mm (0.5 in.) edge clearance and 25 mm (1 in.) duct clearance. A large amount of extruded epoxy was observed on the edges and inside the ducts in Beam 6 after post-tensioning. Figs. 4(a) and 4(b) show the applica-

tion of epoxy on the face and annuli, and on the top strip, respectively.

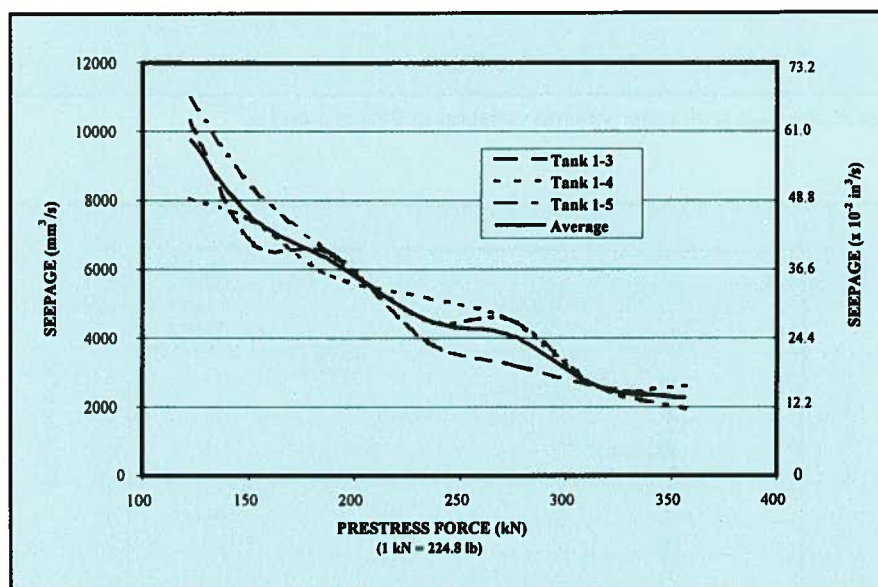
Fig. 7. Effect of prestress level on joint seepage for Beam 1.

The prestress forces and resulting joint stresses for the additional test on Beam 1 are presented in Table 2. Fig. 7 shows that the joint seepage rate decreased by about 770 percent as the post-tensioning force increased about three times.

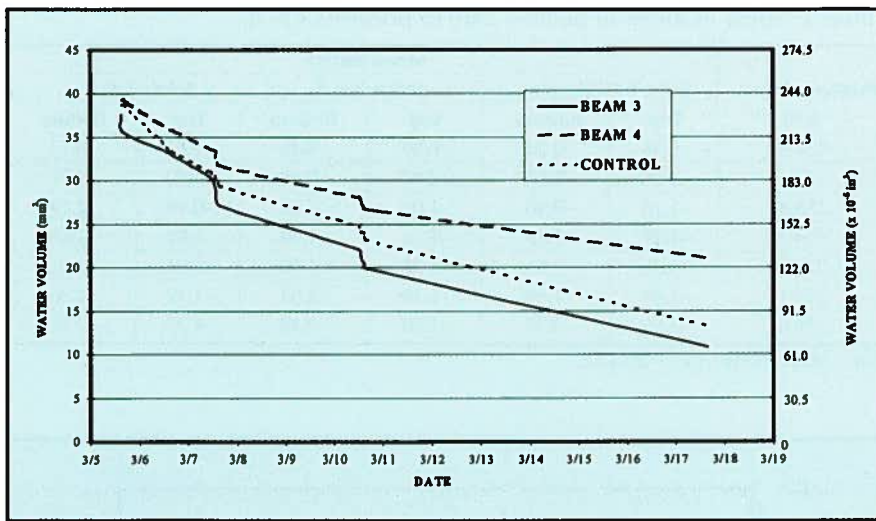
Fig. 8. Average tank water volume variation in Beams 3 and 4.

Fig. 8 compares the average seepage behavior of joints from Beams 3 and 4 in terms of the change in tank water depth. Seepage lines for both beams are nearly linear, which means that the seepage ratios were generally constant. The sudden drops in the seepage lines represent increased evaporation when the tanks were uncovered to take water depth readings.

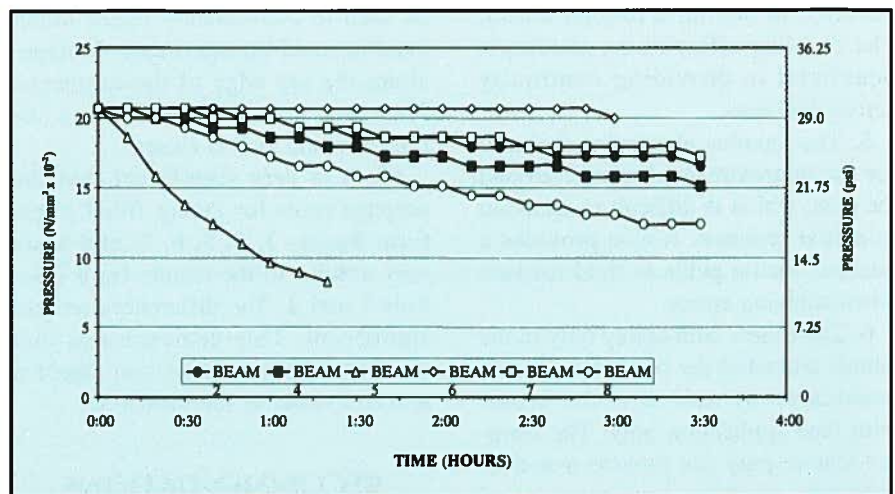
Fig. 10. Pressure variations in beams.

The lowest pressure drops of the multiple tests for each beam are illustrated in Fig. 10. The pressure drop lines for the beams are fairly linear, indicating constant pressure losses with time. All of the beams, except for Beam 5, maintained over 75 percent of initial pressure after one-and-a-half hours and over 50 percent after three hours.

The data for Beam 5 demonstrated that the ducts maintained 50 percent of the initial pressure for at least one hour. The water pressure in Beam 6 remained at  $21 \times 10^{-2}$  MPa (30 psi) for the entire three-hour test period. This beam indicated that the use of annuli with a one-face application created a watertight seal across all of the joints, demonstrating that single-face application with a filled annulus functions well. Excluding Beams 1 and 3, no water leakage from the joint edges of any beams was detected.

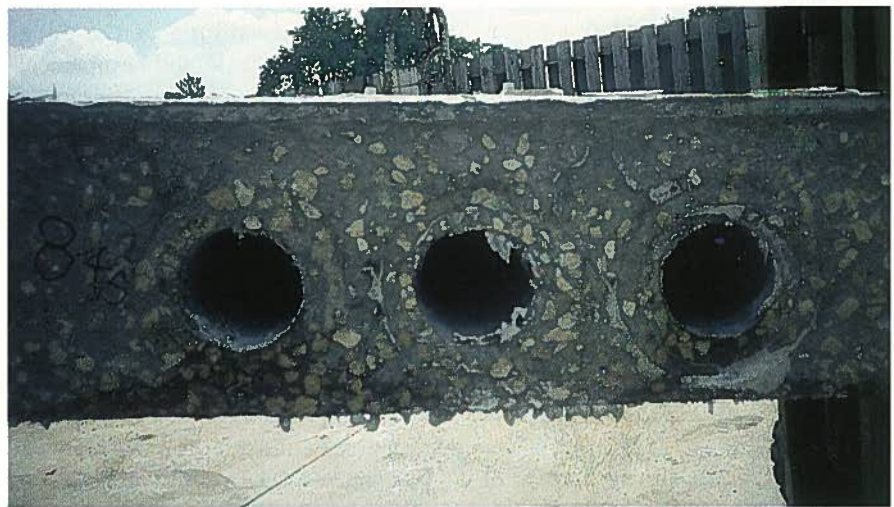
Fig. 11. Joint separation for failure test.

The high bonding strength of the epoxy was evident when Beam 5 failed through the middle of the first segment rather than at a joint. This strong epoxy quality limited the number of separated joints to about two for each beam. The separated joint below Tank 8-4 is shown in Fig. 11.
