INVESTIGATION INTO THE STRUCTURAL PERFORMANCE OF MMFX REINFORCING

Marcus H. Ansley, PE, Florida Department of Transportation

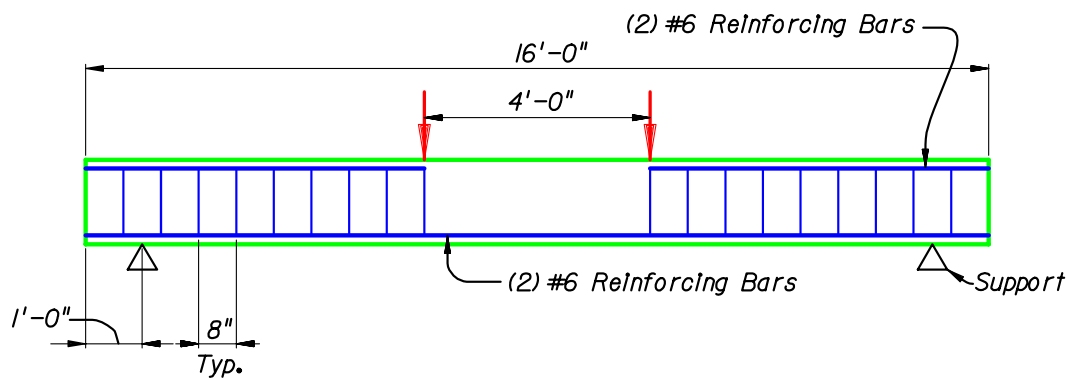
Fig. 1 Typical Beam Test Setup

The test setup for the first three tests can be seen in Figure 1.

For the first test the two number 6 bottom-reinforcing bars were the reinforcing of interest and were varied between the two material types. The second and third tests were a variation of this test with a splice provided at midspan to check bar bond and development. Test 2 used a 10-inch lap to force a bond failure and test 3 provided a Class C lap splice for the Grade 60 reinforcing of 30.5 inches. The Test 2 and 3 configurations are depicted in Figure 2. As in Test 1 the flexural steel was varied, MMFX for one beam and Grade 60 for the other

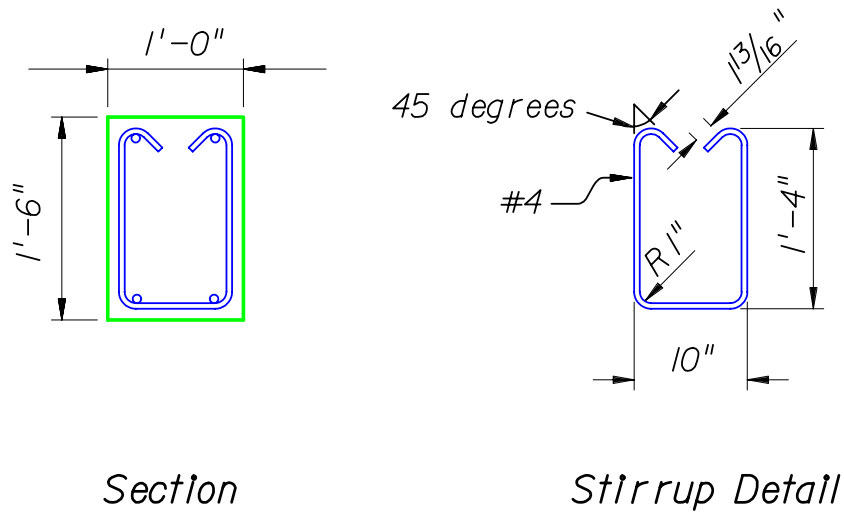
Fig. 3 Test Beam Cross-Section and Stirrup Dimensions

All beam tests had the same cross section properties. These are provided in Figure 3 along with the stirrup dimensions. A cover of 1 inch on the stirrups was used for all tests.

The cross section of the beam and the configuration and spacing of the stirrups remained the same. In this case, the flexural steel (3 #10) was ASTM A615 and only the stirrup steel was varied between the specimens.

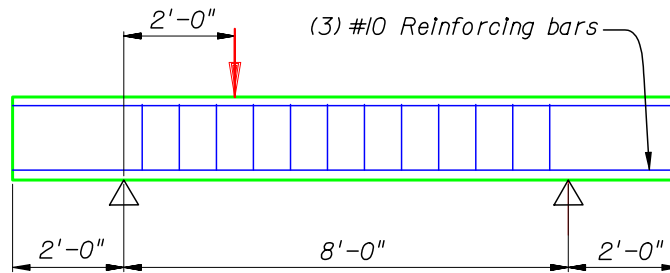
Fig. 4 Test Setup for Test 4

The intent of test 4 was to compare the performance of the reinforcing types when used as shear reinforcing. To insure a shear failure a different span, loading and reinforcing layout was required. The layout used for Test 4 is shown in Figure 4

Crack gages were not used for the shear test. The instrumentation consisted of 2 LVDTs at the actuator, one at each bearing and one at the centerline of the span and the load cell inline with the jack. In addition, rollers were not used at the bearings but 7 inch wide neoprene pads were used instead. This was done due to safety concerns with rollers caused by the brittle and sudden nature of a shear failure.

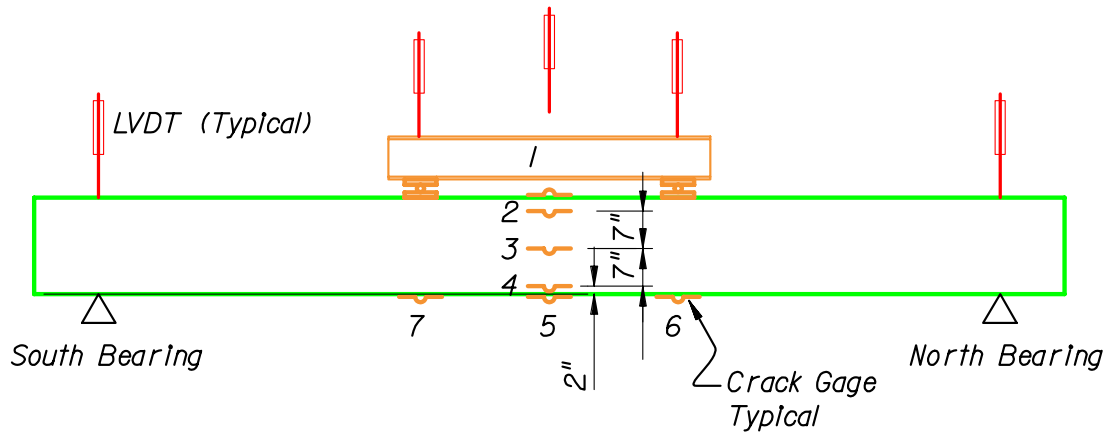
Fig. 5 Location of Instrumentation

The flexural tests were instrumented with crack gages and LVDTs (displacement gages) as shown in Figure 5. A load cell was provided in line with the single actuator to measure the force being applied to the beam. The crack gages had a gage length of 200mm. As shown in Figure 5, the crack gages were numbered from 1 to 7. Two LVDTs were used at the actuator location to monitor if any transverse rotation was occurring.

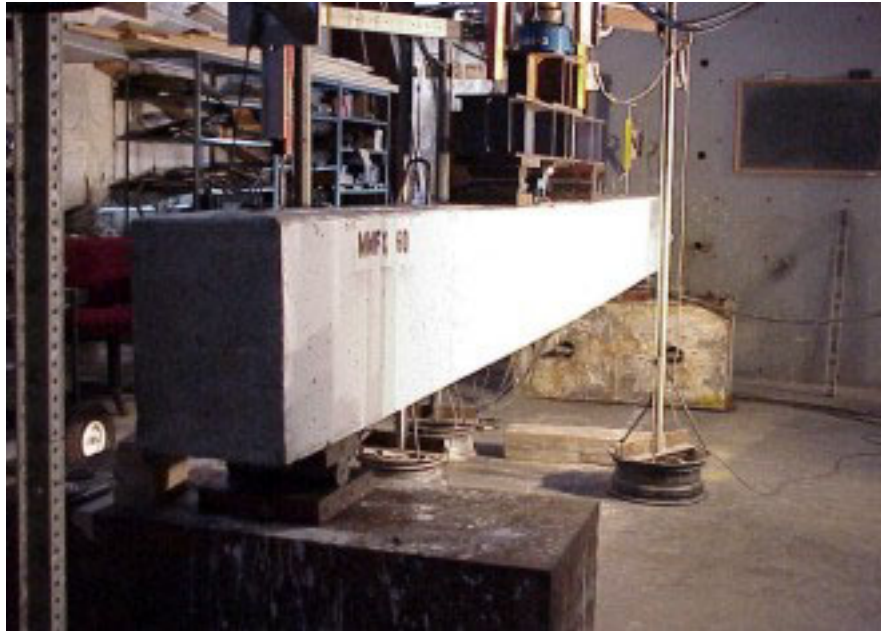
Fig. 6 Beam During Test

A photograph of a beam with the instrumentation undergoing testing is shown in Figure 6. This beam is the first flexural test with Grade 60 reinforcing. Pinned rollers were used for the supports.

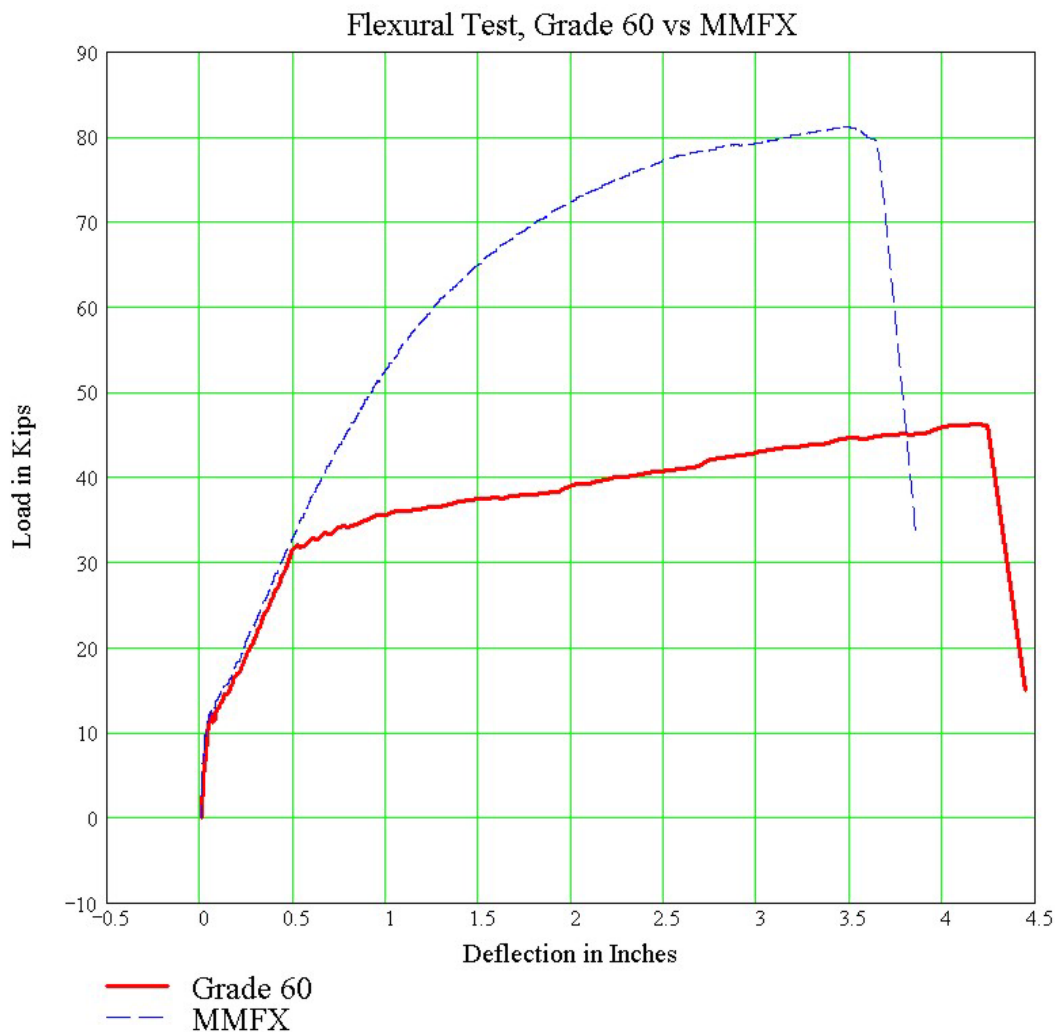
Fig. 7 Test 1 Results

Test 1 was a comparison of pure flexural behavior between MMFX and Grade 60 reinforcing. The bottom reinforcing for both beams was two #6 bars. Figure 7 plots for both beams, the deflection at the north load location versus the applied load from the actuator. Using the south load location would change the plots very little since the difference in the deflections was on the order of 0.02 inches for most of the loading. The difference in beam behavior is due solely to the difference in the reinforcing material properties.

For a general idea of the ductility, the area under the load deflection curve for the MMFX reinforced beam is around 40 percent greater than that of the one for the Grade 60 reinforcing. It can also be observed that the behavior of the two beams is very similar up to the yield loading of the Grade 60 beam at around 32 kips and both exhibit the same cracking load at around 10 kips.

with the MMFX reinforcing, the ductility was inadequate. If the area under the load deflection curve is used to measure ductility, the MMFX beam had 35 percent more ductility than the Grade 60 beam in the unspliced condition. However, for the spliced condition the Grade 60 beam had almost 300 percent more ductility than the MMFX spliced beam. Lap splices, hook embeddings, etc. that are sufficient for Grade 60 reinforcing will likely be inadequate for MMFX reinforcing. It is not readily apparent what yield stress should be used for detailing with this reinforcing. Possibly the 0.2 percent offset method would provide an acceptable value. The whole approach of how to deal with reinforcing that lacks a distinct yield point, around which most codes are written, needs to be addressed.

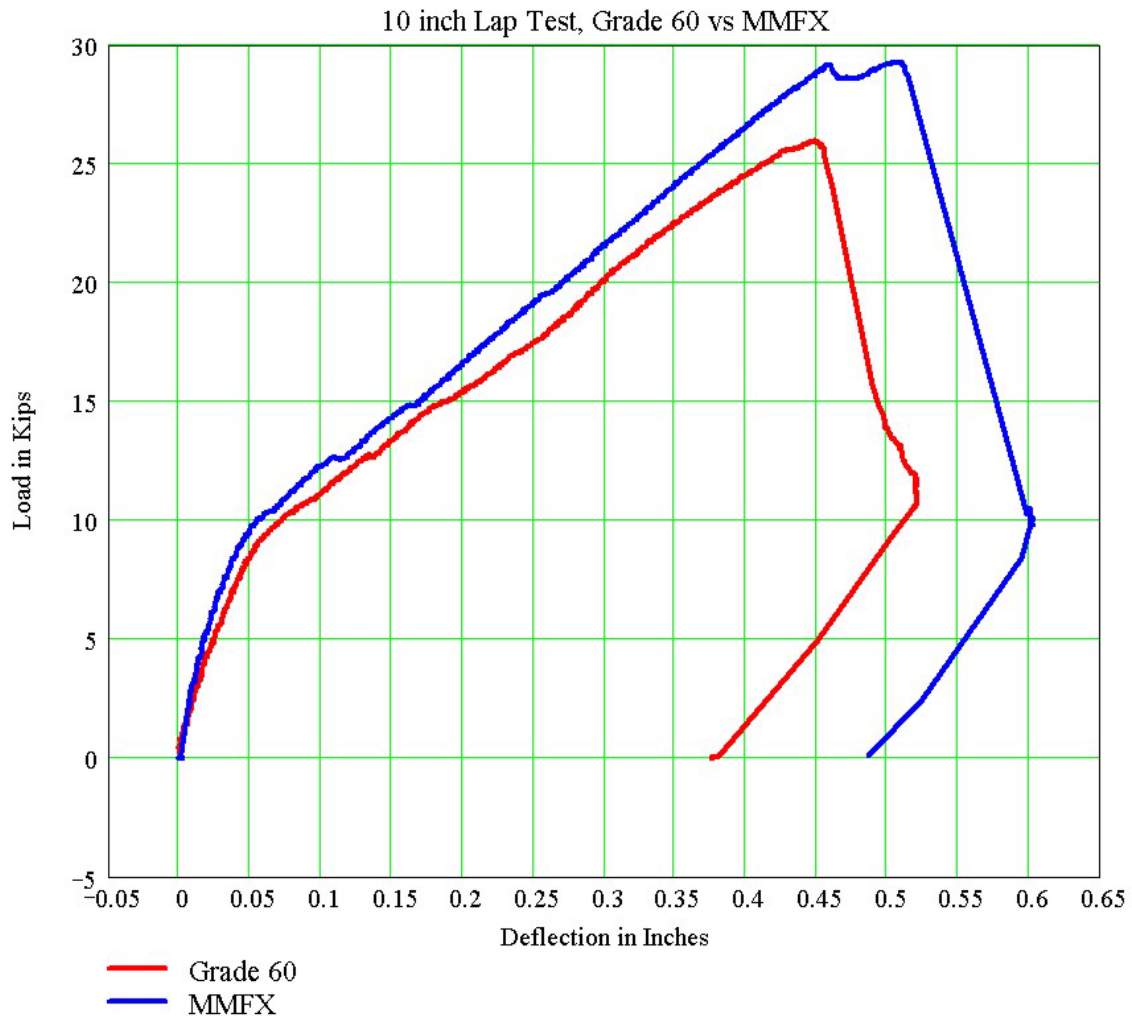
Fig. 8 Test 2 Results

Test 2 was the same as test 1 but the flexural steel was lapped 10 inches at midspan instead of being continuous. Figure 8 provides the load deflection curve.

Examining Figure 8 it is apparent that both beams failed before yielding of the reinforcing was reached. In addition, this test indicates that the bond behavior of the MMFX reinforcing is equal to or slightly better than that of the Grade 60 reinforcing.

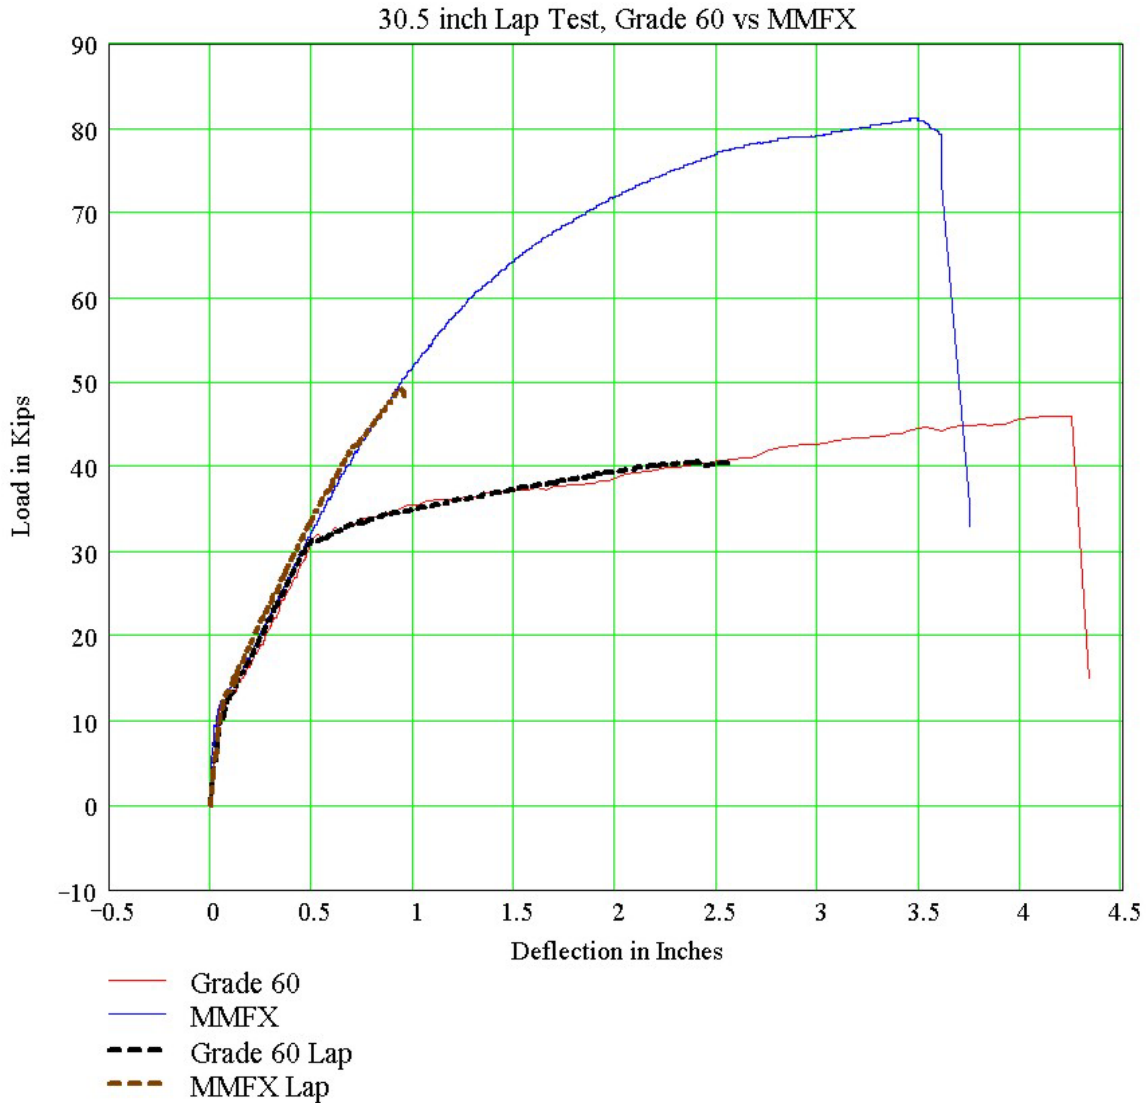
Fig. 9 Test 3 Results

For Test 3 the lap was increased to 30.5 inches. In Figure 9 the results of Test 1 are included with Test 3 so that the effect of the lap can be easily seen. It is apparent from this Figure that the lap provided was sufficient to provide the Grade 60 beam with ductile behavior, however, this lap length was not sufficient to provide ductile behavior for the MMFX reinforcing. Similar to the results of Test 2, the MMFX reinforcing did demonstrate bond behavior equal to or better than the Grade 60 reinforcing since it failed at a greater load.

The behavior of the MMFX reinforcing compares favorably to the typical Grade 60 reinforcing. However, due to its higher strength and to some extent the lack of a distinct yield point attention must be given to detailing with this reinforcing. Test 3 indicates the potential problems with a blind substitution where, although the strength was actually greater

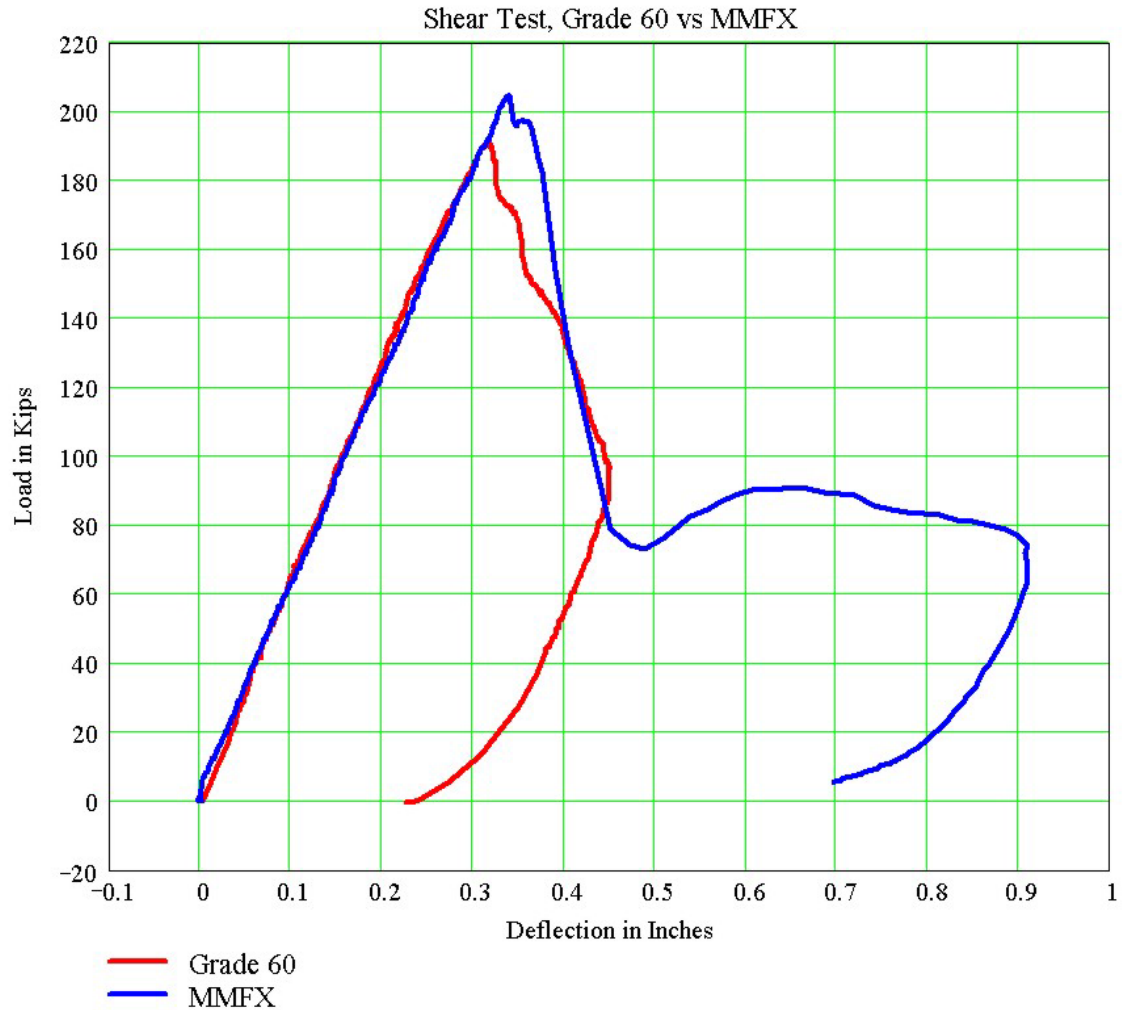
Fig. 10 Test 4 Results

The intent of Test 4 was to compare the performance of Grade 60 and MMFX stirrups in a condition where a shear failure was expected. Figure 10 is a graph of the applied load and the deflection at midspan of the beam.

In reviewing the results it is believed that the stirrups played only a minor part in the shear capacity of the section. Looking at the failure location for the MMFX section, Figure 11, and the Grade 60 section, Figure 12, it can be seen that a strut and tie model would be appropriate. The yield stress of the number 10 bars used for longitudinal reinforcing was 69 ksi. A simple truss model indicates that at a load of 231 kips the longitudinal reinforcing would reach yield. This is a little more than the 190 to the 200 plus kips where actual failure occurred for the Grade 60 and MMFX sections respectively. One possibility is that the interior bar of the three longitudinal bars was not as effective as the exterior bars.

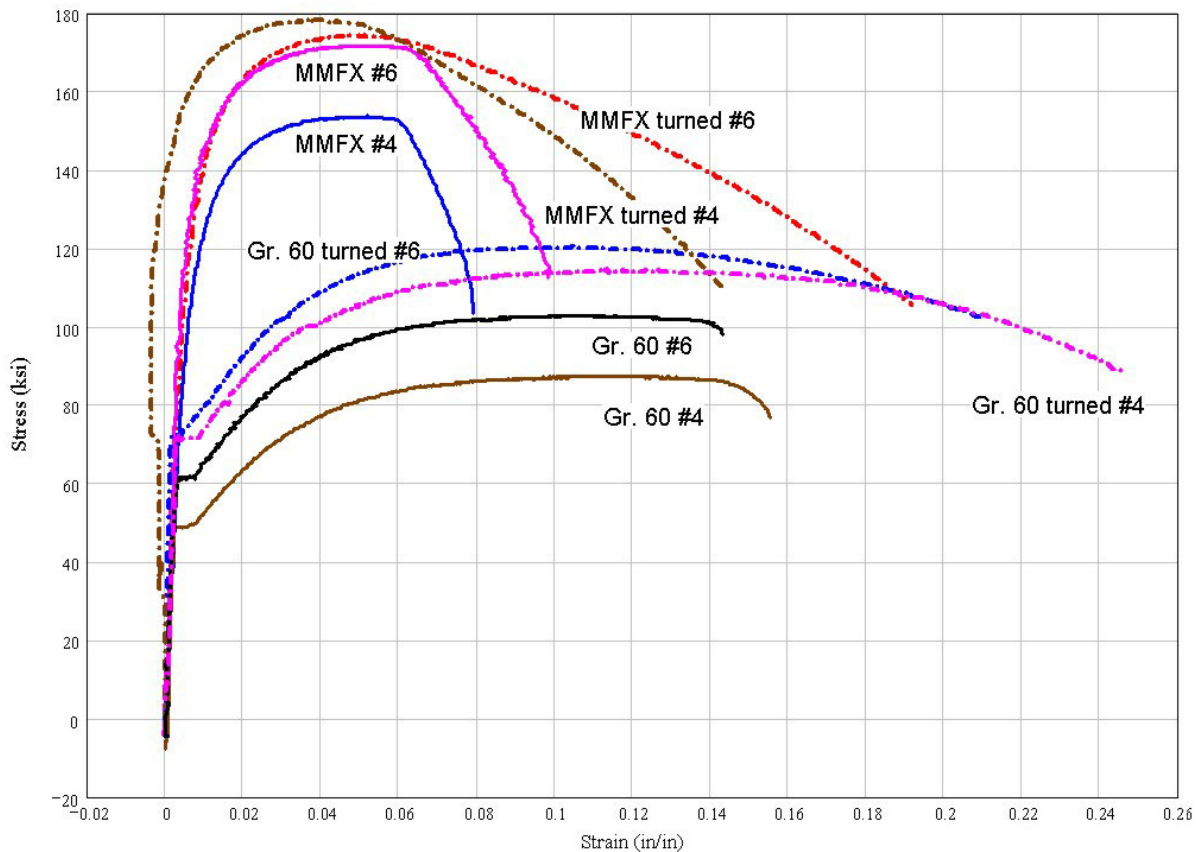
Fig. 13 Stress Strain

A number of tension tests were conducted on samples of the Grade 60 and MMFX reinforcing. Figure 13 contains a stress strain diagrams for several of the tests.

The bars labeled as turned were milled down on a lathe to remove enough material so that the bars were smooth and without ribs. These turned bars were tested with elongations measured over 2 inches. The remaining tests were on full size bars with elongations measured over 8 inches. The variation between the response of the number 6 bars and the number 4 bars in terms of strength and yield was consistent for both the MMFX and Grade 60 reinforcing. This disparity became much less when the bars were tested as coupons with the ribs removed. Also it can be seen that the MMFX bars lack a distinct yield point. The odd behavior of the MMFX turned number 4 bar is believed to be due to slippage of the knife-edges of the extensometer.

The disparity between the number 4 bars and number 6 bars when tested as whole bars versus when tested as coupons indicates that the present rib sizes may be detrimental for these smaller bars. We recently tested full size bars conforming to ASTM A955 (stainless) and noticed a similar disparity in behavior between number 5 and number 4 bars.
