COMPOSITE BEHAVIOUR OF HOLLOWCORE SLABS AND CAST-IN-SITU CONCRETE TOPPING

Maged A. Youssef, PhD, P. Eng., Department of Civil and Environmental Engineering, Western University, London, ON, Canada
Aiham Adawi, Ph.D. Candidate, Department of Civil and Environmental Engineering, Western University, London, ON, Canada

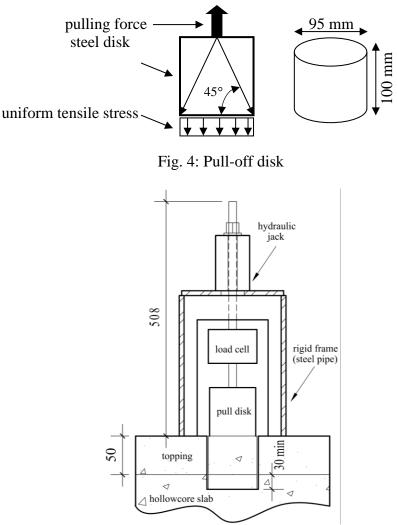
Fig. 5: Pull-off apparatus (dimensions in mm)

The bottom of the steel disk was roughened to enhance its bond to the concrete topping. A 10 mm (0.39 in) thick steel pipe was used to provide the needed rigid frame. It encompassed the load cell and supported the hydraulic jack. Fig. 5 shows the pull-off apparatus, which was customized according to the requirements of CSA A23.2⁴ and manufactured at the machine

shop of Western University. The hydraulic jack was attached to a manually operated hydraulic pump and the load cell was connected to a digital meter that displays the load increments. The maximum reading is stored automatically on the digital meter. General test setup is shown in Fig. 6. The rate of loading was approximately 80 N/s (18 Ib/s), which satisfies the required range of 50 to 100 N/s (11 to 22 Ib/s) specified in CSA A23.2⁴. The rate of loading was controlled by monitoring the digital load meter while increasing the tensile load using the manual hydraulic pump.

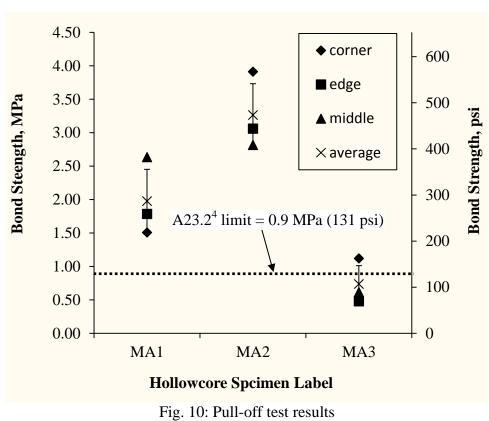
Fig. 9: Observed failures in pull-off tests

Fig. 9 shows the two observed failure mechanisms. Cores for slabs MA1 and MA3 failed when the concrete toppings were separated from the hollowcore slabs at the interface (interface failure). Failure loads for these cores provide a direct measure of the interface bond strength. Failure of cores for slab MA2 was due to concrete tensile failure of the hollowcore slab (HC failure). It is clear that the interface bond strength for slab MA2 is higher than the recorded failure stresses.

(a) Interface failure

(b) Hollowcore failure

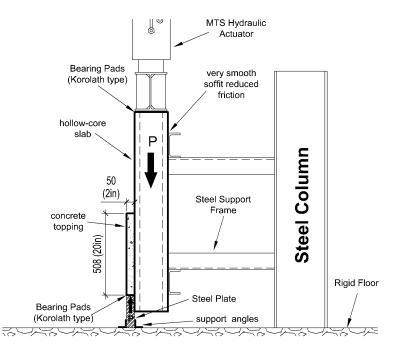
Fig. 13: Push-off test layout

and 13 show the test setup where the hollowcore slab specimen is installed in the vertical direction and the concrete topping rests on a 50 mm (2.0 in) thick steel plate. The shear force is applied by the MTS hydraulic actuator on a spreader steel beam that pushes the hollowcore slab specimen downward. The steel plate develops a reaction force that is applied on the concrete topping. This force generates a shear stress along the interface between the hollowcore slab and the topping. The steel frame positioned behind the hollowcore specimen was designed to prevent the overturning of the test specimen during the test. The soffit side of the hollowcore slab specimen was sufficiently smooth to allow free movement of the steel frame and guarantee that it does not provide additional resistance. 50 mm (2.0 in) wide by 3 mm (0.12 in) thick Korolath brand bearing pads were used under the steel spreader beam and between the steel plate and the concrete topping to guarantee a uniform stress distribution at those locations.

The push-off test was conducted in a vertical orientation to permit easier alignment of the MTS hydraulic actuator with the existing vertical support frame at the structures lab. Figs. 12

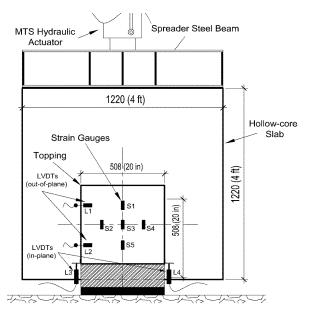
Fig. 14: Push-off test instrumentation

To capture the state of strains in the concrete topping, strain gauges were attached on its top surface as illustrated in Fig. 14. Strain gauges S1, S3, and S5 measured strains in the direction of the applied load. Strain gauges S2 and S4 ensured that the load was distributed uniformly over the slab cross section. The push-off test induced two types of stresses on the interface between the concrete topping and the hollowcore slab: (1) shear stresses (stresses parallel to the interface) and (2) peel stresses (stresses perpendicular to the interface). Movements in the shear and peel directions were recorded using four Linear Variable Displacement Transducers (LVDTs), L1 to L4, as shown in Fig. 14. LVDTs L3 and L4 were attached to the hollowcore slab with their armatures resting on angle brackets attached to the side of the concrete topping. This setup allowed LVDTs to read the differential displacement between the hollowcore slab and the concrete topping.

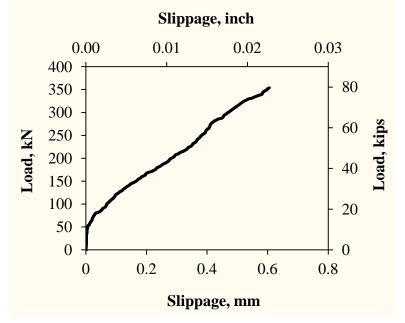
Fig. 15: Load versus slippage curve

Extremely brittle and abrupt failure was observed at a load of 359 kN (81 kips). This corresponds to an average horizontal shear stress, $v_{h avg}$, of 1.39 MPa (202 psi), which is higher than the limits stipulated by CSA A23.3¹ [0.7 MPa (102 psi)] and ACI 318² [0.55 MPa (80 psi)]. The measured slippage at failure (average of LVDTs L3 and L4) was 0.61 mm (0.024 in). The load versus slippage curve is shown in Fig. 15. The slippage readings in the graph were calculated based on the average readings recorded from LVDTs L3 and L4. Very small slippage values were measured up to a load of about 50 kN (11 kips). The shear stiffness was significantly reduced after this load. The shear force is resisted at the interface by two mechanisms, bond and friction. The bond between the hollow core slab and the topping might have been lost at the mentioned load and resulted in the reduced stiffness. Peel displacement measured by LVDTs L2 is shown in Fig. 16. The decrease in peel stiffness at a load of about 50 kN (11 kips) is consistent with the slippage behaviour.

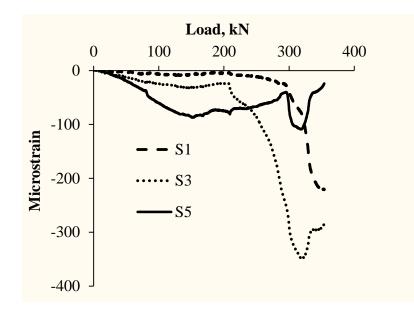
Fig. 17: strain readings for S1, S3 and S5

The measurements of concrete strains recorded by gauges S2, S3 and S4 were in close agreement. Fig. 17 shows the strain readings from strain gauges S1, S3 and S5. It is clear that the strains in the topping are varying. Strain gauge S5 initially recorded the highest readings as it is the closest to the loaded end. However, at the load of 200 kN (45 kips), readings for strain gauge S3 started to increase at a higher rate than S5, which indicates that the interface layer was fractured in the region of S5. The interface layer was further fractured at a load of 300 kN (68 kips) and the load started to transfer to region of S1.

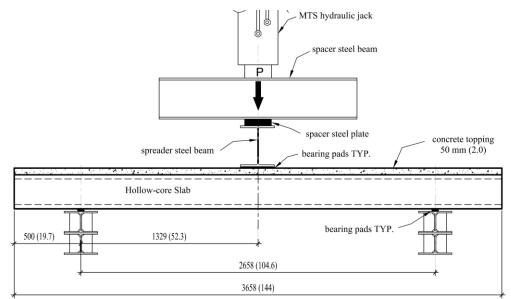
Fig. 20: Full-scale test setup

The bond strength of the concrete topping was first evaluated using two pull-off tests. The full-scale test was then conducted using three point bending method to generate the highest possible horizontal shear stress, Fig. 20. The total length of the slab was 3658 mm (144 in) with the supports located 500 mm (19.7 in) from each end.

Including the 50 mm (2.0 in) concrete topping thickness, the depth of the composite slabs was 254 mm (10.0 in). The distance between the support reaction and the point load was 1329 mm (52.3 in), which results in shear span to depth ratio of 5.23. The horizontal shear resistance is related to the strength of the interface layer between the hollowcore slab and the concrete topping along the shear span. To increase the values of the horizontal shear stresses and the corresponding slip, the contact surface was reduced by inducing a separation in the concrete topping. This was achieved by saw cutting the concrete topping across the span as illustrated in Fig. 21. The saw cut created a 2 mm (0.08 in) wide separation in the topping that is 50 mm \pm 3 mm (2.0 in \pm 0.12) deep.

(a) Full-scale test setup schematic, mm (in.)

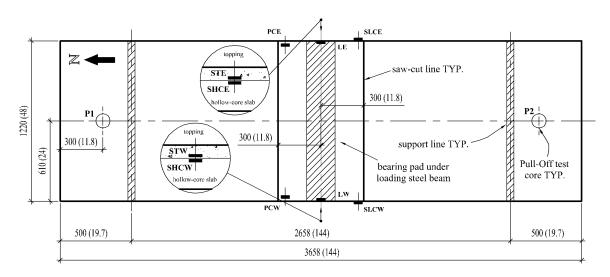
(a) Instrumentation layout for slab FMAC, mm (in.)

Instrumentation of the slab specimen is illustrated in Fig. 22. The slab specimen was instrumented with six LVDTs and four strain gauges to measure deflection (LVDTs LW and LE), slippage (LVDTs SLCE and SLCW), peel (LVDTs PCE and PCW) and concrete strains (STW, STE, SHCW, SHCE). The deflection, slippage, and peel LVDTs were located along the east and west edges of the tested specimen. The four strain gauges measured the concrete strains above and below the interface at the midspan section. The full-scale test was conducted using a load rate of 10 kN (2.25 kips) per minute to failure. The instrumentation data was collected through a data acquisition system every second.

Pull-off tests were conducted at locations P1 and P2 shown in Fig. 22(a). The bond strength at those locations was evaluated as 1.96 MPa (284 psi) and 1.14 MPa (165 psi). The observed failure mechanism for the full-scale test is shown in Fig. 23. The slab failed at a load of 245 kN (55 kips) due to strands rupture. The corresponding mid-span deflection is 71 mm (2.8 in). The slippage at failure was measured as 1.95 mm (0.077 in) on the east edge and 3.28 mm (0.13 in) on the west edge. The peel at failure was 0.32 mm (0.013 in) on the east edge and 1.63 mm (0.064 in) on the west edge.
