## WASHINGTON STATE PRECAST SINGLE SPAN BRIDGE RECORD – CHIEF JOSEPH DAM BRIDGE REPLACEMENT PROJECT

Jian Xu, PhD, PE, KPFF Consulting Engineers, Seattle, WA  
Tom Whiteman, PE, KPFF Consulting Engineers, Seattle, WA  
Aaron Simmons, PE, Douglas County Transportation and Land Services, East Wenatchee,  
WA

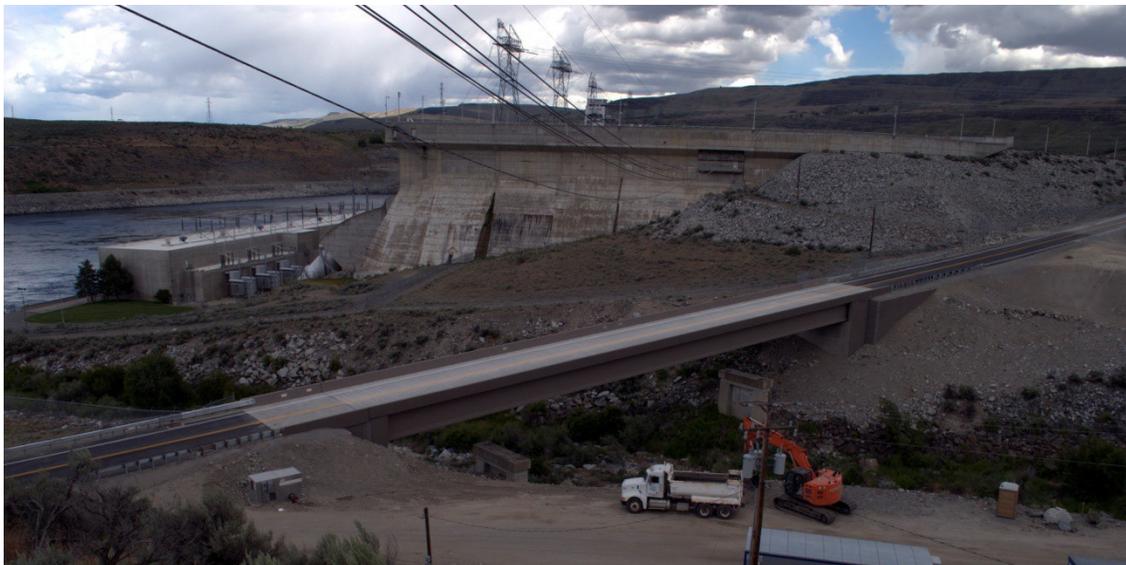
Fig. 1 A View of Chief Joseph Dam Bridge, Douglas County, WA

The new bridge carries two lanes of traffic and was built on the same alignment as the existing one (Fig. 1). It is a 73.2 m (240 feet) long (back of pavement seat to back of pavement seat) and 9.8 m (32 feet) wide single span post tensioning spliced concrete girder bridge. There is a 7.6 m (25 feet) long approach slab on each end. Figure 2 shows the bridge elevation view. The total deck area is 866 m<sup>2</sup> (9,280 ft<sup>2</sup>) including the approach slabs.

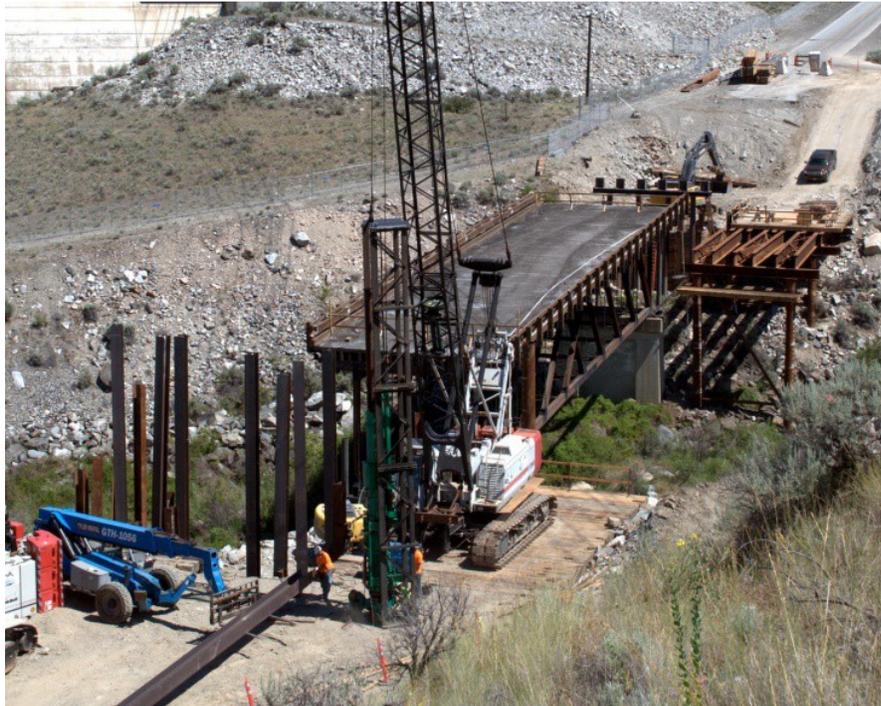
Fig. 8 Work Bridge Installation

First, the existing approach spans were removed, excavation for new abutments initiated and shoring was installed. A pile supported work bridge was constructed next to the existing alignment concurrently for construction access (Fig. 8). The work bridge stopped at the ends of existing truss span at both sides, and a finger structure, which was a part of the work bridge and extruded into the existing bridge alignment, was constructed at each end (Fig. 9). The finger structures were partially supported on the existing truss piers. They served not only as the temporary supports to the girder segments during girder erection but also were the construction access to move the existing truss and install new girders. After the abutment concrete was poured and cured, the existing truss was moved to the work bridge alignment by two cranes to make a complete access from both ends of the bridge (Fig. 10). The innovation of this construction sequence was the reusing the existing truss as part of the work bridge. The structural resistance of the truss was checked against the construction loads, which included the weight of girder and hauling truck. The latest inspection report of the existing bridge was referenced to get reasonable strength reduction factor for each structural element. After the existing truss was moved and settled on the temporary piers, the girder segments were installed (Fig. 11). A gap of 0.61 m (2 feet) was left between precast concrete girder segment ends for the closure joint girder splice. Temporary braces and cables were provided during girder erection and before diaphragms were placed (Fig. 12).

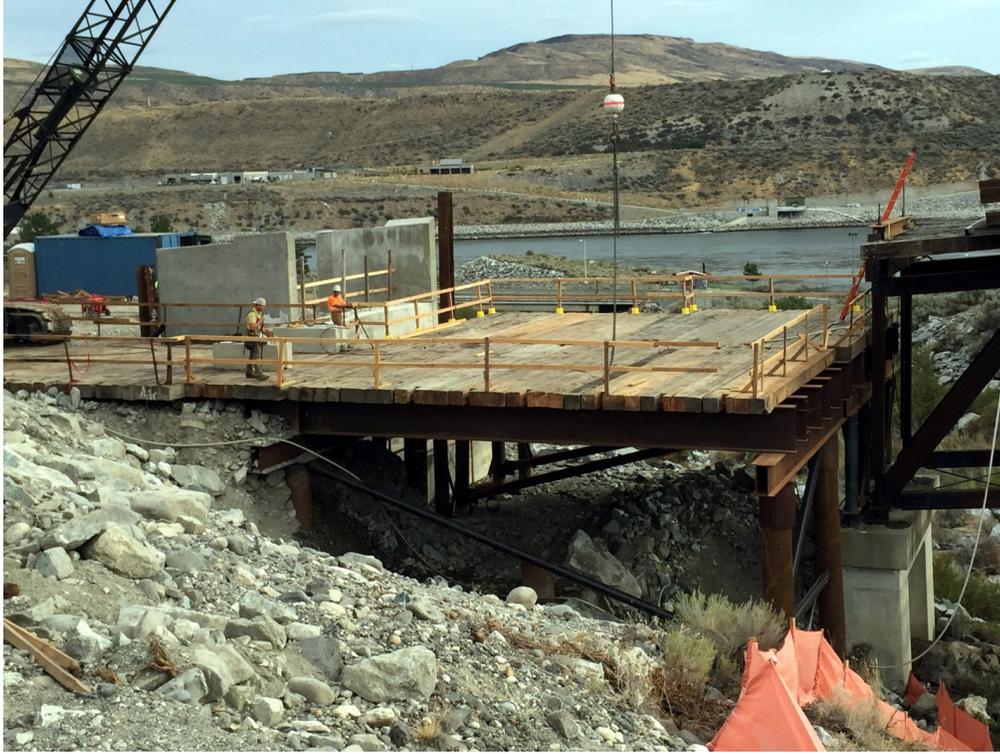
Fig. 9 Finger Work Bridge Installation

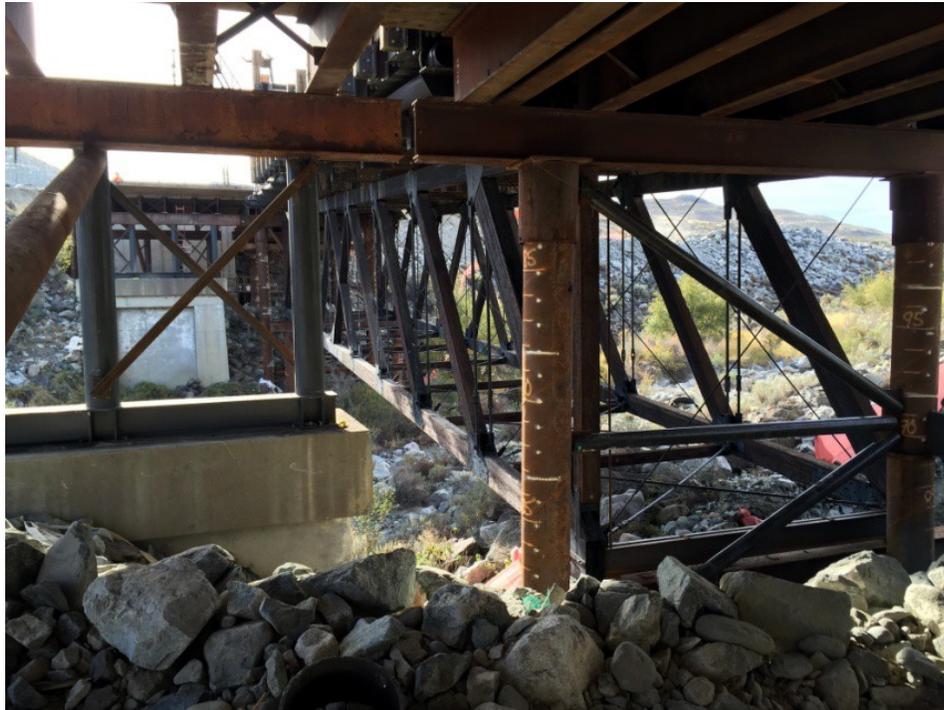
Fig. 10 View from Bottom after Truss Movement

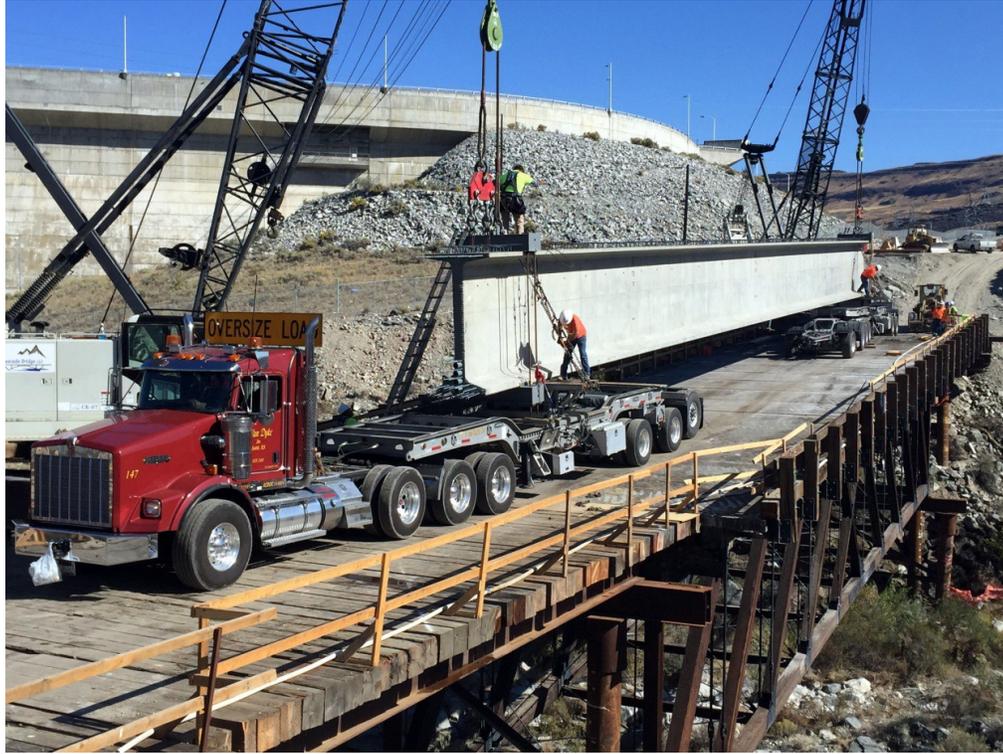
Fig. 11 Girder Installation

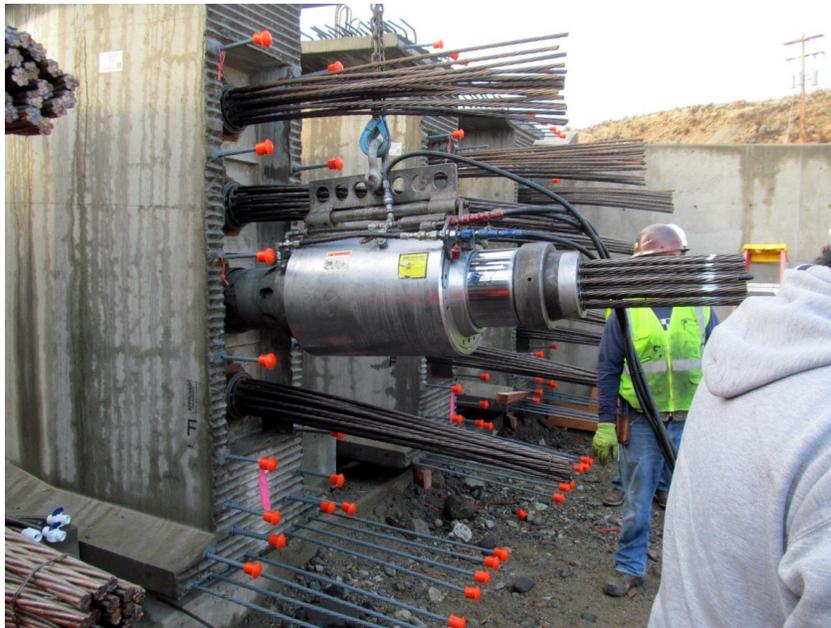
Fig. 13 Post-tensioning Application

Once the segment closure joints were formed, and concrete was placed and had attained the required strength, the post-tensioning was applied. The post-tensioning force was controlled by gauge readings and verified by strand elongation (Fig. 13). The girders lifted off from the temporary support seats approximately 25 mm (1 in.) after post-tensioning was applied, which matched the theoretical calculations. The tendon ducts received grouting the day after post-tensioning was applied. The grouting was used for corrosion protection and to achieve a reliable bonding between strands and girder.

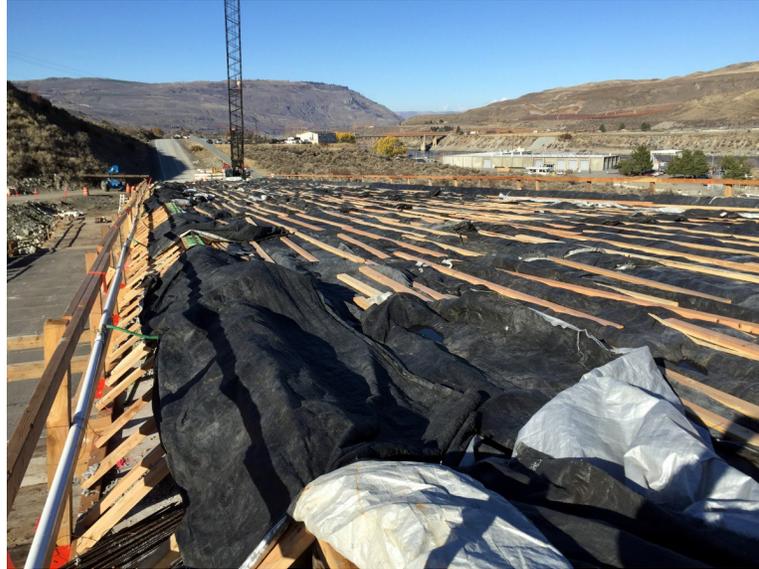
Fig. 14 Insulating Blanket on Curing Deck Concrete

Intermediate and end diaphragms were placed 2 days after grouting. After temporary supports and bracing were removed, the bridge deck slab was placed. It was mid November when the deck slab concrete was poured, and the local low temperature had dropped below 2°C (35°F). Concrete strengths can be adversely affected by the low temperature. These affects can range from durability issues to low compressive strength neither of which is desirable. Based on the requirement of WSDOT Standard Specification<sup>5</sup>, to achieve adequate curing, the temperature of the concrete shall be maintained above 10°C (50°F) during the entire curing period or 7 days, whichever is greater. The concrete temperature shall not be allowed to fall below 2°C (35°F) during this time. The protecting measures included the use of blankets placed over the concrete, enclosure on bottom, and use of space heaters below the deck (Fig. 14). Concrete temperature was monitored during the whole process.

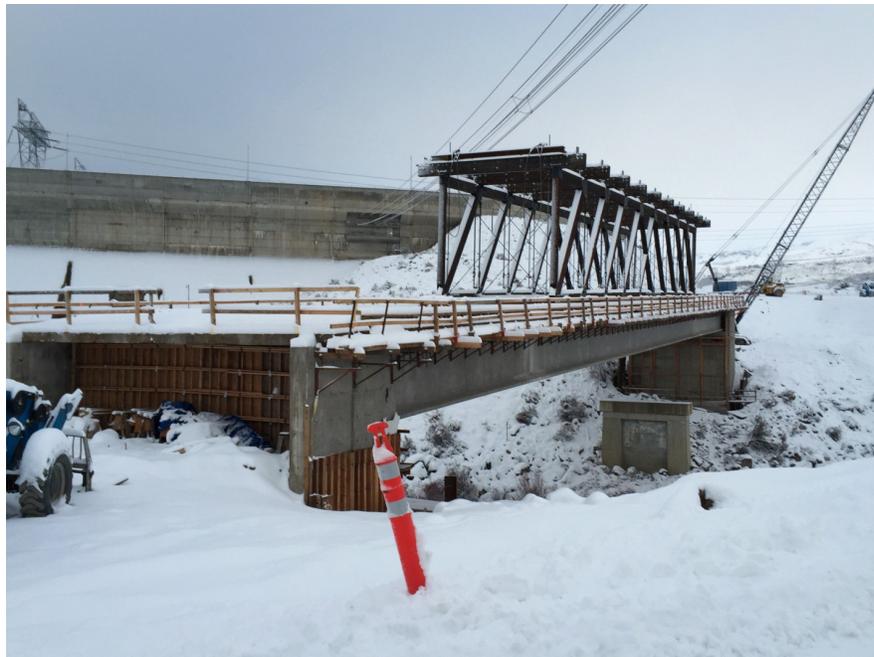
Fig. 15 Project on Hold

After the deck slab was placed, the existing truss was lifted by cranes up to top of the new bridge deck, and the project was put on hold due to the extreme cold weather (Fig. 15). The traffic barriers, approach slabs and retaining walls were installed in 2016. The bridge was opened to traffic in June 2016.
