# Architectural and Structural Precast/Prestressed Concrete Renovates Landmark Ohio Stadium

*After 75 years of service, the “Horseshoe,” The Ohio State University’s historic landmark stadium, was badly in need of restoration, code-mandated modifications and expanded seating capacity. This high-visibility, \$195 million project called for a structural system that could meet the dual challenge of preserving the original classical architecture while providing uninterrupted stadium use for three football seasons during construction. Architectural precast concrete enhanced the aesthetics of the arched motif shell, giving the stadium its powerfully arcaded form. Structural and architectural precast elements composed the new lower and upper deck levels. The renovations to the entire stadium were possible only with the production predictability and design flexibility of precast/prestressed concrete components, including raker beams, triple risers and large curved architectural precast panels. This article explains how the precast concrete construction provided a highly successful, owner pleasing renovation solution.*

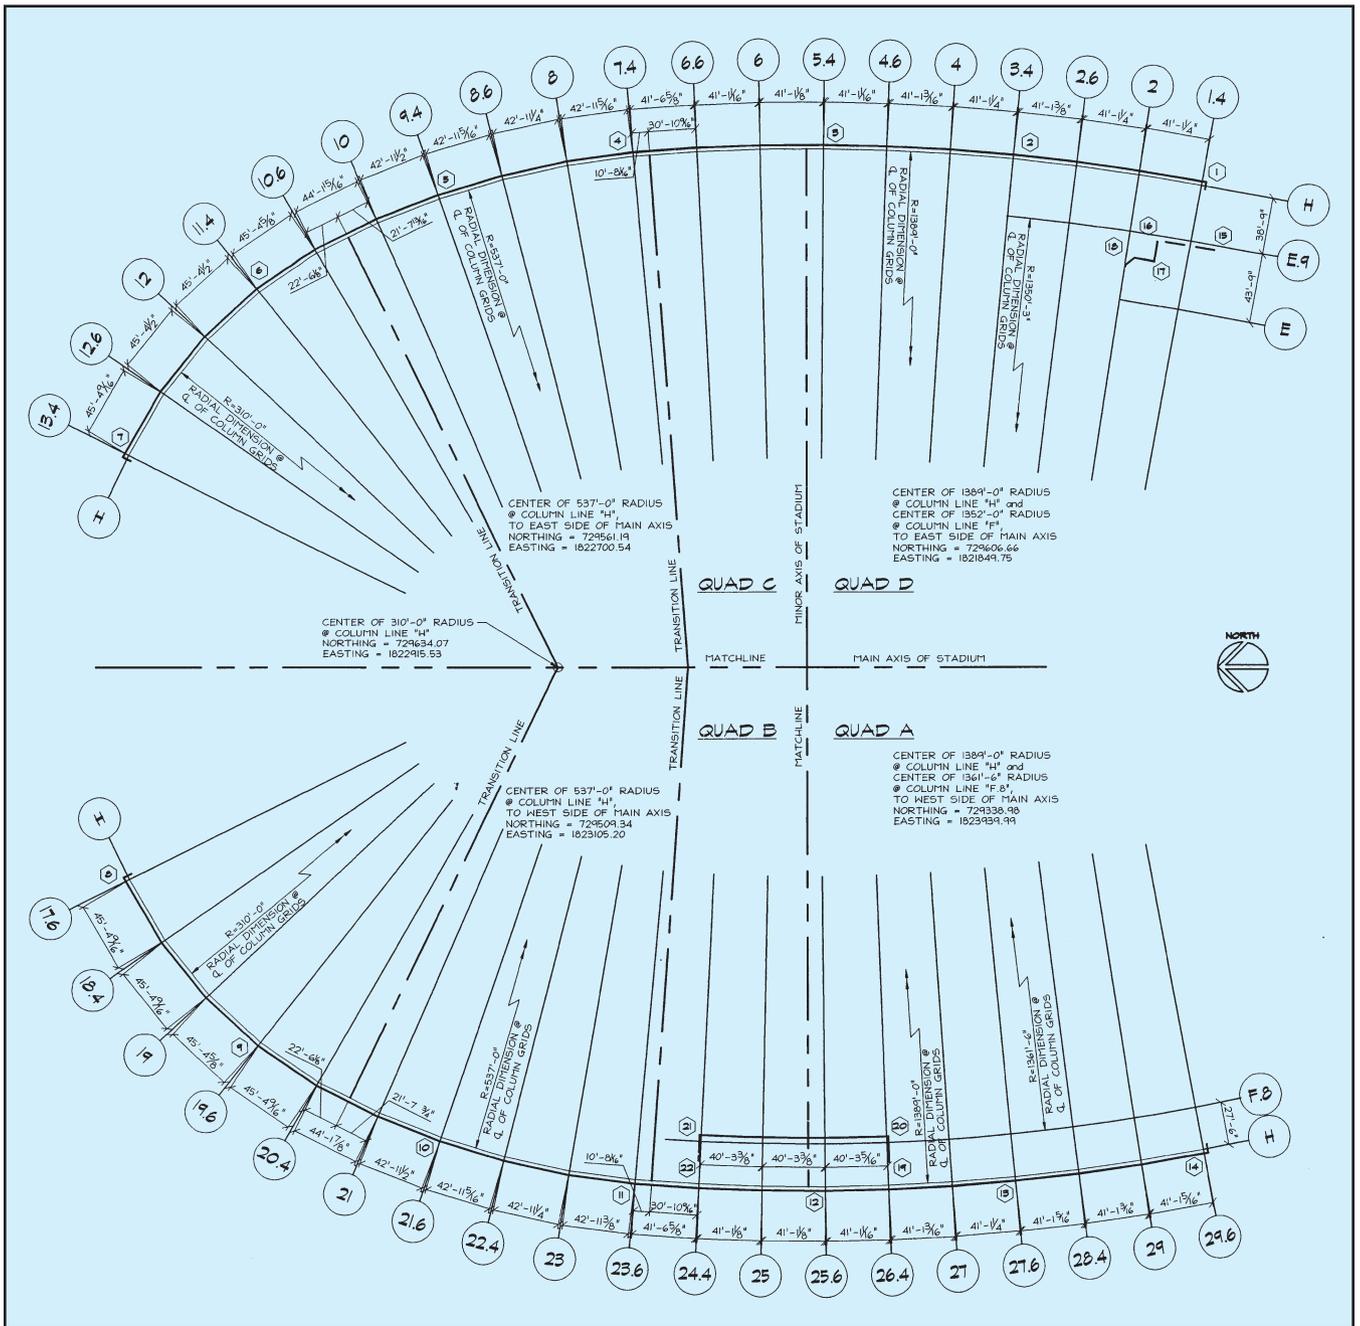
Fig. 4. Plan view of stadium. Three different radii were used for the architectural precast curved shell panels.

Precast architectural panels for the exterior cladding formed the smooth, curved shape using three different design radii, resulting in some very complex geometry. With the production of very large panels, the erector was able

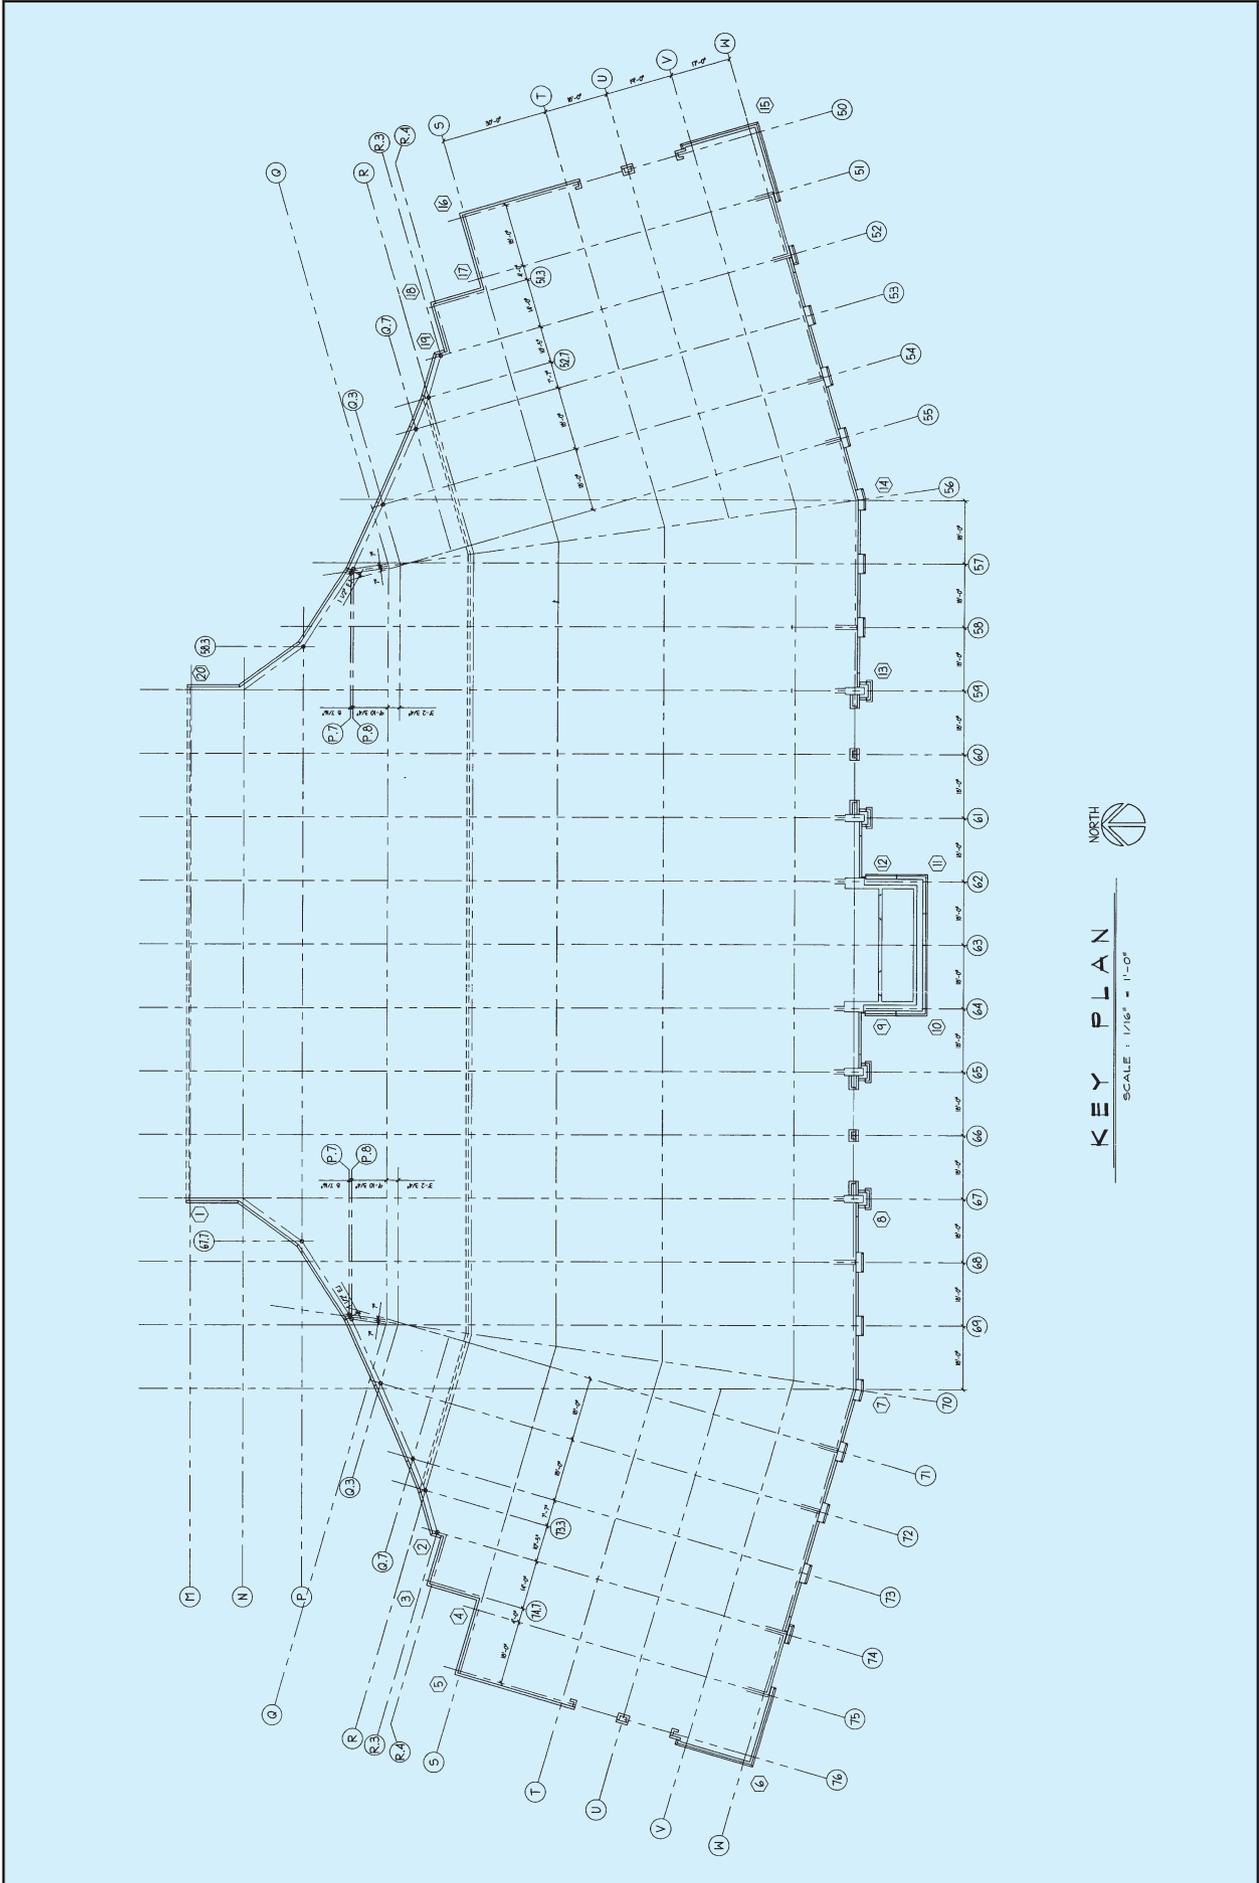
Fig. 5. Plan view of the south end zone expansion.

new construction in the south end zone establishes a visual break, or opening, at the south ends of the existing east and west sides of the stadium, leaving the horseshoe footprint intact. These openings function as entrance ramps to bring the players down from the existing grade to the new lowered playing field. Architectural precast panels, with similar historical detail as the main stadium, clad the exterior of the south end zone structure (see Figs. 5, 6, and 7). Quantities of components for the south end zone structure are provided in Table 3.

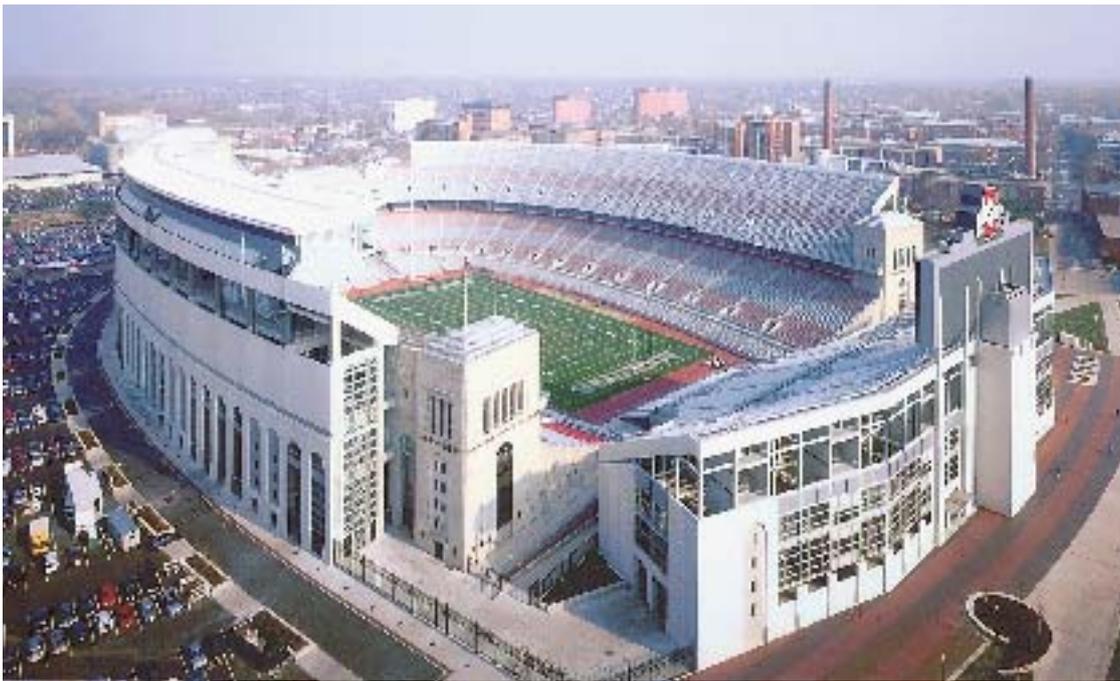
Fig. 6. The Horseshoe's original footprint is retained via an architectural break at the opening to the south end zone.

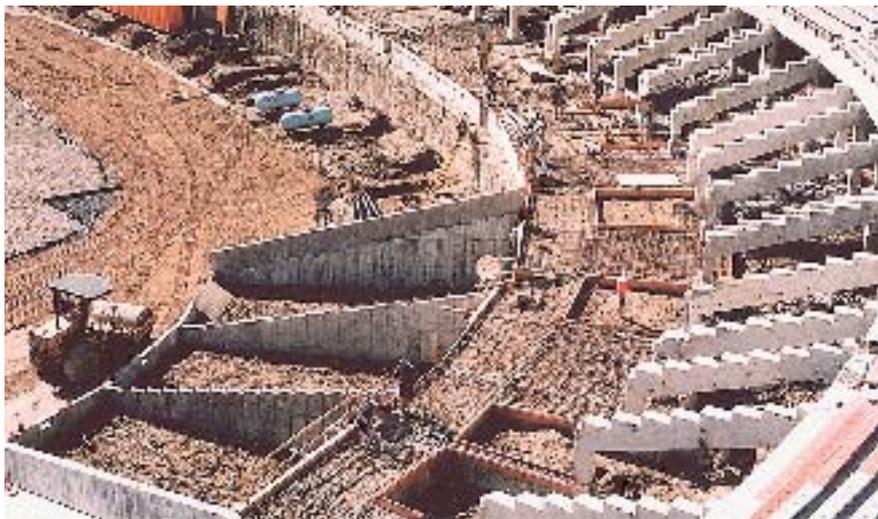
Fig. 8. Erection of the structural precast concrete raker beams at the excavated Lower AA Deck.

Excavation began immediately after the last home football game in 1999, with removal of the goalposts, as earth-moving equipment began round-the-clock excavation. The lower infield walls and a significant portion of the existing lower seat deck was demolished, allowing room for the placement of the new precast walls, vomitories, and risers. The designers reconfigured the seating geometry to improve sight lines for fans at all seating deck levels — namely, the new precast concrete lower deck, the new precast concrete intermediate level (replacing the existing lower deck), and the existing deck above. Precast concrete work began at the north end zone, or the closed end of the Horseshoe, and proceeded southward with both an eastside and westside crane, to speed the installation (see Figs. 8 and 9).

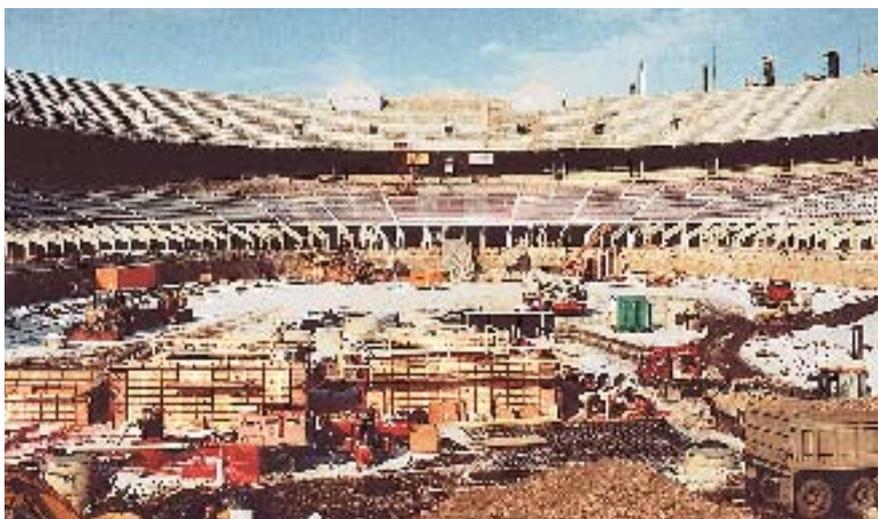
Fig. 9. Precast concrete erection moves simultaneously down from the north end zone.

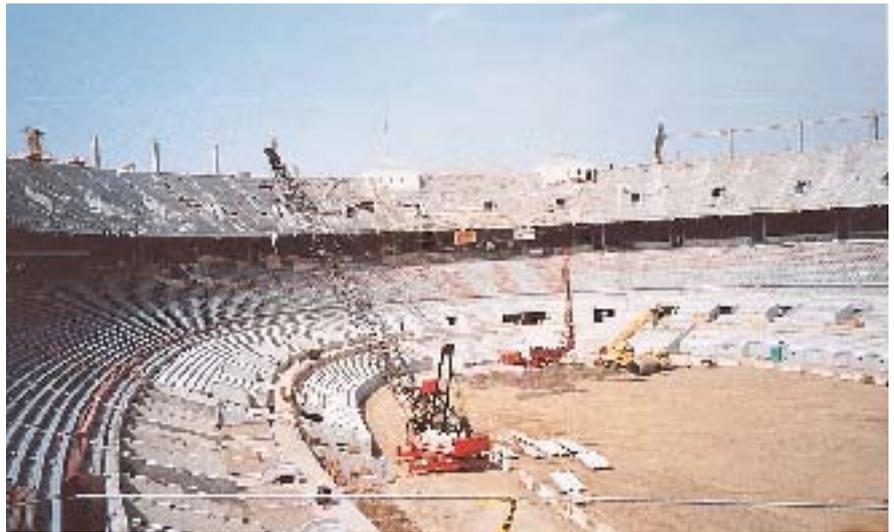
Fig. 10. New playing surface, excavated down 14 ft (4.3 m), places the playing field almost 6 ft (2 m) below the groundwater table.

With the completion of the slurry wall, demolition and cleanup crews carried out their work, and precast erection proceeded rapidly down both sides of the stadium simultaneously from the north to meet tight schedule deadlines. As precast erection proceeded, work on the engineered turf system could begin. Due to the drainage piping and turf system, no construction equipment or trucks were allowed beyond the point of the advancing precast erection (see Figs. 10 and 11).

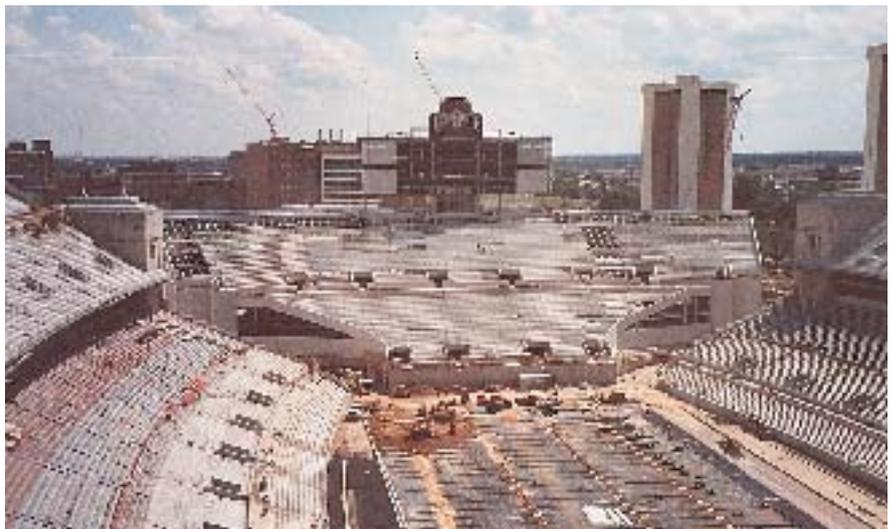
Fig. 11. Once the initial construction for the engineered turf drainage system began, no construction equipment was permitted on the stadium infield.

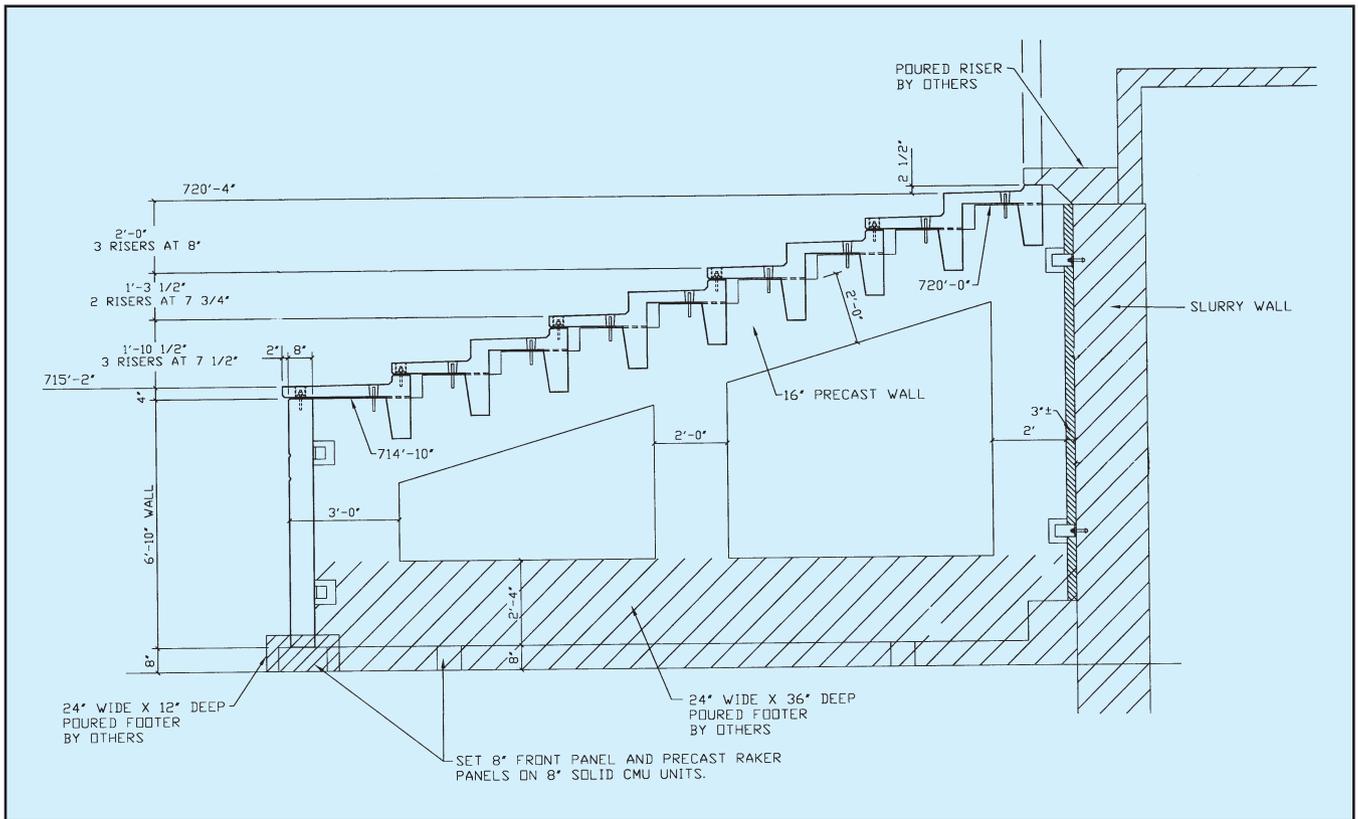
Fig. 12. Section through Lower AA Deck, showing the slurry wall.

Inside and immediately infield of the now-exposed upper slurry wall, the new precast risers were supported on precast walls. To reduce schedule time, trenches were dug for foundations and the walls were then erected

by shimming on top of concrete masonry units. With the walls temporarily braced, concrete was placed around and under the base of these walls for permanent support. Riser erection proceeded quickly behind the footer pours (see Fig. 12).

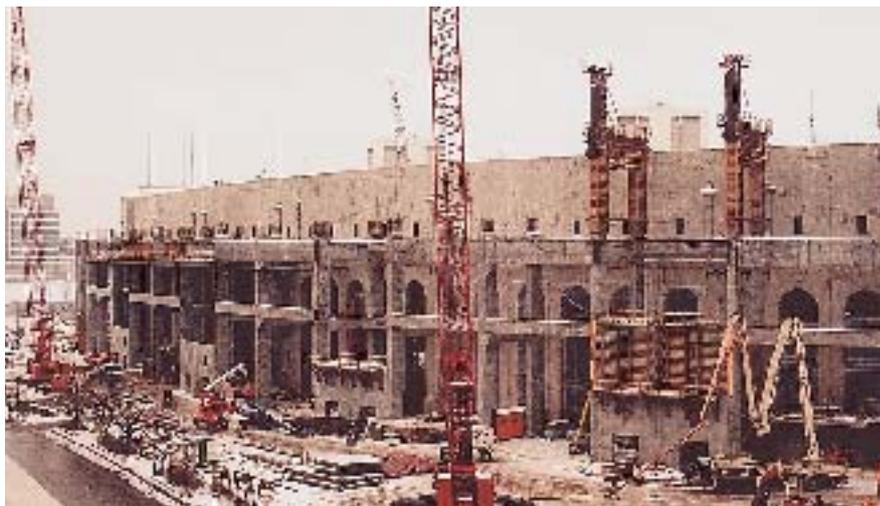
Fig. 13. Cast-in-place concrete columns and platforms provide structural support for precast expansion for the new Upper C deck.

For the new 19 rows of seats on the east and west sides, cast-in-place concrete was used for the construction of columns and platform to the top of the existing stadium. Above this platform, precast “stepped” raker beams and triple risers were used. The upper deck was erected on the elevated cast-in-place platform. For the press box, constructed of steel framing, transverse trusses were assembled on the ground and lifted as one piece.

Erection of precast elements at the press box area on the west side proved to be a challenge. Some of the longitudinal steel bracing members had to be temporarily left out to allow for crane lines for erection of the precast risers. Balancing the necessary amount of longitudinal bracing with erector requirements was a delicate operation (see Figs. 13 and 14).

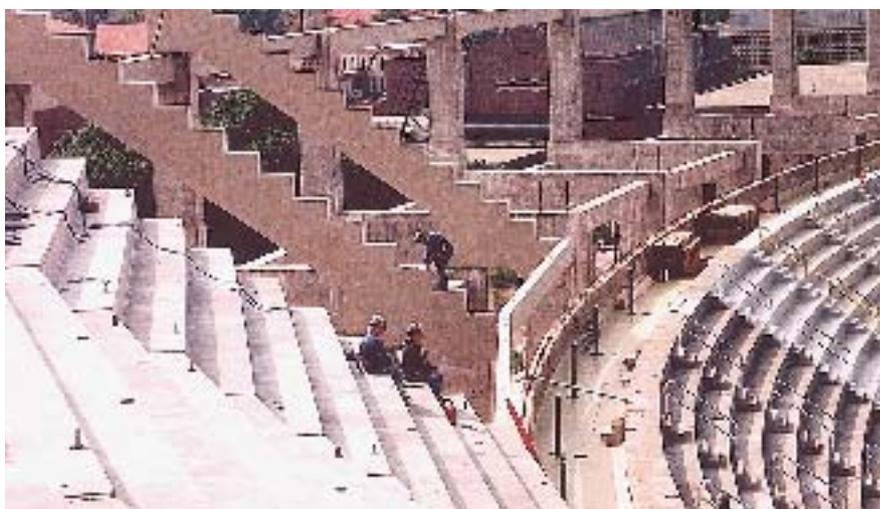
Fig. 14. Triple precast structural concrete risers provided erection efficiency and cost savings in the construction of the added 19 stadium rows.

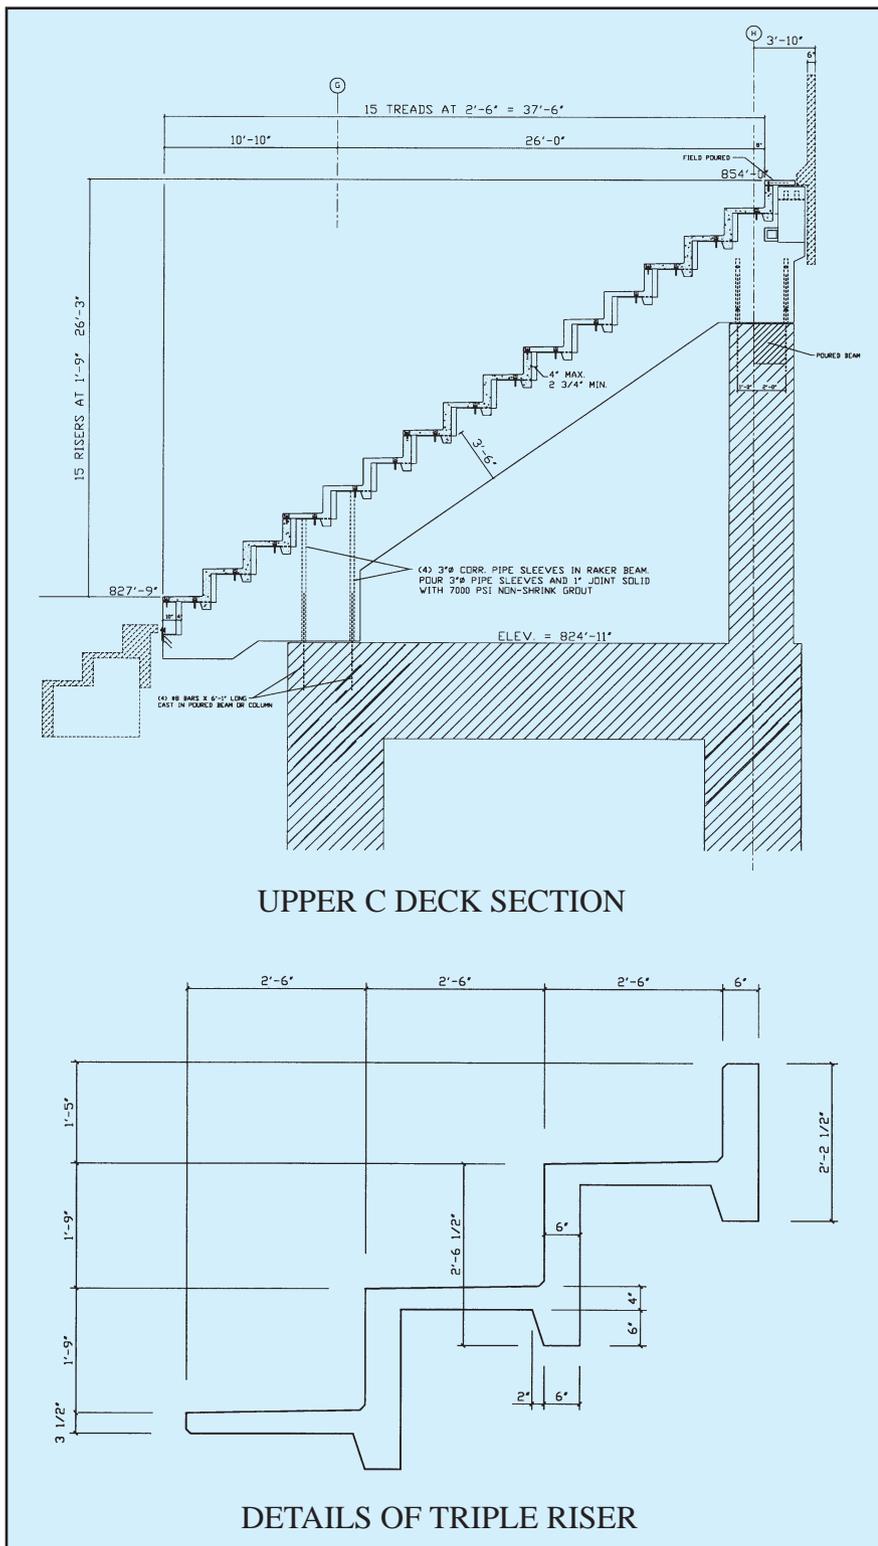
Fig. 15. Upper C Deck section (top) showing how triple risers provided erection efficiencies over original design with double risers.

The precaster chose to use triple risers instead of double risers for the upper decks (see Fig. 15). Typical riser span was 40 to 45 ft (12 to 14 m) long. Based on the good experience on

a previous job using triple risers, the precaster felt that using precast raker beams allowed good control of the bearing surfaces for more accurate and even support to all legs. The oval shape of the stadium meant that all the column lines fan outward radially. Therefore, all risers had skewed ends with many risers presenting different skew angles at opposite ends of the same riser.

The advantages of using triple risers included reductions in the required amount of joint caulking and number of riser-to-riser connections, faster erection, and one-third fewer component truckloads to transport to the site. Shipping permits allowed only one-

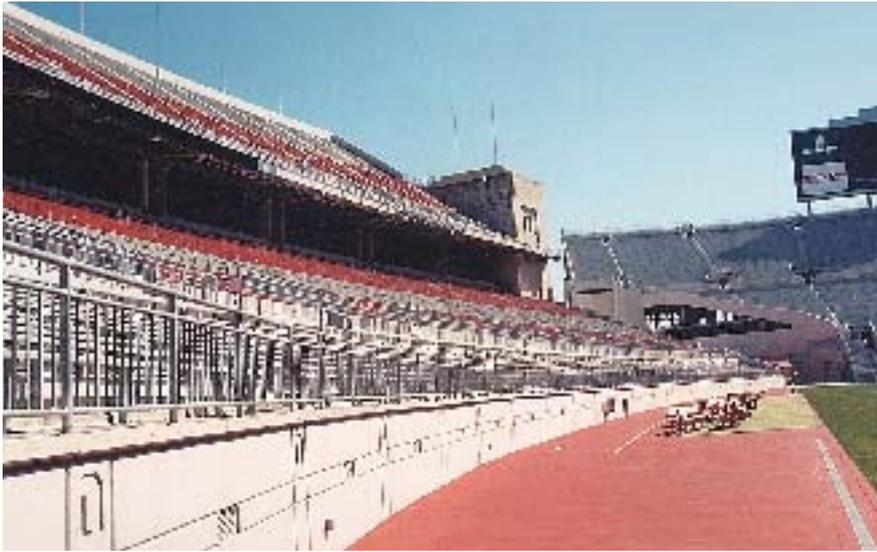
Fig. 16. Architectural precast concrete fascia walls at playing level provided owner-pleasing detailing of the OSU block “O” logo.

One of the most attractive and owner-pleasing elements of the precast panels that make up the inner perimeter fascia walls is the OSU traditional “Block O” logo cast into the pieces at every column line (see Figs. 16 and 17).

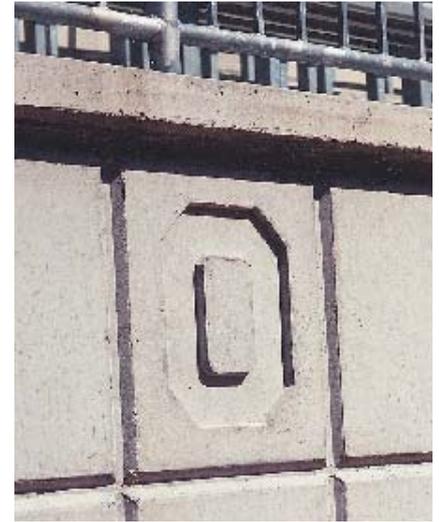
Fig. 17. Close-up detail of team logo letter on infield architectural precast fascia wall.

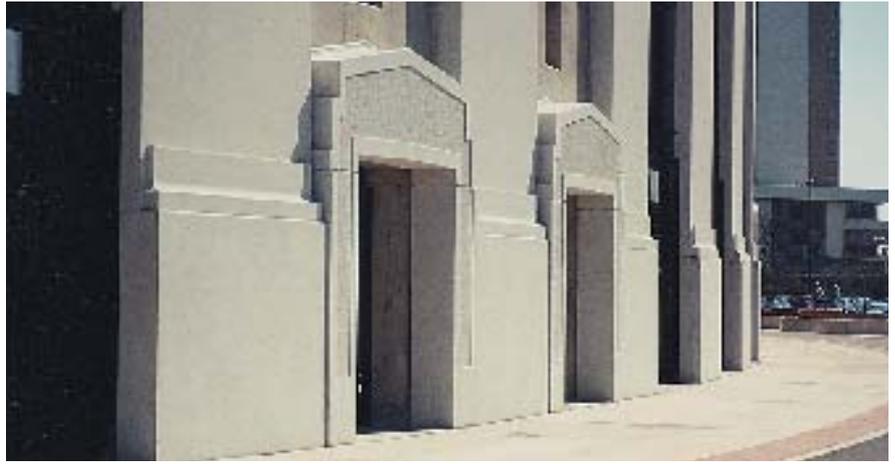
Fig. 20. Entrance portals were given a bush-hammered finish to work in aesthetic harmony with the older existing cast-in-place concrete.

Entrance portals received a “bush-hammered” finish to match the same

design appearance as the existing façade. The outer precast walls were sandblasted to blend with the existing concrete. The textured, bush-hammered precast finish works particularly well with the original historic look of the north rotunda (see Figs. 20 and 21).

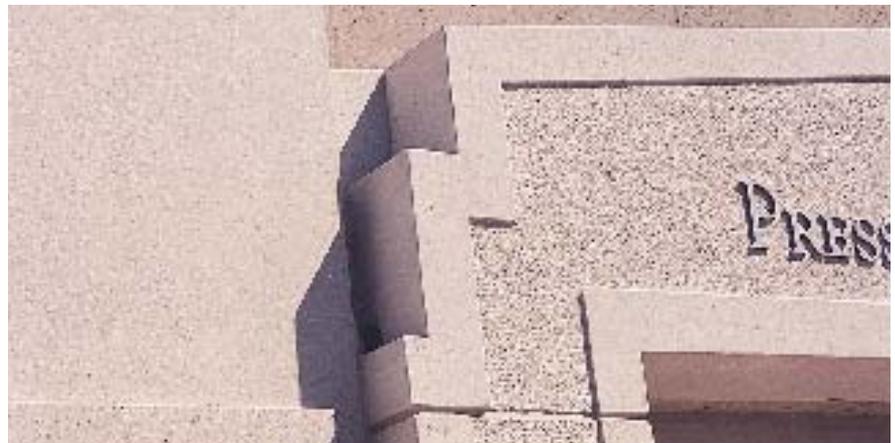
Fig. 21. Bush-hammering finish detail at the press entrance to the stadium.
