Structural Tests of Precast, Prestressed Concrete Deck Panels for California Freeway Bridges

Full-scale structural tests of five precast, prestressed concrete bridge deck panels have been carried out in simple bending to failure at the San Diego State University Structural Engineering Laboratory in San Diego, Calif. The purpose of the tests was to demonstrate to Caltrans that the precast concrete panels act compositely in flexure with a cast-in-place topping slab so that they can be used for California bridges. To ensure that the full deck width was active in resisting the applied loads, steel I-beams the width of the deck were used under the load and at the reaction points. Neoprene bearing pads were incorporated at the supports to allow free rotations at the deck ends. Each bridge deck consisted of a precast, prestressed concrete deck panel with a cast-in-place topping slab, with no reinforcing bars crossing the interface between slabs. Of particular interest was the verification that no horizontal shear slip occurred between the two slabs and that the deck acted as a fully composite member to failure. One test featured the precast concrete slab by itself, three of the tests inv

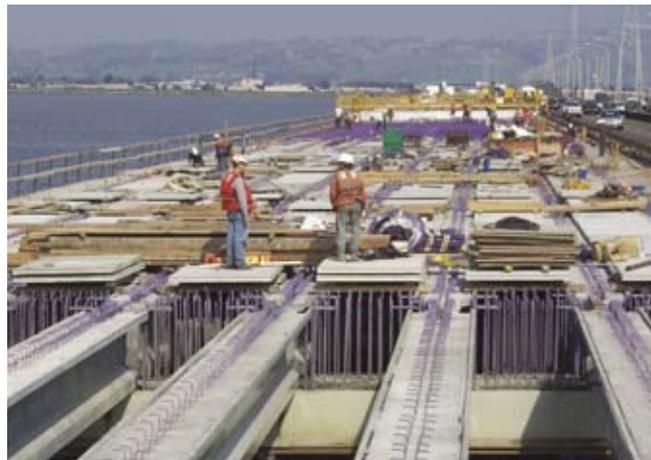
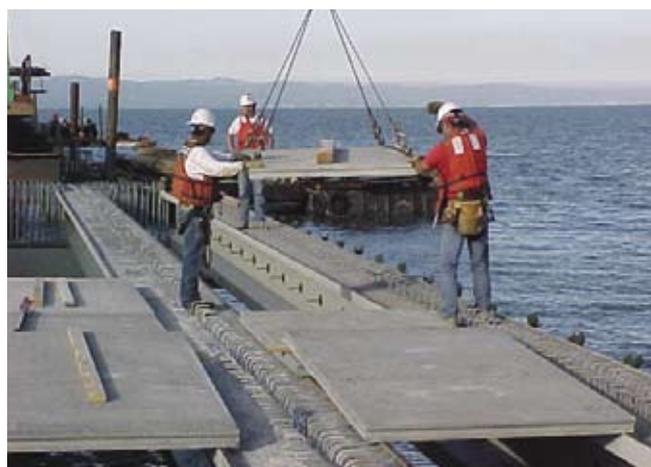
Fig. 1. Precast concrete slabs are being placed on precast, prestressed concrete girders for widening the San Mateo-Hayward Bridge.

In order to reduce the cost and construction time of the SR-22 HOV Widen Design/Build Project, contractor Granite-Myers-Rados, Joint Venture (GMR-JV) and designer PBS&J are recommending the use of precast, prestressed concrete deck panels with cast-in-place (CIP) topping for about 30 bridges in California. Deck panels will span between precast, prestressed concrete girders, placed one after another on camber strips, followed by the CIP concrete slab placed across the whole bridge deck. (Note that the CIP topping slab acts as both a structural component and the final riding surface of the deck.) A similar application of precast concrete deck panels was used for widening the San Mateo-Hayward Bridge (**Fig. 1**).

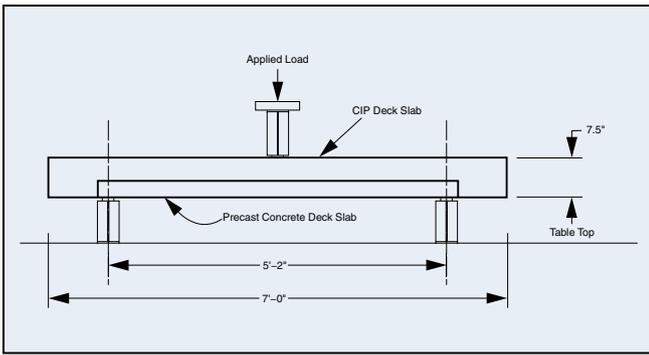
Fig. 2. Side view of overall setup for bridge decks tested in simple bending. Note: 1 in. = 25.4 mm.

The tests were conducted in simple bending with a point load applied at midspan and reactions at the ends of the precast concrete slab (**Fig. 2, 3**). Because the loading head diameter and reaction table width were less than the 2 ft (0.6 m) slab width, relatively rigid steel I-beams were designed to spread the applied load and reactions evenly across the section width. For both precast concrete and CIP slab details, see **Fig. 4**. Vertical stiffeners were added to the I-beams at critical load points (under the loading head and at the sides of the reaction table [**Fig. 2, 3, 5**]).

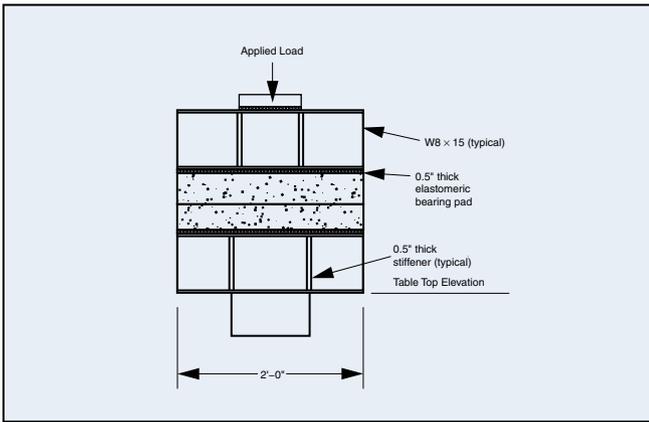
Fig. 3. End view of overall setup for bridge decks tested in simple bending. Note: 1 in. = 25.4 mm.

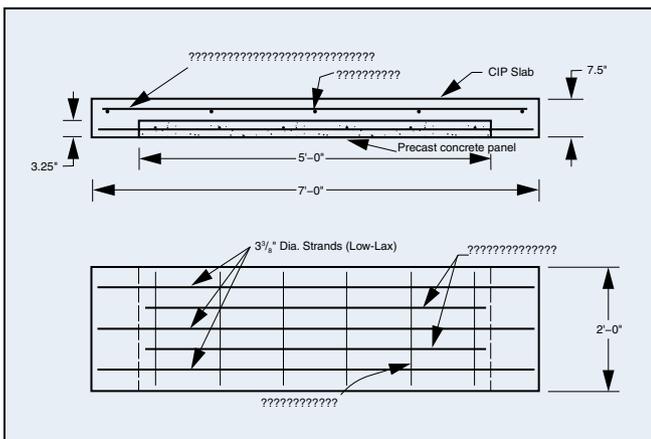
Fig. 4. Precast concrete panel and cast-in-place slab details. Note: 1 in. = 25.4 mm.

Including the precast concrete and CIP slabs, the total size of each test specimen was 7 ft (2.1 m) long, 2 ft (0.6 m) wide, and 7.5 in. (190 mm) thick. The precast concrete slab dimensions were 5 ft 4 in. (1.6 m) long, 2 ft (0.6 m) wide, and 3.25 in. (83 mm) thick. The precast concrete deck panels were cast by Pomeroy Corp. at its Petaluma, Calif., plant and were shipped to the SR-22 HOV bridge site in Orange County, Calif., so that the CIP toppings could be added by contractor GMR-JV.²

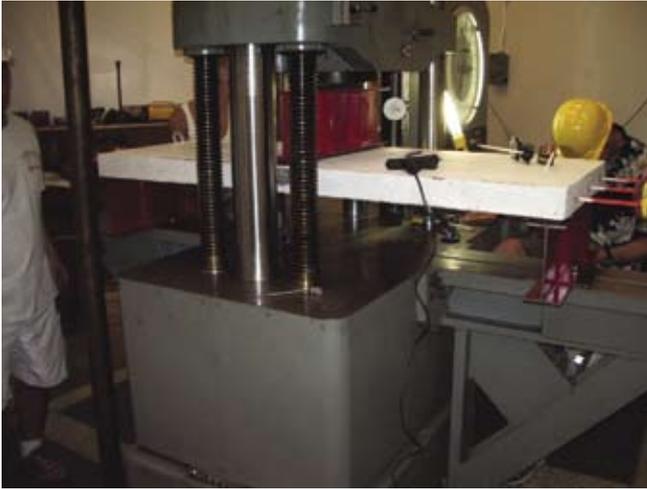
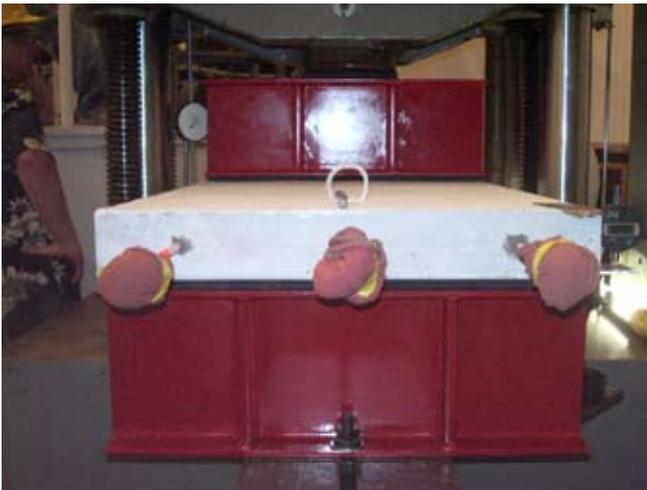
Fig. 5. Isometric and end views of overall test setup with the Test 1 precast concrete panel.

The structural tests were performed monotonically in displacement control to failure. It is considered displacement control because the structure is loaded by slowly moving the crosshead of the testing machine down and measuring the force that develops. The crosshead moves or displaces up and down by rotating a loading button on the control panel, which activates the machine to turn three large spirally threaded shafts on either side of the crosshead (Fig. 5).

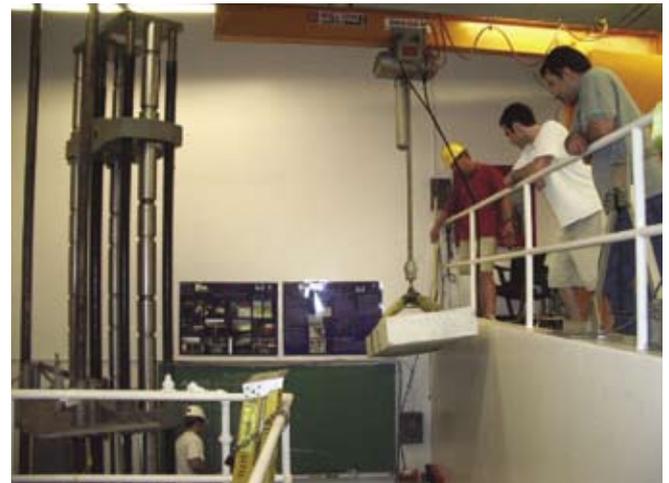
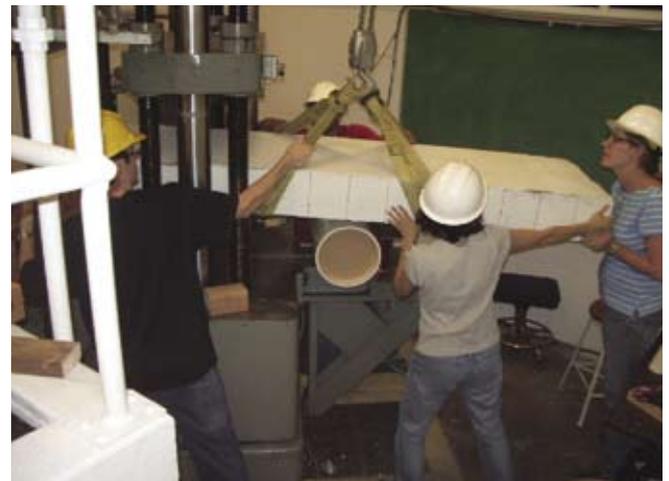
Fig. 6. Lowering a precast concrete panel onto rollers for positioning.

A given test unit was lifted with a crane over the upper-floor lab rail and lowered into the testing pit and onto oversized rollers that were temporarily placed on the reaction table (Fig. 6). Straps were removed and the deck slab was rolled into approximate position by hand. The straps were

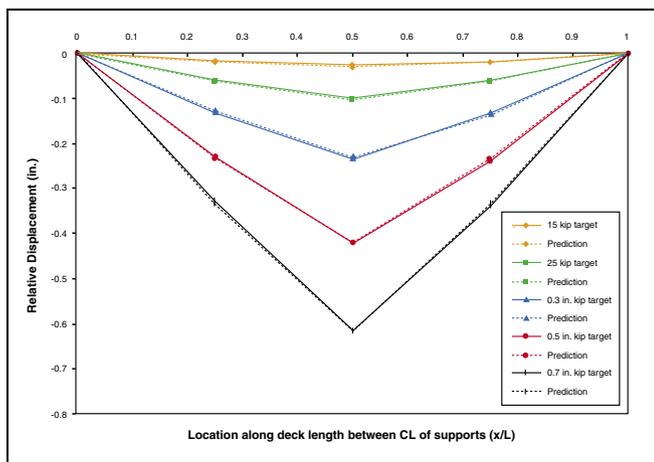
Fig. 7. Predicted and measured displacement profiles at various targets, Test 2. Note: 1 in. = 25.4 mm; 1 kip = 454 kg.

Predicted and measured relative displacement profiles are displayed in **Fig. 7, 8, 9, and 10** at specific force and displacement target levels for Tests 2 through 5. Test 1 (precast concrete deck panel only, Fig. 5) is not included here because displacements were not measured at the one-quarter span locations. The first target level in each of the figures represents linear behavior, with the second target including some cracking.

The remaining three targets represent increasing cracking and full development of plastic hinging at the critical midspan section. These excellent comparisons demonstrate that the prediction analyses accurately reflect the deformations along the length of the deck in the elastic range, through extensive flexural cracking, and into large plastic deformations.

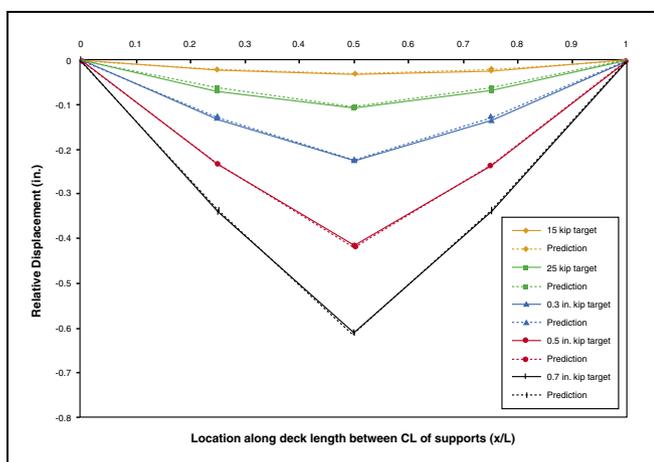
Fig. 8. Predicted and measured displacement profiles at various targets, Test 3. Note: 1 in. = 25.4 mm; 1 kip = 454 kg.

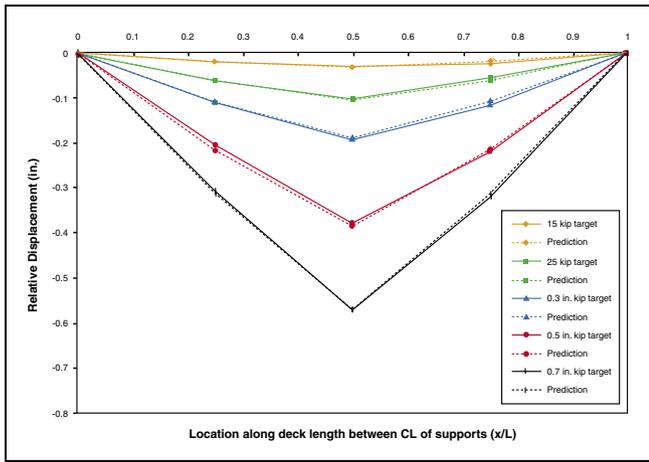
Fig. 9. Predicted and measured displacement profiles at various targets, Test 4. Note: 1 in. = 25.4 mm; 1 kip = 454 kg.

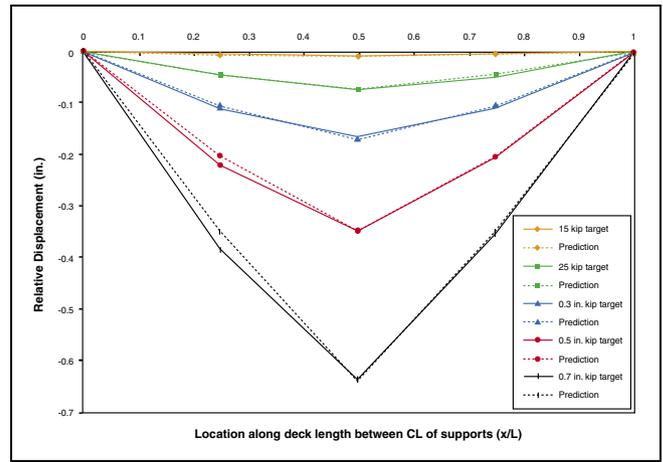
Fig. 10. Predicted and measured displacement profiles at various targets, Test 5. Note: 1 in. = 25.4 mm; 1 kip = 454 kg.

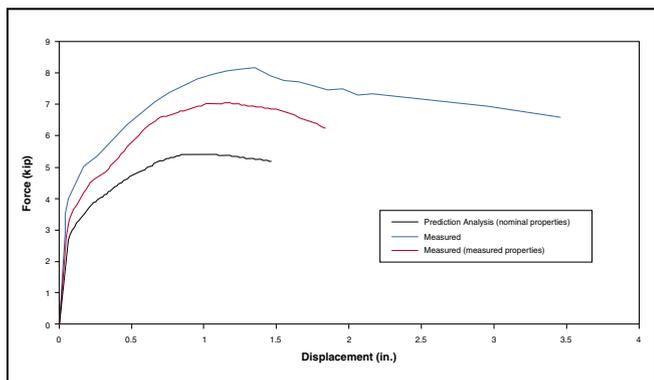
Fig. 11. Precast concrete deck panel, measured and predicted behaviors, Test 1. Note: 1 in. = 25.4 mm; 1 kip = 454 kg.

force of 8.15 kip (36.3 kN) (Fig. 11). Predicted maximum force and associated relative displacement were 7.02 kip (31.2 kN) and 1.2 in. (31 mm), respectively (Fig. 11). Predicted displacement capacity was 1.84 in. (46.7 mm) at a compressive strain for the unconfined concrete of 0.005.

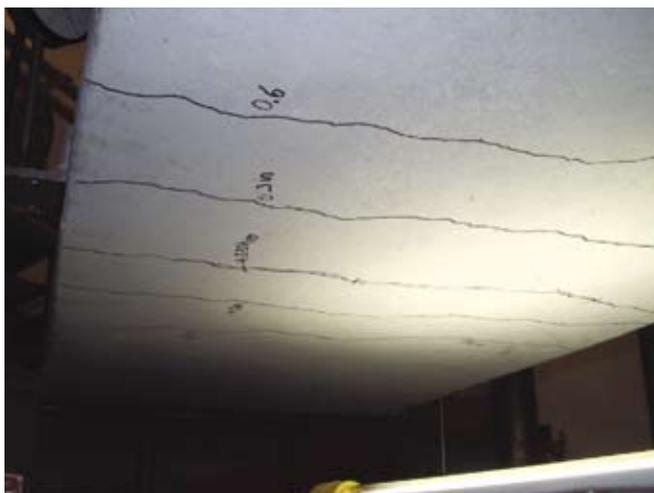
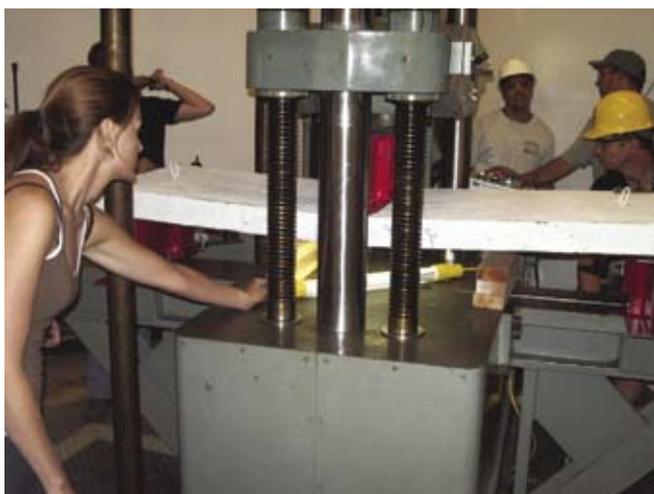
Fig. 12. Displacement target of 0.6 in. (15.2 mm), Test 1.

Cracking began at the target force of 4.275 kip (19.0 kN) with a full-width crack developing on the bottom of the slab at midspan at the maximum moment location. Additional cracks formed on either side of the center crack at the 0.3 in. (7.6 mm) target displacement. At the target displacement of 0.6 in. (15.2 mm), well-distributed cracking was observed with an average spacing of 4.5 in. (114 mm) (**Fig. 12**).

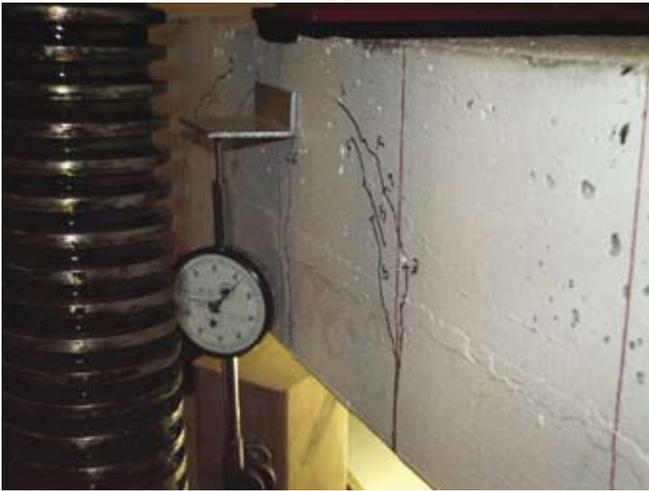
Fig. 13. Displacement target of 0.6 in. (15.2 mm), Test 2.

More extensive cracking developed at the target vertical displacement of 0.5 in. (13 mm) (with an average crack spacing of 5 in. [127 mm]), and the tops of the cracks began to rotate from the vertical as they extended higher, indicating the influence of shear. Inclined cracking became much more extensive at the target displacement of 0.6 in. (15.2 mm), with significant flexure-shear cracks forming (Fig. 13).

Note that the crack progression through the section at different target levels can be seen from Fig. 13 by reading the felt pen numbers adjacent to transverse tick marks that indicate the end of the crack up to that target level. Thus, one photograph taken near the end of the test can show the complete

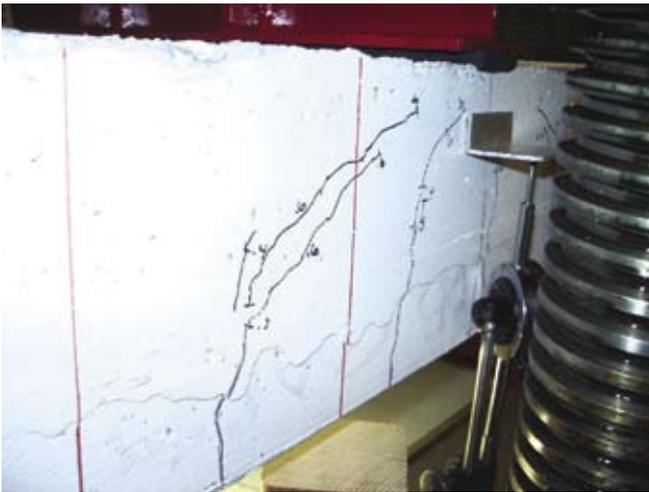
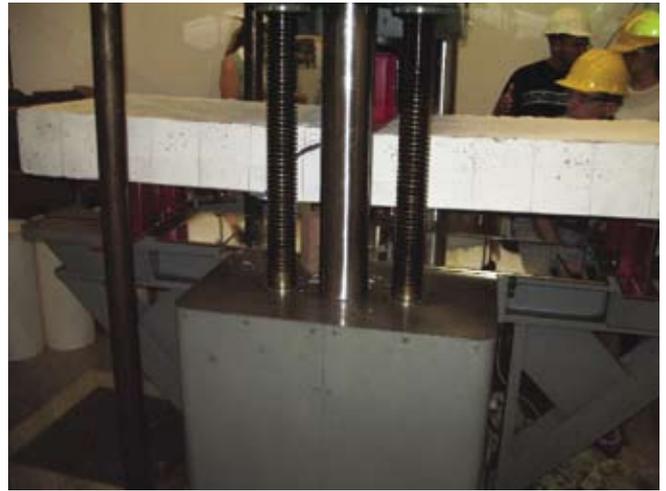
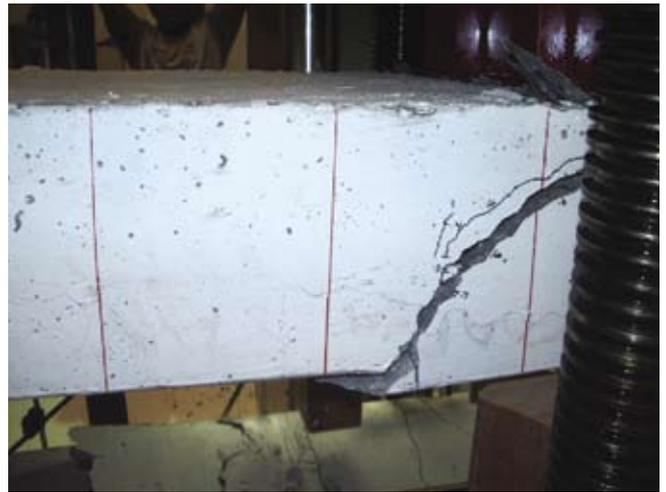
Fig. 14. Displacement target of 1.0 in. (25.4 mm), Test 2.

Concrete spalling started at 0.6 in. (15.2 mm) target displacement. More extensive flexure-shear cracks developed at 0.8 in. (20.3 mm) of displacement, resulting in significant loss in force. Wider flexure-shear cracks were observed at 0.9 in. (22.9 mm) target displacement. Sudden shear failure occurred at 1.0 in. (25.4 mm) target displacement, ending the test (**Fig. 14**).

The failure developed across the full width of the section along a flexure-shear crack line and resulted in a large visible offset between the two sides of the structure (**Fig. 14**). Prediction analyses and real-time measured test data were projected on the laboratory wall so that visitors could watch the comparisons as they developed.

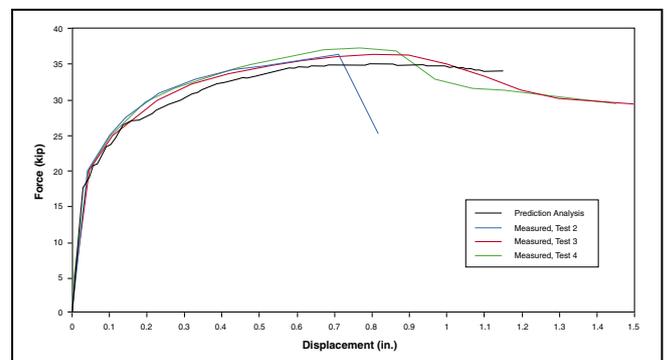
Fig. 15. Precast concrete panel and cast-in-place slab, measured and predicted behaviors, Tests 2–4.

Note that no horizontal shear slip was observed or measured between the precast concrete panels and CIP slabs, indicating that fully composite behavior was maintained throughout the test. This is also demonstrated by the close correlation between the measured and predicted force-deformation responses (**Fig. 15**).

35.0 kip (156 kN) at a relative displacement of 0.86 in. (21.8 mm). Predicted relative displacement capacity was 1.15 in. (29.2 mm) at a compressive strain of 0.005, compared with the measured relative displacement at failure of 0.946 (24.0 mm). Measured and predicted force-deformation results are given in **Fig. 15**.

The measured crack width where failure occurred opened up from a stable 0.315 in. (8 mm) just before failure, to 3.54 in. (90 mm) following failure. The maximum measured force was 36.2 kip (161 kN) at a relative displacement of 0.9 in. (22.9 mm) compared with the predicted maximum force of 35.0 kip (156 kN) at a relative displacement of 0.86 in. (21.8 mm). Measured and predicted force-deformation plots are given in Fig. 15.

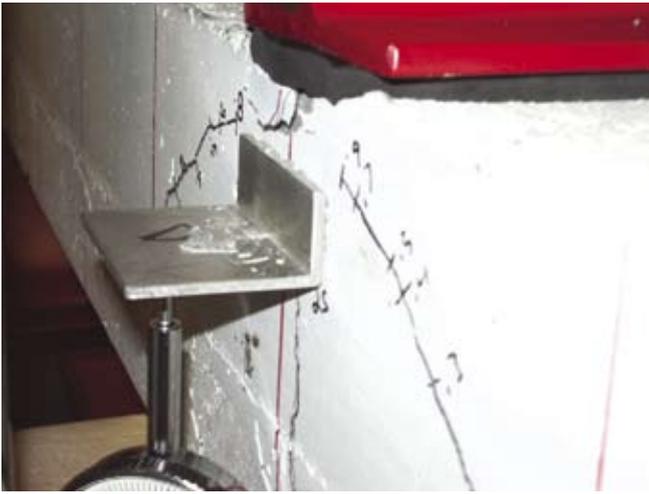
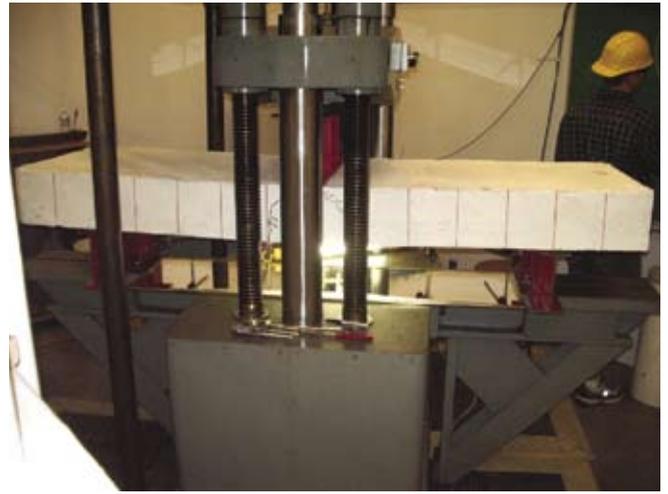
Fig. 16. Displacement target of 1.0 in. (25.4 mm), Test 3.

Spalling initiated at the 0.5 in. (13 mm) target and became more severe at the 0.7 in. (17.8 mm) target displacement. By the 0.9 in. (22.9 mm) target displacement, fully extended flexure-shear cracks had developed on either side of the load point. At the 1 in. (25 mm) target level, the flexure-shear cracks were visibly widening and extending toward each other (**Fig. 16**).

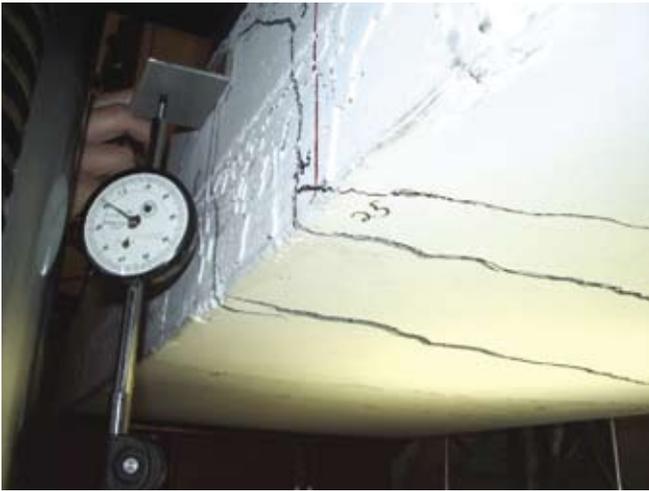
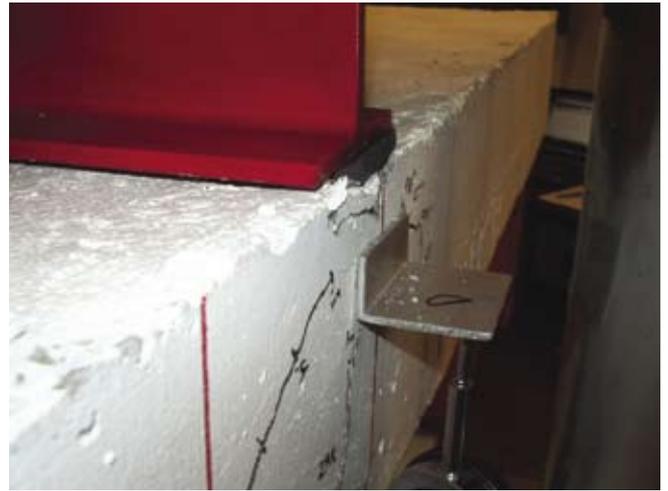
Fig. 17. Displacement target of 1.0 in. (25.4 mm), Test 4.

A loss in force occurred at the 1 in. (25 mm) target level (0.865 in. [22.0 mm]) relative displacement (Fig. 17), with flexure-shear cracks that developed on either side of the applied load joining arcs at the slab centerline just below the crushing and spalling of the concrete. Flexure-shear cracks widened noticeably, as did the extent of spalling, at the 1.2 in. and 1.4 in. (31 mm and 36 mm) target displacement levels.

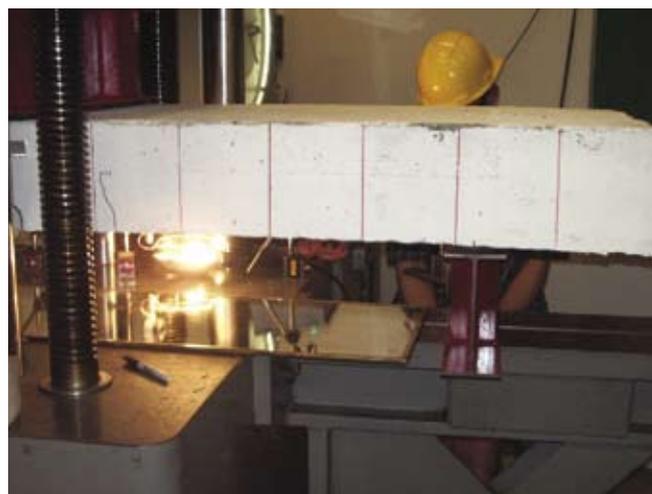
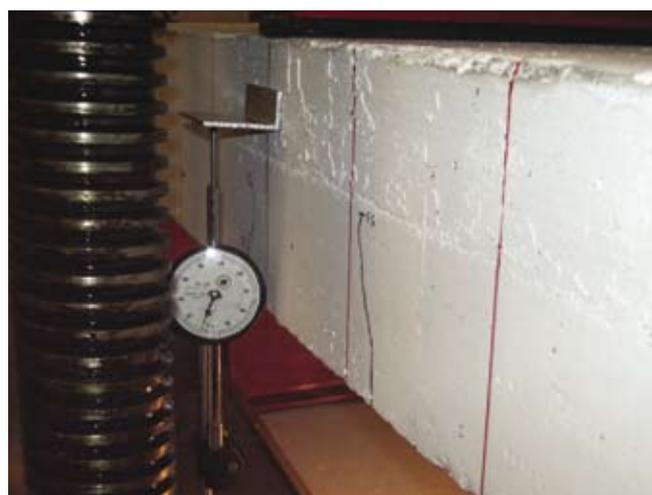
Fig. 18. Force target of 15 kip (67 kN), Test 5.

Flexural cracking began at 10 kip (44.5 kN), with more full-width cracks occurring at 15 kip (66.8 kN) (Fig. 18). By the target displacement of 0.3 in. (7.6 mm), previously formed flexure cracks started turning in as they extended upward, showing the influence of shear. By the target displacement of 0.8 in. (20.3 mm), the flexure-shear cracks had taken form but were not yet very wide. The flexure-shear cracks crossed the marked vertical red lines without any slip between the slabs.

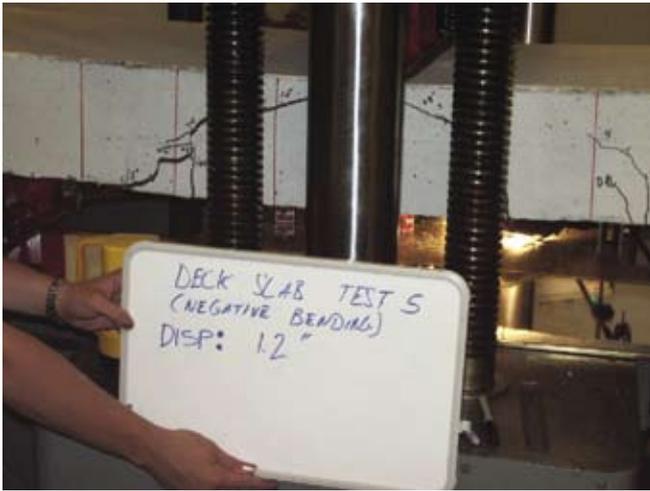
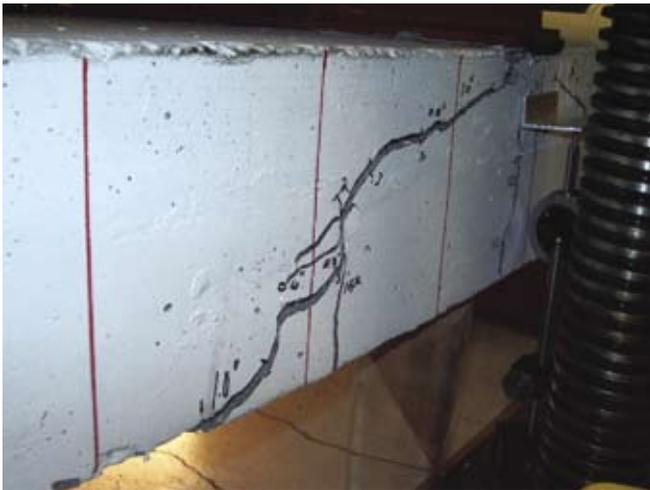
Fig. 19. Displacement target of 1.2 in. (31 mm), Test 5.

At a target displacement of 1 in. (25 mm), the flexure-shear cracks began to widen significantly, resulting in a sudden shear failure at a target of 1.2 in. (31 mm) (Fig. 19). In the top picture of this figure, a short horizontal crack is seen on the right side at the interface between the slabs that developed at the 0.4 in. (10.2 mm) target level. The short interface crack in this negative bending test did not result in any horizontal slip between the slabs and had no effect on the final failure mode. This type of interface crack was not seen in any of the positive bending tests.

Note that the final failure plane follows a straight, inclined shear line that is an extension of the previously formed

flexure-shear crack (the failure plane extends across the top of the original flexure crack and continues at the angle of the flexure-shear crack, allowing the structure to separate into two pieces).

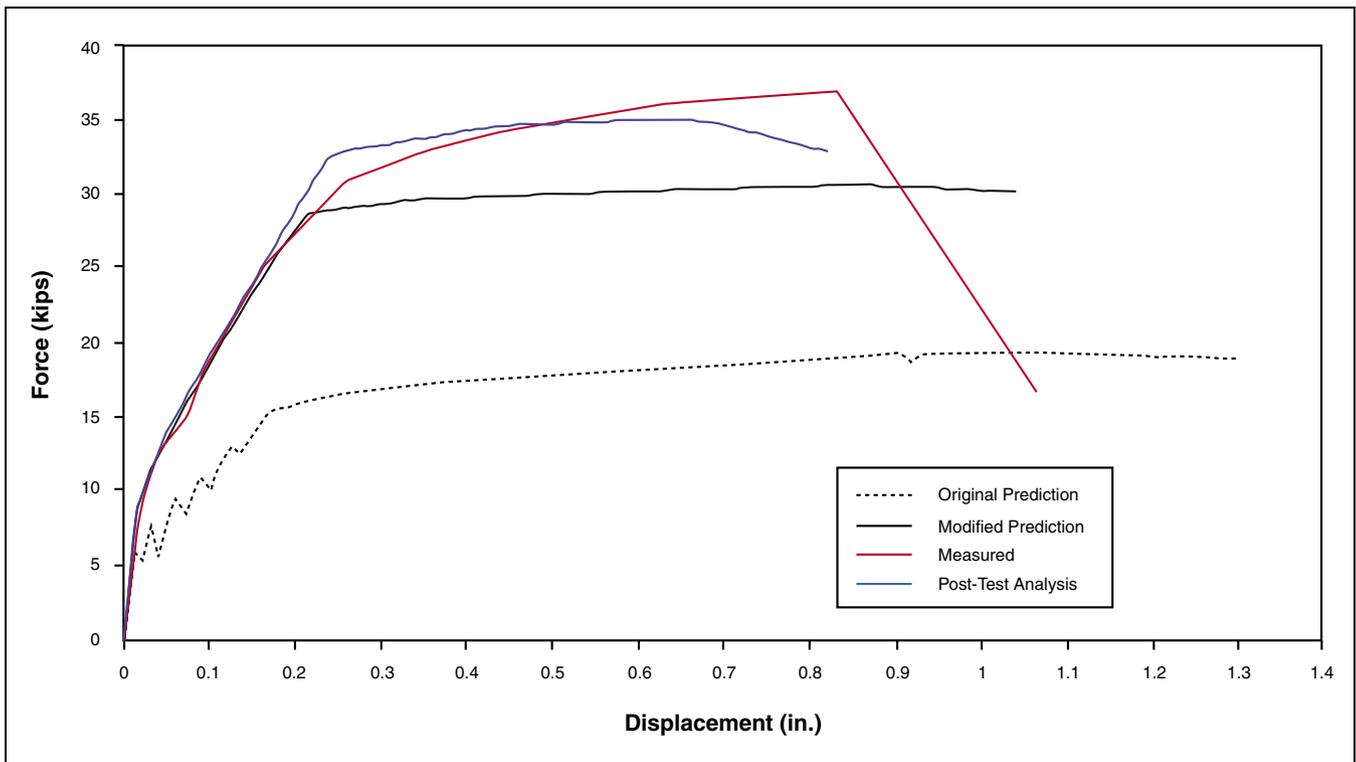
Fig. 20. Precast concrete panel and cast-in-place slab (negative bending), measured and predicted behaviors, Test 5.
 Note: 1 in. = 25.4 mm; 1 kip = 454 kg.

found in the post-test analysis given in Fig. 20. Because the #5 reinforcing bar samples could not be found following the deck tests, a couple of sample #5 bars were removed by jackhammer from the uncracked region of one of the deck units and tested to failure, providing measured material properties for the #5 bars and improved force-deformation analysis results as indicated in Fig. 20.
