Proposed evaluation and repair procedures for precast, prestressed concrete girders with end-zone cracking

Christie J. Hasenkamp, Sameh S. Badie, Kromel E. Hanna, and Maher K. Tadros

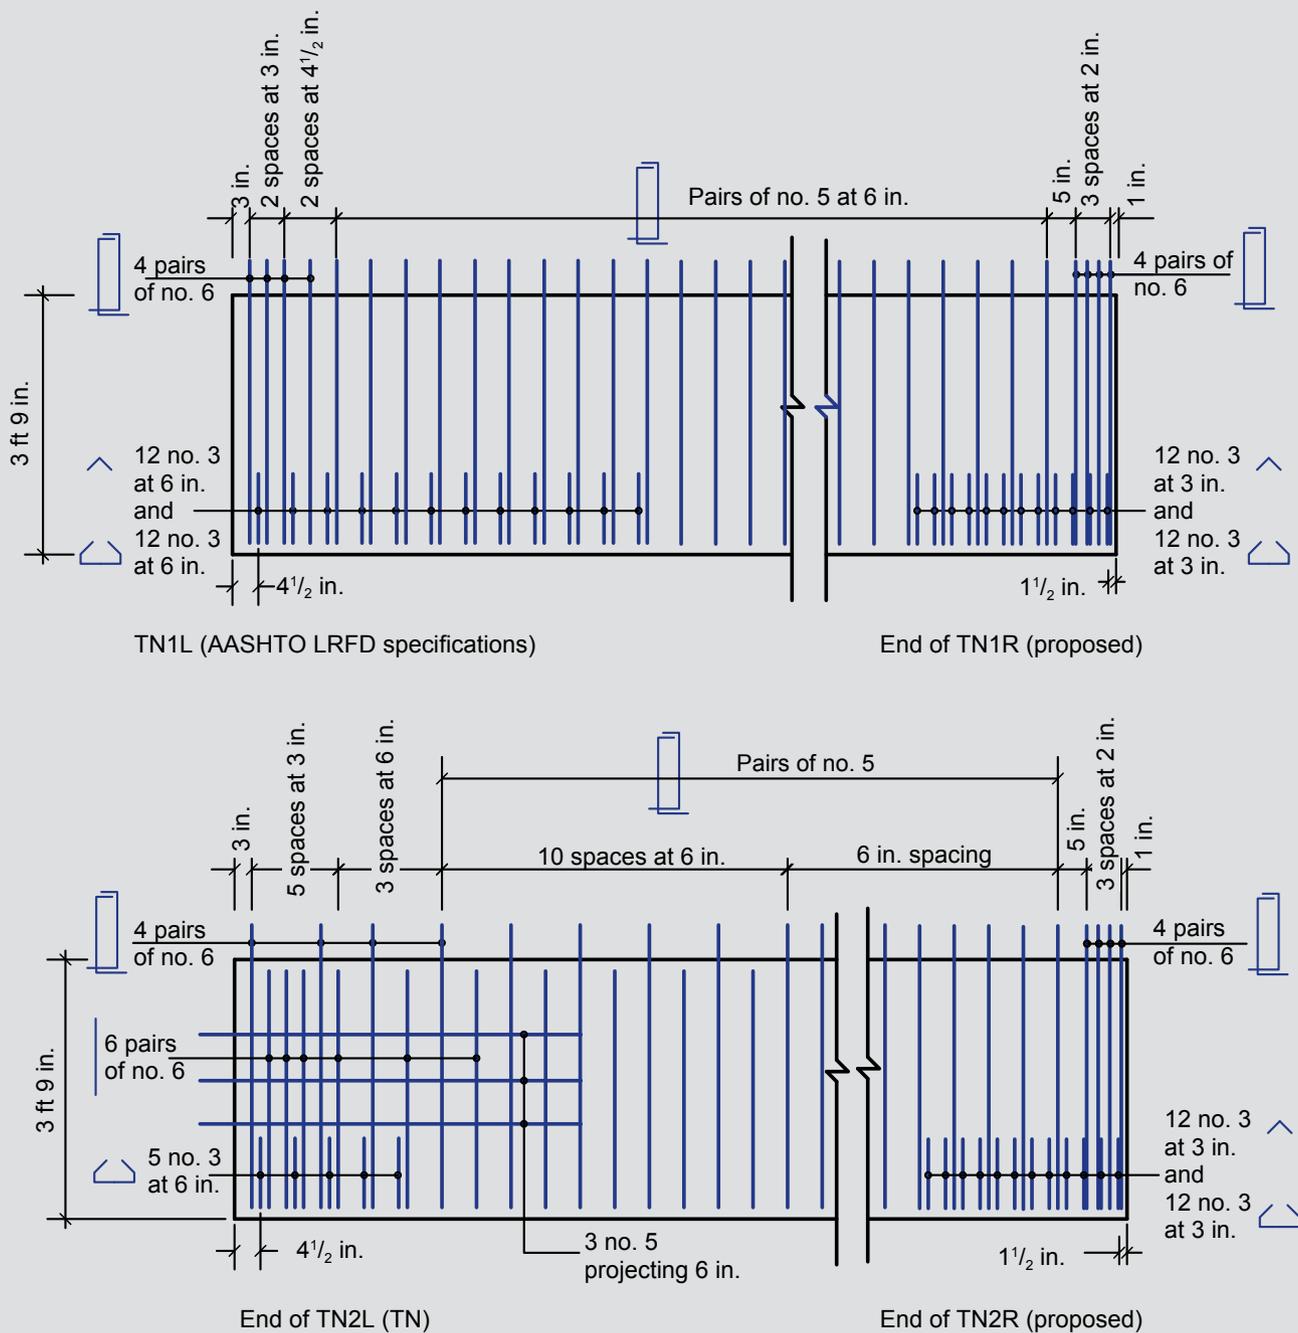
Figure 1. End-zone reinforcement details. Note: no. 3 = 10M; no. 4 = 13M; no. 5 = 16M; no. 6 = 19M; no. 8 = 25M; 1 in. = 25.4 mm; 1 ft = 0.305 m.

Among the end-zone reinforcement details used on the eight specimens were the American Association of State Highway and Transportation Officials' (AASHTO's) *LRFD Bridge Design Specifications, 4th Edition—2008 Interim Revisions*⁸ detail and a proposed detail. The proposed detail was developed by the research team based on research conducted by Tuan et al.⁹ The AASHTO LRFD specifications and proposed details recommend that the end-zone reinforcement be designed to resist 4% of the total prestressing force at transfer and that the reinforcement should be designed for a service stress not exceeding 20 ksi (140 MPa). The AASHTO LRFD specifications state that this reinforcement should be distributed within one-fourth of the depth of the girder from the end of the girder, while the proposed detail recommends that 50% of this reinforcement be placed within one-eighth of the depth of the girder from the end of the beam and the remainder should be placed between one-eighth and one-half of the girder depth from the end. **Figures 1** through **4** give details of the end-zone reinforcement of the eight specimens.

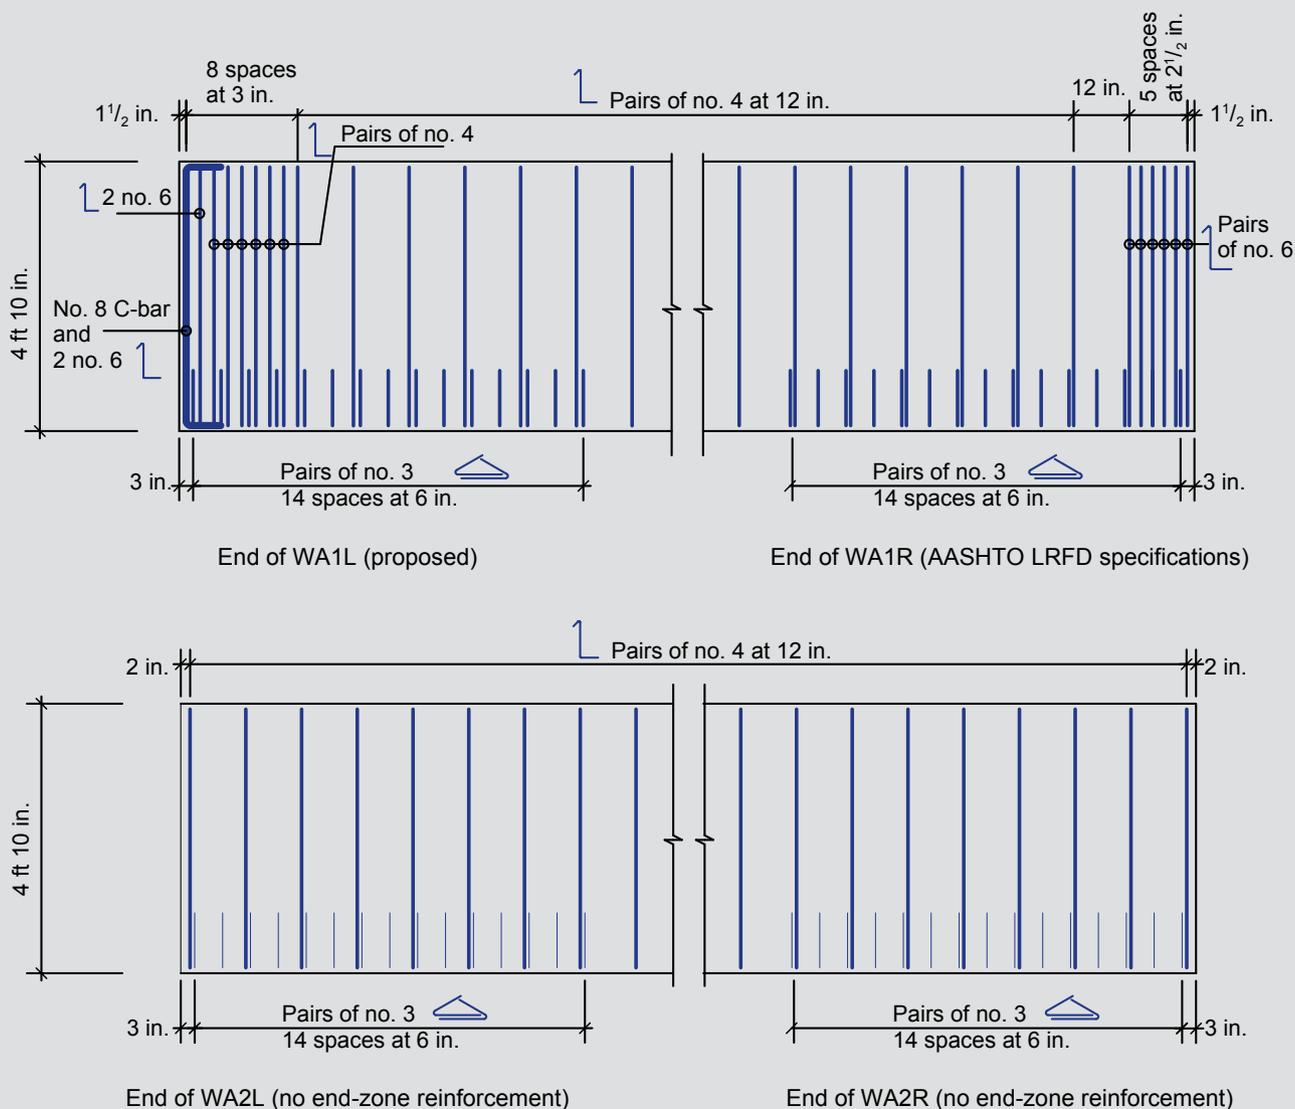
Figure 2. End-zone reinforcement details. Note: no. 3 = 10M; no. 4 = 13M; no. 6 = 19M; no. 8 = 25M; 1 in. = 25.4 mm; 1 ft = 0.305 m.

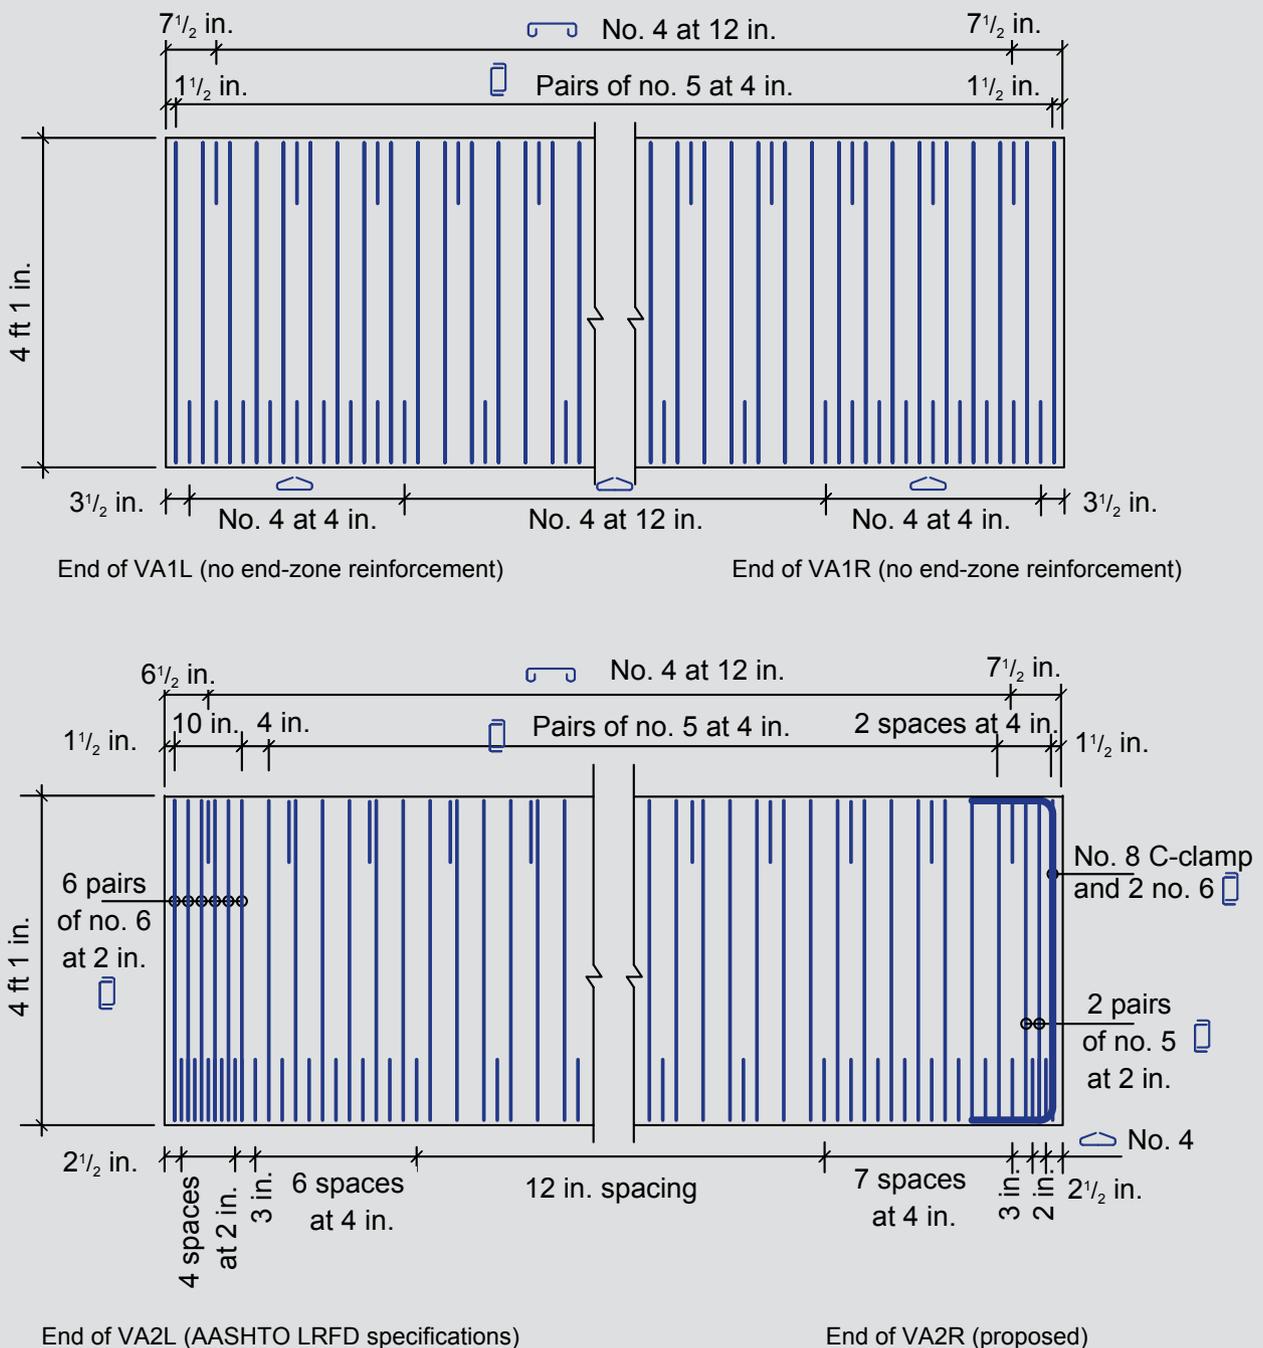
Figure 3. End-zone reinforcement details. Note: no. 4 = 13M; no. 5 = 16M; no. 6 = 19M; no. 8 = 25M; 1 in. = 25.4 mm; 1 ft = 0.305 m.

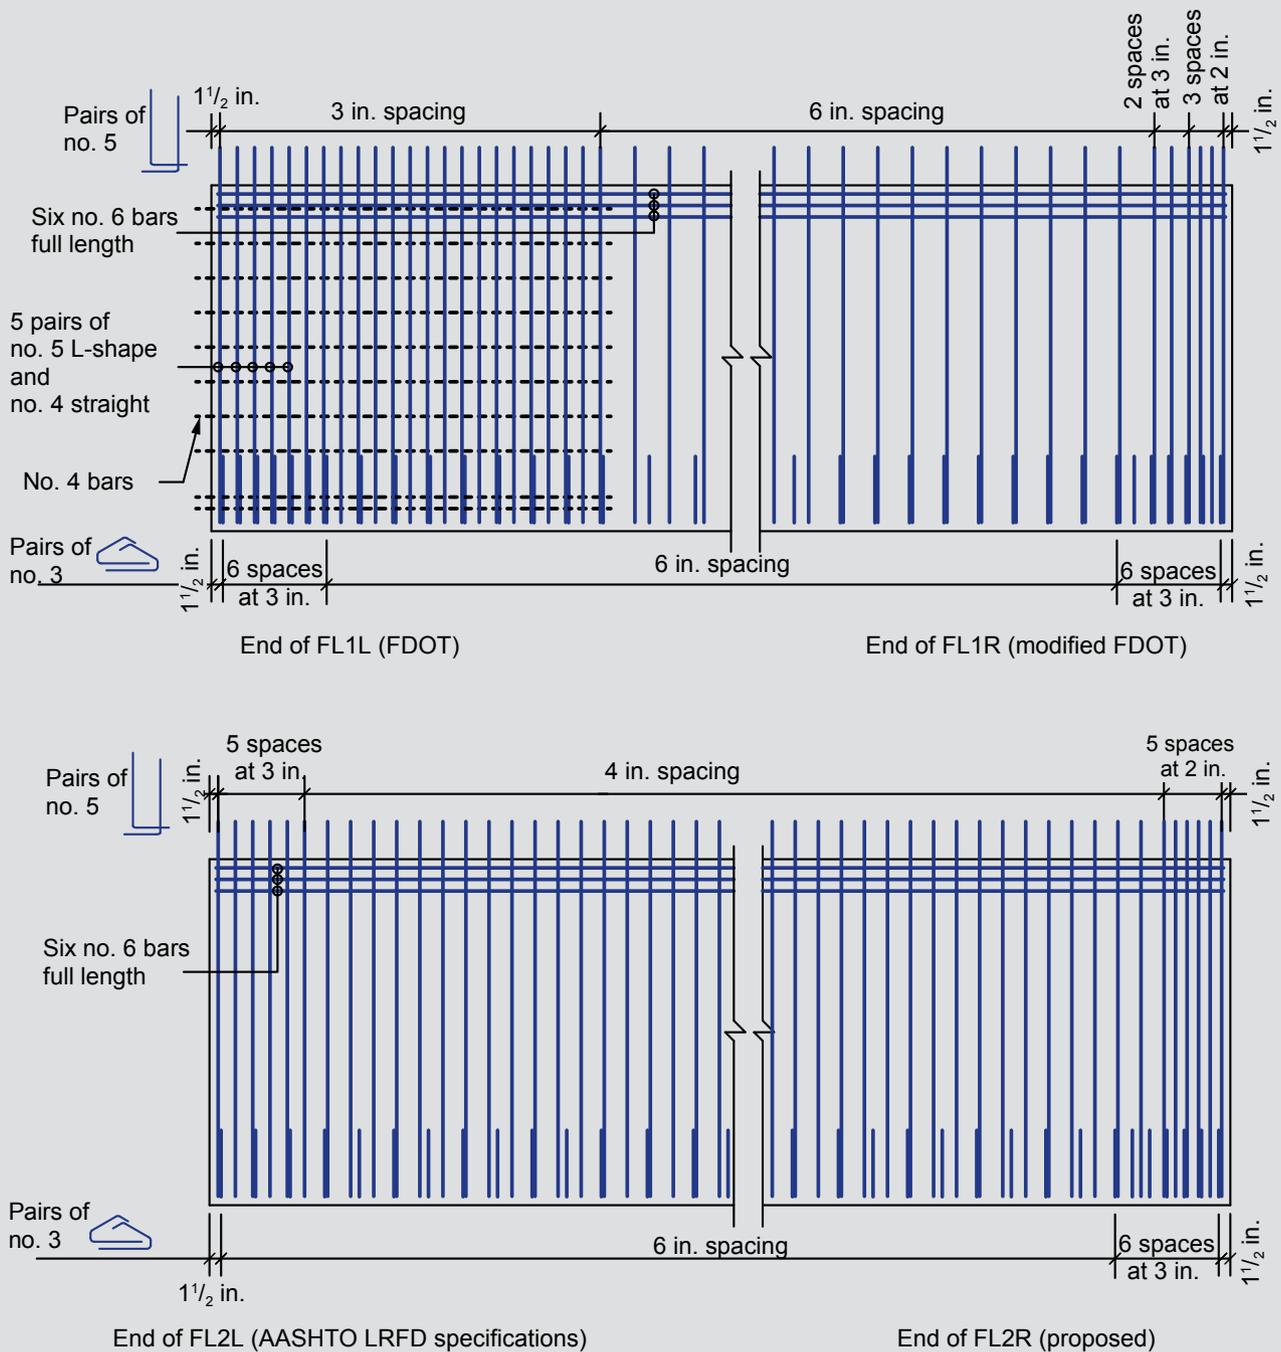
Figure 4. End-zone reinforcement details. Note: no. 3 = 10M; no. 4 = 13M; no. 5 = 16M; no. 6 = 19M; 1 in. = 25.4 mm.

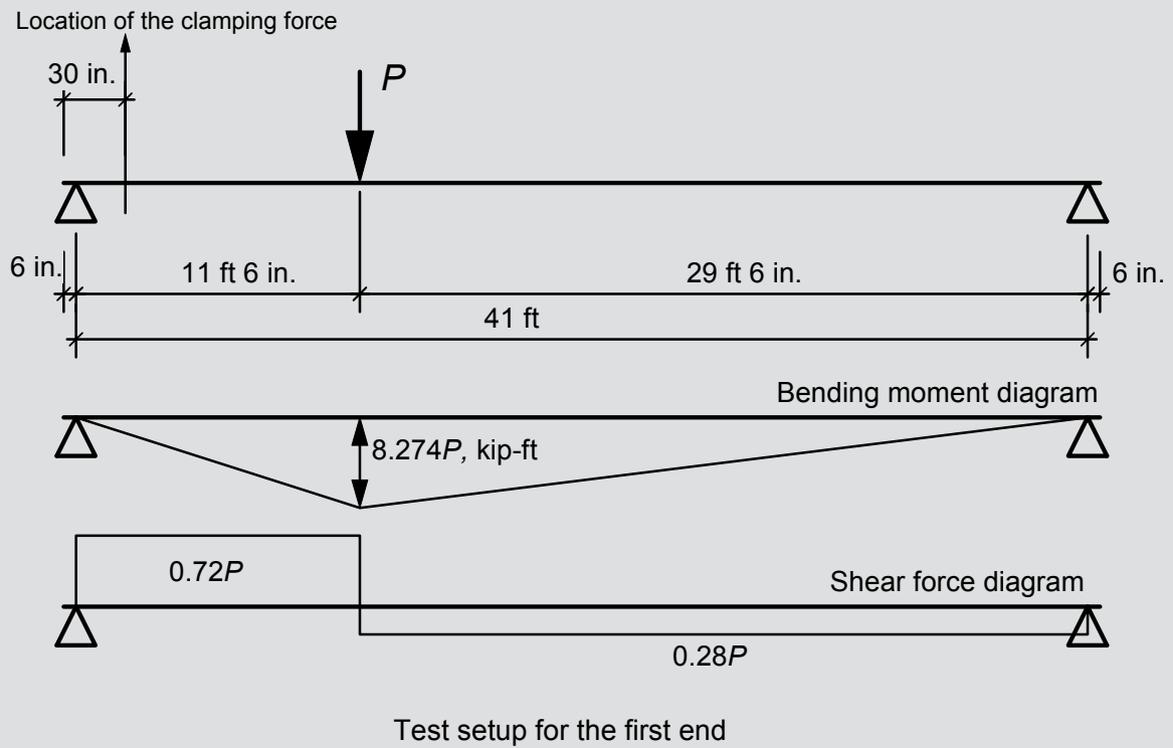
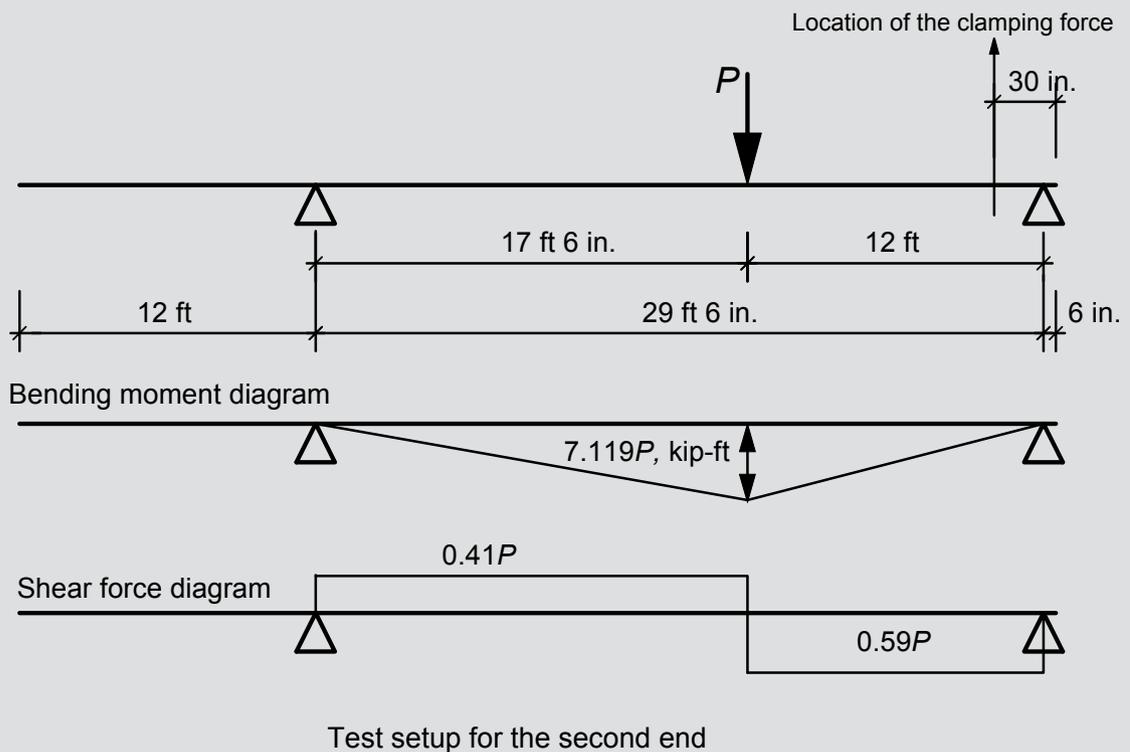
Figure 5. Support and loading arrangement of the full-scale specimens. Note: P = load. 1 in. = 25.4 mm; 1 ft = 0.305 m.

from the other end. Once the test on this end was complete, the support on this end was moved 12 ft inside the specimen and the load setup was placed 12 ft from the second support (Fig. 5). This setup enabled testing both ends of every specimen without any effect from the tested end on the performance of the second end of the specimen.

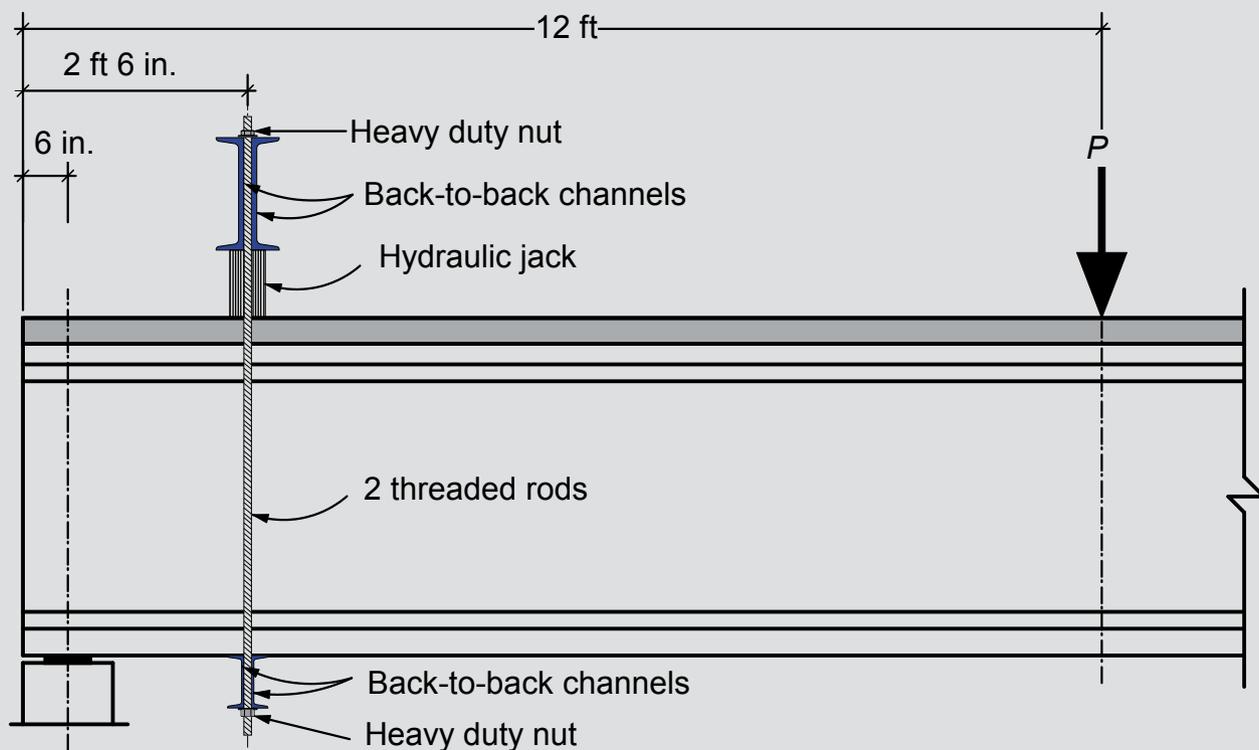
Figure 6. Location of the point load and clamping mechanism.

provided by using a hydraulic jack attached to a self-equilibrium frame built around the specimen (Fig. 6). The clamping force was calculated as the balance between the reaction developed by the actual bridge girder (due to the weight of the slab, barrier, wearing surface, and utilities) and the reaction generated by the 42-ft-long (13 m) specimen.

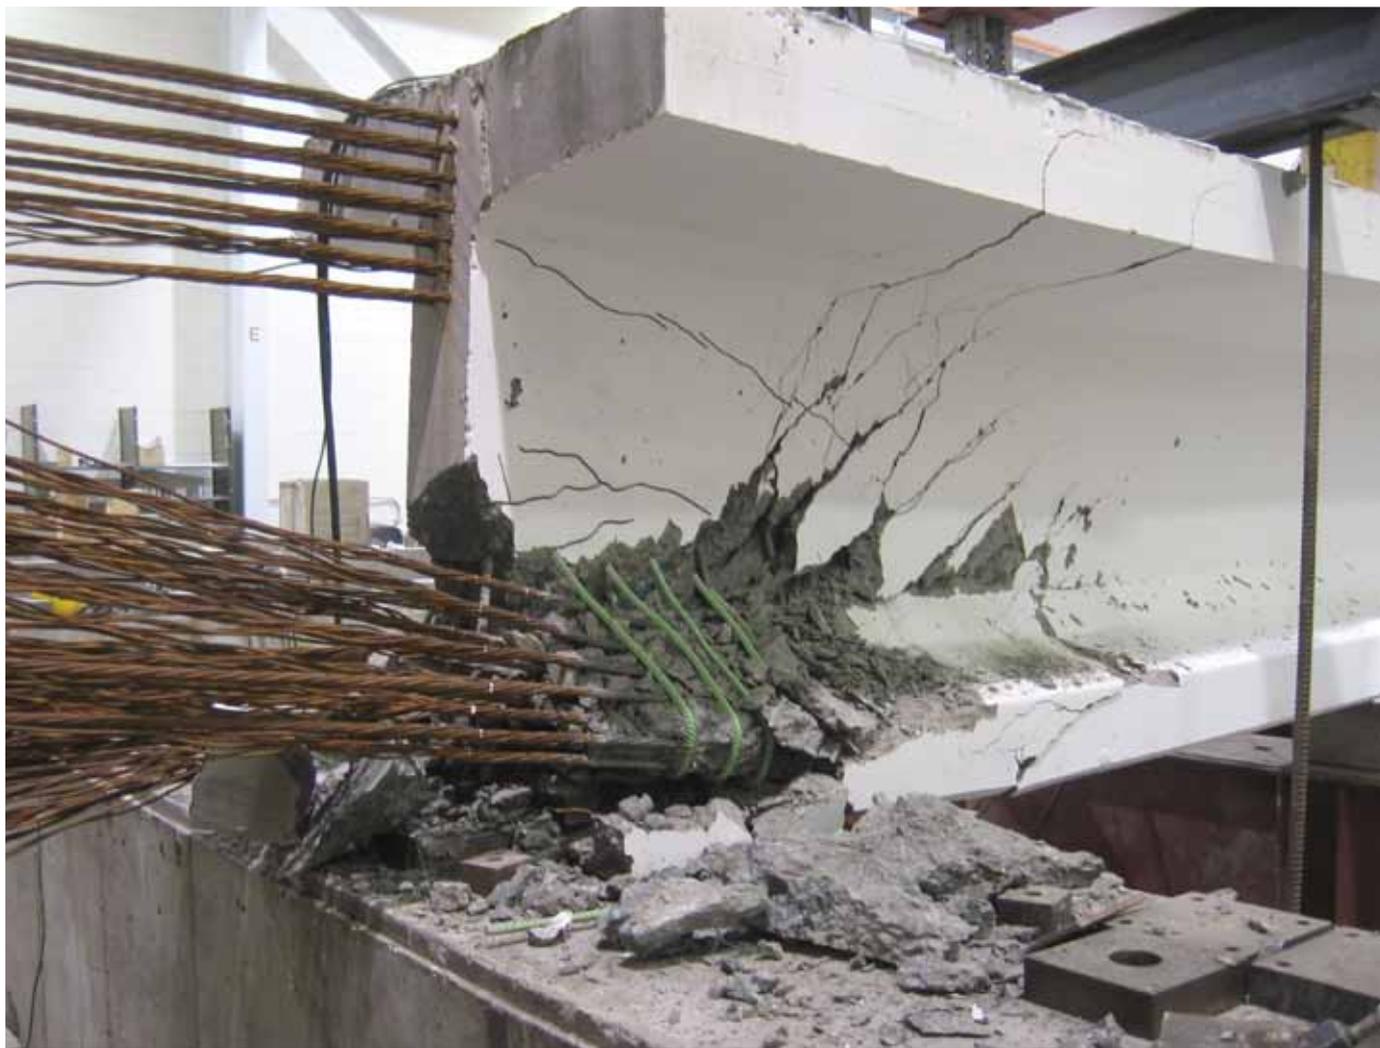
Figure 7. Premature failure of end VA1R due to inadequate bearing area.

two ends, VA1R and FL1L, did not develop the measured capacity due to fabrication flaws. End VA1R was the first Virginia end tested, and it failed prematurely due to inadequate bearing area (Fig. 7). This occurrence prompted the team to devise a pivoting support with a larger bearing area (Fig. 8). As a result, the three remaining ends of the VA specimens failed in flexure as designed, where all ends sustained loads higher than their design capacities. End FL1L failed prematurely in shear due to a mix-up at the precast concrete plant that caused this end of the girder to

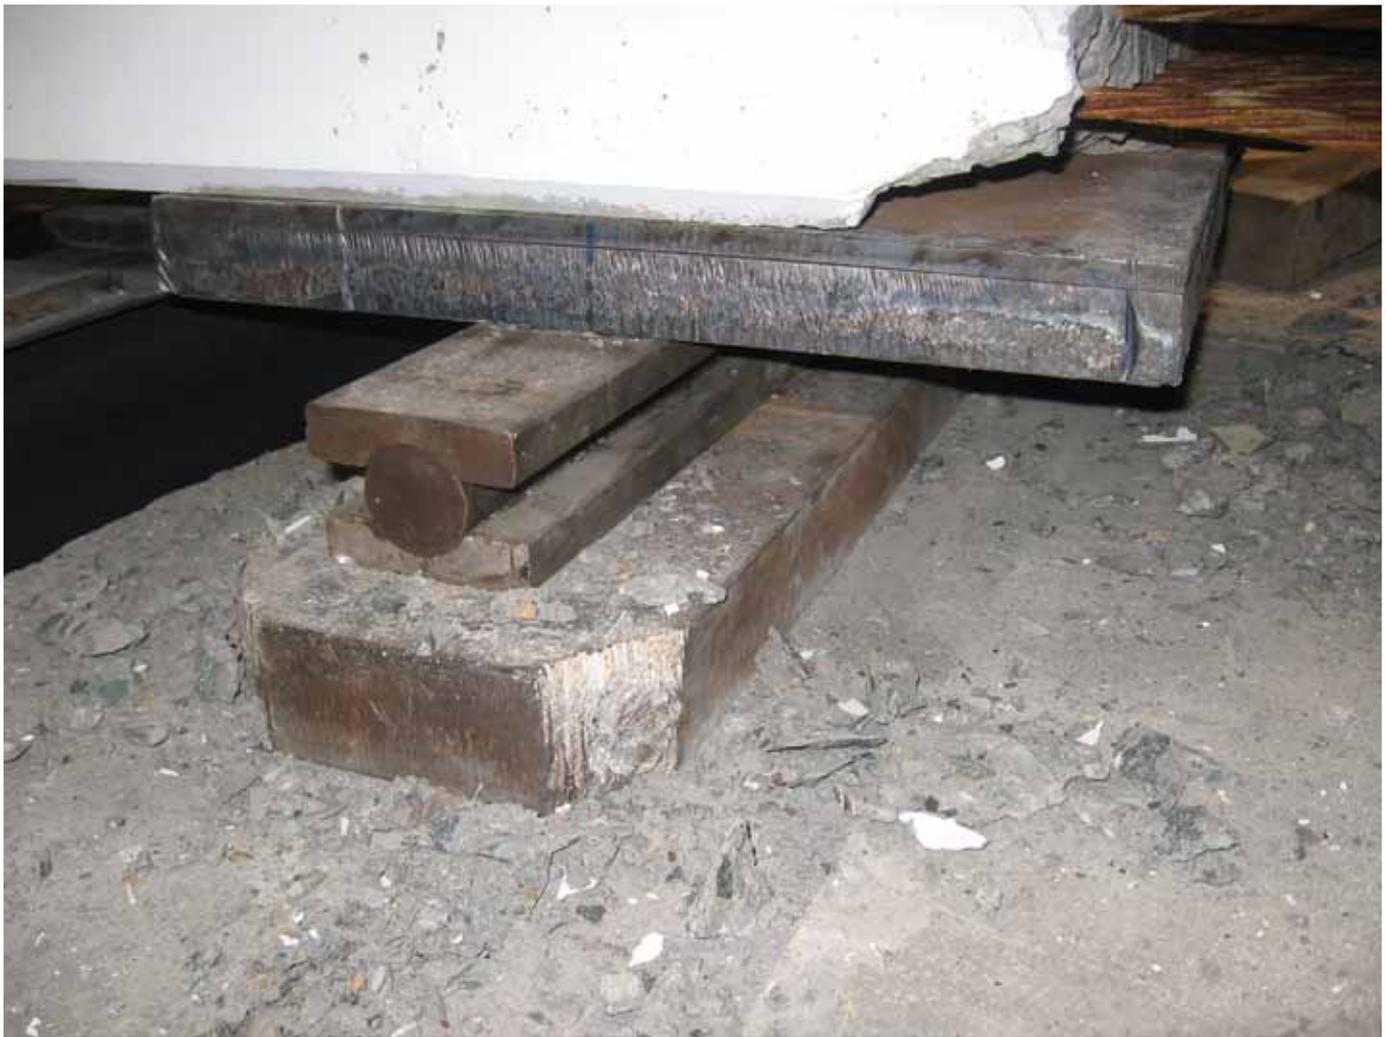
Figure 8. Pivoting support with a larger bearing area used for ends VA1L, VA2R, and VA2L.

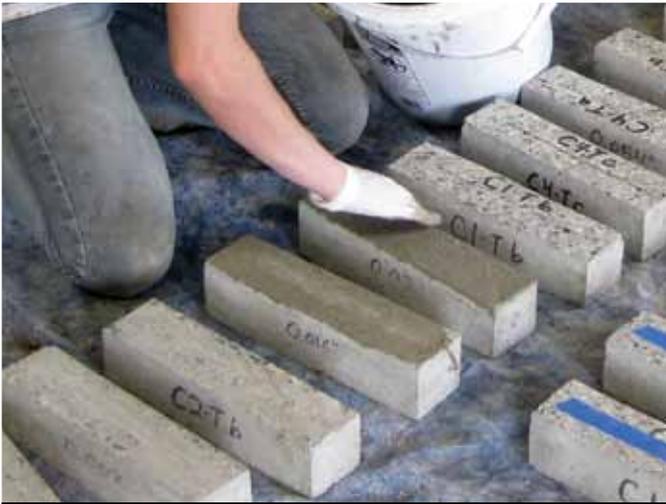
Figure 9. Hand application of the hydraulic cementitious material.

the crack) of the first set was sealed only with the specified sealant. The top surface of the specimens of the second set had a hydraulic cementitious material rubbed into the cracks by hand (Fig. 9) and were then sealed with the same sealant as the first set. The sealants were applied with a roller. The specimens were placed on their sides, and the selected sealants were applied to their specific sets. This orientation mimics the orientation of the cracks on the webs of production girders.

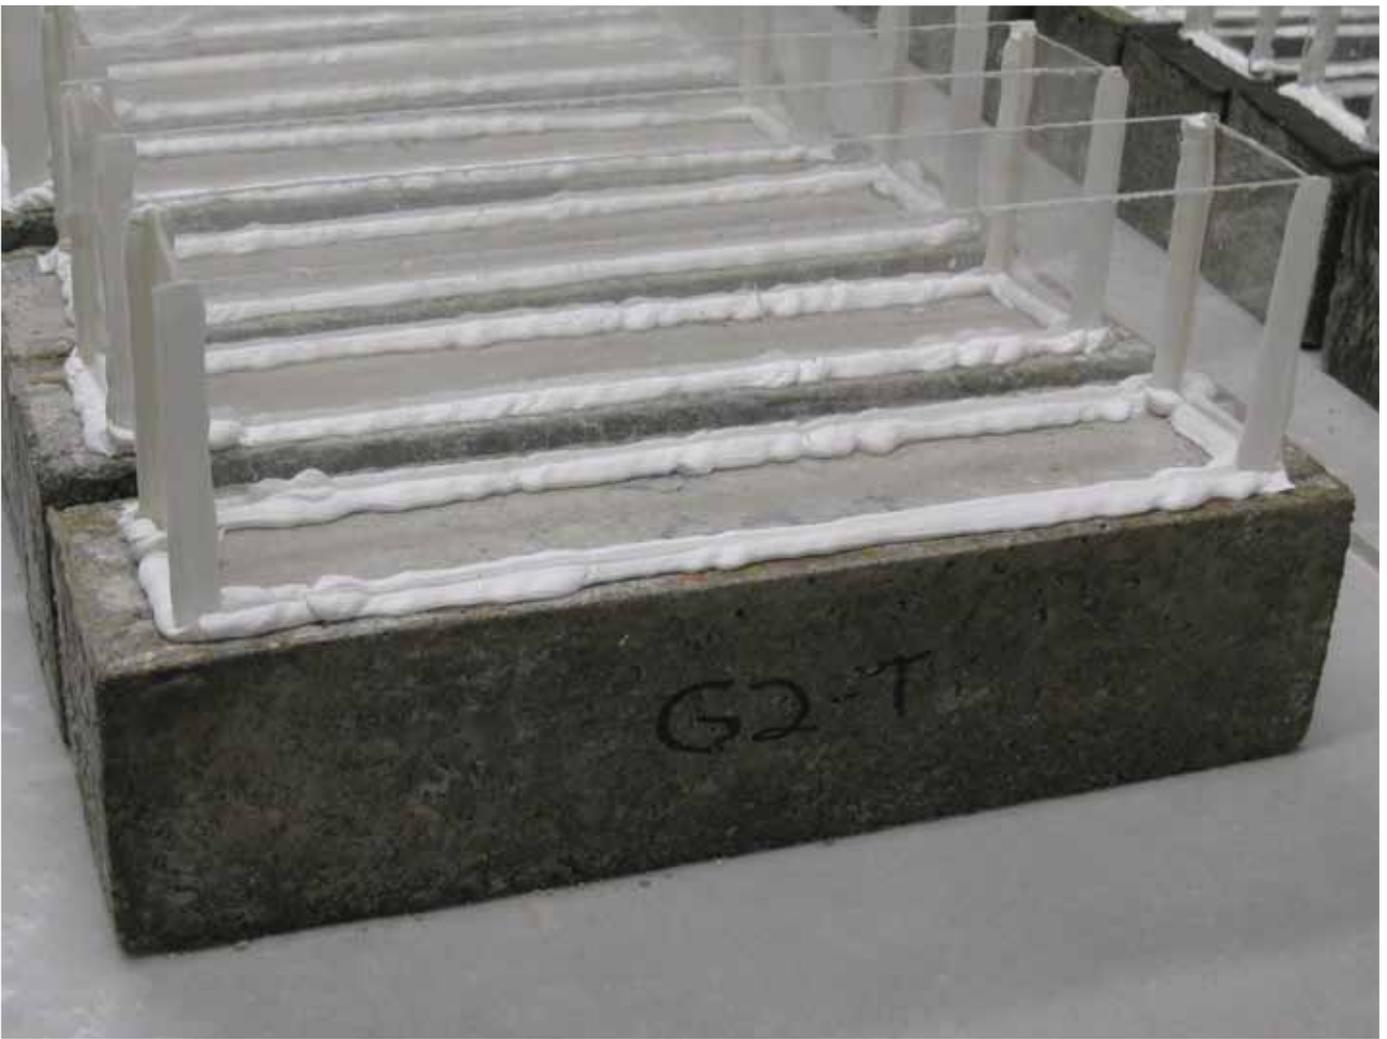
Figure 10. Specimens with water dams.

Once the specimens dried, they were turned upright and a 3-in.-tall (76 mm) rectangular plastic dike was built on the top surface of each specimen around the artificial crack so that water could pond on the repaired surface. Waterproof caulking material was used to secure the dikes in place (Fig. 10). The specimens were then weighed and the data recorded as W_1 .

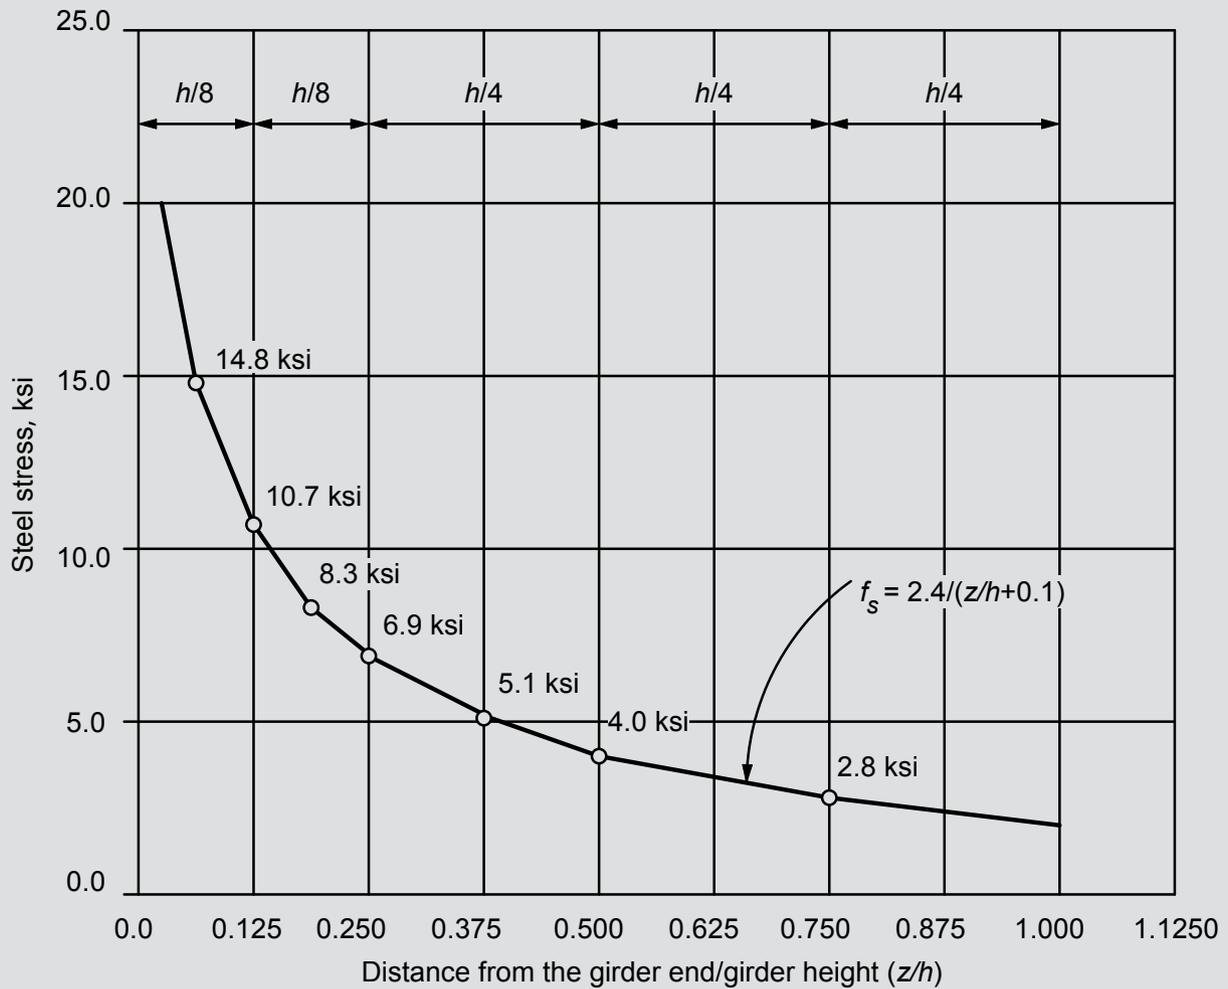
Figure 11. Average measured stress in end-zone reinforcement versus distance from the member end. Note: 1 ksi = 6.895 MPa.

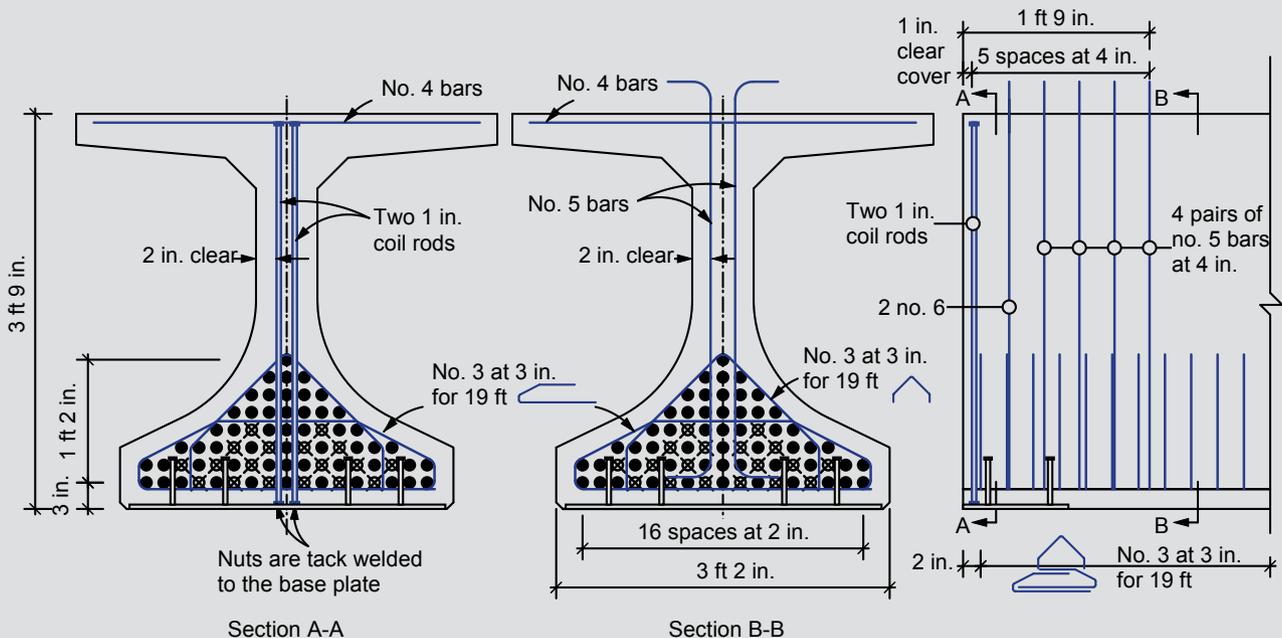
Figure B.1. Web end reinforcement details of example 1 using the proposed requirements. Note: no. 3 = 10M; no. 4 = 13M; no. 5 = 16M; no. 6 = 19M; 1 in. = 25.4 mm; 1 ft = 0.305 m.

The threaded coil rods are provided with nuts at the top and bottom for anchorage. The bottom nuts are welded to the steel base plate (**Fig. B.1**). The details of the new Florida I-beam provide only one strand across the thickness of the web to allow for 2 in. (50 mm) clear cover on the web vertical reinforcement.

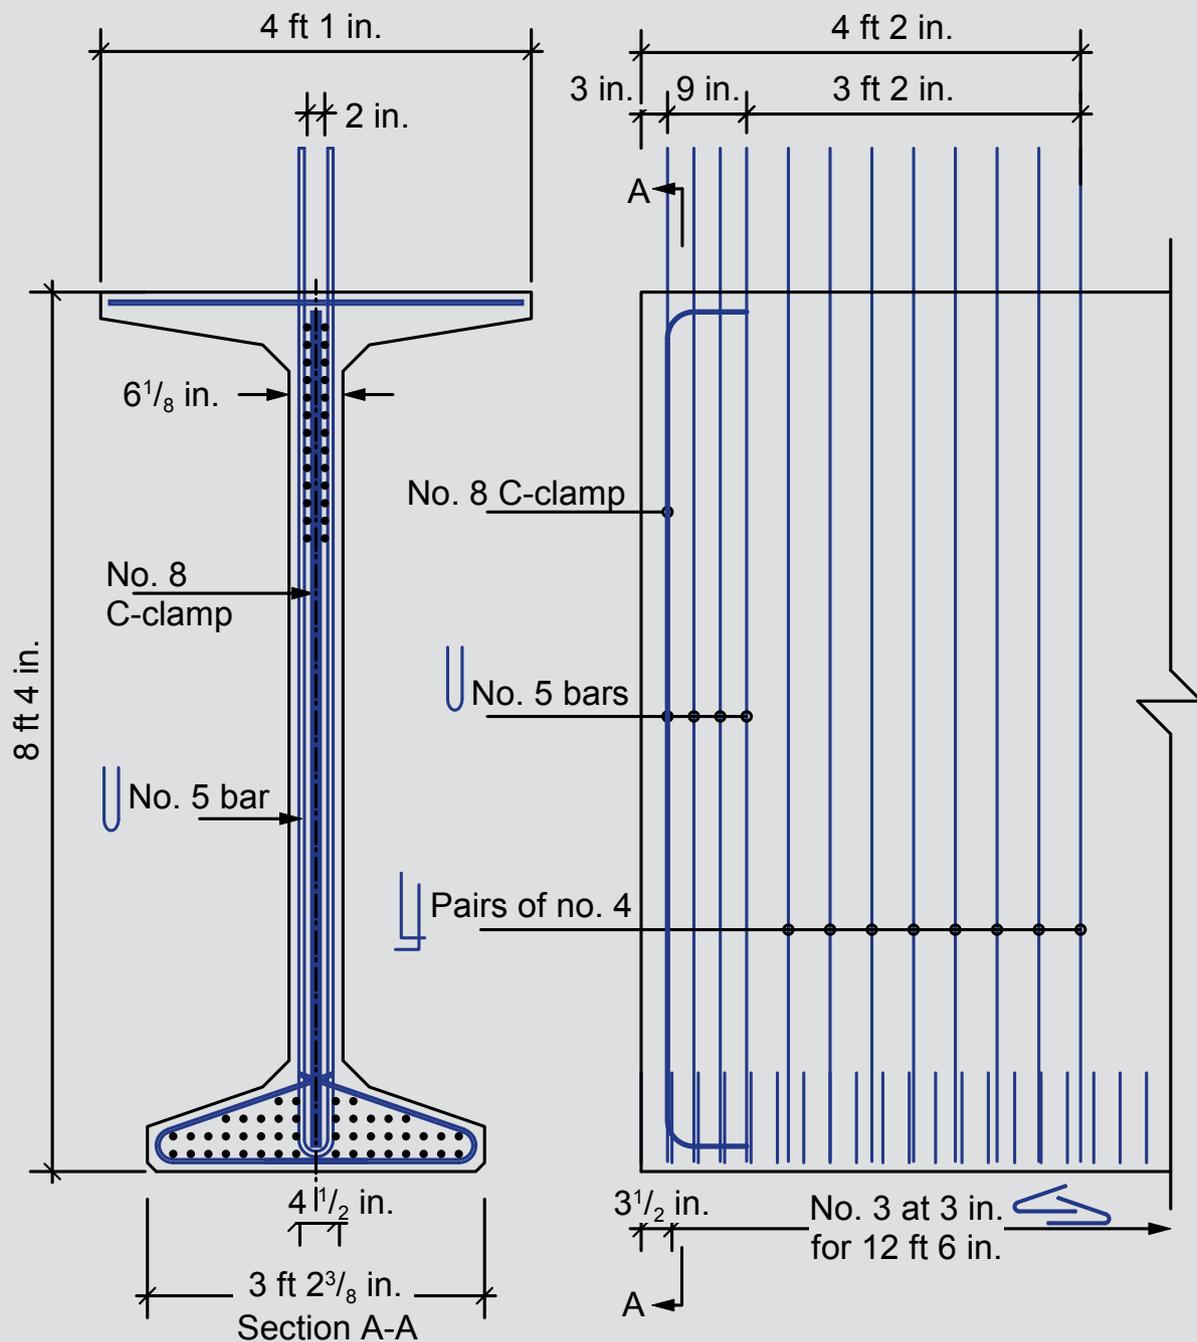
Figure B.2. Web end reinforcement details of example 2 using the proposed requirements. Note: no. 3 = 10M; no. 4 = 13M; no. 5 = 16M; no. 8 = 25M; 1 in. = 25.4 mm; 1 ft = 0.305 m.
