Effects of alkali-silica reaction and delayed ettringite formation on anchorage of prestressing strands in trapezoidal box beams with dapped ends

Nancy A. Larson, Oguzhan Bayrak, and James O. Jirsa

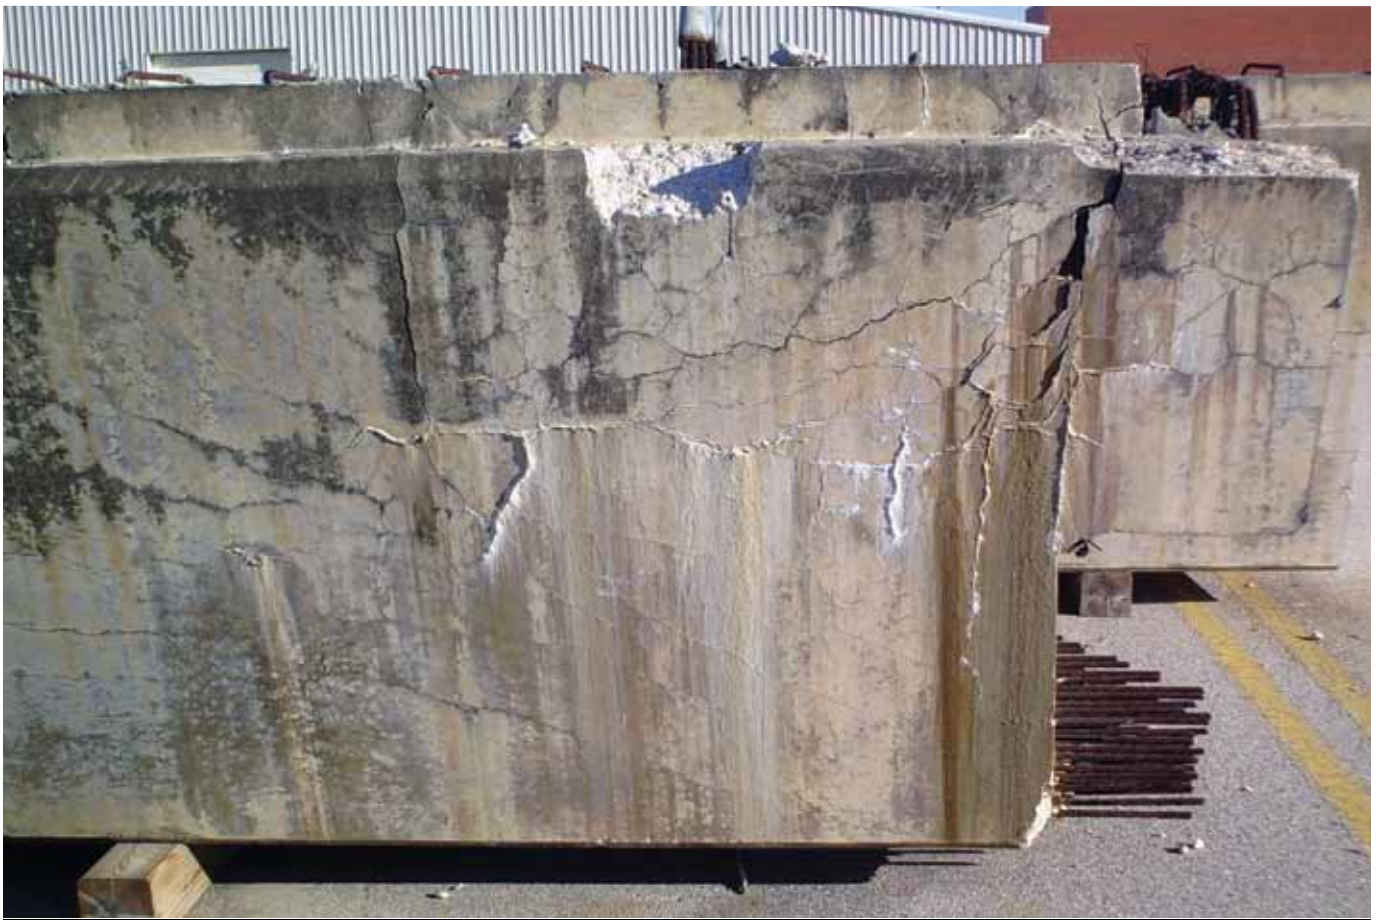
Figure 3. Visual effects of alkali-silica reaction and delayed ettringite formation.

The surface cracking patterns and visible exterior damage caused by either mechanism are virtually indistinguishable from a structural engineer's perspective. A brief discussion of the chemical and physical properties of the mechanisms will be provided, but no distinction will be made between their deleterious effects in the rest of this report because both mechanisms were present in the trapezoidal box beams. The petrographic analysis did indicate, however, that ASR was the primary premature concrete deterioration mechanism responsible for the distressed concrete in the beams examined in this study.

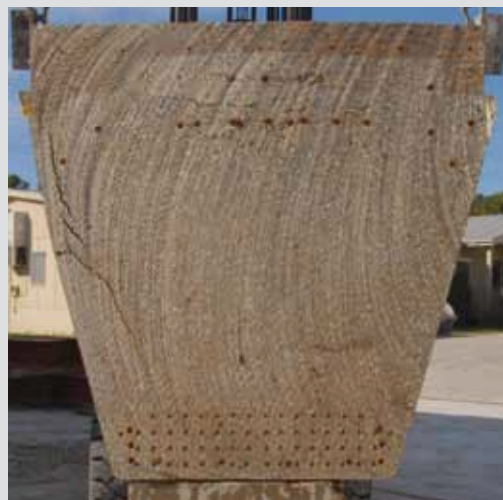
Severe cracking parallel to the surface

Figure 7. Typical alkali-silica reaction and delayed ettringite formation–related defects in end block cross sections.

Contrary to the outward appearance, the surface cracks did not penetrate deeply into the structural core of the member. In fact, all of the cracks terminated within 10 in. (250 mm) of the beam's surface. The most notable cracks ran paral-

lel to the left side of the cut faces (**Fig. 7**). This interior cracking corresponded to the more heavily cracked face of the box beam segment. While the wide parallel cracks occasionally intersected surface cracking, they did not appear to be a direct extension of discrete surface cracks. It is more likely that the internal cracking was the result of the presence of highly localized restraint in the vicinity of the transverse reinforcement and the lack of compatibility between the confined structural core and free concrete surface. While the transverse reinforcement provided confinement to the structural core, the cover concrete was free to expand away from the core.

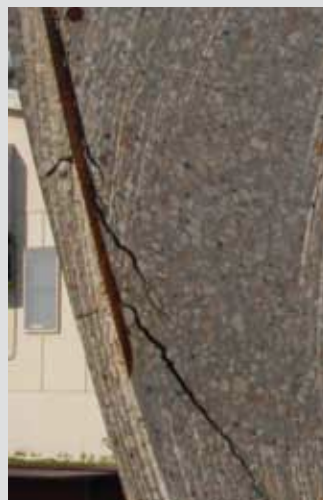
Debonding
of the reinforcement

The cut face intersected the transverse reinforcement in two of the cross sections (Fig. 7). In both cases it appeared as though the cracking led to debonding of the back side of the transverse reinforcement by the black epoxy in the center picture. The debonded length was relatively short in both cases but could have affected the splice in the vertical bars at that location. Despite the observation, the beams did not exhibit stirrup anchorage failure during testing, so it can be assumed that a similar defect in other box beams might not affect overall structural performance.

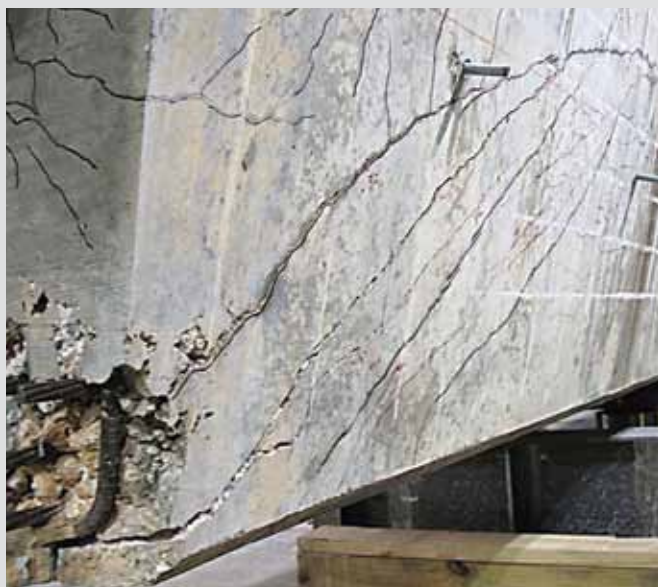
Cracking in the transfer length

Figure 9. Typical features of alkali-silica reaction and delayed ettringite formation–damaged segment failure.

Loading of the lightly and heavily cracked beams at a shear span-to-depth ratio of 1.85 resulted in shear-induced anchorage failures. In general, diagonal cracks (preexisting and load-induced) extended into and opened within the transfer length of the prestressing strands (**Fig. 9**). The cracks have been highlighted for the benefit of photographs and identifying the formation of new shear cracks during testing. Subsequent extension of the diagonal cracks across the bottom of the box beam was accompanied by minor spalling in several of the beams. A loud pop signified significant slip of the prestressing strands and was followed by a drastic loss of load-carrying capacity. In most cases, the shear-induced anchorage failure was accompanied with extension of preexisting ASR/DEF cracks.

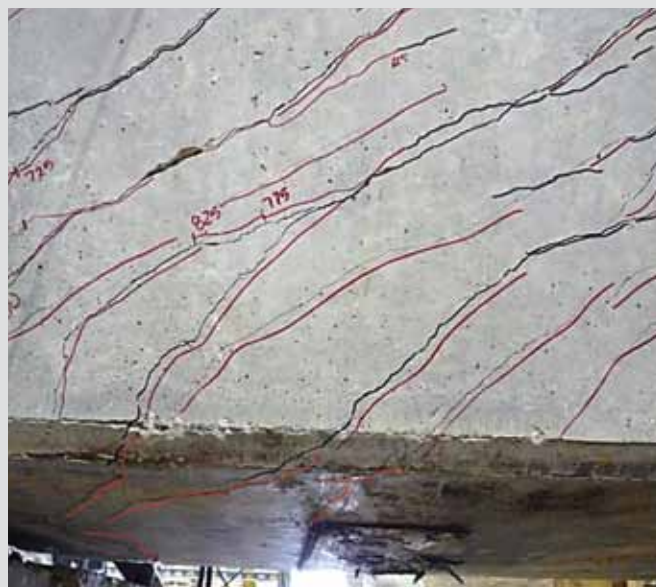
Bottom-side anchorage cracks

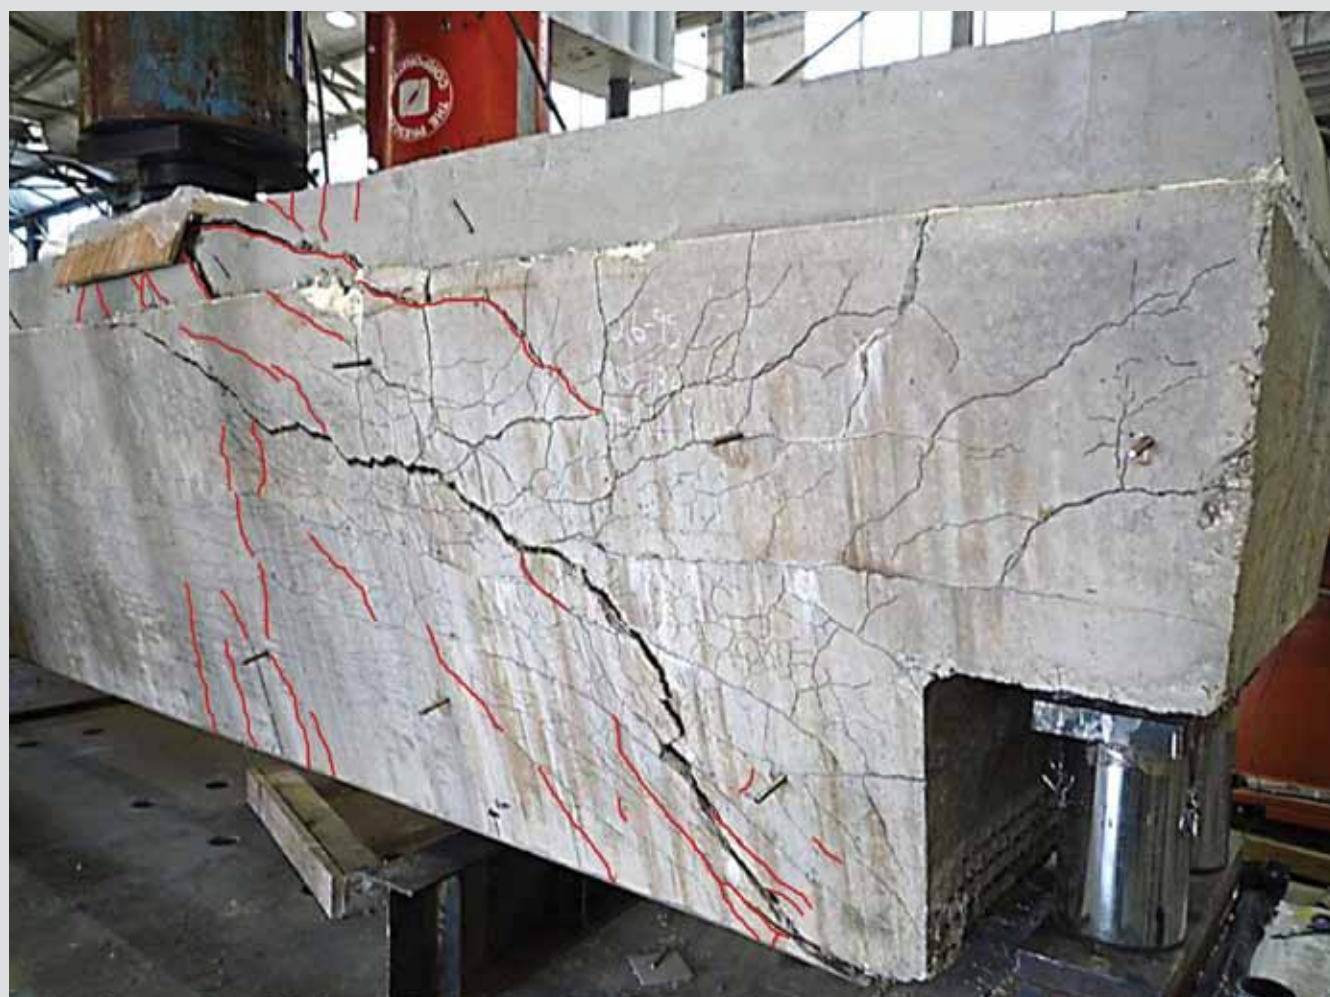
The heavily cracked segment produced the most sudden, pronounced failure of the damaged dapped ends (**Fig. 9**). Cracking at failure followed preexisting ASR/DEF cracks between the load and bottom corner of the beam, forming a large, continuous crack that widened extensively and

extended into the deck under the hydraulic rams and under the beam in the strand anchorage area. The maximum applied shear resisted was 659 kip (2930 kN). The lightly damaged segment failed at 703 kip (3130 kN).

Postfailure widening and extension of alkali-silica reaction and delayed ettringite–formation cracks

The only notable crack on either face of the heavily damaged segment (Fig. 9) corresponded to a preexisting ASR/DEF crack. Overall, the results suggest that either greater ASR/DEF-related damage led to the development of higher internal compressive stresses that further delayed the formation of load-induced cracking or that there was no need for more cracks to form because extensive cracking already existed. Briefly stated, the serviceability characteristics of the damaged dapped ends generally supported the assertion that the expansion-induced compressive stresses within an ASR/DEF-affected member can effectively offset (and po-

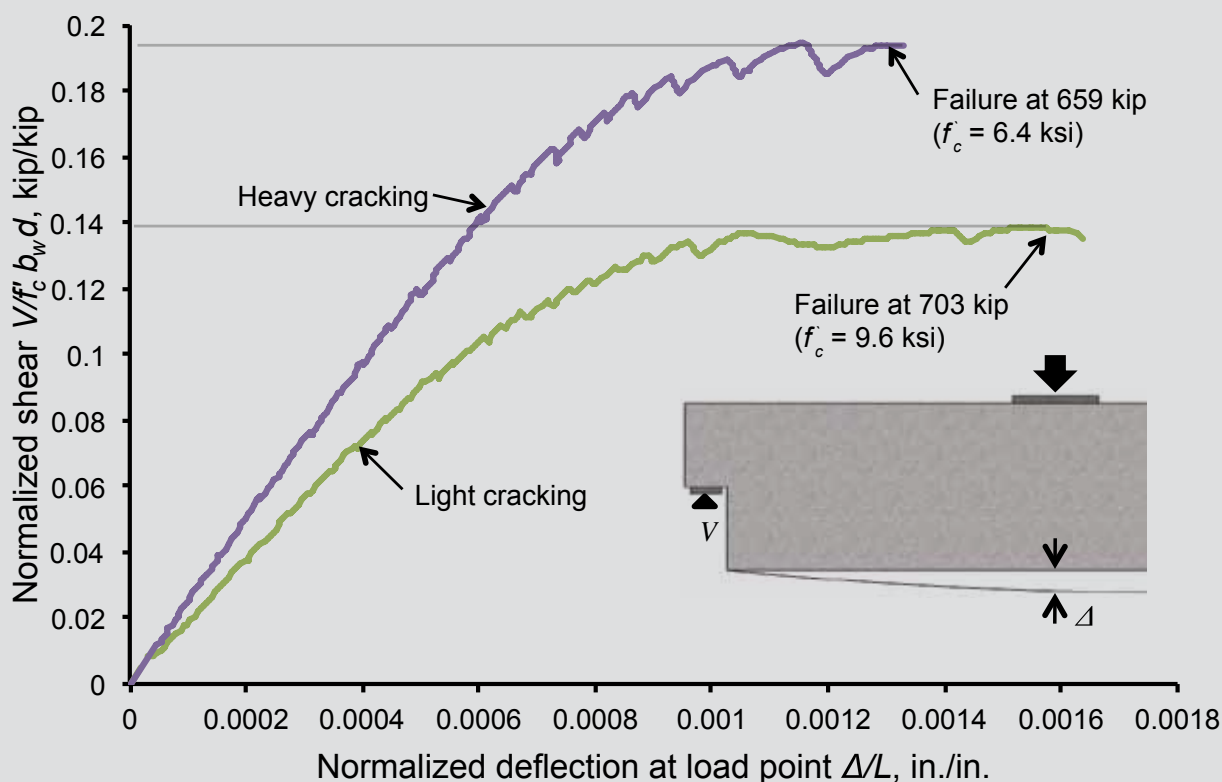
The linear-elastic response extended to 70% or 80% of the maximum applied shear (**Fig. 10**). After that level, the stiffness reduced as a result of preexisting crack growth and new crack development. The most significant aspect of the load-deflection plot of the distressed dapped ends is the greater stiffness of the more damaged beam.

Figure 10. Load-deflection responses (normalized shear stress). Note: b_w = web width; d = beam depth; f'_c = concrete strength calculated from core strength; L = beam length measured from center of supports; V = total shear measured by load cells plus the appropriate calculated self-weight of the specimen; Δ = deflection measured at the load point. 1 in. = 25.4 mm; 1 kip = 4.448 kN.

It is likely that restraint of the ASR/DEF-related expansions by the dapped-end reinforcement led to the development of compression within the structural core concrete, eliciting a stiffer material response. Concrete cores were removed and tested to estimate the strength in each beam, and it was found that the heavily cracked beam had a lower compressive strength than the lightly cracked beam. ASR/DEF-induced compression has been shown to be capable of offsetting (and superseding) the loss of mechanical strength or stiffness due to the microstructural cracking in previous research as well.⁵

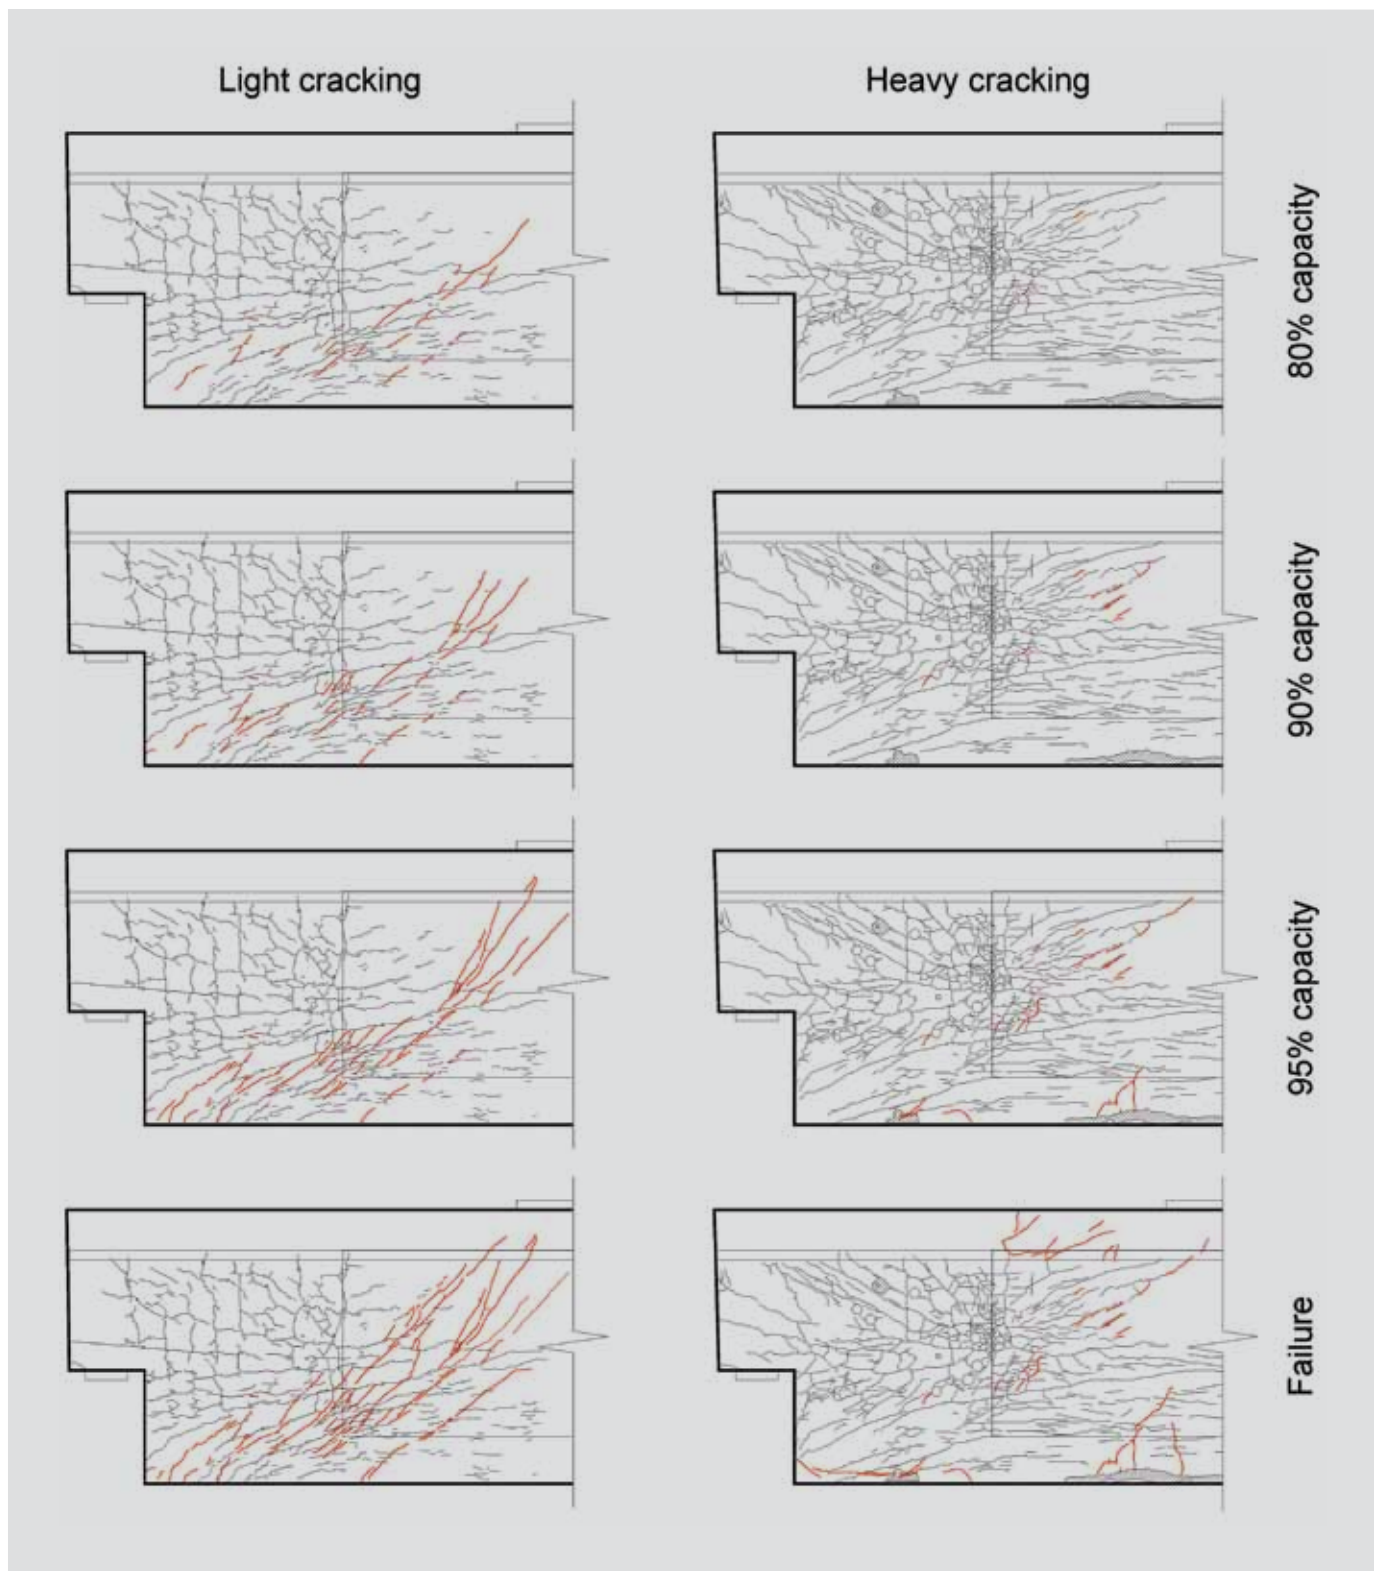
cracking in the damaged segments. **Figure 11** shows the development of load-induced cracking in the lightly and heavily damaged segments. The illustrations cover the full range of behavior noted during the tests. The response of the segment with light cracking was similar to an undamaged segment. First cracking occurred at a relatively high percentage of the capacity (67%), but an extensive crack network was nonetheless present before failure. The behavior of the heavily cracked beam (subject to 0.25 in. wide [6.4 mm] cracks) was drastically different. Well-defined shear cracking did not develop at any point in the dapped-end test, including failure. It is possible that the cracking was distributed in the strut due to the ASR/DEF distress, but no significant new crack formation was observed.

Figure 11. Diagonal cracking on the lightly and heavily damaged specimens.
