# Renovation of Plaza Towers Grand Rapids, Michigan

*Architectural precast concrete became the solution of choice in replacing a brick tiled surface with metal frame panel system that had suffered deterioration leading to air and water infiltration over the exterior of a 31-story hotel, residential apartment and condominium building in Grand Rapids, Michigan. A total of 1440 precast components were used on this job including wall panels with punched openings for window units, spandrels, and column covers. Production challenges included a variety of finishes in some panels such as a light buff acid etch, a dark "brick red" retarded finish, accents, and embedded granite panels to replicate and match granite accents on the building. The end result is a magnificent exterior façade that has added elegance and value to a previously deteriorated building. This article discusses the major features of the repair program for renovating the exterior wall.*

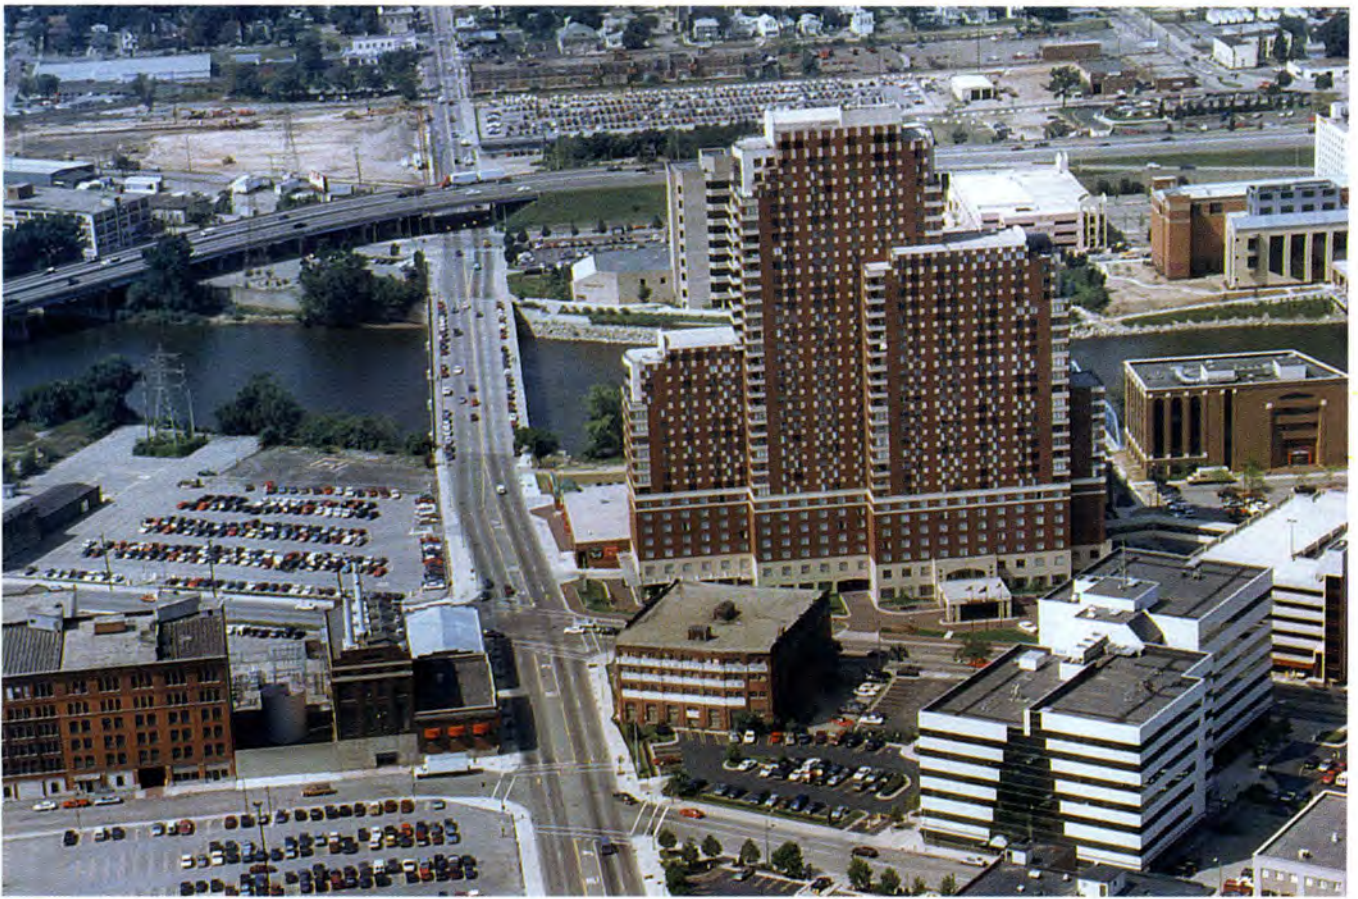
Fig. 1. Panoramic view of west elevation of Plaza Towers showing existing metal cladding.

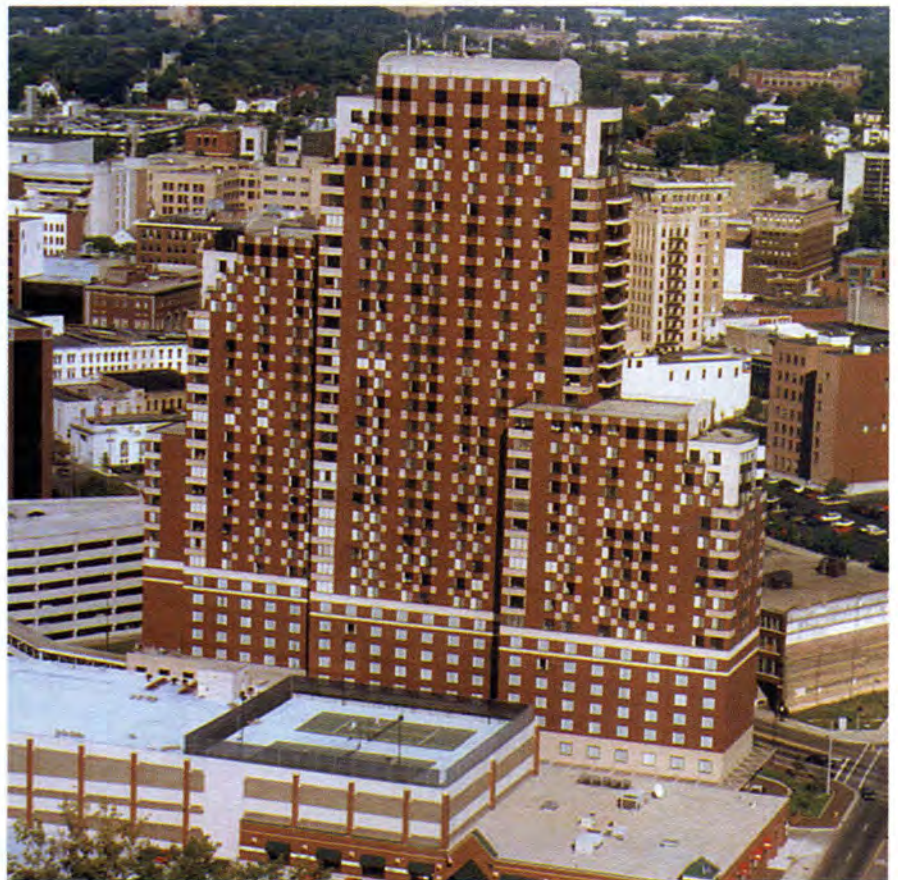
Fig. 2. Exterior view of east elevation of building showing metal cladding.

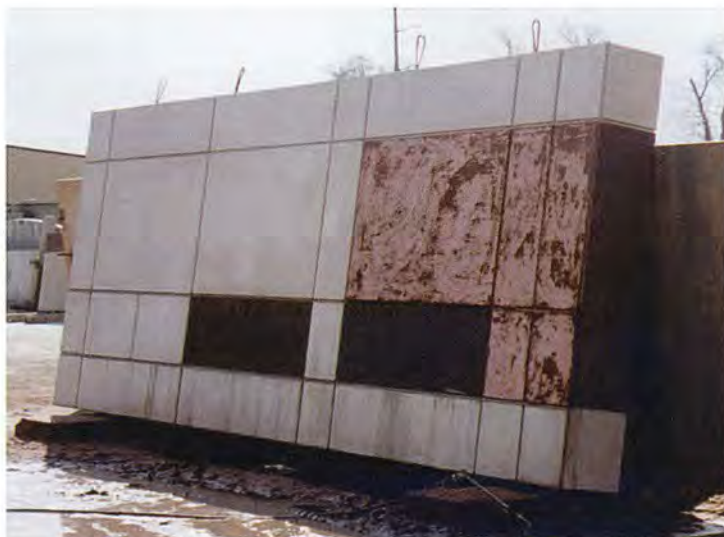
Fig. 11.  
Wall panel  
in precaster's  
yard.

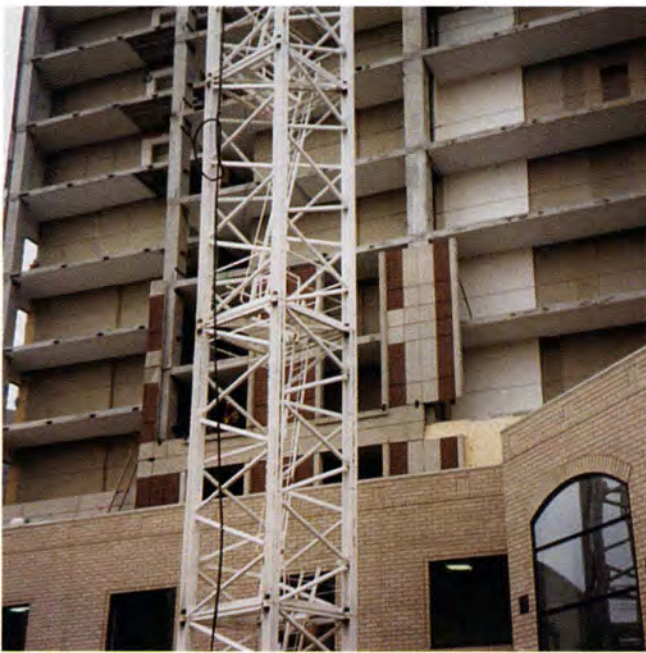
Fig. 12. Precast repair in progress.

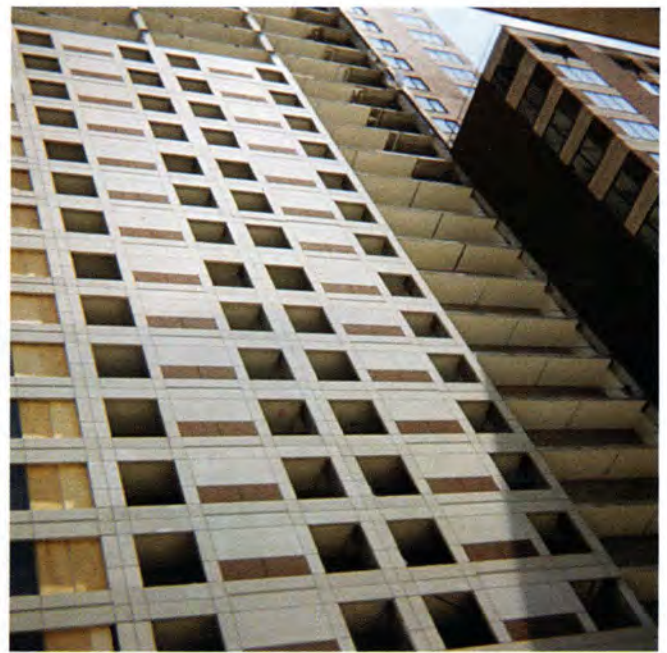
Fig. 14. Precast cladding partially in place.

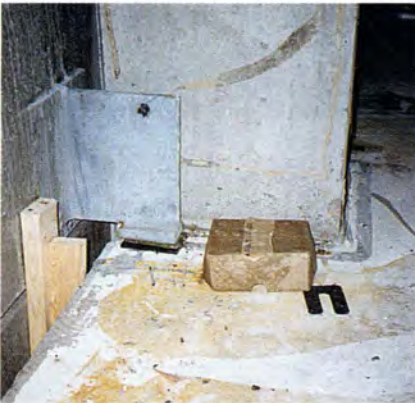
Fig. 13. Closeup of Connection #1 (see Fig. 9).

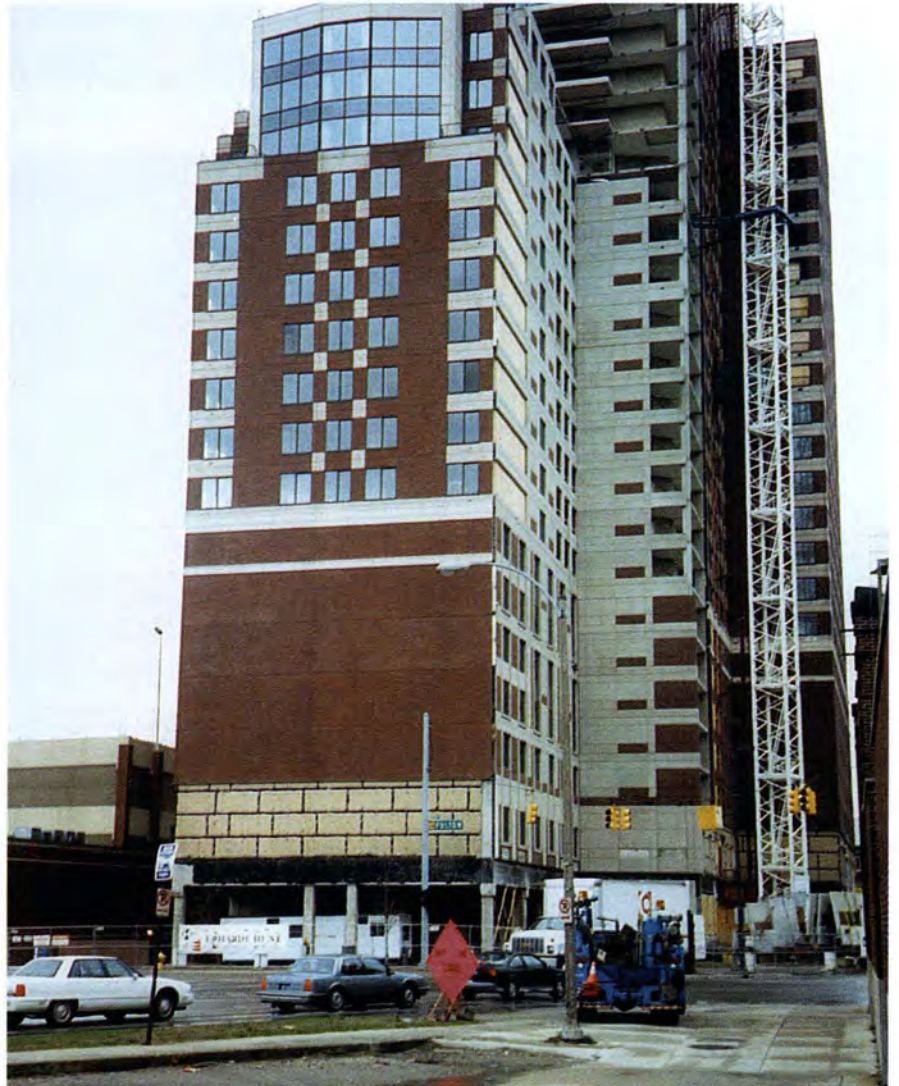
Fig. 15. Exterior view of north elevation of building showing receiving of precast components.

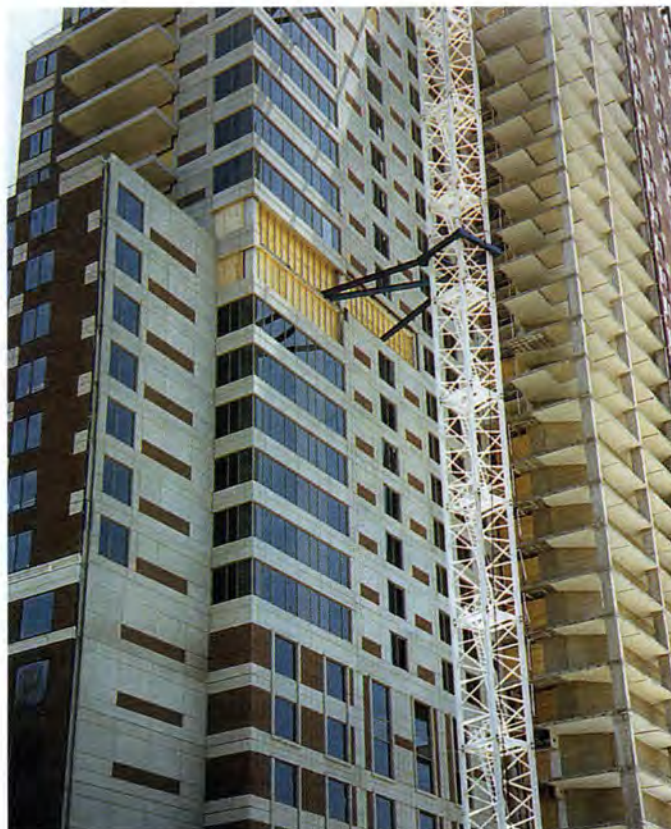
Fig. 16.  
Exterior view of  
east elevation of  
building showing  
removal of  
existing metal  
panels. Structure  
is ready to receive  
new precast  
panels.

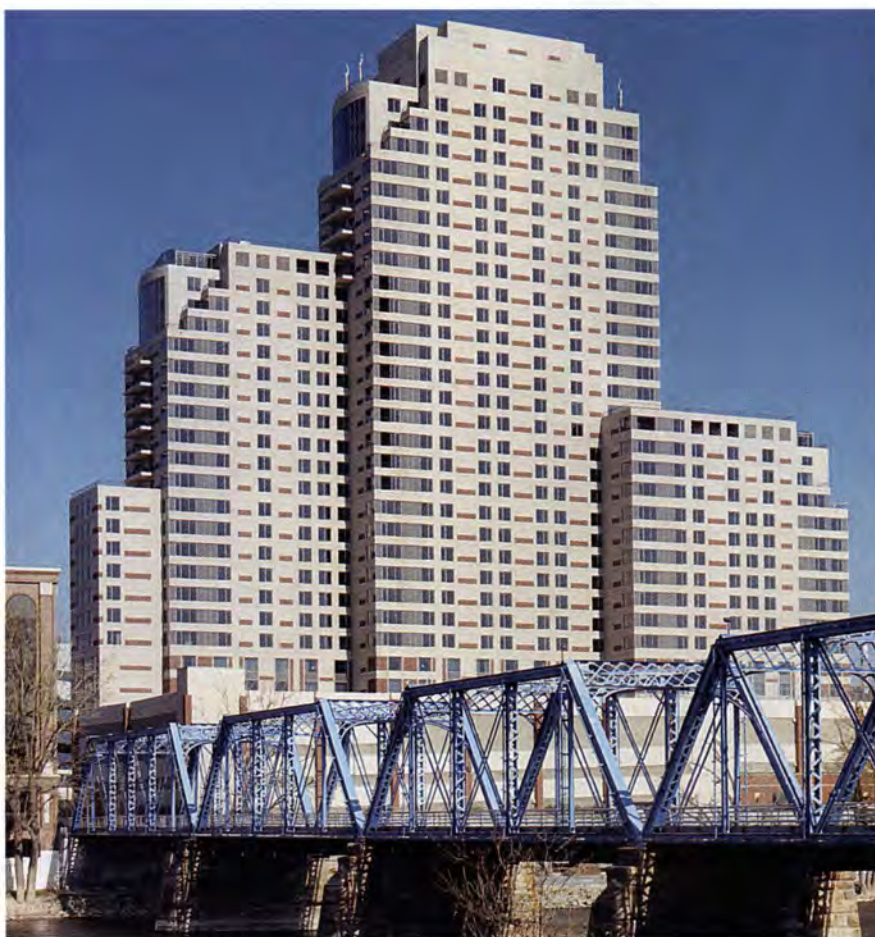
Fig. 17. Exterior view of southeast elevation of building complete with new precast cladding.

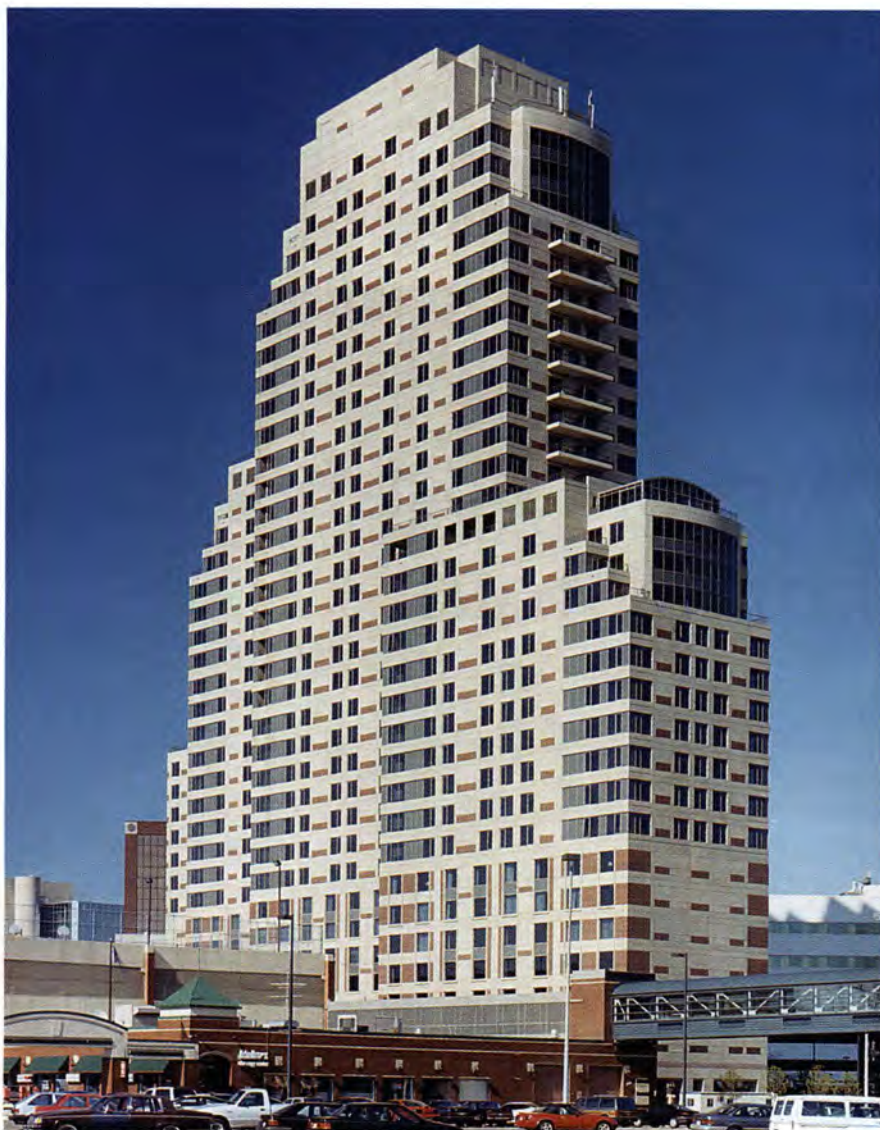
Fig. 18. Exterior view of northeast elevation of building complete with new precast cladding.

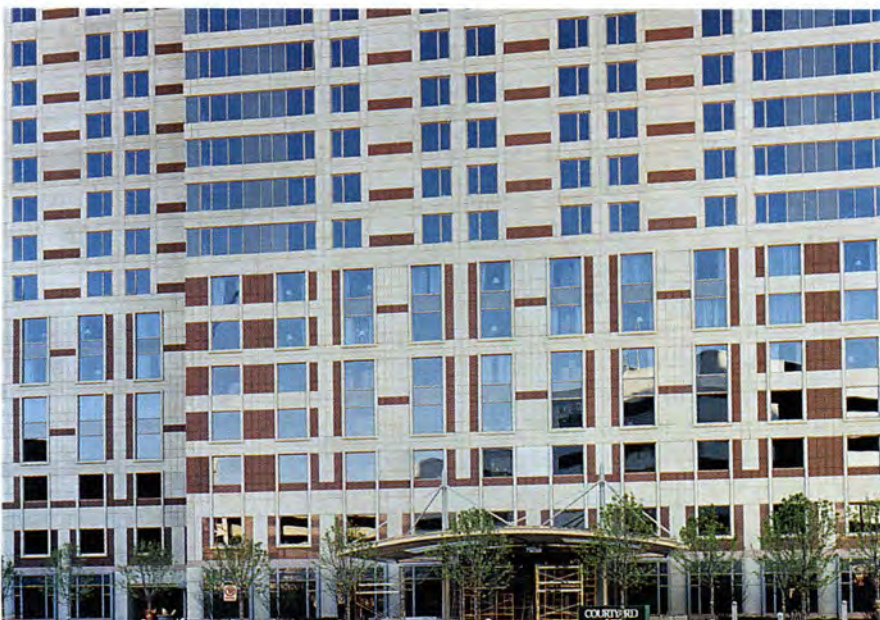
Fig. 19. Exterior view of completed east elevation of courtyard of building.
