CORROSIVE BLEED WATER IN POST-TENSIONED TENDONS

Matthew D. Bricker, Department of Civil and Environmental Engineering,
The Pennsylvania State University, University Park, PA

Andrea J. Schokker, PhD, Department of Civil and Environmental Engineering,
The Pennsylvania State University, University Park, PA

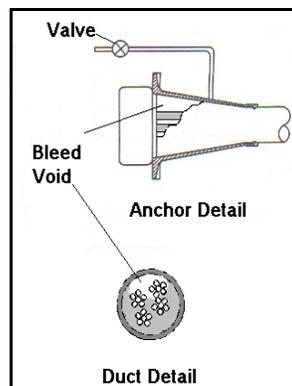
Figure 1: Grout Bleed Void Details.

Resistance to segregation or bleed has been recognized as a key property of high performance grouts. Segregation of the grout takes place when the mix water and the cement particles separate due to sedimentation or high pressures. This problem is exaggerated where the post-tensioning tendon consists of seven-wire steel strands. The seven-wire strands contain six outer wires wound about a central wire. The mix water is able to seep into the interstitial voids between wires and is then driven upward by the pressure head of the surrounding grout.¹⁰ Bleeding of grouts used in post-tensioned construction is particularly problematic because the water is trapped in the duct. The bleed water tends to migrate to the high points of the tendon and form a bleed void, as depicted in Fig.1. The water may be reabsorbed by the grout, evaporate, or remain in place for a long time. In either situation, a grout void is formed in the duct where the tendon is susceptible to corrosion. Typical void locations are the tendon anchorages, and any intermediate tendon high points. Grouts that resist bleeding have been formulated. These grouts are considered bleed resistant, and are often thixotropic in nature. Bleed resistance is usually achieved with the addition of a gelling agent, similar to the admixture developed by Schupack.⁸

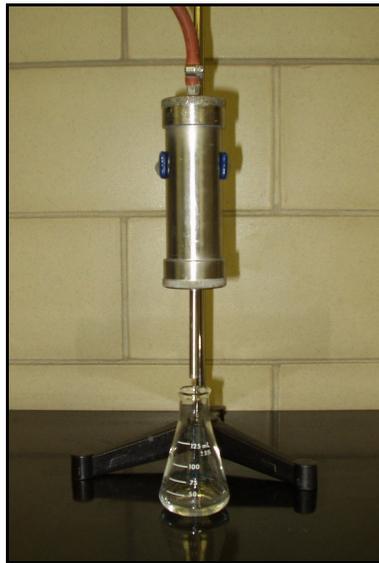
Figure 2: Schupack Pressure Filter.

Each grout was mixed using both Type I/II and Type II cement to investigate cement-admixture interactions and two specimens were made for each mix. Admixture dosages were made according to the recommendations of the manufacturer. The water-cement ratios of the grout mixes were adjusted in order to achieve a target fluidity of 11-30 seconds in the ASTM C939 Flow Cone Test¹⁹ in accordance with the recommendations of the PTI Guide Specification for Grouting of Post-Tensioned Structures.⁹ The freshly mixed grouts were also subjected to the Schupack Pressure Bleed Test as a measure of bleed resistance. The bleed water was collected from the freshly mixed grout with the Schupack Pressure Filter, shown

in Fig.2. This test was developed to model the pressures and filtering effects experienced by grout in a post-tensioned tendon.^{8,19} The pH of the grout bleed water was also measured as an indication of its potential corrosion protection capability.

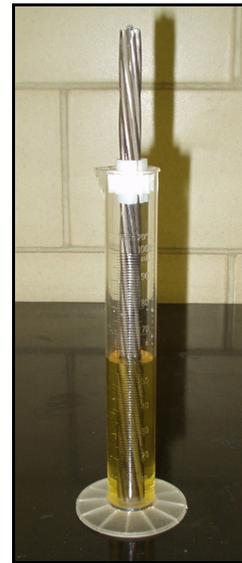
Figure 3: Test Specimen.

The test specimens, as shown in Fig.3, consisted of a length of seven-wire prestressing strand placed in a 100 mL graduated cylinder containing 50 mL of bleed water. The strand surface was cleaned with acetone and the strands were weighed beforehand. All strands were taken from the same spool for consistency between specimens. The specimens were covered and sealed in an attempt to prevent evaporation and simulate the environment inside of a sealed post-tensioning duct. The strands were exposed to the bleed water in the sealed system for a period of six months.

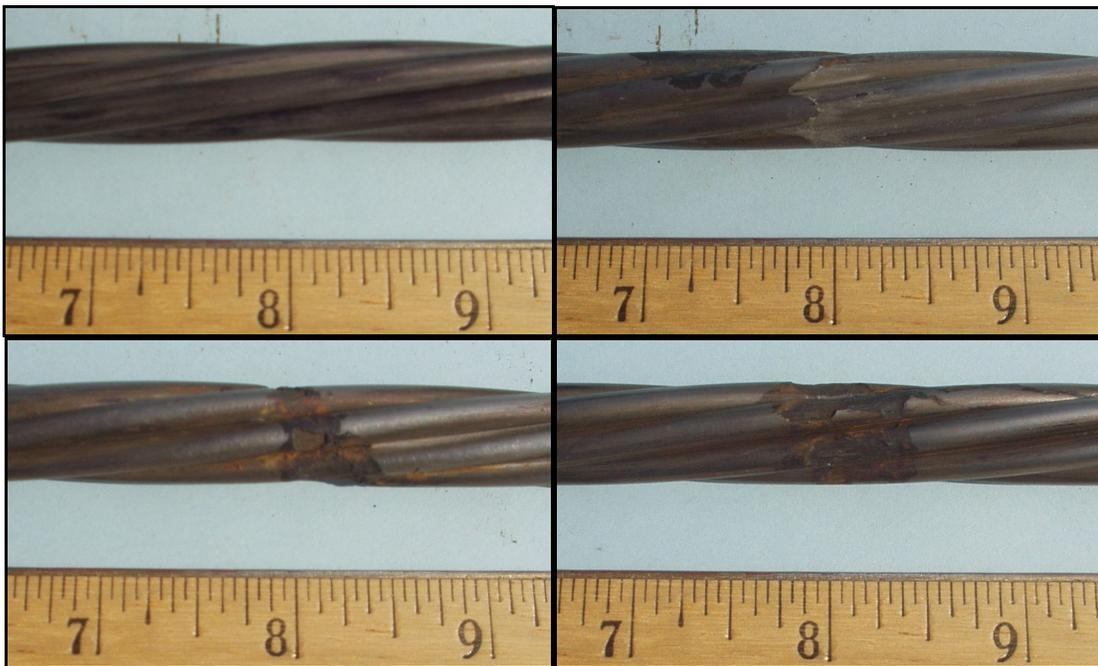
Figure 4: Details of (clockwise from top left) strands with no corrosion, light surface corrosion, and heavy pitting corrosion (2).

Corrosion products were typically seen forming on the seven-wire prestressing strands within one to two weeks after the strand was inserted in the bleed water. The corrosion activity was usually concentrated near the bleed water/air interface, but also occurred on the exposed and submerged portions of some strands. Upon removal of the strands from the bleed water, the corrosion product was removed with a wire brush, and the strands were cleaned with a Scotch™ pad.²¹ The strands were then reweighed to determine the total amount of metal loss. Total weight loss of the individual strands due to corrosion varied from 0.9 to 2.0 percent. This measure of corrosion activity was valuable, but the presence and severity of corrosion pits was deemed a more appropriate measure of corrosion severity. This intense, localized pitting corrosion was commonly observed. The nature and severity of the pitting corrosion was recorded, including the number of wires with pits, total number of pits, largest pit depth, and other corrosion effects for each strand. Greater than fifty percent of the strands tested

developed corrosion pits at least 1/32" in depth. Pitting on this scale would result in a significant reduction in the ultimate strength of the strand. Fatigue effects due to localized stress concentrations may also be a concern when pits are present on the strand surface.²³ Less severe surface and crevice corrosion effects were observed on some strands. Corrosion rate measurements from the testing would be helpful, but the random nature of the observed pitting corrosion prevents the accurate determination of the corrosion rate based on the strand weight loss values. Calculation of the corrosion rate, based on weight loss, is highly dependent on the surface area assumed to be corroding. For example, the corrosion rate based on the portion of the strand surface area exposed to the bleed water (i.e. uniform corrosion) would grossly underestimate the local corrosion rate at the individual corrosion pits. The average total weight loss and maximum corrosion pit depth for each grout mixture is given in Table 2. Details of typical strand corrosion patterns are shown in Fig.4.
