STRENGTHENING OF THE SR 520 EVERGREEN POINT FLOATING BRIDGE BY EXTERNAL POST-TENSIONING

Richard K. Johnson, SE, KPFF Consulting Engineers, Seattle, WA
M. Myint Lwin, FHWA Western Resource Center, San Francisco, CA

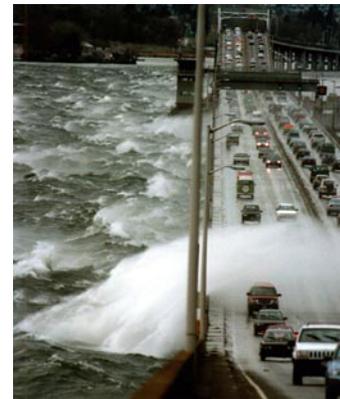
Fig. 1B SR 520 during a storm.

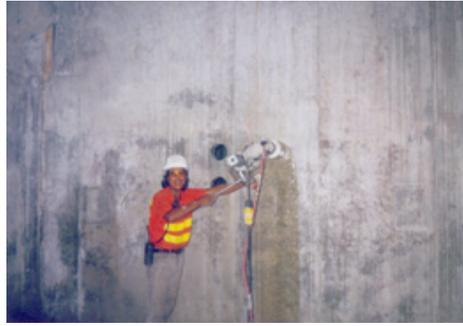
Fig. 4 Core driller removing cores from cells.

The contractor installed a temporary catwalk along the side of the bridge for construction access. During the day, the core drilling, utility relocation, and duct installation crews worked inside the pontoons. At night, one lane of the bridge was closed to allow resupply of the day crews and to remove cores from the cells. A typical day's work for the core drillers involved completing fifty 6-inch diameter by 6-inch long cores. Core hole locations were checked by sighting down the alignment with a laser beam and measuring to the center of each hole. As a precaution, work was halted during the storm season from November to April to ensure that the watertight integrity of the bridge would not be compromised during a storm.

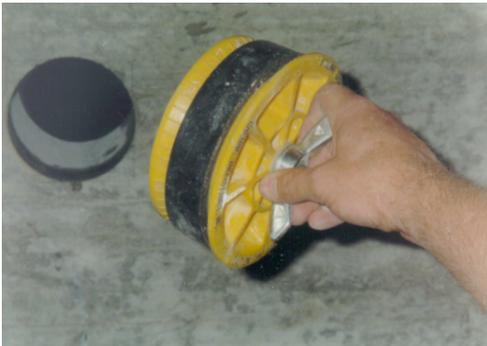
Fig. 5A Watertight plugs are installed in the core holes maintaining integrity.

The duct installation followed the core drilling. High-density polyethylene (HDPE) ducts were installed in 30-foot lengths and sealed in the 6-inch core holes with an elastomeric sealant. Watertight plugs were installed in the ends of ducts at the end of each workday.

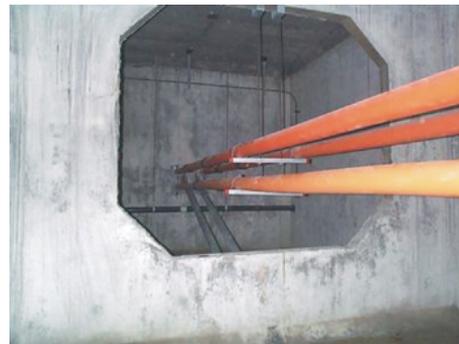
Fig. 5B Post-tensioning tendons run through the pontoon cells.

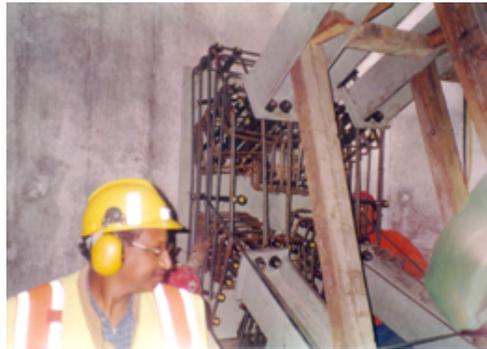
Fig. 6 Spider anchors are assembled inside the pontoon cells.

An optimized steel anchor assembly, with multiple lightweight legs, delivered the post-tensioning force to the pontoon's cross-section, reducing the weight penalty to acceptable levels. The multi-legged nature of the assembly led to its name, "spider anchor." The "spider" anchor has a central bearing transfer assembly that transfers the force of two tendons to six legs, braced against the corbel that anchors the existing pontoon bolts. A concrete closure pour was cast between the legs and the tendon anchor cap assembly to provide added fit-up tolerances. The concrete pour also reduced welding in the confined spaces of the pontoon.

Fitting the anchors to the existing pontoons imposed a formidable challenge, requiring separate surveyed dimensions for each of the 32 tendon anchors. As luck would have it, several of the anchor legs were fabricated out-of-tolerance. KPFF reanalyzed the stresses in these assemblies within 24 hours to ensure that they were within acceptable limits. In many cases, the tensioning sequence was revised to limit the differential force to a maximum of 75 kips (out of 615 kips maximum) between the two tendons anchored on one anchor.

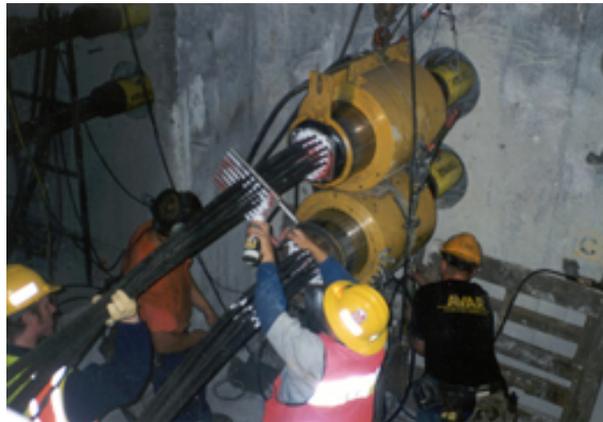
Fig. 7 Post-tensioning operations with 24 feet of elongation.

As the post-tensioning subcontractor, AVAR used four post-tensioning rams simultaneously to complete the job on the west end in 46 hours. The four center tendons were tensioned and work proceeded to the exterior tendons. Two crews of ironworkers worked 12-hour continuous shifts. The post-tensioning of 16 tendons on the west end, each 3,120-foot-long, was completed by noon on Sunday morning, July 18, 1999. The 3,600-foot long tendons on the east side of the bridge were completed in 20 hours.

CTL supplied, calibrated, and monitored load cells on each end of each tendon. The load cells allowed WSDOT and KPFF to quickly determine if the required post-tensioning forces had been achieved. In fact, the total force applied to the bridge was 9,400 kips or 17 percent more than the minimum required to meet the design criteria.

The friction losses in the tendons were consistent with a friction coefficient of 0.2 on the steel pipes at the angle changes and a wobble coefficient of zero. The zero wobble factor is appropriate for external tendons because if the strands rub against the duct, the duct will move laterally and limit the normal force on the duct. If there is no normal force on the duct, there can be no friction and, thus no tendon force losses due to friction. The typical tendon had 25 kips of friction losses (or 4 percent of the jacking force of 615 kips). The total elongation was 24 feet per tendon or 2 miles of total elongation for all the strands. Interestingly enough, when the load cells were checked 24 hours after post-tensioning was completed, the difference in force between the tensioned end and dead end of the tendons was less than 1 percent. Apparently, the friction losses equilibrated throughout the length of the tendons after one day of service.

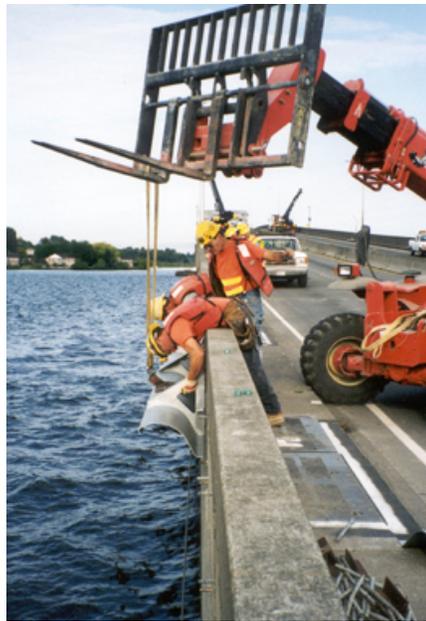
Fig. 8 Installation of wave deflectors.

Completing the project required removal of the precast wave deflector and replacement with a lighter weight steel deflector to assist mitigation of the bridge freeboard loss.
