## CASE STUDY OF A TENNESSEE BRIDGE WITH HIGH-STRENGTH AND NORMAL-STRENGTH CONCRETE BEAMS

X. Sharon Huo, Ph.D., P.E., Tennessee Technological University, Cookeville, TN  
Pingsheng Zhu, M.S., University of Southern California, Los Angeles, CA  
Francis Ung, M.S., EIT, United Consulting Group, Ltd., Norcross, GA

**Keywords:** Bridge, Prestressed concrete beam, High-strength concrete, Normal strength concrete, Instrumentation, Concrete strains, Camber, Time-dependent behavior

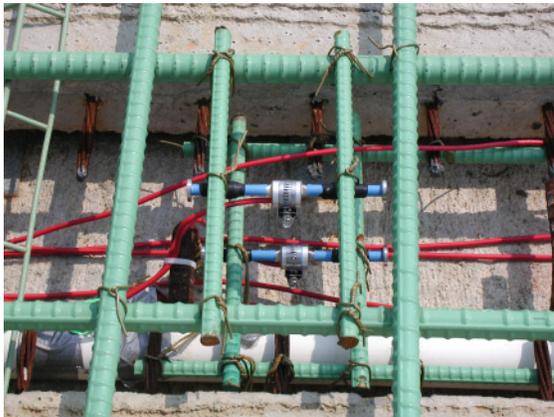
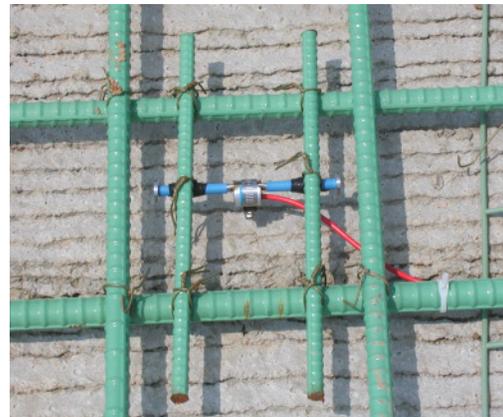
(a) Strain gauges over beam

(b) Strain gauges over precast panel

Fig. 6 Instrumented Cast-In-Place Concrete Deck

The concrete in cast-in-place deck is the standard TDOT Type D concrete. The specified compressive strength of concrete is 4,000 psi. As described in the instrumentation plan, the cast-in-place concrete decks in each bridge lane were instrumented with six vibrating wire strain gauges. Fig. 6 shows the instrumented cast-in-place concrete deck. A diaphragm connected two instrumented beams were instrumented with three vibrating gauges cross the depth of the diaphragm. Fig. 7 shows the instrumented diaphragm. The data collection was started before the concrete placement in cast-in-place deck and continued afterward.

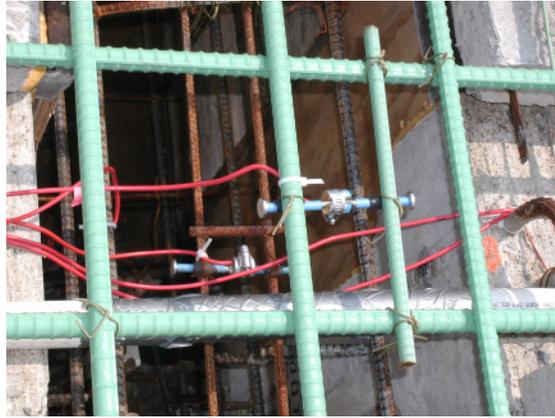
Fig. 7 Diaphragm Instrumentation
