## **PERFORMANCE OF A HISTORIC PRESTRESSED CONCRETE BLOCK BRIDGE**

*A historic prestressed concrete block bridge in Wilson County, N. C. was recently replaced due to deterioration of its timber pile foundation. One of a few constructed by the North Carolina Department of Transportation in the early 1950s, the bridge used post-tensioned concrete block beams with cast-in-place topping to form the bridge deck. It had provided excellent service for 50 years, and at the time of replacement, the bridge was believed to be the last one of its type still in service in N. C. During replacement, the bridge deck was preserved for historical documentation. Three prestressed concrete block beam sections were tested to failure to assess their performance. This paper describes the construction details of the bridge deck and presents the results of the performance tests including the beam material properties, the effective prestress, the load-deflection characteristics, and the ultimate strength.*

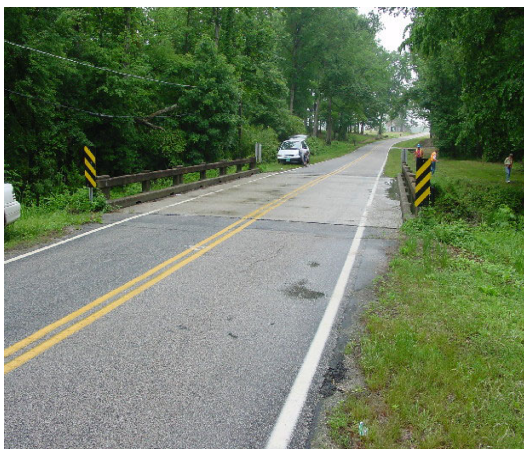
Fig. 1 NCDOT Bridge # 97029

The three-span, two-lane concrete block bridge is shown in service in Figs. 1 and 2. Each span had a length of 5283 mm (17 ft 4 in.) and an overall deck width of 7747 mm (25 ft 5 in.) supported by 19 prestressed block beams placed side-by-side as shown in Fig. 3. Each prestressed block beam was constructed by joining 26 concrete masonry units together, each with a height of 197 mm (7 ¾ in.), using mortar with a joint thickness of 6 mm (¼ in.). The cells of the blocks used on each end were filled with concrete to form a solid block to provide an increased bearing surface for the prestressing anchors and to carry the shear force into the substructure. Fig. 4 depicts the specially shaped concrete masonry block. It should be noted that dimensions are shown in units of millimeters with US units shown in parentheses.

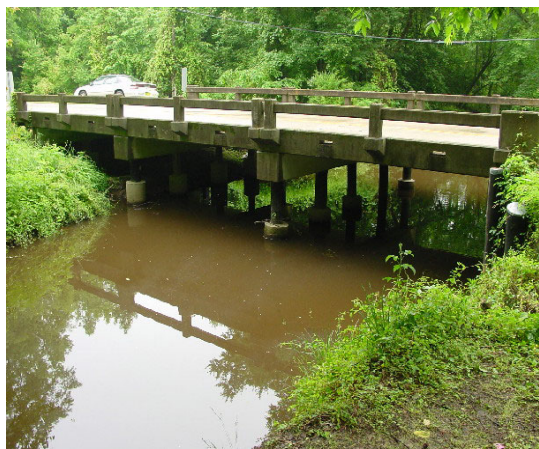
Fig. 2 The Substructure

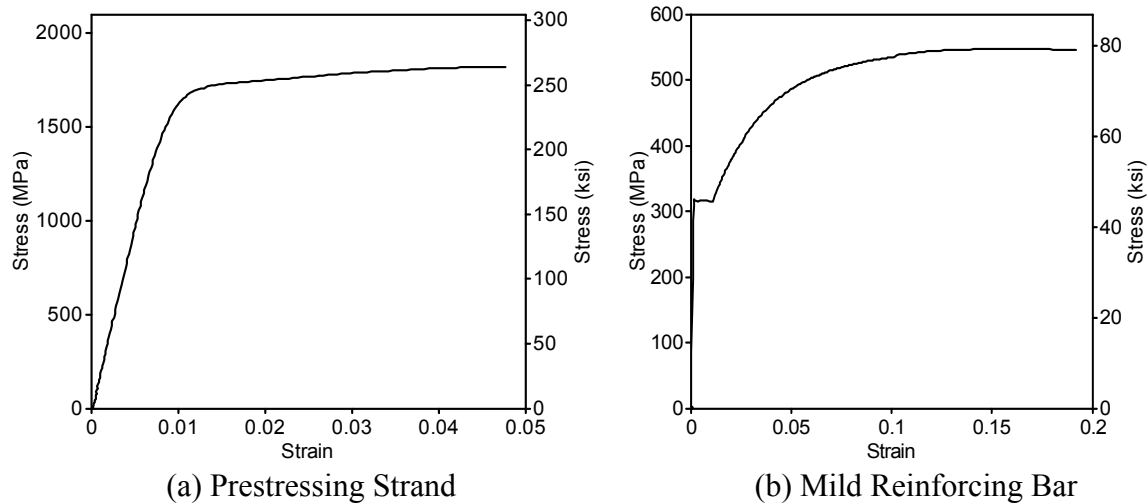
Fig. 7 Steel Stress-Strain Curves

The 9.5 mm (3/8 in.) seven wire prestressing strand sample was removed from girder 2 after flexural testing. The strand sample had been grouted, showing no signs of corrosion, and was located towards the anchorage, therefore would not have yielded during testing. 3/8 in. strand wedge anchors were installed on each end of the sample and subsequently gripped in a tensile testing machine. The strand was tested as per ASTM 370 (Test methods and definitions for mechanical testing of steel products) and Fig. 7(a) shows the resulting stress-strain curve, indicating a 0.2% offset yield stress of 1650 MPa (239 ksi) and an ultimate stress of 1821 MPa (264 ksi).

A sample of 19 mm (3/4 in.) mild reinforcing steel was extracted from a similar location as the prestressing strand in the same girder. The steel was in excellent condition, showing minimal signs of corrosion. The bar was tested as per ASTM 370 (Test methods and definitions for mechanical testing of steel products), resulting in the stress-strain curve depicted in Fig. 7(b), having a yield and ultimate stress of 315 MPa (46 ksi) and 547 MPa (79 ksi) respectively.

The stress-strain curve of the 3/8 in. prestressing strand shown in Fig. 7(a) confirms that the strand used in the bridge was of Grade 250. This was the industry standard in 1954.

The stress-strain curve of the mild reinforcing steel shown in Fig. 7(b) also confirms that the steel was of Grade 40, one that was commonly used in the 1950's.

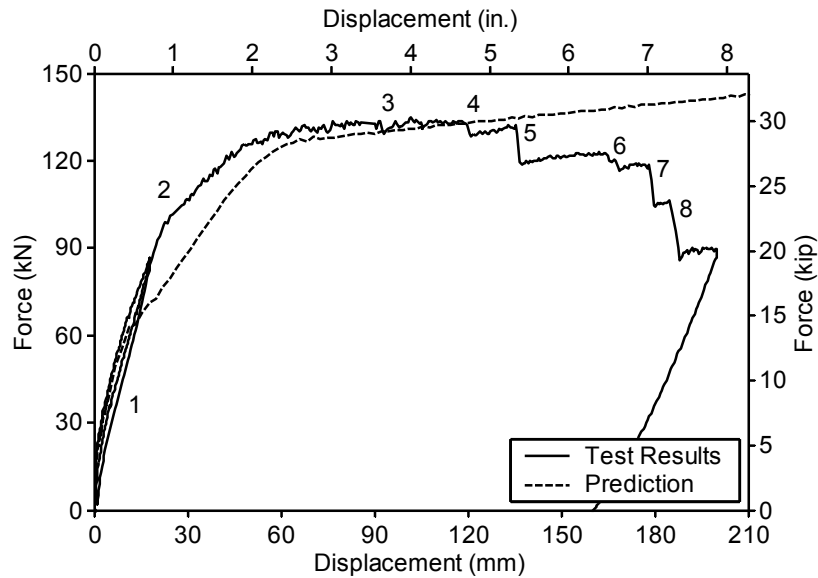
Fig. 9 Force-Displacement History Girder 1 – Flexure

Girder 1 was tested with a span of 4880 mm (16 ft.) and failed in flexure, with the force-displacement history shown in Fig. 9. The numbers on the graph refer to the following events that occurred during testing.

- 1) First cracking of the mortar joints at mid-span was recorded at a load of 37.8 kN (8.5 kips).
- 2) At a load of 111 kN (25.0 kips) the first cracking of face shells was recorded.
- 3) At a mid-span displacement of 92 mm (3.62 in.) with a corresponding load of 134 kN (30.1 kips), one wire in a 7-wire prestressing strand ruptured resulting in a small drop in load.
- 4) A further 2 wires ruptured at a displacement of 118 mm (4.65 in.).
- 5) An additional wire ruptured at a displacement of 135 mm (5.31 in.) resulting in some loss of face-shell. Crushing of compression concrete was first recorded.
- 6, 7, 8) Further wire rupturing and loss of masonry face shells was observed at displacements of 164 mm (6.46 in.), 167 mm (6.57 in.), 178 mm (7.01 in.) and 185 mm (7.28 in.).

A total of five tests were conducted. The first three were designed as flexure tests, but only the first test developed the true flexural failure. As seen in Fig. 9, the load-displacement curve from the test compares very well with the theoretical prediction before extensive cracking developed near the ultimate load. At the stage of progressive cracking, the experimental curve lies slightly above the theoretical curve, indicating the stiffening effect of the concrete in tension. Using the appropriate material properties of concrete and steel determined in this investigation, and neglecting the effect of small residual prestress, the theoretical ultimate load capacity of the beam was found to be 131 kN (29.4 kips) as compared to 134 kN (30.1 kips) obtained from testing, indicating an excellent prediction.

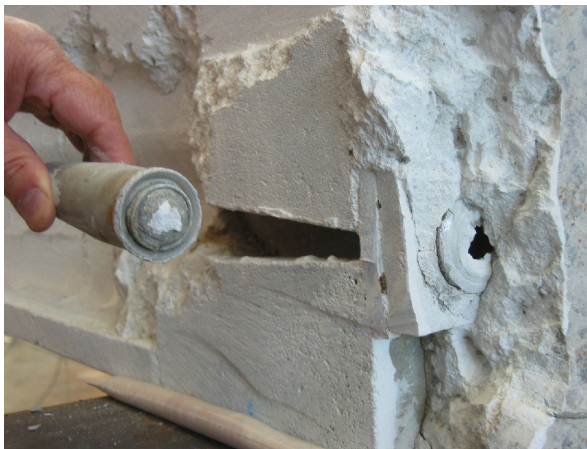
(a) Failed anchorage

Fig. 12 End of Testing Girder 2 in Flexure

have failed and testing was ended. Fig. 12(a) shows the anchorage after it had failed and Fig. 12(b) shows the cracked girder at the end of testing.

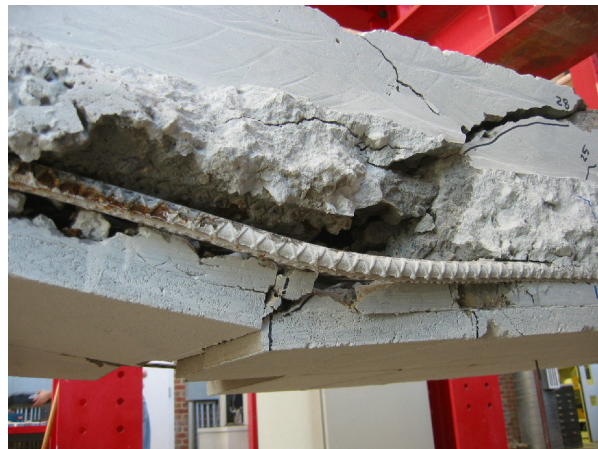
(b) Shear cracked girder
