STRANDS VERSUS BARS FOR POSITIVE MOMENT CONNECTION OF PCBT GIRDERS

Charles D. Newhouse, Ph.D., P.E., Dept. of Civil Engineering, Texas Tech University, Lubbock, TX

ABSTRACT

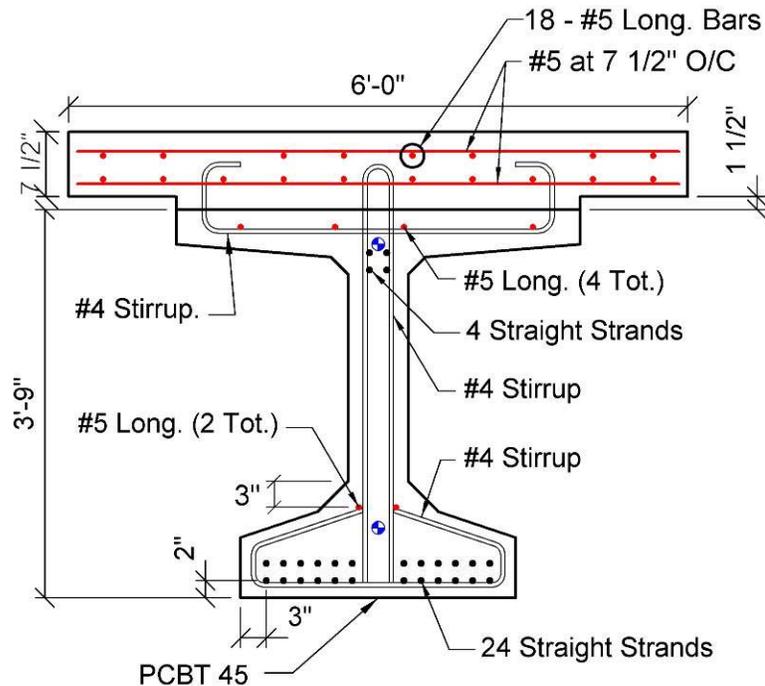
Fig. 1 Typical Test Section

Figure 1 shows the typical test section used for both tests. For each test, two full depth PCBT sections, each 15 ft 4 in. (4.67 m) long and 45 in. (1143 mm) deep were fabricated with different positive moment end connections. For Test 1, the bottom row of 12 - ½ in. (12.7 mm) diameter Grade 270 prestressing strands were extended 24 in. (610 mm) and bent up 9 in. (229 mm) from the ends of the girders. For Test 2, the prestressing strands were cut off flush with the ends of the girders and 4 - No. 6 (19M) Grade 60 hairpin bars were extended 11 in. (279 mm) from the ends of the girders. After fabrication, the girders were transported to the Structures and Materials Laboratory at Virginia Tech where the girders for Test 1 were assembled and the girders for Test 2 were placed in temporary storage.

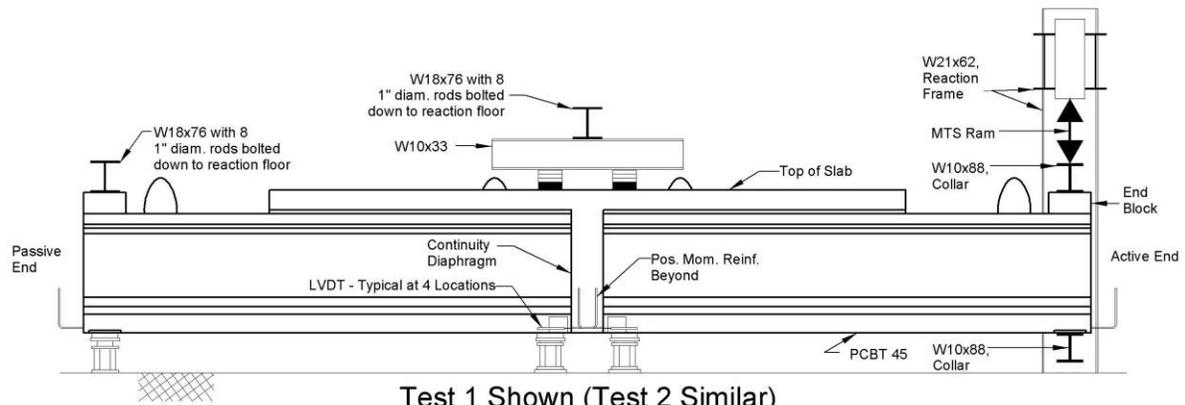
Fig. 2 Elevation of Test Setup

Figure 2 shows a side elevation of the test setup and Figure 3 shows a close-up of one of the LVDTs used to measure the openings at the interface of the end of the girder and the diaphragm. Two girders for Test 1 were set end to end with a gap of 12 in. (305 mm) from

Test 1 Shown (Test 2 Similar)

the ends of the girders to produce a two span continuous test setup. The center-to-center bearing length was 14'-0" (4.27 m). Formwork and reinforcing steel were placed to connect the specimens with a reinforced continuity diaphragm and a continuous 6 ft wide (1.83 m) deck. The concrete for the deck and the diaphragm was placed in one pour and was allowed to moist cure for 7 days. The formwork was then removed and the deck concrete was allowed to cure until the target compressive strength of 4,000 psi (27.6 MPa) was reached. Transfer beams were then placed across the top of the specimens at the passive end and the center and bolted down to the reaction floor. The support for the active end was removed and a frame with an MTS actuator was used to support the end with collar beams. This arrangement allowed for the active end of the two span setup to be moved up and down to apply both positive and negative moments at the continuity connection. The test setup for Test 2 was similar, except that the gap at the ends of the girders was 13 in. (330 mm).

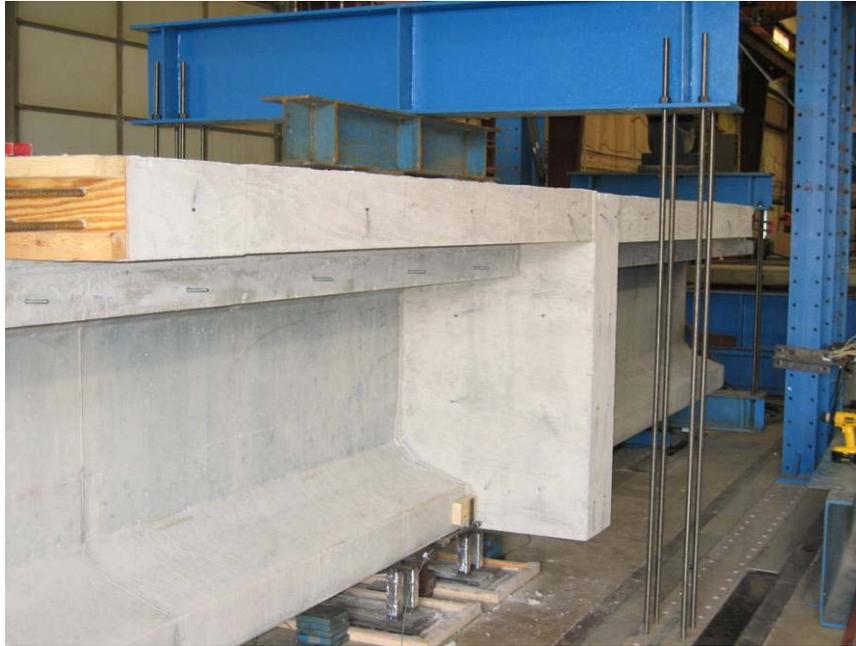
Fig. 4 Overall Test Setup

Figure 4 shows an overall photo of a test setup for Test 1. The setup for Test 2 was similar. A transfer beam bolted down to the reaction floor is located directly above the continuity diaphragm and the MTS actuator is attached to the far end of the setup with the two collar beams.

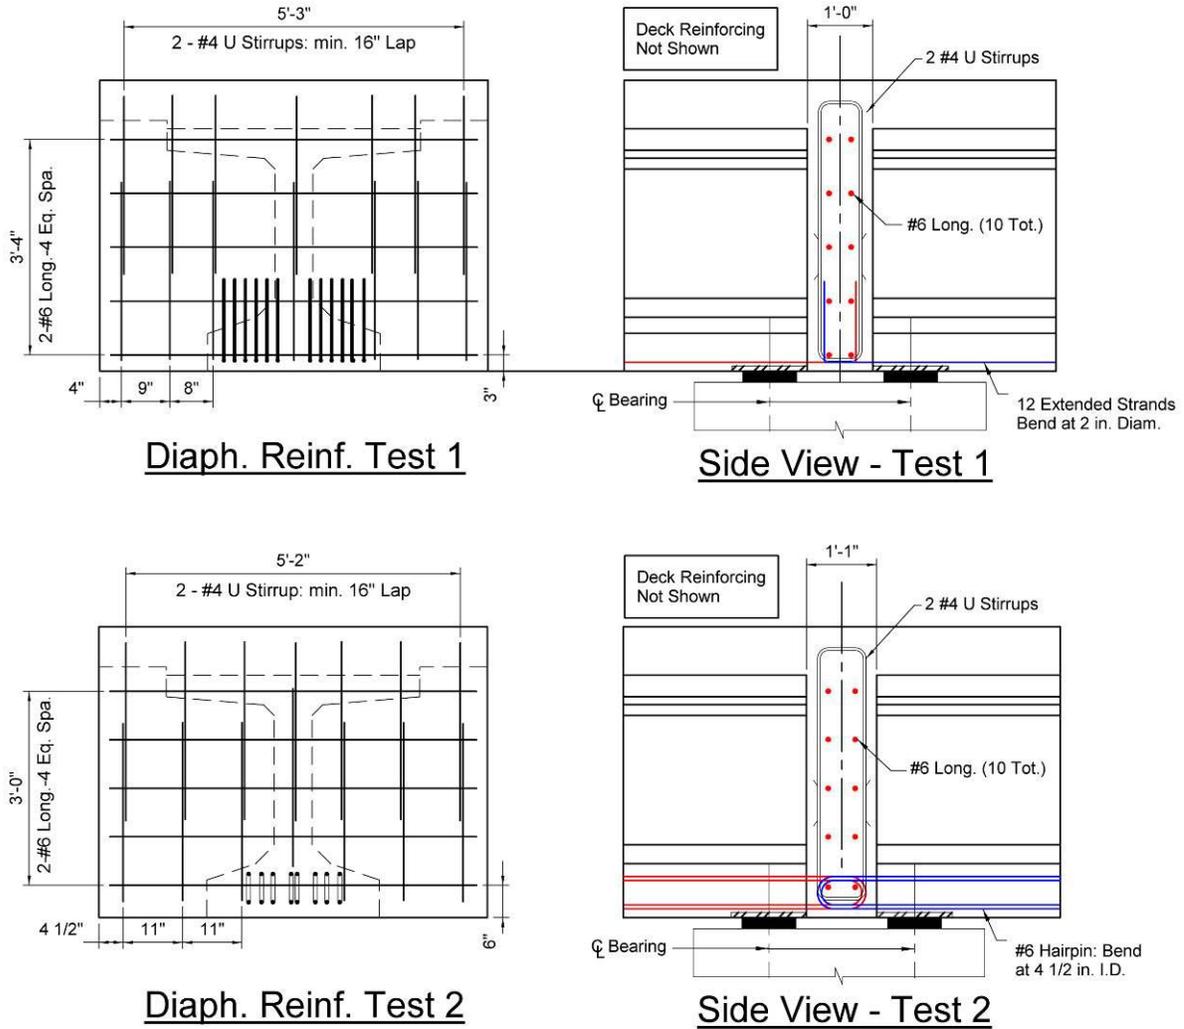
Fig. 5 Details of Continuity Diaphragm Reinforcing

The connections were designed to resist the maximum positive design moment using an easy to construct cast-in-place connection. The 2 in. (50.8 mm) on center pattern for the prestressing strands within the girder was not changed since doing so would result in additional work for the fabricator. For the connection with the extended strands, Test 1, the entire bottom row of 12 prestressing strands were extended and bent up at 90 degrees. For the connection with the extended bars, Test 2, four No. 6 (M19) hairpin bars were placed against the prestressing strands and extended out 11 in. (279 mm). The strands were cut off flush with the end of the girder. Since the recent NCHRP Report 519 did not recommend relying on the embedment of the girder into the diaphragm to provide for an increase in moment resistance, the ends of the girders were designed to be flush with the face of the continuity diaphragms.⁵ For simplicity, the continuity diaphragm and the deck were cast at the same time.

The ultimate positive moment capacity of the connection in Test 1 with the strands was calculated using the allowable ultimate stress in the strands from Equation 1 shown previously. This equation allows the stress in the prestressing strand to reach 98.2 ksi (677 MPa) at ultimate, only 36 percent of its design ultimate strength of 270 ksi (1860 MPa). For Test 2 with the bars, Whitney's equivalent stress block with a phi of 0.9 was used to determine the ultimate positive moment capacity. Figure 5 shows the details of the reinforcing at the continuity connections. The No. 6 (19M) hook bars were designed with the top leg extending 5 ft (1.52 m) into the end of the girder and the bottom leg extending 4 ft (1.22 m) into the end of the girder (based on recommendations in Reference 5). However,

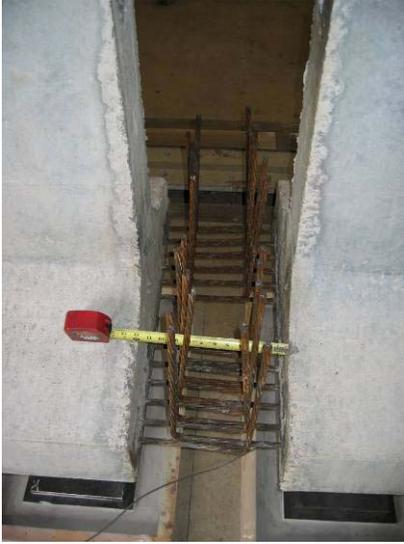
Fig. 6 Extended Strands for Test 1

the bars were fabricated with equal length legs, with both the top and bottom legs extending approximately 4 ft (1.22 m) into the end of the girder. Figure 6 shows the extended strands for Test 1 and Figure 7 shows the extended bars for Test 2.

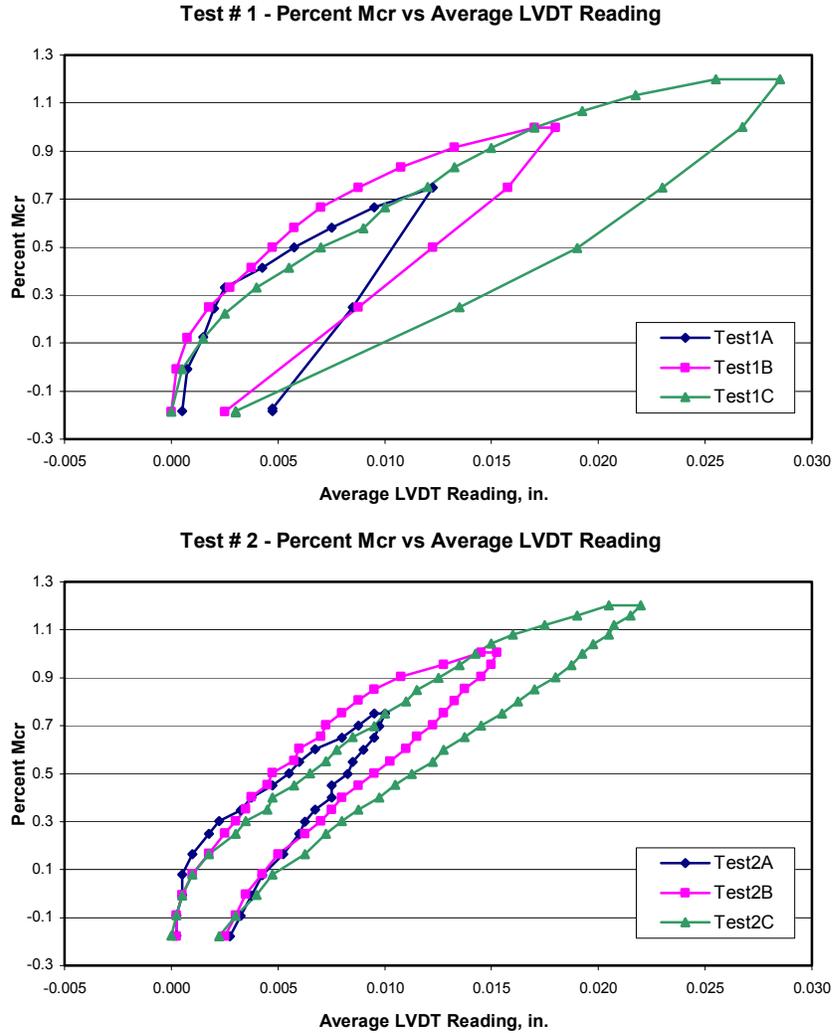
Fig. 8 Service Test Results

The results of the service tests, Tests A through C, for both Test 1 and Test 2 are shown in Fig. 8 at the same scale so that an easy comparison can be made. The moment applied to the continuity diaphragm as a fraction of the design cracking moment, M_{cr} , is plotted on the vertical axis and the average measured LVDT reading at the bottom of the interface of the continuity diaphragm and the end of the girder is plotted along the horizontal axis. Four LVDTs, one at each of the four corners, were placed near the bottom of the interface to measure the crack openings at those locations (see Figure 3). The magnitudes of the crack openings at the four locations were similar, so the results are presented as an average of the four values. The LVDT readings compared well with visually observed measurements of the crack openings using both a crack comparator card and dial gages.

The initial visual cracking at the bottom of the interface occurred at approximately $0.41 M_{cr}$ (215 ft-kips or 292 kN-m) for Test 1 and $0.45 M_{cr}$ (236 ft-kips or 320 kN-m) for Test 2, both much lower than the design cracking moment $1.0 M_{cr}$ of 523 ft-kips (709 kN-m). This behavior was not unexpected, since the interface at the end of the girder acts as a cold joint, the cracking that occurred can be considered as debonding of the diaphragm concrete from the end of the girder. Even though the cracking is not desirable at such a low moment, the cracking or debonding was well defined along the interface, allowing for possible easy mitigation.

Based on the shapes of the responses to the initial tests shown in Figure 8, the two tests show similar responses to the initial service tests. However, Test 2 with the extended bars exhibited slightly smaller crack openings at the bottom of the interface than Test 1. The ratio of the design ultimate positive moment of Test 1 to Test 2 was 0.92, while the observed ratio of the average LVDT reading of Test 1 to Test 2 was 1.32, indicating that based on the design ultimate positive moments, Test 2 displayed a stiffer response to the initial service tests.

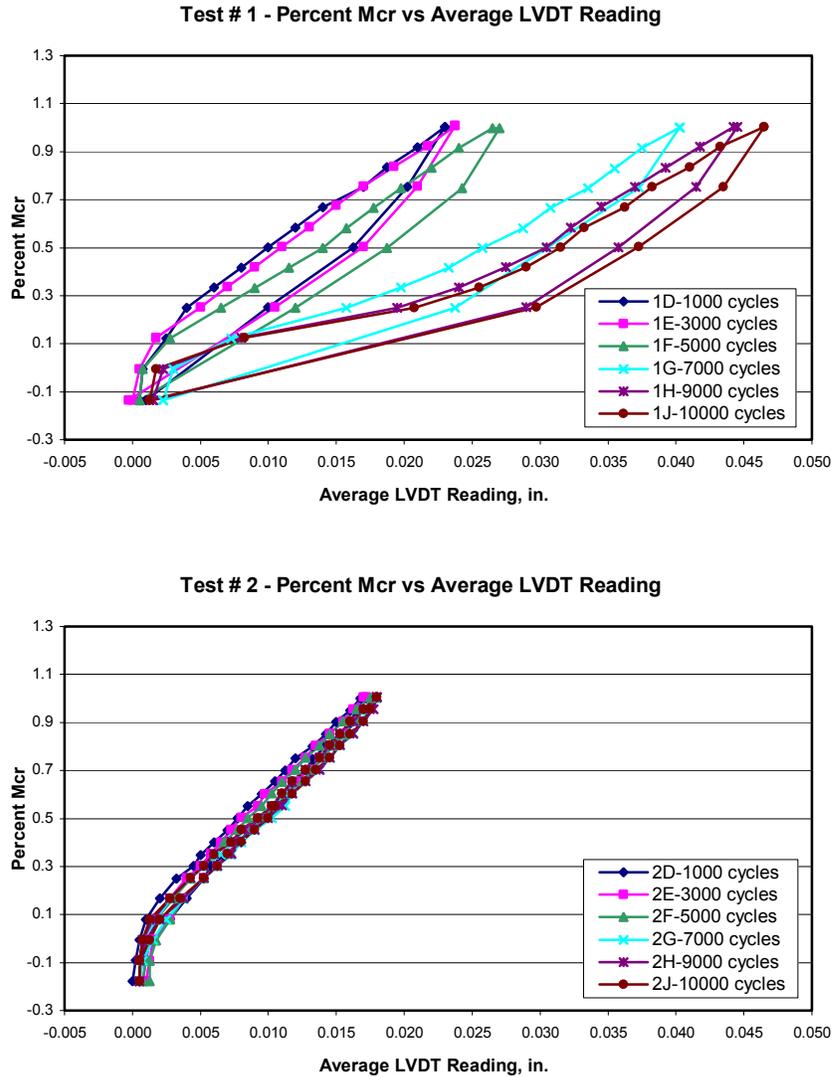
Fig. 9 Cyclic Test Results

The results of the cyclic tests, Tests D through J, for both Test 1 and Test 2 are shown in Figure 9 at the same scale so that an easy comparison can be made. The two span specimens were initially subjected to an active end load that would cause a zero applied moment at the continuity connection in order to zero all of the instrumentation. A set of measurements was taken, the cyclic loads were applied, and then the specimens were tested up to 1.0 times the design positive cracking moment, M_{cr} . The percent of the cracking moment applied is shown on the vertical axis and the average measured LVDT reading is shown on the horizontal axis. The cyclic loads included both positive and negative moments, but the loading for the response shown in the figure was done only in the positive moment range in order to match Tests A through C.

Both tests maintained integrity throughout the cyclic loading phase and were able to withstand the applied moment of 1.0 times the cracking moment even after being subjected to 10,000 cycles. However, by comparing the responses, it is apparent that Test 2 with the bars performed better than Test 1 with the strands. After application of the 10,000 cycles, Test 1 displayed an average LVDT opening of 0.047 in. (1.19 mm) while Test 2 displayed an average LVDT opening of only 0.018 in. (0.46 mm), approximately 2.6 times less opening at the interface. Therefore, under cyclic loads, Test 2 remained stiffer than Test 1.

The response of Test 2 to the cyclic loads remained virtually unchanged throughout the testing. However, the response of Test 1 did change significantly. As Salmons reported, untensioned prestressing strands have been observed to develop a tendency to slip when

pulled in tension.⁸ It is believed that as the untensioned strands in the diaphragm are pulled, the wires have a tendency to twist and locally unwind through the surrounding concrete. For a pretensioned strand, Hoyer's effect acts to counteract the loss in development due to the twisting action. However, for the strands in the diaphragm which are not pretensioned, it is believed that the strands developed a lower bond throughout the applied cycles because of the unwinding of the strands from the location of the interface to the 90 degree bend and localized concrete damage. This lower bond allowed the magnitude of the cracking as measured by the LVDT readings to increase.

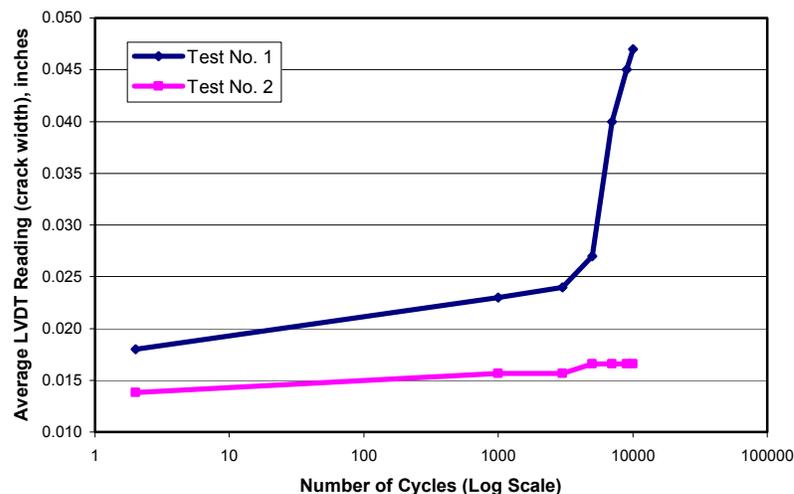
Fig. 10 Average LVDT Reading versus Number of Cycles

Figure 10 shows average measured LVDT reading on the vertical axis plotted against the number of cycles shown on a log scale on the horizontal axis. Test 2 shows desirable behavior, with a slight, linear increase in the average measured LVDT reading throughout the 10,000 cycles. Test 1 shows undesirable behavior beginning at approximately 5,000 cycles, with a significant increase in the average measured LVDT reading.

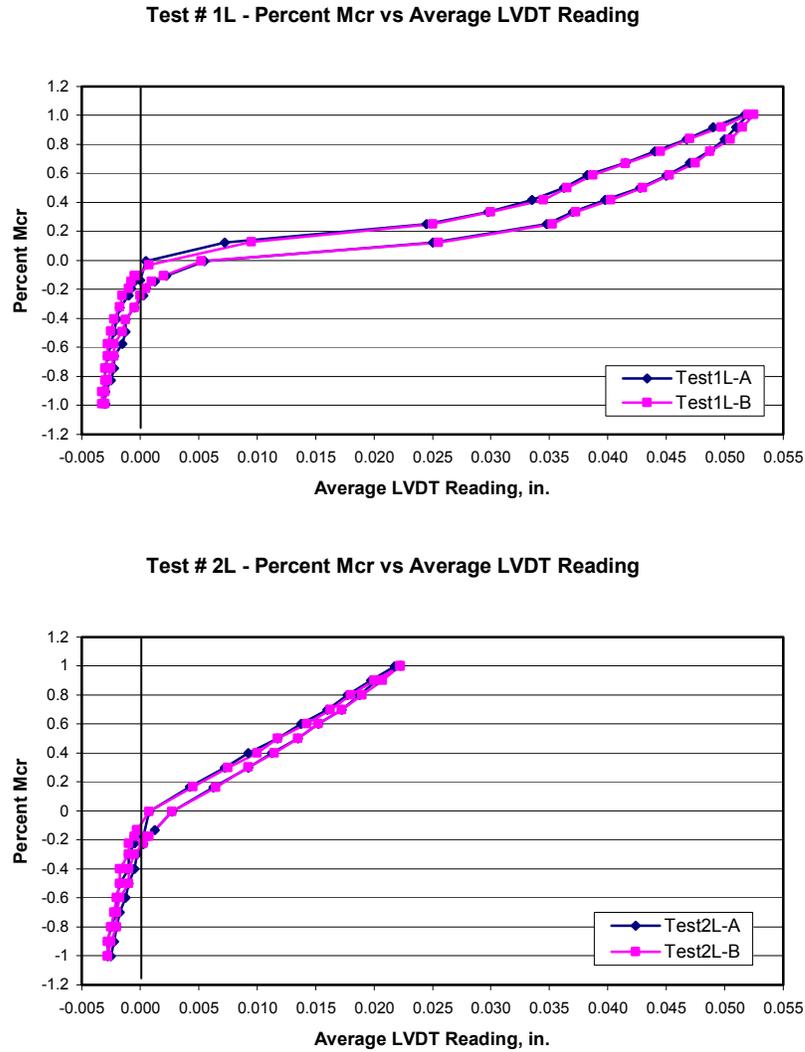
Fig. 11 Negative Moment Testing Results

Figure 11 shows Test L for both Test 1 and Test 2. Both tests were performed by first applying a positive cracking moment and then applying a negative cracking moment. Two complete load cycles were performed for each test, the first cycle designated “A” and the second cycle designated “B”. Both tests display good repeatability from the first cycle to the second. Test 1 continued to display a response indicating that the strands were twisting through the diaphragm concrete until the 90 degree bend is engaged. Test 2 displays a nearly linear response in both the positive and negative moment directions.

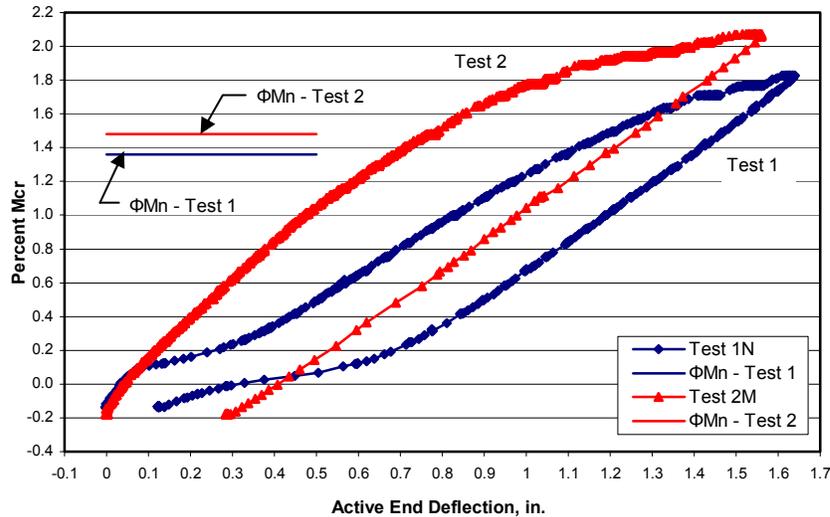
Fig. 12 Ultimate Strength Test Results

The purpose of the ultimate strength testing was to confirm the design ultimate positive moments could be obtained even after the cyclic loading. Both tests were taken to a near failure positive moment by increasing the active end deflection and monitoring the applied load. Figure 12 shows the results for both Test 1 and Test 2, with the applied moment on the vertical axis and the observed active end deflection along the horizontal axis.

For safety reasons, the bottom of the diaphragm could not be monitored continuously during the test. However, it was inspected periodically in order to determine when first cracking occurred in the bottom of the diaphragm. For consistency, the capacities are presented as a fraction of the design positive cracking moment, 523 ft-kips (709 kN-m). For Test 1, first cracking was noticed at an applied moment of $1.4M_{cr}$, and for Test 2, first cracking was noticed at an applied moment of $1.2M_{cr}$. Both tests reached and exceeded the design ultimate positive moments. For Test 1, the observed capacity approached slightly over $1.8M_{cr}$ while the design ultimate moment, ϕM_n , was $1.36M_{cr}$. For Test 2, the observed capacity approached slightly over $2.0M_{cr}$ while the design ultimate moment, ϕM_n , was $1.48M_{cr}$. The ratio of the observed to design moments was 1.32 for Test 1 and 1.35 for Test 2. Therefore, both design methods for predicting the design ultimate positive moments provided conservative estimates, over predicting the capacities by factors of 1.32 and 1.35, respectively.

Significant cracking occurred on the bottom of the continuity diaphragms for both tests near the ultimate loads, indicating that both the strands and the bars were able to transfer tensile forces well beyond the forces required to be transferred for service loads. The cracking on the bottom of the diaphragm was limited to a region confined within the width of the bottom flange of the girders, also indicating that the transfer of load within the connection occurred primarily within the width of the bottom flange of the girder.
