ALL-PRECAST CONSTRUCTION SPEEDS CRITICAL BRIDGE REPLACEMENT PROJECT

Robert C. Larson, PE, Alpha & Omega Group, Raleigh, NC
Richard Nickel, Carolina Bridge Company, Inc., Orangeburg, SC

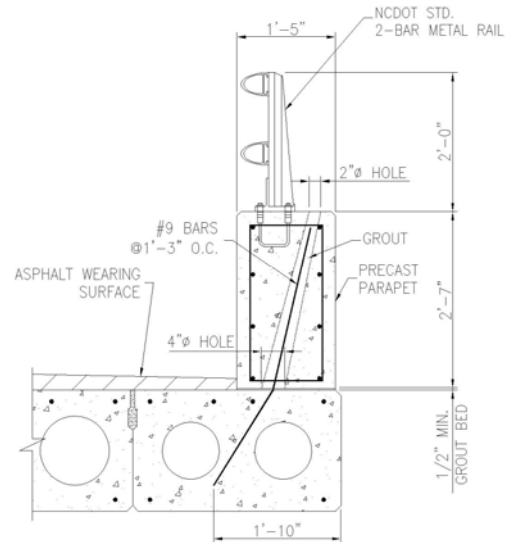
Upon award of the contract, Carolina Bridge employed Alpha & Omega Group (A&O) to design a contractor-proposed alternate parapet as a means to reduce construction time. The contract plans specified the parapet as precast sections most of which were 10' (3.05 m) in length. (Figure 2) Each section was to be set in place on a mortar bed, and then connected by grouting to reinforcing steel projecting from the slabs. The contractor proposed instead to cast the parapets directly onto the exterior slab units at the precasting plant, after transfer of prestressing force to the units and removal from the forms. By eliminating the handling, grouting, and curing of 234 parapet segments he hoped to ensure completion on or ahead of the required schedule. Other benefits of the alternate parapet design included fewer joints in the parapet, elimination of field connections, better detail at skewed joints, and a more positive bond between the parapet and the voided slab unit. The parapet change was proposed at no additional cost to the State.

Figure 2: Contract parapet design

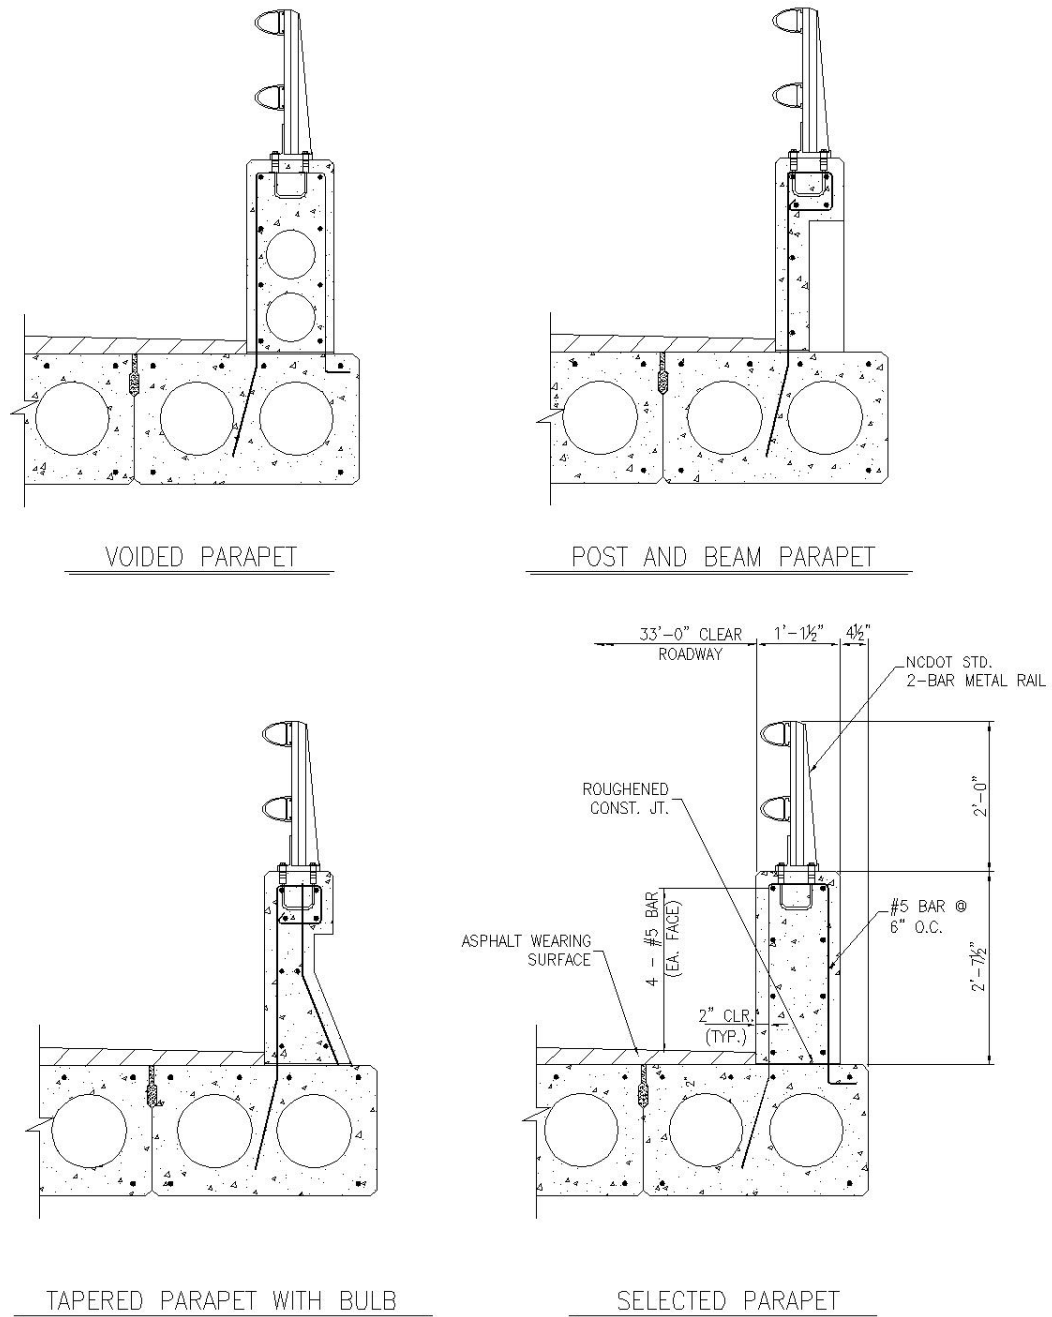
After preliminary discussions with NCDOT, A&O abandoned the contractor's original concept of using a standard three-bar metal railing on a shortened parapet, as it did not meet the code vehicle impact requirements (TL-3 Criteria from AASHTO LRFD Code). Several parapet configurations were then considered, (Figure 3) with the goal of minimizing the combined shipping and lifting weight of the 50' (15.24m) exterior slab unit with parapet attached (the heaviest piece to be handled on the project). Options considered included (1) a rectangular parapet with longitudinal circular voids, (2) a concrete post-and-beam parapet with a web wall at the traffic face, and (3) a parapet with a bulb at the top and a tapered outside face. Ultimately a rectangular parapet fabricated from sand lightweight concrete was selected. Compressive strength of the concrete at 28 days (f'_c) was 5000 psi (34.5 MPa) and the design unit weight was 120 pcf (1920 kg/m).

Figure 3: Parapet options considered

Parapet thickness and reinforcing were determined using the AASHTO Load Factor Design method. The design transverse loading was a 54,000 lb. (240 kN) horizontal load applied at 24" (610 mm) above the roadway surface (LRFD TL-3 Criteria). Shear force controlled the thickness of the parapet section and a 1'-1 1/2" (343 mm) thickness was selected. (Shear strength was one of the few code requirements where the use of lightweight concrete affected the design with a 0.85 reduction factor being applied.) To resist moment at the base of the parapet, #5 vertical reinforcing bars were provided, spaced at 6" (152 mm) on centers along the parapet. The above parapet design was then analyzed using the yield line analysis method from the AASHTO LRFD Code, and found to be adequate.

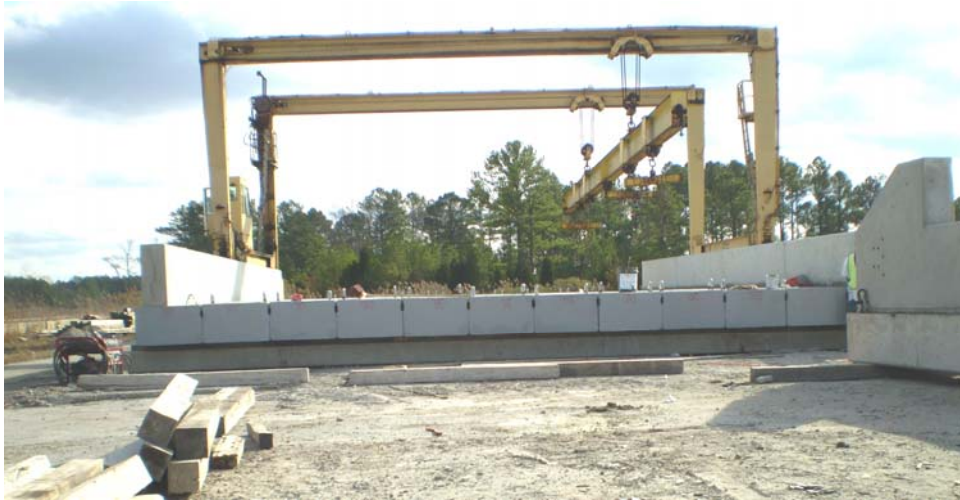
The 240 voided slab units, as well as over 200 - 12" (305 mm) and 16" (407 mm) square prestressed piles, were fabricated by Bayshore Concrete Products Corporation at Chesapeake, VA. Precast reinforced bent caps were fabricated by Florence Concrete Products, Inc., Florence, SC. After the slab units were cast using conventional methods, the exterior units were moved to an unused casting bed for placing of the parapets. Parapet forms were supported independently of the slab unit. In this way, the forms would remain level even as the slab deflected due to the weight of the plastic concrete, ensuring a straight finished product. Mock erection and match-marking of each span is standard practice (Figure 4), but in this case two spans at a time were erected in sequence to further check the parapet alignment between spans. The contractor made several trips to the prestressing plant during fabrication to inspect the quality and alignment of the parapets.

Figure 4: Mock erection at prestressing plant

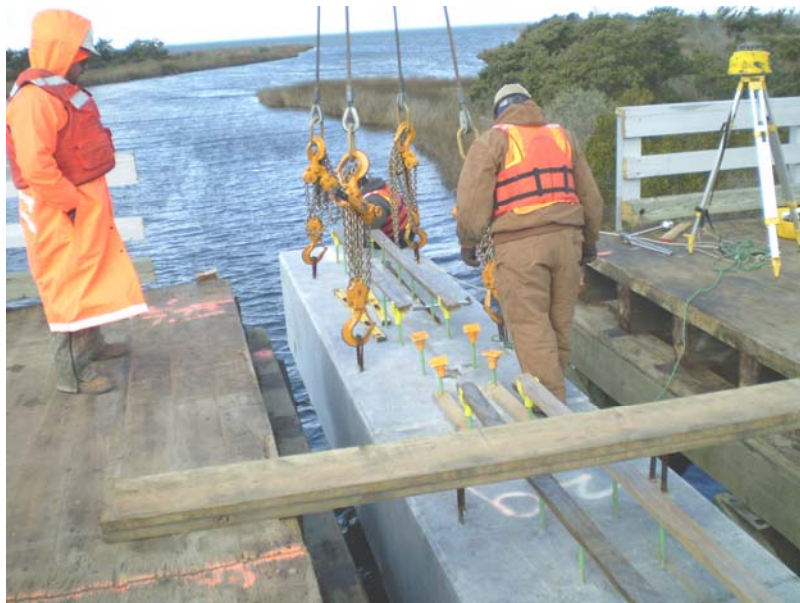
Meanwhile, construction was well underway at the project site, proceeding from north to south. Once the roadway was closed on January 2, the pile driving crew could work uninterrupted. Following closely behind, a second crew installed precast caps on the piles (Figure 5). Frequently, the two crews were working simultaneously on a single bridge, and both crews used the existing timber structures as a working platform (Figure 6). As conditions (primarily temperature) permitted, a third crew followed, mixing and pumping the grout to permanently connect the piles and caps. Once this grout had cured and the remaining timber structure was removed, the superstructure slab units were installed span by span (Figure 7).

Figure 5: Precast cap segment being placed between sections of existing deck.

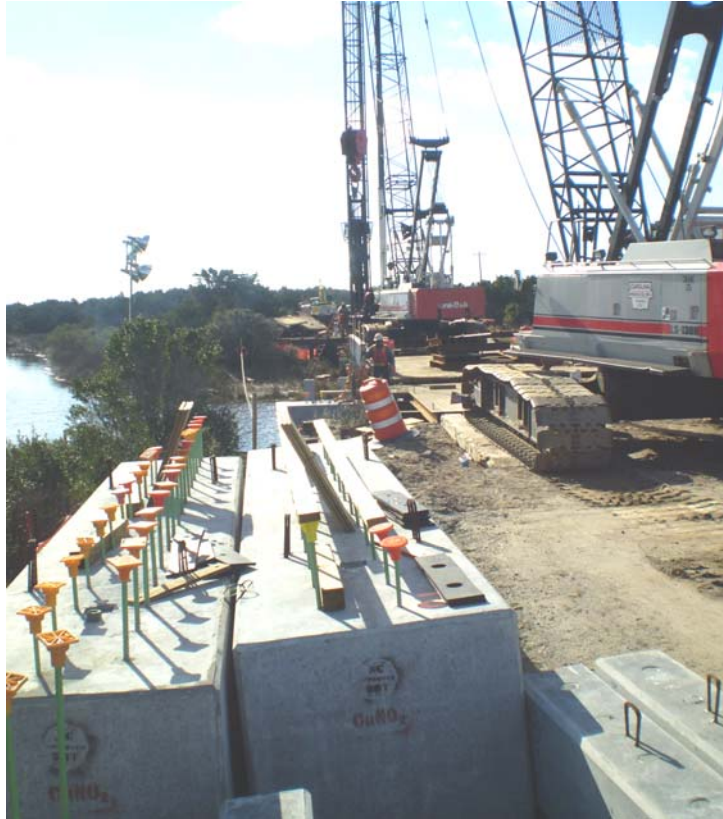
Figure 6: Substructure cap segments being placed by crane in foreground while piles are driven on the same bridge (background).

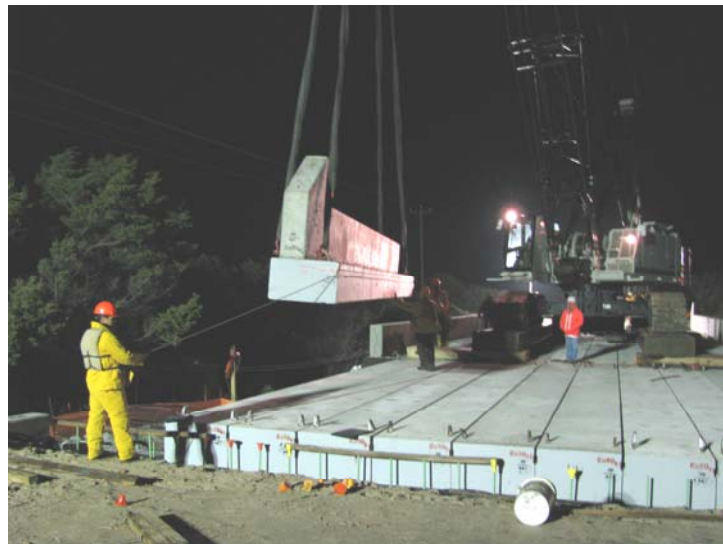
Figure 7: Field erection of precast slab and parapet.

As each span was placed, the crane moved out onto the new span to place the units for the next span. In this way, each structure was constructed “top down” as required by the contract documents. Finally, the slab units were posttensioned transversely and shear keys were cast

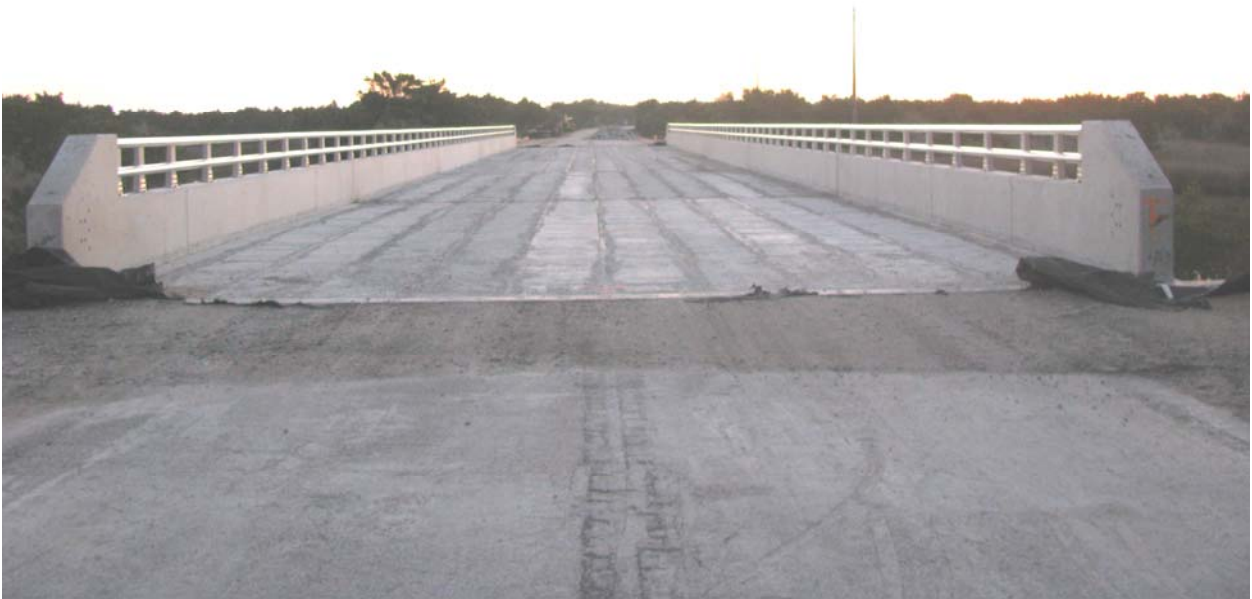
between the slab units to lock the units together permanently. At this point, the bridges were substantially complete and suitable for traffic under temporary conditions (Figure 8).

Figure 8. All precast sections in place, bridge ready for traffic.
